Batavia Kill Watershed

Stream Design and Monitoring Evaluation

Greene County, New York

Design Report Prepared by Buck Engineering PC

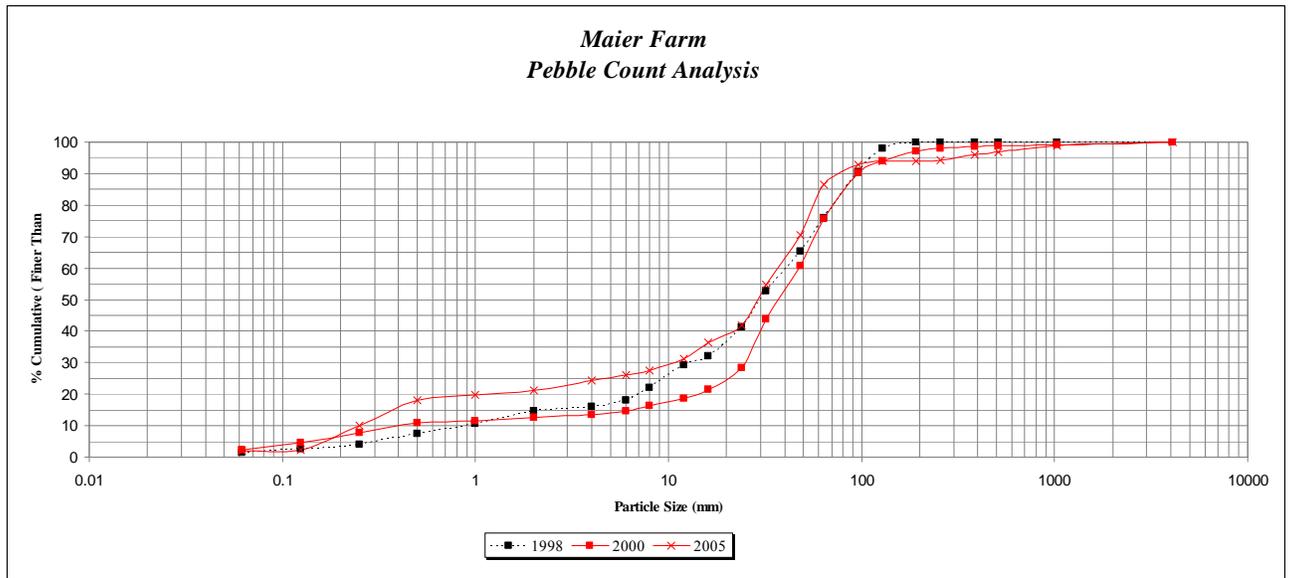
Figure 4. Cumulative pebble count data for the Maier Farm Site.

Cumulative pebble count data for the Maier Farm Site during 1998, 2000, and 2005 are compared in Figure 4. A graph showing data from all sampled years is provided in Appendix A. Pre-restoration data (1998) are colored black, while post-restoration data (2000 and 2005) are colored red, with different line styles and symbols for two different years. The data show that the pebble count distributions vary from year to year, but there are few observable trends in the data when comparing pre-restoration data to post-restoration data. Post-restoration data fall around the pre-restoration data, with year to year variability showing no apparent trends in the mid-regions of the distribution. In the lower and upper portions of the distribution (fine sediment and cobble size fractions, respectively), the data indicate that there is a larger percentage of fine sediment and cobble material in the post-restoration channel. This trend is most likely due to the lack of pre-restoration data. Data for pre-restoration conditions were collected from one cross section, most likely in a riffle location. Post-restoration data were collected from multiple cross sections, including riffles and pools. Therefore, the trend towards finer sediment in the post-restoration channel could be attributed to the difference in

sampling one riffle versus a combination of riffles and pools. The trend towards larger cobble size material in the post-restoration channel could also be attributed to the sampling or more riffle locations along the reach following restoration.

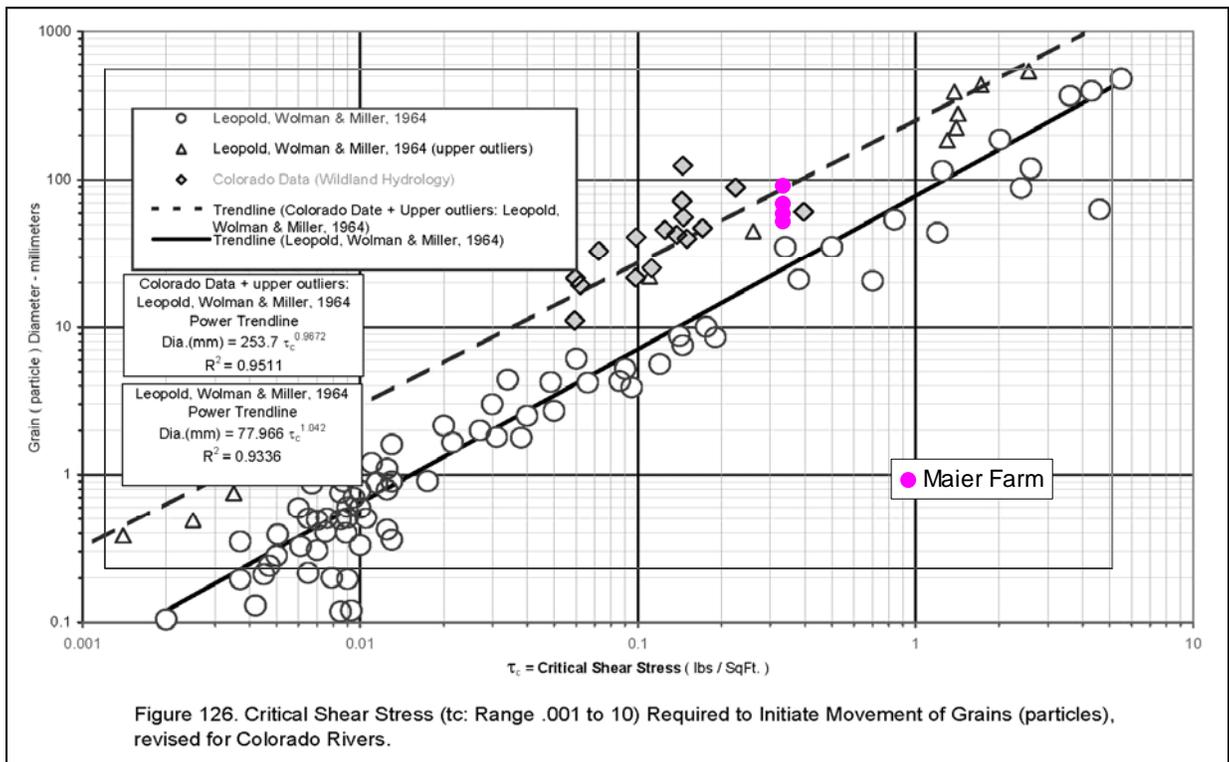
Figure 5. Shields Curve Diagram showing Maier Farm critical shear stress calculations for each monitoring year.

The largest particles sampled from the bar were plotted against the boundary shear stress and are shown in Figure 5. The largest particles sampled from the bar are smaller than those sampled from Brandywine. However, the particle size variability is within the range of the data used to develop the Colorado trendline. Furthermore, the lower as-built and post as-built mean bankfull riffle depths produce boundary shear stress values that are closer to 0.3 lbs/ft². From the Colorado curve, this shear stress produces a particle size of 78 mm. The average of the largest bar samples was 82 mm. In other words, the as-built and post as-built mean depths represent the competency requirements better than the design.

Overall, the sediment transport competency analysis suggests that the channel dimension and slope are sufficient to prevent long term aggradation or degradation. Observed fluctuations in the bed elevation are part of the natural variability associated with channels responding to large floods.

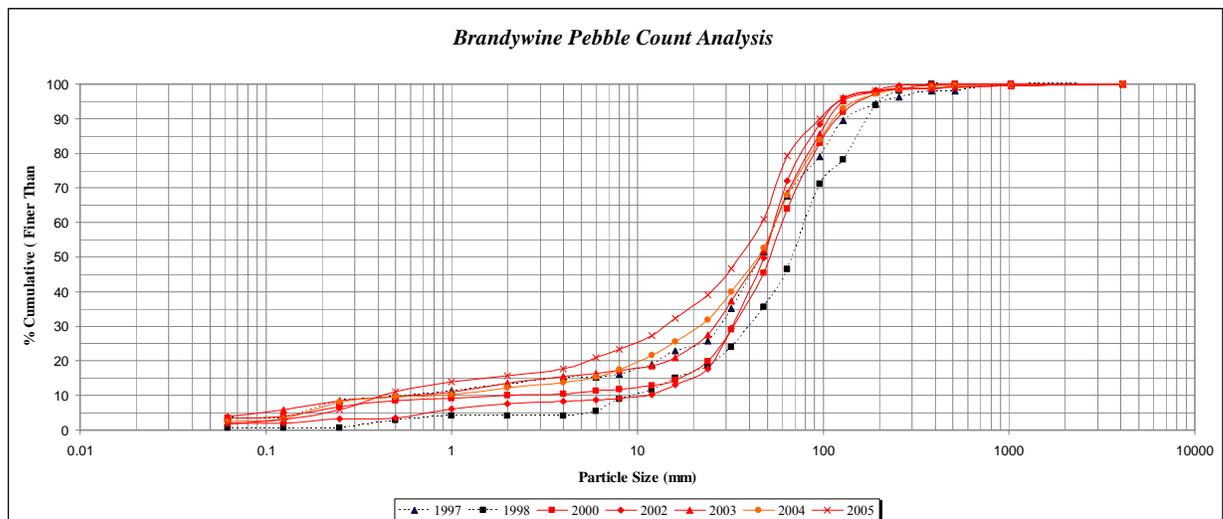
Figure 6. Cumulative pebble count data for the Brandywine Site.

Cumulative pebble count data for the Brandywine Site are compared in Figure 6. Pre-restoration data are colored black, while post-restoration data are colored red, with different line styles and symbols for different years. The data shown for 1997 and 1998 (pre-restoration sampling years) can be viewed as an indication of natural variability in bed material samples from year to year, since no modifications were made to the project reach during these years.

The post-restoration data from 2002 through 2005 indicate a trend towards the bed material becoming finer. For these years, particles in the D20 to D50 range become smaller each year. For sampling year 2005, particle sizes in the D10 to D95 range are the smallest of any sampled years. To further investigate this trend, cumulative bed material samples were compiled for each post-construction year for only riffle features. This analysis was conducted to determine if fine material was collecting in pools and skewing the overall data. The data compiled for riffles are presented in Figure 7.

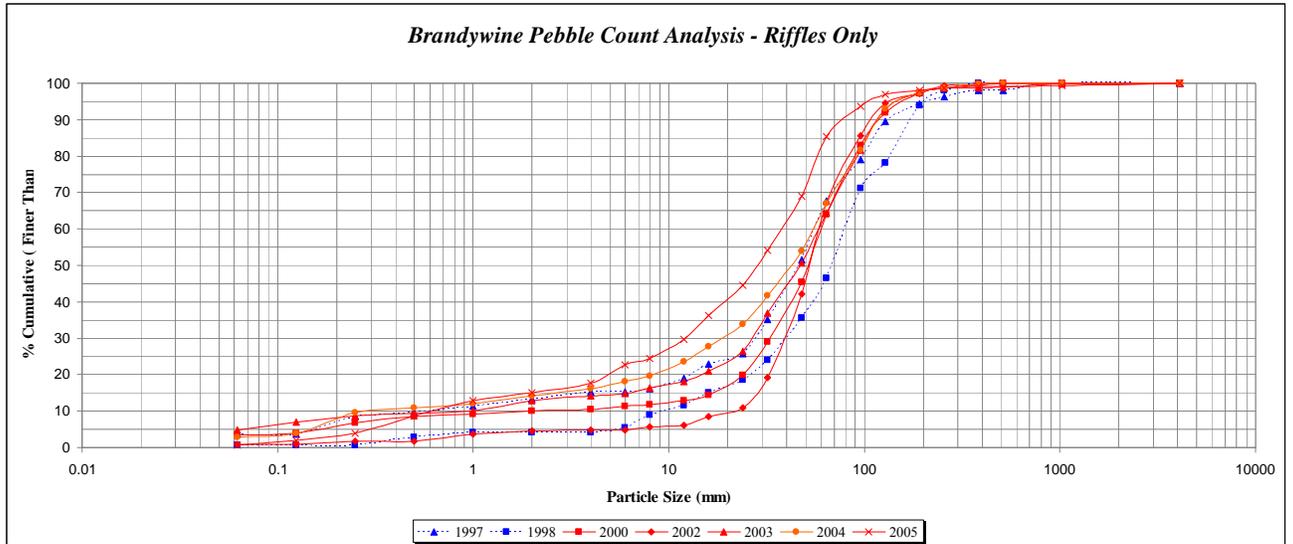
Figure 7. Cumulative pebble count data for the Brandywine Site, using riffles only.

The trend towards finer bed material is more apparent in the data compiled for riffles, indicating that overall particle distributions have become finer from 2002 through 2005, including riffle features.

While there is an apparent trend towards finer bed material over the past four years, the cause of this trend is more difficult to determine. Possible causes for the trend could be increased instability within the project reach, increased instability and fine sediment production in the upstream watershed above the project, or an influx of fine sediment produced during the extreme storm events during 2005. To accurately identify which of these possible causes is responsible for the observed trend, the sediment monitoring plan for the site will need to be modified in a way to allow assessment of causes. Future monitoring of sediment levels and bed material conditions in an upstream control reach could provide valuable information.

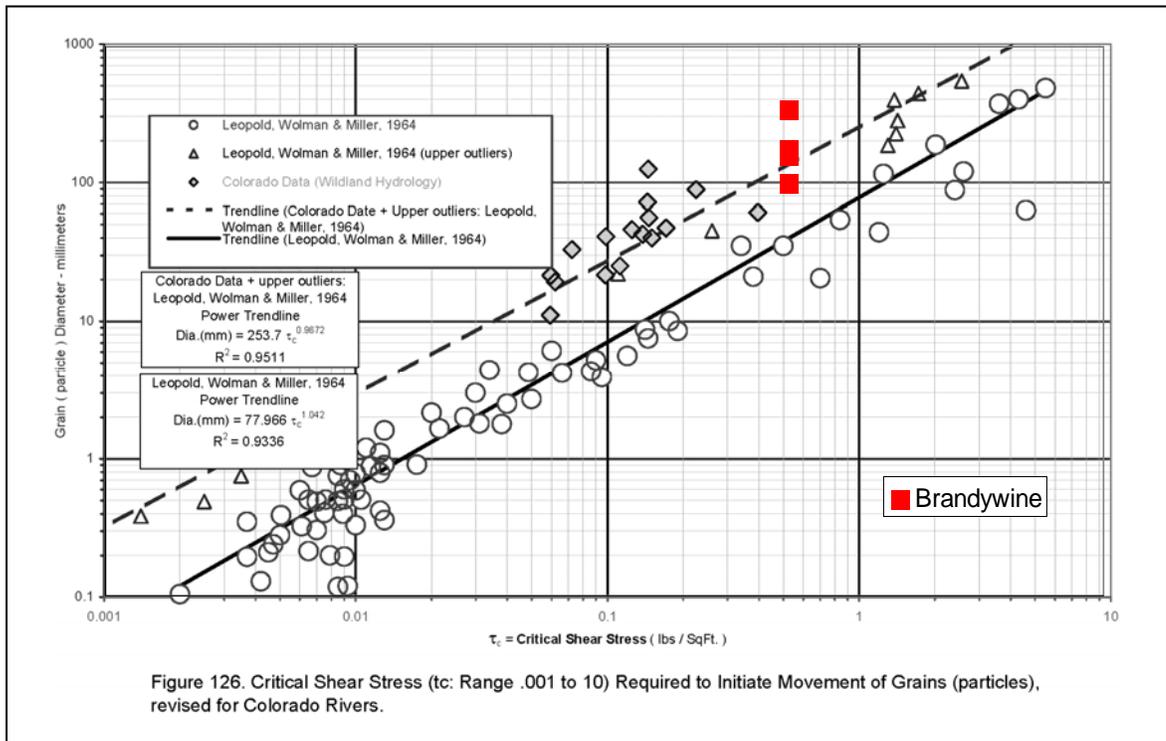
Figure 8. Shields Curve Diagram showing Brandywine critical shear stress calculations for each monitoring year.

B) Boundary Shear Stress Analysis. The boundary shear stress for the design riffle was 0.55 lbs/ft². The largest particles sampled from the bar were plotted against the boundary shear stress and are shown on Figure 8. The graph shows that these data bracket the dashed trendline within the range of the plotted data. For a shear stress of 0.55 lbs/ ft², the trendline predicts that a particle size of 142 mm should be mobile. It appears that the Colorado trendline is a reasonable predictor of the largest particle that would be deposited on a point bar during a bankfull discharge.

Overall, the sediment transport competency analysis shows that the bed material became finer after the large floods, both on the riffles and the point bars. The required depth analysis supports the cross section and profile observations (in the upper reach) that aggradation is more of a concern than degradation. The degradation in the lower reach cannot be explained by this analysis. Finally, the

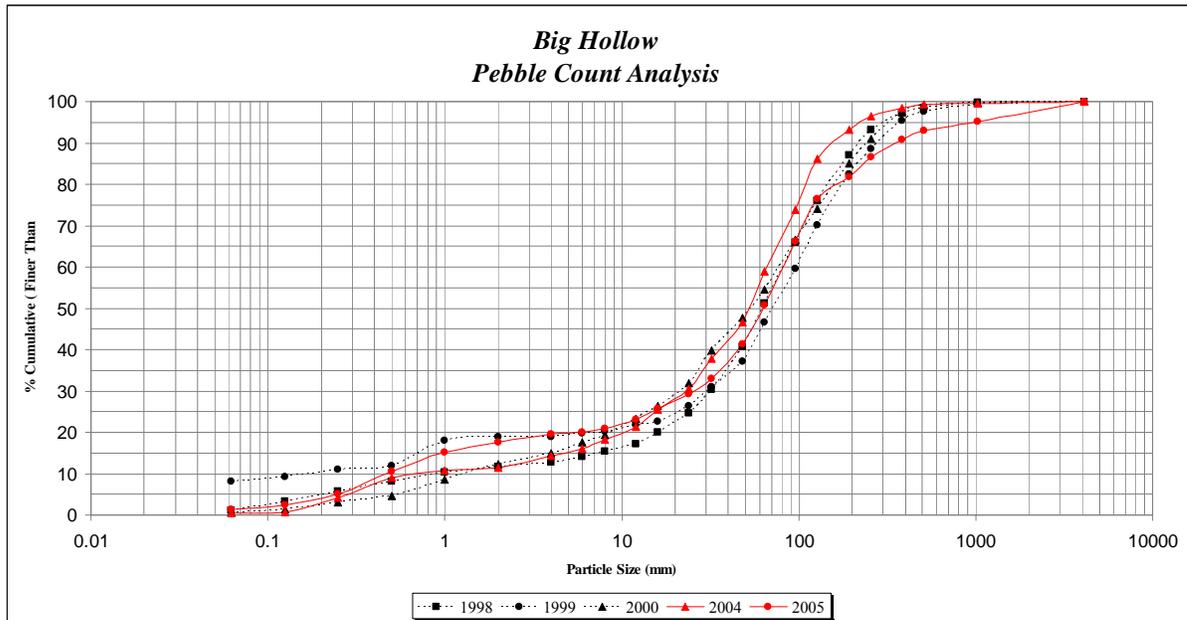
Figure 9. Cumulative pebble count data for the Big Hollow Site.

Cumulative pebble count data for the Big Hollow Site are compared in Figure 9. Pre-restoration data are colored black, while post-restoration data are colored red, with different line styles and symbols for different years. The data show that the pebble count distributions vary from year to year, but there are few observable trends in the data when comparing pre-restoration data to post-restoration data. The post-restoration distribution curves generally fall within the variability documented in year-to-year pre-restoration data.

One notable variation is a measured increase in the D95 size particle for 2005, as compared to other sampled years. This apparent increase in the larger size fraction of the distribution is most likely due to the substantial amount of large bed material that was deposited through the system during the floods that occurred in 2005.

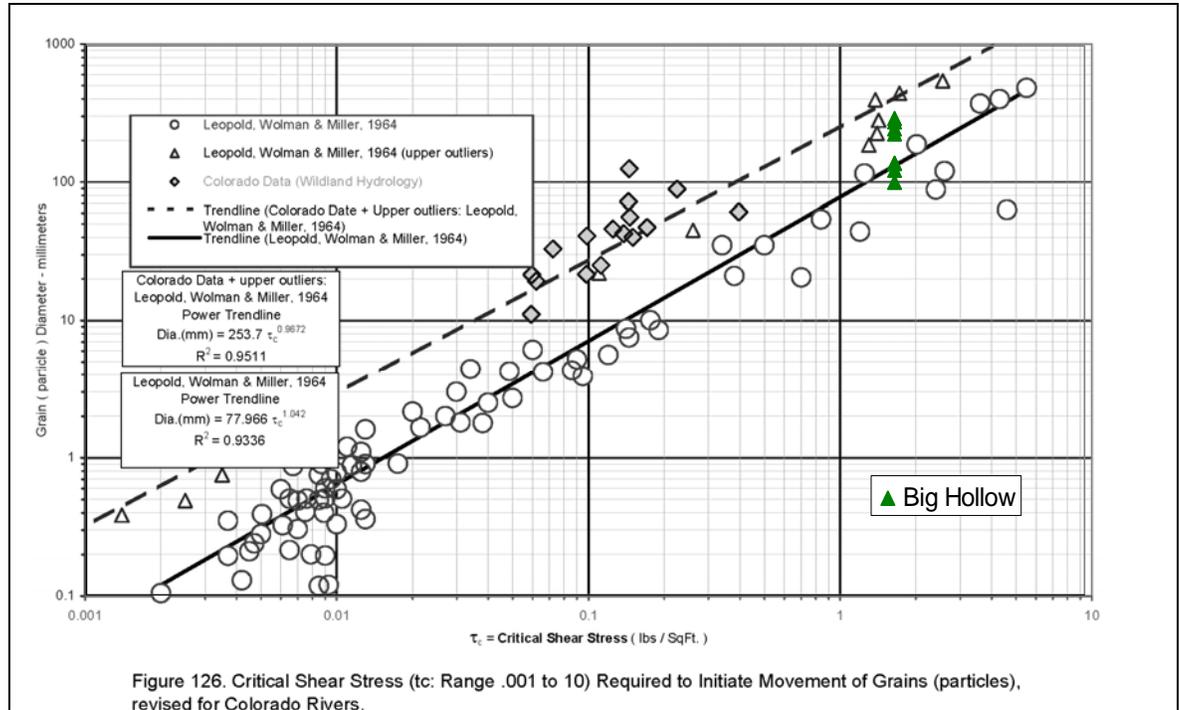
Figure 10. Shields Curve Diagram showing Big Hollow critical shear stress calculations for each monitoring year.

B) Boundary Shear Stress Analysis. The boundary shear stress for the design channel is 1.7 lbs/sq ft, by far the highest of the three project sites. The largest particles sampled from the bar were plotted against the boundary shear stress and is shown on Figure 10. Three of the data points plot on the solid trendline and four plot below the dashed trendline but within the range of the data points used to create the trendline. This separation in data does not correlate with project construction or storm events. Again, this variability is likely due to the variability in bed material associated with the floods and channel avulsions. Overall, Big Hollow had the most problems with vertical stability of the three project reaches. However, these changes were not well represented by the sediment transport competency analysis.
