Schoharie Creek Management Unit 5

Town of Hunter - Station 124311 to Klein Ave. (Station 108605)

This management unit begins at Station 124311, continuing approximately 15,705 ft. downstream to Klein Ave. in the Town of Hunter.

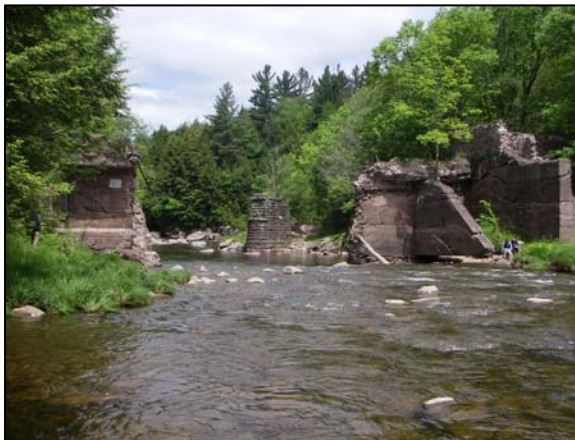
Old dam at Station 123240

At the downstream end of this wetland was an old compromised dam (Station 123240). The remains of this structure extended into the active stream channel causing a backwater effect during high flow events, resulting in some upstream aggradation. The concrete sill across the stream remains in-tact providing grade control and forming a large deep pool below.

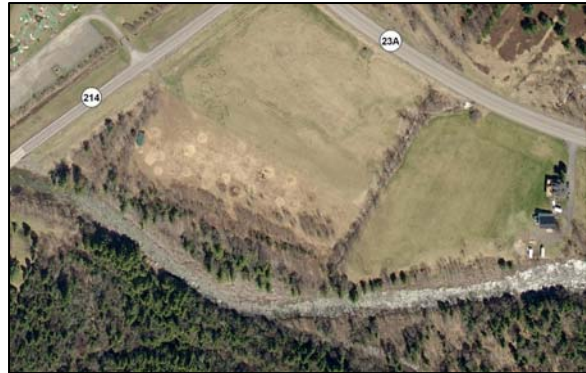
Downstream the land use on the right streambank changed from forested to agricultural, with herbaceous vegetation and several mature trees in the riparian zone. A vigorous buffer with mature trees is important at this site because it may also filter nutrients and pollutants, if any, from the adjacent agricultural fields.

Planting site at Station 121100

Recommendations for this site include augmentation of existing buffer with the planting of additional native trees and shrubs along the streambank and the upland area (Station 121100). Buffer width should be increased by the greatest amount agreeable to the landowners. Increasing the buffer width to at least 100 feet will increase the buffer functionality.

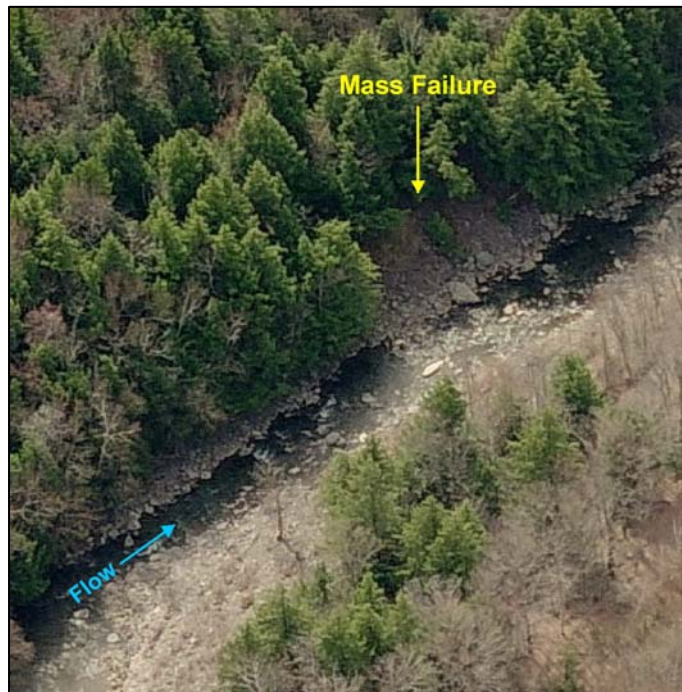
The increase in water and sediment loading from these tributaries, combined with entrenchment of the Schoharie, may have contributed to the streambank erosion directly downstream of the Schoharie's confluence with the two tributaries. An area of approximate 7,099ft² of the left streambank was experiencing erosion (Station 120200). The hillslope had been undermined by toe erosion, resulting in the mass wasting of the bank. This erosion had left the face of the stream bank unvegetated and highly susceptible to future erosion.

Bank erosion at Station 120200

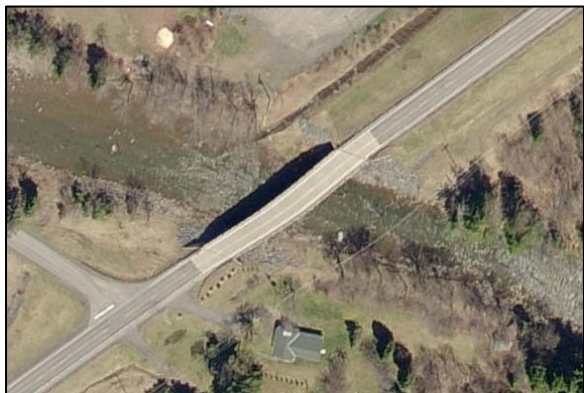
Downstream, the stream passed under the NYS Route 214 bridge (Inset C, Station 119600) (BIN 1041310). This bridge may constrict the floodplain at very high flows, but

NYS Route 214 bridge at Station 119600

appeared to pass most flows effectively. Flood damage to bridges is typically caused by inadequate hydraulic capacity of the bridge, misaligned piers and/or abutments, or accumulation of debris. As bridges are replaced over time, these issues should be evaluated and adjusted if necessary to lessen the probability of flood damage by providing a more effective conveyance channel that

promotes water and sediment flow through the bridge opening. Rip-rap was installed on both the upstream and downstream streambanks to provide scour protection. While rip-rap and other hard controls may provide temporary relief from erosion, they are expensive to

install, degrade habitat, and require ongoing maintenance or may transfer erosion problems to upstream or downstream areas. Alternate stabilization techniques should be explored for streambanks whenever possible. Two stands of Japanese knotweed (*Fallopia japonica*) had established in the rip-rap along the right streambank upstream and downstream from the bridge. Japanese knotweed is an invasive non-native species which does not provide adequate erosion protection due to its very shallow rooting system and also grows rapidly to crowd out more beneficial streamside vegetation. Removal of these Japanese Knotweed plants are recommended to prevent the spread of this invasive species (See Section 2.7 Riparian Vegetation), and native shrub and sedge species should be interplanted through this rip-rap to help strengthen the revetment, while enhancing aquatic habitat.

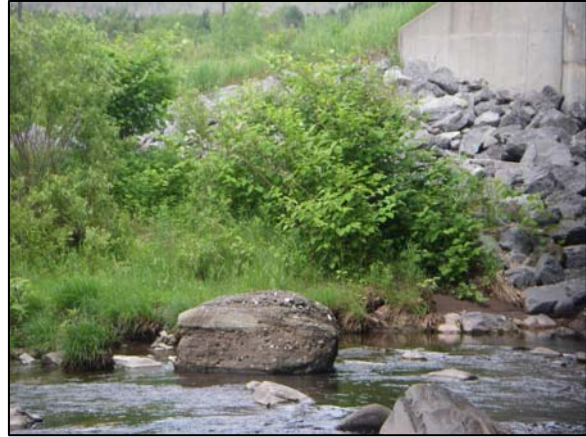
Japanese Knotweed at Station 119600

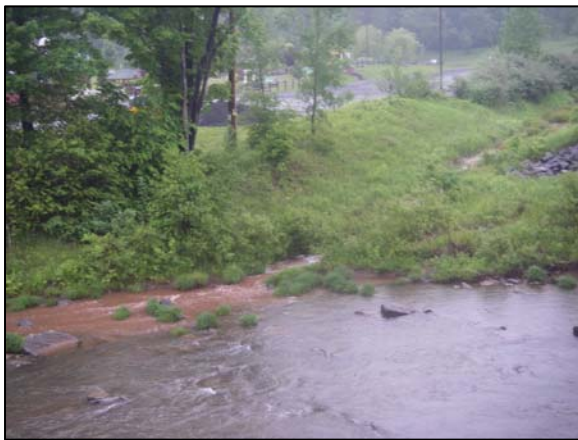
Stormwater drainage ditch at Station 119550

Approximately 50ft downstream from this bridge, a stormwater drainage ditch entered the Schoharie Creek on the right streambank (Station 119550). As shown in the photo to the left, during rainfall events *turbid* water flows into the Creek from this ditch. Turbidity is basically cloudiness of a body of water caused by the suspension of organic and inorganic particles. Turbidity can be a significant problem as these

particles absorb and transport contaminants, and make the disinfection for water supply process more difficult. In addition to public health risks, turbidity also impacts ecological integrity in the streams and reservoirs. Potential water quality impacts of stormwater inputs at this site should be evaluated. This evaluation could be achieved as part of an initiative to conduct a detailed and comprehensive assessment of existing community stormwater

infrastructure with the goal of identifying and prioritizing potential areas for installation of stormwater *best management practices* (BMP's).

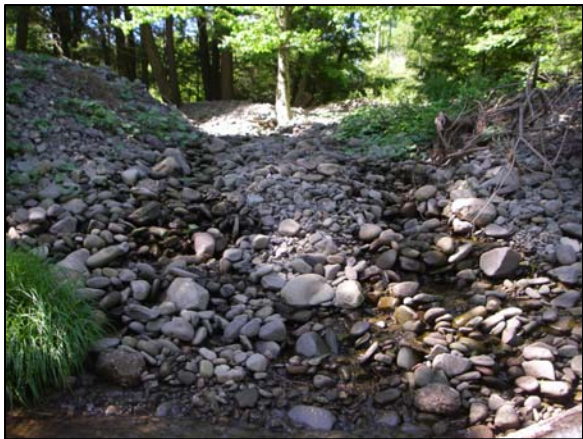
Tributary confluence at Station 118700 looking upstream

non-contact activities, including trout spawning. The confluence at station 118700, most likely created during a flood event, was choked with gravel. The second confluence of this

tributary, which also showed signs of high sediment load, was at Station 11870. The left streambank between these two confluences was undercut. This type of bank generally provides good cover for macroinvertebrates and fish and is resistant to erosion. However, if the bank becomes seriously undercut it might be vulnerable to collapse.

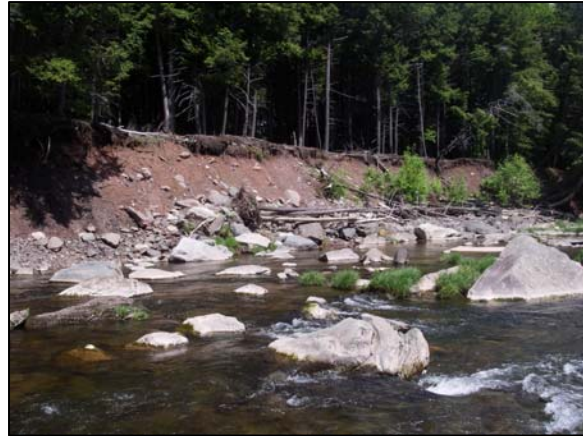
As stream's *sinuosity* increased downstream, the erosive forces on the outside bank also increased causing the mass wasting of the left streambank (Station 117860). This erosion wiped out many large trees from the streamside and exposed a 9,686ft² area of clay and silt. Woody debris and larger rocks deposited at the streambank toe may provide some erosion protection. On the opposite streambank

Bank erosion at Station 117860

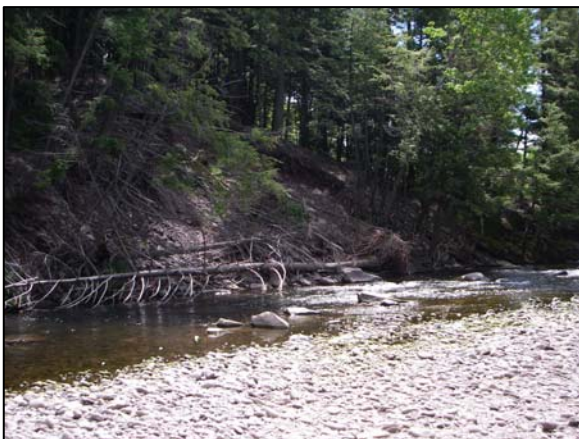
Bank erosion at Station 117320

As the stream continued to meander the erosive forces were transferred to the right streambank triggering another mass failure (Station 11730). The stream flowed directly against the valley wall, increasing the *shear stress*, or force of flowing water, on the stream bank during high flow events and had severely eroded the toe exposing a 9,123ft² area of soil with some clay in the substrate.

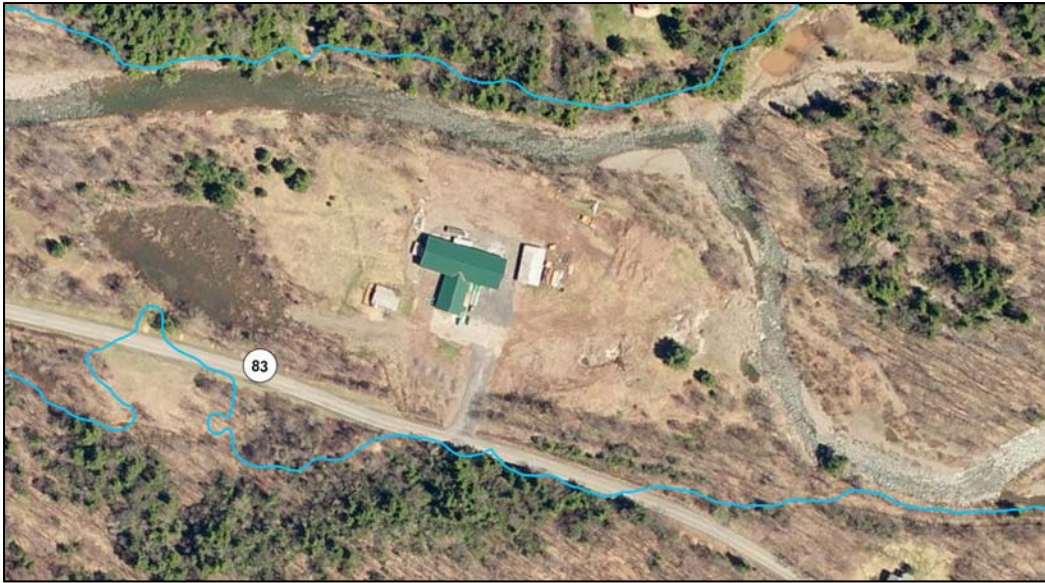
As commercial development of the left streambank began revetment had been placed on the bank (Station 114300-113200). This entire property is located within the 100-year flood boundary, or the area which has a 1% chance of being inundated in any given year. The 1959 historical aerial photographs show this bank was once lined with buildings which were probably subjected to frequent flooding. In 2006, only three structures were located on the property and were set back from the streambank. To resolve flooding issues, the best solution at this site would be to relocate these structures outside the 100-year floodplain to allow the stream to utilize its floodplain without causing property damage. However this option seems unlikely. An alternative measure which may help

*Planting site at Station (114300-113200)
2006 aerial photograph with 100-year flood boundary represented by blue line*

decrease flooding would be to increase the quality of the stream buffer. Plantings of native trees and shrubs in the riparian zone would help to slow the flow of run-off from the floodplain and allow sediment and its attached pollutants, if any, to settle out before reaching the stream. The increased vegetation would also slow flood waters and trap large woody debris. The right streambank was also eroding. As the stream took a sharp turn, the thalweg flowed directly into the right streambank resulting in the largest mass failure in this management unit (Inset B, Station 113700). This erosion had exposed an estimated area of 14,585ft² with some clay in the substrate, and led to the loss of many mature trees. Although the house on this residential property is not threatened the loss of land is a concern. Restoration of this streambank would require an in-depth survey and design.

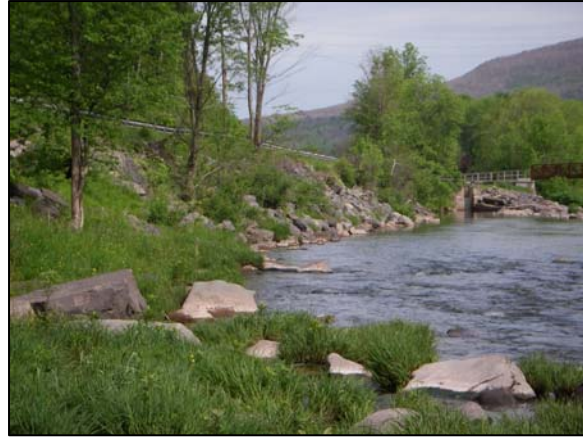
Rip-rap had been installed on the County Route 83 embankment on the left streambank (Station 111140). Some vegetation was growing within this rip-rap, however this site's stability and habitat value would benefit from additional plantings of native trees and shrubs. Two piped outfalls were located along this rip-rap (Station 110600). Stormwater runoff from these outfalls discharged onto the rip-rap rocks, reducing the risk of bank erosion, but heating the water in the summer.

Rip-rap at Station 111140

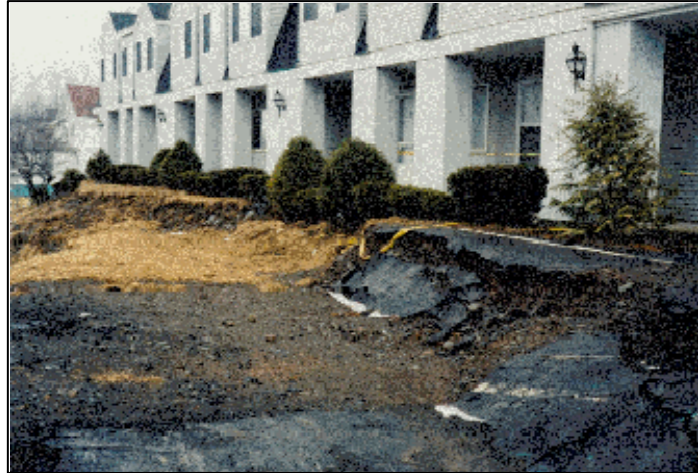
Downstream, the Melody Woods condominium complex on the right streambank had experienced repetitive damage during high flow events (Station 109900-109350). This complex was substantially damaged by the flood of April 1987, and in October 1995 a severe flood resulted in damage to the site which made the structures extremely vulnerable to

*Melody Woods Complex after 1996 flood event
(Station 109900-109350)*

future floods. Months later, in January 1996, a mid-winter rain on snow event produced a flood of a 100-year magnitude, and the streambank failures became extreme, threatening the immediate safety of the condominium complex and adjoining properties.

The condominium complex restoration site presented a number of stability problems, with eroded banks as high as 27ft, deep silty clay soils under the glacial outwash materials that the buildings were constructed on, and a severe weight load at the top of the slope due to the buildings. On the lower project reach, the flood undercut retaining walls which had been in place for many previous floods and it eroded mature vegetation which had been providing stability to the streambank. The down cutting action of the channel into the clay materials resulted in the failure of the adjoining streambanks and upper slopes. As a result of the flood, a 1500' reach of the Schoharie was at severe risk in future floods.

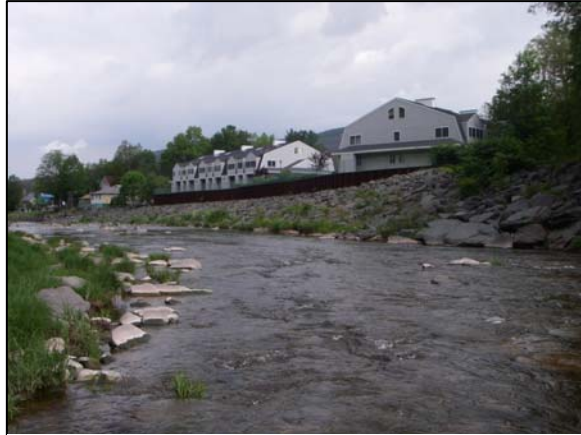
*Melody Woods Complex 2006
(Station 109900-109350)*

agencies, 3 federal agencies and a number of local municipal units, the project was extremely complex and risky. In 1997, construction was completed on a steel sheet piling and stacked rock rip-rap wall designed to protect the site from 100-year floods. Due to the hard work and diligent effort of the many project partners, the project was completed under budget and on schedule in the fall of 1997. Since that time, the site has experienced several floods with no additional damage to the buildings.
