Schoharie Creek Management Unit 6

Town of Hunter – Klein Ave. (Station 108605) to Bridge St. (Station 104521)

This management unit begins at Klein Ave., continuing approximately 4,085 ft to Bridge St. in the Town of Hunter.

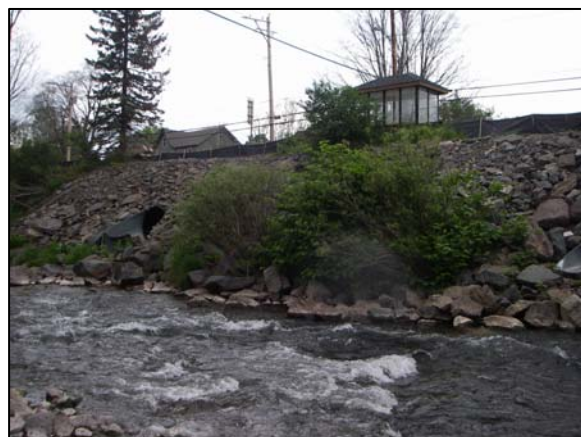
Rip-rap with two stormwater outfalls had been installed on the right streambank downstream from the bridge (Inset D, Station 108500). A stand of Japanese knotweed (*Fallopia japonica*) had established in the rip-rap. Japanese knotweed is an invasive non-native species which does not provide adequate erosion protection due to its very shallow rooting system, and also grows rapidly to crowd out more beneficial streamside vegetation. Removal of this Japanese Knotweed stand is

Rip-rap at Station 108500

recommended to prevent the spread of this invasive species (See Section 2.7 Riparian Vegetation) and native shrub and sedge species should be interplanted through this rip-rap to help strengthen the revetment, while enhancing aquatic habitat.

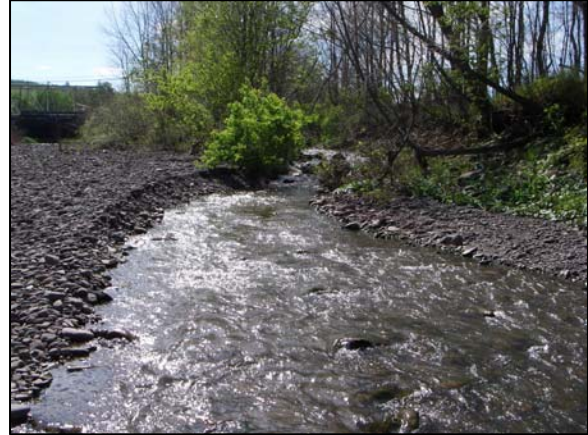
Shanty Hollow Brook entered from the left streambank (Station 108100). This tributary drains the slopes of Hunter Mountain before it reaches the flatter topography of the valley floor where it enters the Schoharie Creek. As a result of this stream slope change, the tributary lost its ability to transport sediment gathered from the mountain slopes, and began to deposit sediment at its mouth and into the more gently

*Shanty Hollow Brook (Station 108100)
looking upstream*

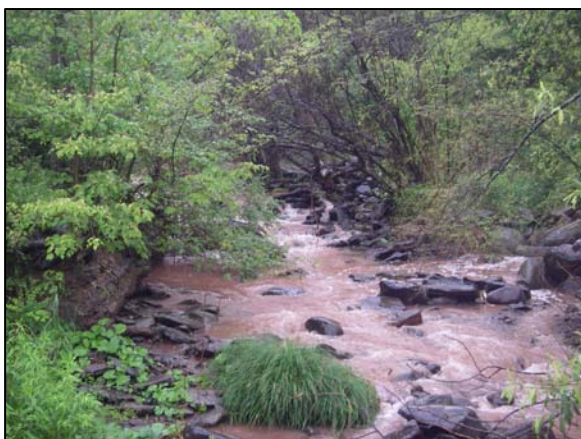
*Shanty Hollow Brook after rainfall event
Station 108100 - looking upstream*

As shown in the photo, during rainfall events *turbid* water flows into the Schoharie from Shanty Hollow Brook. Turbidity is basically cloudiness of a body of water caused by the suspension of organic and inorganic particles. Turbidity can be a significant problem as these particles absorb and transport contaminants, and make the disinfection process more difficult. In

addition to public health risks, turbidity also impacts ecological integrity in the reservoirs and streams. The turbidity source and potential water quality impact at this site should be evaluated. This evaluation could be achieved as part of an initiative to conduct a detailed and comprehensive assessment of existing community stormwater infrastructure with the goal of identifying and prioritizing potential areas for stormwater *best management practices* (BMP's).

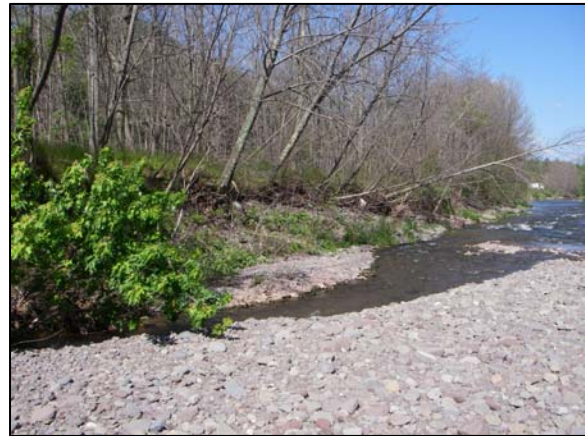
This increase in runoff and sediment load from this tributary may have contributed to the streambank erosion on the left streambank (Station 108100). An area of approximately 4,072 ft² was experiencing erosion, resulting in the loss of some mature trees along the bank. To prevent future erosion, native vegetation plantings are recommended for site, including vegetative protection of the toe.

Bank erosion at Station 108100

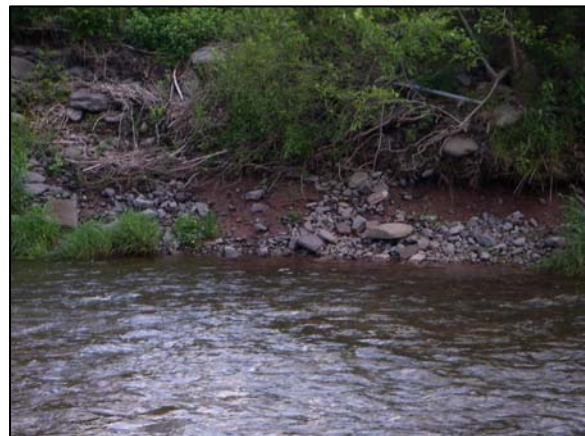
Downstream of the revetment, the right streambank had been scoured causing numerous clay/silt exposures posing a potential threat to water quality (Inset C, Station 107630). Fine sediment inputs into a stream increase *turbidity* and can act as a transport mechanism for other pollutants and pathogens. Planting of willow *fascines* and

Clay/silt exposure at Station 107630

sedges along the toe of the bank is recommended to provide protection against erosion. Native trees and shrubs, including willows should also be planted on the face of streambank to improve stability.

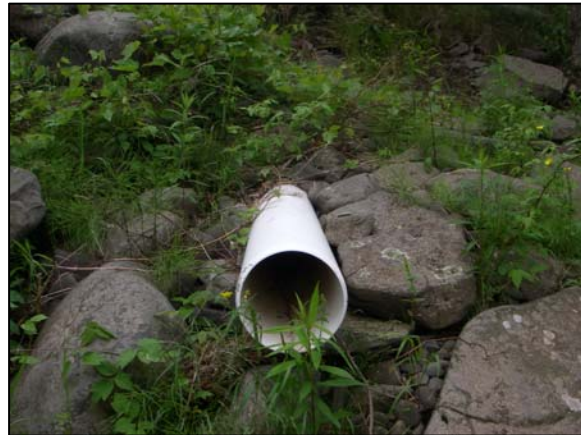
Near the upstream end of the stacked rock wall, at Station 106425, was an NYS permitted discharge point, permitted to the Hunter Liftside Transportation Corporation (SPDES permit# NY0212288). This permit allowed for the discharge of 0.0810 million gallons per day of treated sanitary wastewater to Schoharie Creek from the Hunter Mountain wastewater treatment plant. This wastewater treatment plant was

SPDES outfall at Station 106425

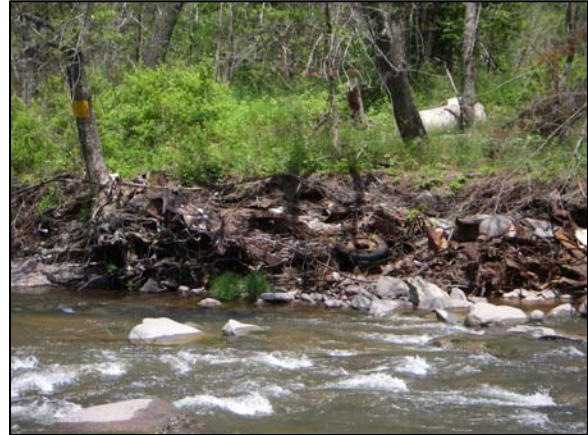
Downstream, the right streambank showed signs of scour during past high water events (Inset B, Station 105960). Grasses have begun to revegetate the bank face, however, additional plantings of native shrubs and sedges would increase bank stability. At the downstream end of this erosion, an old dump site was documented along the streambank (Station 105550). To prevent introduction of his material, and any possible pollutants, into the stream the dump should be removed.

Dump at Station 105550

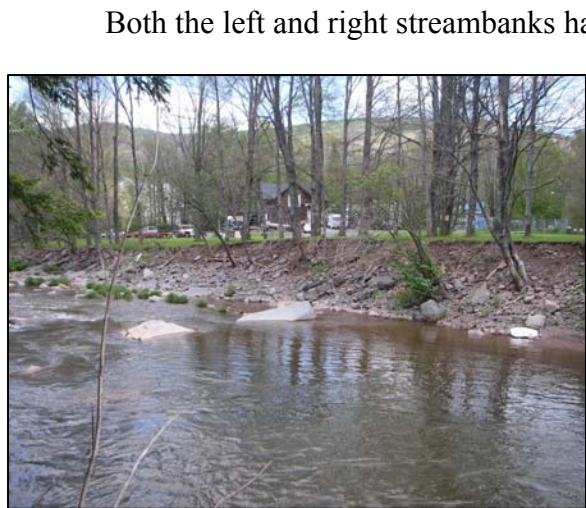
Bank erosion on right streambank at Station 105140

Both the left and right streambanks have been eroded downstream (Inset A, Station 105140). A Bank Erosion Monitoring Site (BEMS) was monumented to study erosion along this reach at Station 105300. A cross-section and long profile survey were conducted to collect baseline data. In the future this cross-section can be resurveyed to calculate the bank's erosion rate. Erosion at this site had fractured the lower shale bedrock bank and exposed a large 9,432ft² erosional area on the upper hillslope. At the top of the

slope, the end of Schoharie Avenue has been forced to close due to safety concerns. Erosion along the right streambank has scoured an area of 2,179ft².

Full restoration of the site is recommended, including the use of vegetated reinforced soil slope (VRSS) soil bioengineering system to stabilize the upper bank and grout to address the crack in the bedrock and increase the longevity of the project. VRSS is an earthen structure constructed from living, rootable, live-cut, woody plant material branches, bare root, tubling or container plant stock, along with rock, geosynthetics, geogrids, and/or geocomposites. The VRSS system is useful for immediately repairing or preventing deeper failures, providing a structurally sound system with soil reinforcement, drainage, and erosion

Recommendations for the right streambank include planting native trees and shrubs along the streambank and the upland area. Buffer width should be increased by the greatest amount agreeable to the landowners, but increasing the buffer width by at least 100 feet will increase the buffer functionality. In-depth survey and engineering design would be required to plan a stream restoration project at this site. This survey and design started in early 2007.

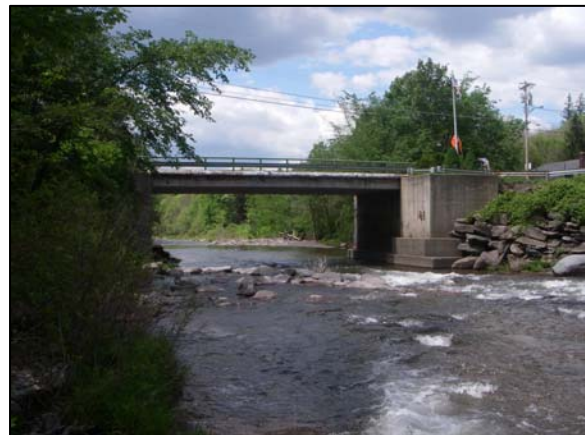
At the downstream end of this management unit the stream passed under the county bridge at Bridge Street in the Village of Hunter (BIN# 3201430). This bridge may constrict the floodplain at very high flows, as evidenced by minor deposition upstream, but passes most flows effectively. Flood damage to bridges is typically caused by inadequate hydraulic capacity of the bridge, misaligned piers and/or abutments, or accumulation of debris. As bridges are replaced over time, these issues should be evaluated and adjusted if necessary to lessen the probability of flood damage by providing a more effective conveyance channel that promotes water and sediment flow through the bridge opening.

Bridge at Bridge Street – Station 104521
