Schoharie Creek Management Unit 7

Towns of Hunter and Jewett – Bridge St.(Station 104521) to Station 91473

Figure 4.7.1 Management Unit 7 - 2006 aerial photography with stream feature inventory

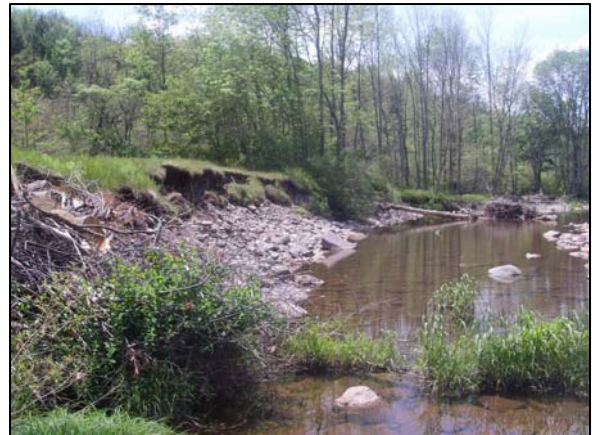
A road crossing had been built across the flood chute to allow the landowner access to their land. This crossing had a low flow channel cut into it but still obstructed higher stream flows. Immediately downstream the left streambank had eroded exposing an area of 950ft². To prevent future loss of land, planting of native trees and shrubs is recommended along the streambank and riparian buffer along with installation of willow *fascines* and sedges along the toe of the bank to provide protection against toe erosion.

Eroding bank and planting site at Station 101130

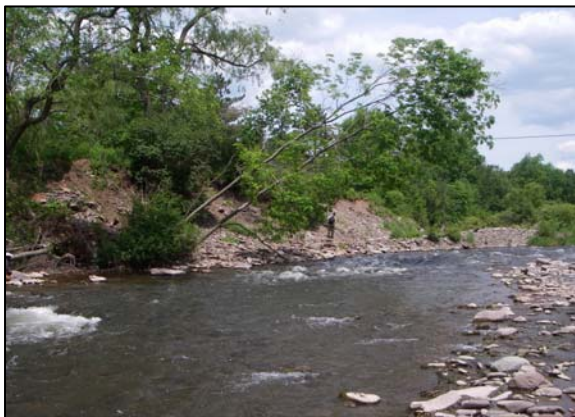
Bank erosion at Station 99700 - looking upstream

Near the downstream end of the flood chute, a piped outfall which drained stormwater from County Route 23A, was located on the right streambank (Station 99700). Stormwater inputs combined with flood chute flows had eroded a large 4561ft² area on the right streambank leaving it unvegetated (Station 99700). This erosion site is also a good candidate for *bioengineering* stabilization techniques, which use plantings to bind stream banks.

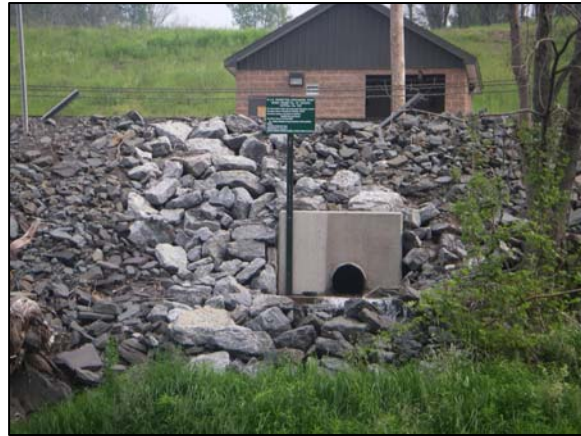
Downstream the stream channel straightens and becomes confined by the County Route 23A embankment on the right streambank and the streambank on the left. Rip-rap had been installed on much of the road embankment (Station 98500-97400). Along this rip-rap was an NYS permitted discharge point, permitted to the Village of Hunter (SPDES permit# NY0241075). This permit allows for the discharge of 0.3259 million gallons per day of treated sanitary wastewater from the Village treatment plant to the Schoharie Creek. The State Pollutant Discharge Elimination System (SPDES) program, administered by NYS Department of Environmental Conservation (DEC), governs discharges to surface and ground waters through the issuance of wastewater and stormwater discharge permits.

SPDES outfall at Station 98300

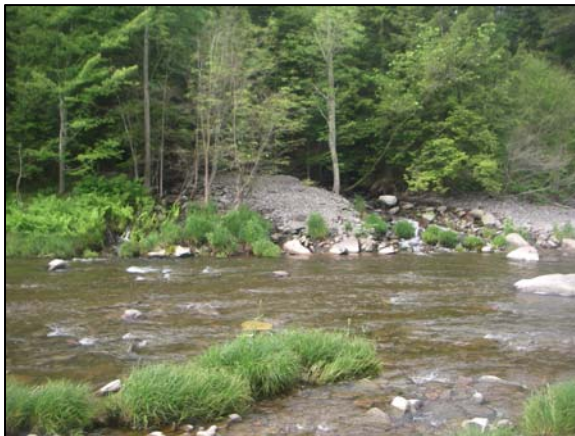
Tributary at Station 98500

result of this stream slope change, the tributary loses its ability to transport sediment gathered from the mountain slopes, and began to deposit sediment at its mouth and into the more gently sloped Schoharie Creek. This is a common feature of confluence areas, which often contain extensive sediment bars, function as important sediment storage areas, and are typically among the most dynamic and changeable areas in the stream system. The

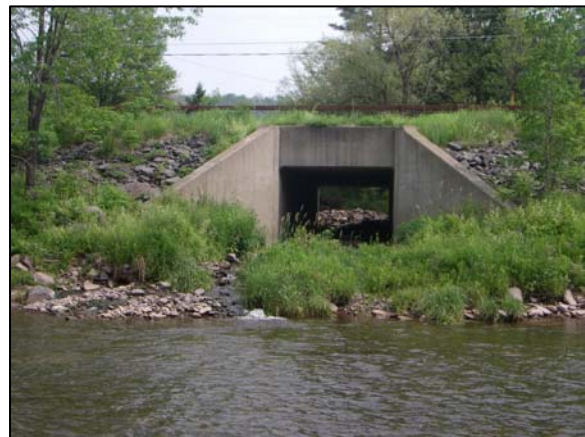
Just upstream from the Deming Rd. bridge another tributary entered the Schoharie Creek from the right streambank (Station 97500). This tributary begins on the East Jewett Mountain Range before flowing under County Route 23A through a large box culvert and joining the Schoharie Creek. As shown in the photo, this tributary also appeared to be a sediment source. This tributary was classified as C by the NYSDEC.

Tributary at Station 97500 - looking upstream

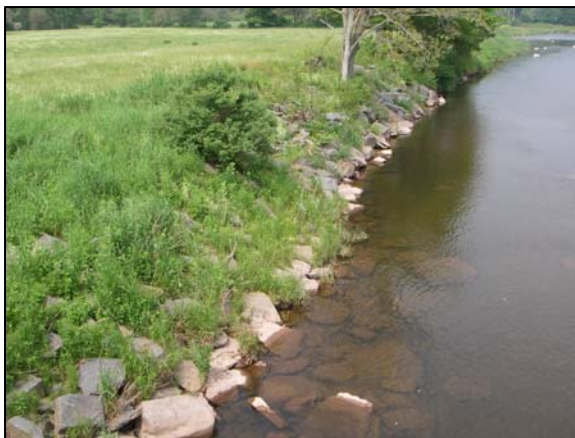
Planting site at Station 97370-95800

effectively. Both bridge abutments had been reinforced with sheet piling and had rip-rap installed on both downstream streambanks. There were agricultural fields on the left streambank (Station 97370-95800). A riparian buffer of native trees and shrubs should be planted along this streambank and corridor. Buffer width should be increased by the greatest amount agreeable to the

landowner. Increasing the buffer width by at least 100 feet will increase the buffer functionality, such as filtering nutrients and pollutants, if any, from the agricultural fields. At the downstream end of the agricultural field was a 4175ft² area of eroding bank (Station 96000). Streambank stability could be improved at this site with the planting of willow *fascines* and sedges along the toe of the bank, along with native trees and shrubs on the face of stream bank.

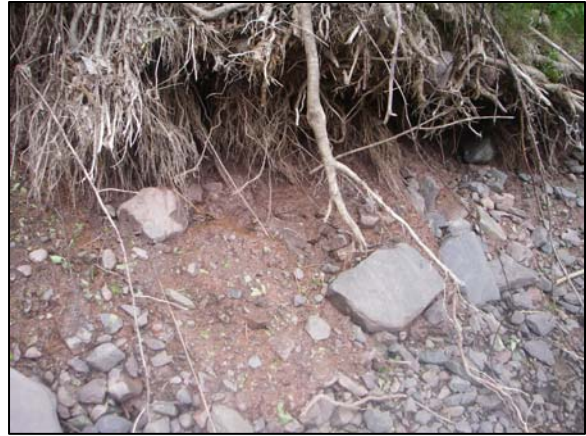
The right streambank of the next meander bend had suffered minor erosion during high flow events (Station 93150). This erosion exposed an 96ft² area of clay/silt.

Clay exposure at Station 93150

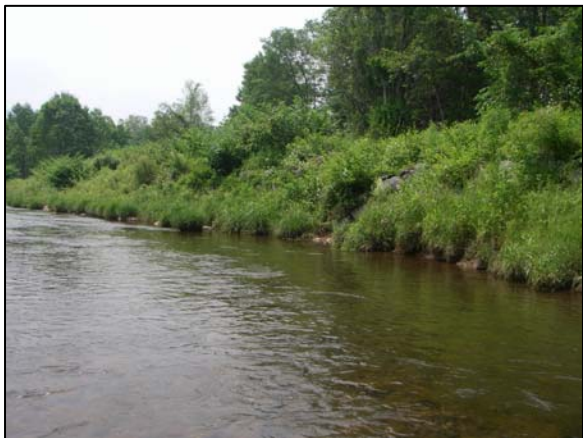
Rip-rap at Station 92040

Along the right streambank rip-rap had been installed (Station 92040). Native vegetation had grown through this rip-rap and will serve to strengthen and increase its longevity while also improving the aquatic habitat of the reach. While this growth occurred naturally, inserting plant material into the soil between rip-rap during or after installation can have the same desired effect.

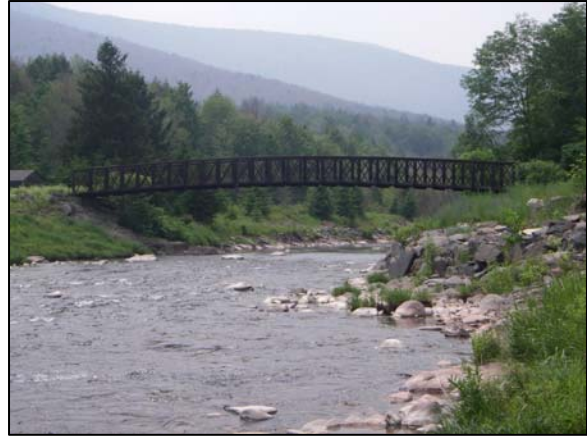
At the end of the management unit the stream passed under a private bridge on an unpaved road (Station 91473). This bridge, built in the mid 1990's, was in good structural condition and appeared to pass most flows effectively. However, during large flood events floodwaters have spread over the right abutment, causing erosion and deposition, then back into the stream channel downstream of the bridge. According to landowner accounts, maintenance of the road and bridge due to stream related problems has cost thousands of dollars. Installation of flood plain drainage, and/or regrading of the right streambank floodplain area to floodplain elevation, at or just above the bankfull stage, could reduce flooding. Leveling this area would decrease the local flow concentration that is currently

Bridge at Station 91473

causing erosion while still providing over bank access during flood flows. The riparian area throughout the reach, including the immediate terrace area should be vegetated with native trees and shrubs. An established riparian community could reduce erosion and flood velocities in the bridge and road access area and discourage further widening of the stream channel. With the exception of planting, in-depth survey and design would be required to implement these recommendations.
