Schoharie Creek Management Unit 8

Town of Jewett – Station 91473 to Carr Road Bridge (Station 83957)

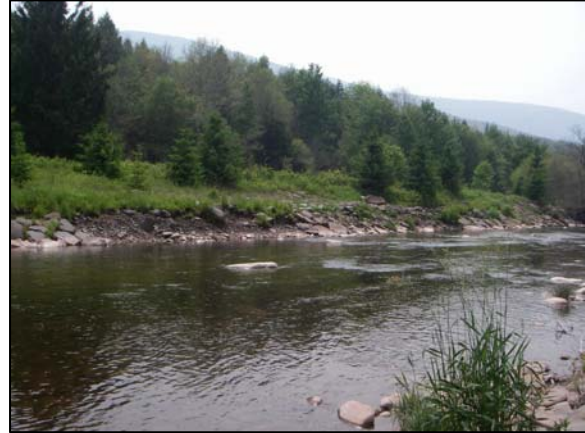
Directly downstream from the bridge, rip-rap had been installed along 290ft of the left streambank (Station 91400). This rip-rap was in poor condition, and at two locations where the rip-rap had failed clay/silt exposures were documented. Fine sediment inputs from these exposures can be a water quality concern because they increase *turbidity* and can act as a transport mechanism for other pollutants and pathogens. While rip-rap and other hard controls may provide temporary relief from erosion, they are expensive to install, degrade habitat, require ongoing maintenance or may transfer erosion problems to upstream or downstream areas. Alternate stabilization techniques should be explored for streambanks whenever possible. Native shrub and sedge species should be interplanted along the toe of this streambank to help strengthen the revetment, while enhancing aquatic habitat. A combination of trees and shrubs should also be planted along the streambank and adjacent *riparian* buffer to increase bank stability. At the downstream end of this rip-rap the left streambank had eroded along 108ft and had caused several mature trees to fall from the top of the bank (91100). The stability of this streambank could also be improved with plantings along the toe and bank.

Rip-rap and planting site at Station 91400

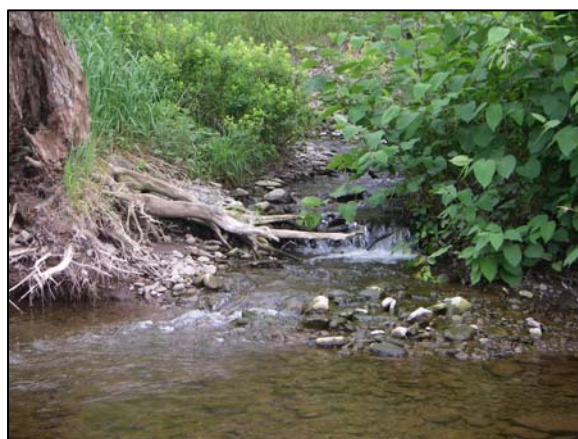
Tributary at Station 90200 - looking upstream

Downstream on the left streambank, an unnamed *tributary* entered the Schoharie Creek (Station 90200). This tributary drains the steep slopes of Rusk Mountain, before it reaches the flatter topography of the valley floor where it enters the Schoharie Creek. As

a result of this stream slope change, the tributary loses its ability to transport sediment gathered from the mountain slopes, and began to deposit sediment at its mouth and into the more gently sloped Schoharie Creek. This is a common feature of confluence areas, which often contain extensive sediment bars, function as important sediment storage areas, and are typically among the most dynamic and changeable areas in the stream system. The New York State Department of Environmental Conservation classifies streams and rivers based on their “best use” (NYSDEC, 1994). This tributary was classified as C, indicating that the best uses for this stream were the support of fisheries and other non-contact activities.

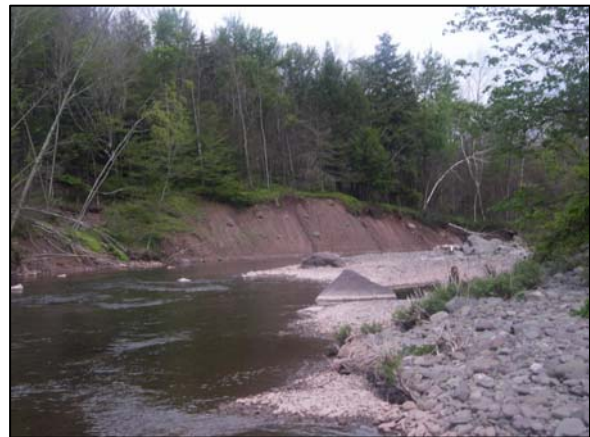
This reach, including the flood chute, serves as a storage area for excess sediment and woody debris supplied by upstream tributaries and streambank erosion. The resulting *aggradation* had shifted the erosional force of flood flows onto the left streambank of the main channel resulting in a large erosion area of approximately 5,343ft² and exposing a 270ft² area of clay (Station 89670). Due to the erosion, many mature trees have fallen into the stream adding to in-stream woody debris and sediment.

Bank erosion at Station 89670

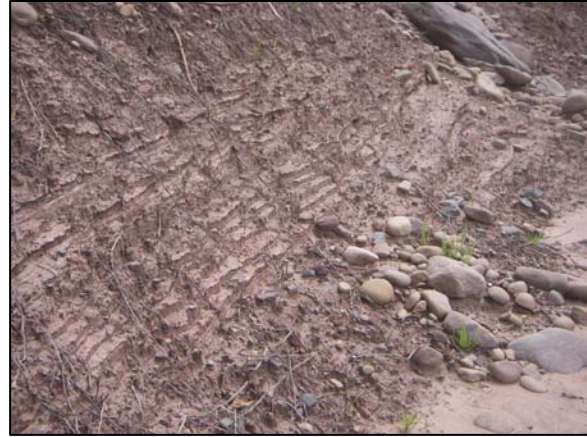
As the stream *meandered* downstream, the *thalweg*, or deepest part of the stream channel, flowed up against the right streambank causing significant bank erosion (Station 89000, Inset C). Streambank erosion often occurs on the outside of meander bends where the stream velocity is greatest during high flows. A 9,013ft² area of streambank had been left unvegetated exposing a substantial amount glacial lake silt/clay (Station 889000).

Clay exposure at Station 88900

A bank erosion monitoring site (BEMS) was installed along this bank to study this erosion (Station 88700). A cross-section and longitudinal profile survey were conducted to collect baseline *morphology* data. In the future, this cross-section can be resurveyed to calculate the bank's erosion rate. If the erosion rate accelerates significantly, full restoration to address property loss and water quality threats should be considered for this site. This would likely involve establishment of a well-vegetated bench on the right bank with rock vanes to direct stream flows away from the bank, regrading and then revegetation of the bank face, and establishment of channel geometry throughout the unit to more effectively convey the *sediment load*. The riparian area at the top of the bank was covered by *herbaceous* vegetation and if left undisturbed should allow for native tree and shrub species to establish. To speed this process trees and shrubs could be planted. While enhancement to the riparian buffer is recommended for this site, alone it will not solve this erosion problem.

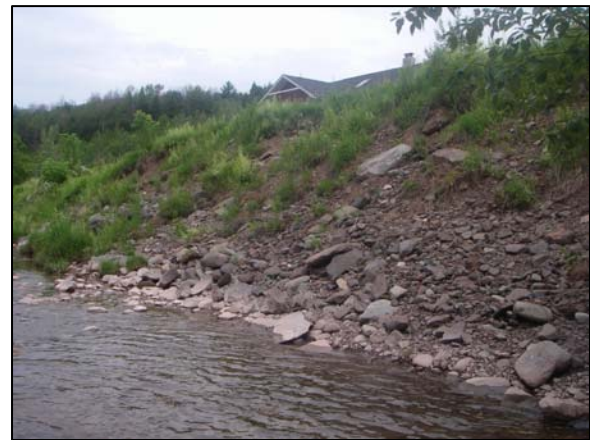
The right streambank had also been eroded with only herbaceous vegetation in the riparian zone (Station 88000). Mown lawn or pasture does not provide as much resistance to streambank erosion as the deep and dense root structure found in streamside forest. To promote a more mature vegetative community along the streambank and in the floodplain mowing to the stream edge should be stopped.

Bank erosion and planting site at Station 88000

Gradually, vegetation will begin to grow within the buffer but planting of native trees and shrubs can give the buffer a good head start. If it is important for the landowner to maintain a stream view, plantings of low growing vegetation could be installed. Plantings of shrubs and sedges along the streambank will also help to reduce erosion.

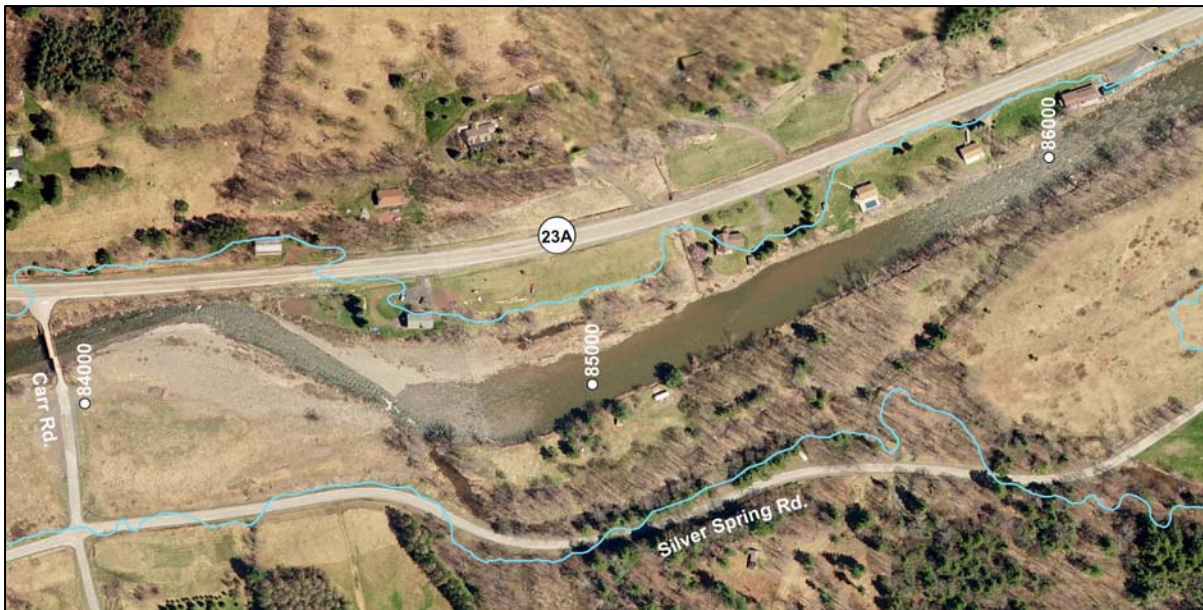
From Station 86200 downstream to the end of the management unit at Carr Road, residences along the right streambank have suffered repeated flooding due to their location within the floodplain. To resolve flooding issues, the best solution would be to relocate these structures outside the 100-year floodplain to allow the stream to utilize its floodplain without causing property damage. However this option seems unlikely. Silver Spring Road was first built along the Schoharie Creek. After years of sustaining flood damage, the Town of Jewett working with landowners, relocated the road outside the floodplain to its present day location.

2006 aerial photograph with 100-year flood boundary represented by blue line

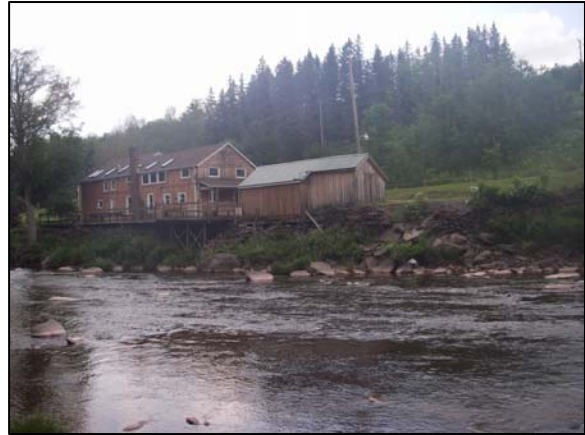
A 320ft stacked rock wall was installed to protect a home on the right streambank at the edge of the Schoharie Creek (Station 86250). A section of this wall had failed due to stormwater which flows over the edge of the bank. This problem may be corrected with grading at the top of the bank to redirect stormwater. The building of a well-vegetated bench within the stream channel could reduce flood water velocities near this bank and lessen its susceptibility to failure.

Stacked rock wall at Station 86250

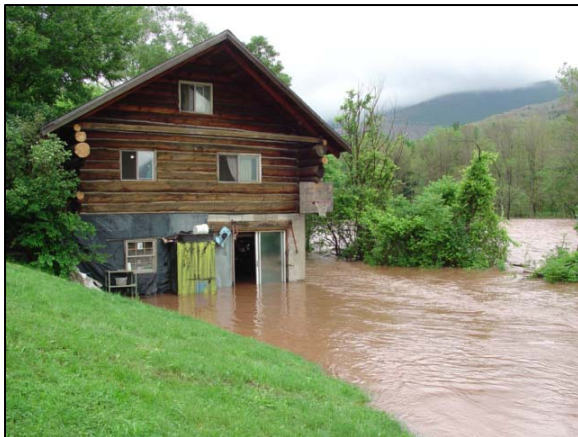
Flooding of residence at Station 84700

Downstream, floods regularly flow through the lower level of the home on the right streambank (Station 84700). To protect this home an upstream berm had been built. The berm was approximately 45ft in length and started at the existing high terrace, which the house sits upon, and ran perpendicular to the home towards the stream. The berm was roughly 20ft wide and 4-6ft high. Although this berm may protect the home from some

flooding, additional flood proofing of the lower level is recommended. The septic system for this home poses a water quality threat and should be relocated outside of the floodplain. The homeowner is currently working with the Catskill Watershed Corporation (CWC) Septic Rehab and Replacement program to replace this septic system (See Section 2.12). Construction is expected by the end of 2007.

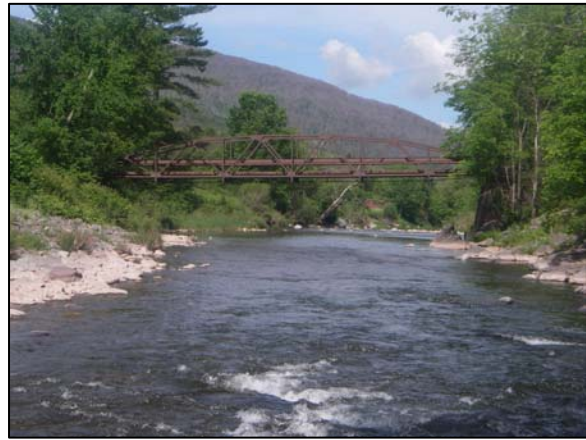
At the end of this management unit, the stream passed under Carr Road bridge. While *bankfull* flows appeared to flow freely through this bridge, higher flows overtop the bridge and flow over Carr Road rendering the bridge impassable. This bridge is the sole access residents have to cross the Schoharie Creek, and during floods residents are cut off from emergency services. Repeated repair of Carr Road after flood events has also been very costly. Installation of *floodplain drainage*, using culverts set at the floodplain elevation under the bridge approach, would increase hydraulic capacity of the bridge and help mitigate this problem. A hydraulic analysis of Carr Road bridge and upstream floodplain is the first step necessary to begin planning for remediation of flood concerns in this area.

Bridge at Carr Road (Station 83957)

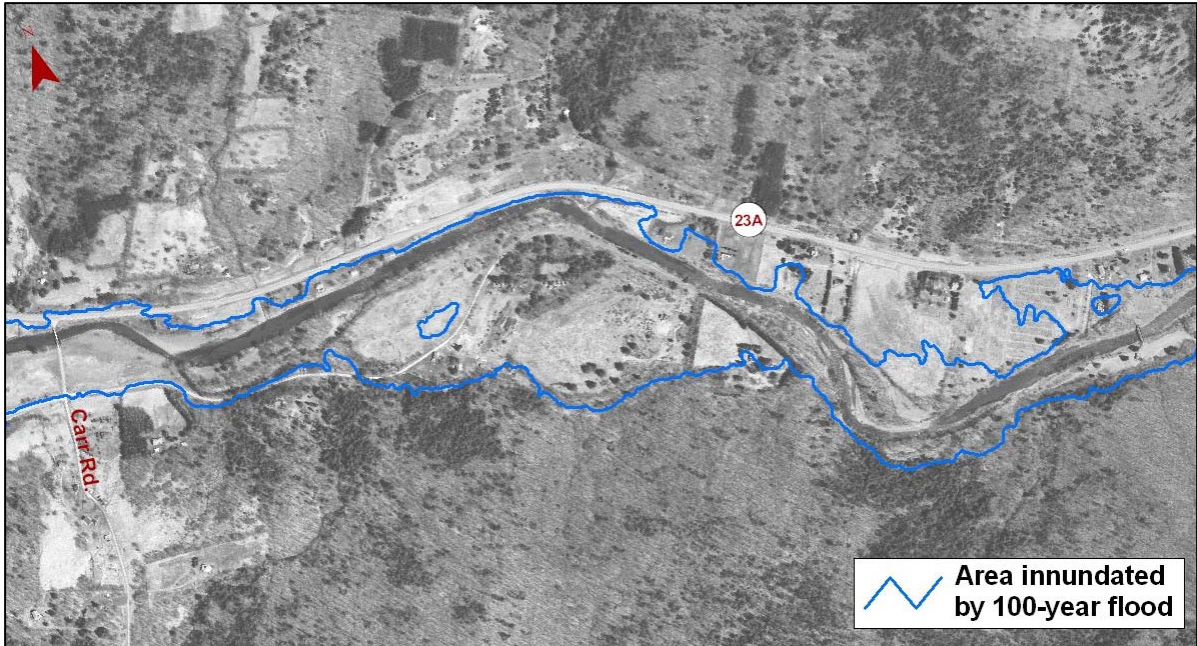
According to the new floodplain maps (below), twenty-five existing structures in this unit appeared to be situated within the estimated 100-year floodplain. The 100-year floodplain is that area predicted to be inundated by floods of a magnitude that is expected to occur once in any 100-year period, on the basis of a statistical analysis of local flood record. Most communities regulate the type of development that can occur in areas subject to these flood risks.

100-year floodplain boundary map
