Schoharie Creek Management Unit 9

Town of Jewett – Carr Road Bridge (Station 83957) to County Route 17 (Station 70652)

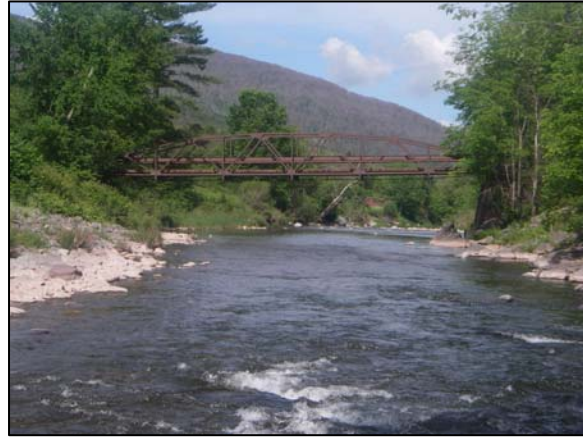
This management unit began as the stream passed under the Carr Road bridge. While *bankfull* flows appeared to flow freely through this bridge, higher flows overtop the bridge and flow over Carr Road rendering the bridge impassable. This bridge is the sole access residents have to cross the Schoharie Creek and during floods residents are cut off from emergency services. Repeated repair of Carr Road after

Bridge at Carr Road (Station 83957)

flood events has also been very costly. Installation of *floodplain drainage*, using culverts set at the floodplain elevation under the bridge approach, would increase hydraulic capacity of the bridge and help mitigate this problem. A hydraulic analysis of Carr Road bridge and upstream floodplain is the first step necessary to begin planning for remediation of flood concerns in this area (see Section 4.8 for recommendations).

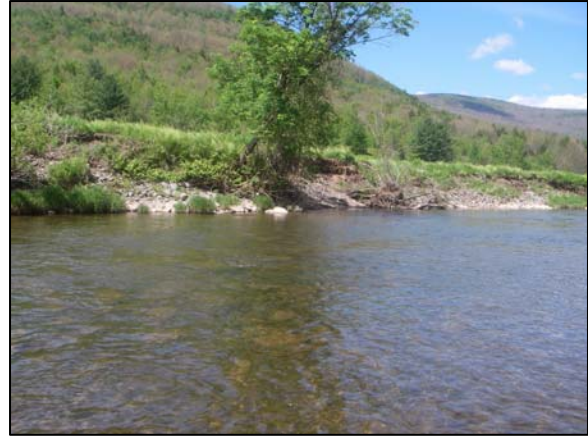
Downstream, approximately 276ft of the left streambank had suffered minor erosion during high flow events (Station 83400). A piped outfall, which discharged stormwater from Little Timber Road onto this streambank, may exacerbate erosion at this site. The stability of this streambank could be improved with plantings of willow *fascines* and sedges along the toe of the bank coupled with trees and shrubs along the bank. These plantings would also improve the aquatic habitat within this reach. Erosion continued downstream for 331ft of the left streambank (Station 82830). This site was also a good candidate for *bioengineering* stabilization techniques.

Bank erosion at Station 83400

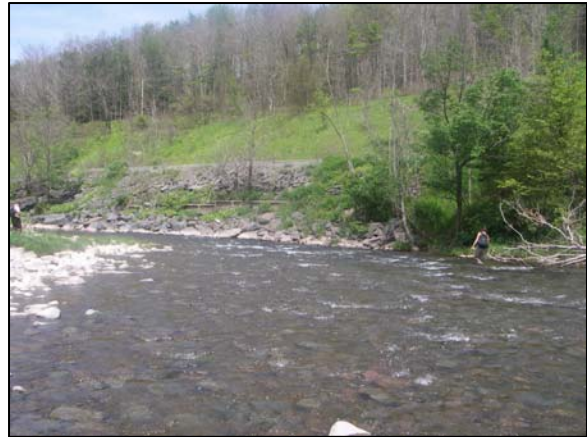
As the stream flowed directly towards the County Route 23A embankment, revetment including 767ft of rip-rap and 90ft of T-wall had been installed along the right streambank (Station 82300). Interplanting of the existing rip-rap, by inserting plantings into the soil between the rocks may help to strengthen and increase the longevity of this rip-rap. These plantings will also improve the aquatic habitat by providing shade, resulting in cooler water temperatures.

Revetment at Station 82300

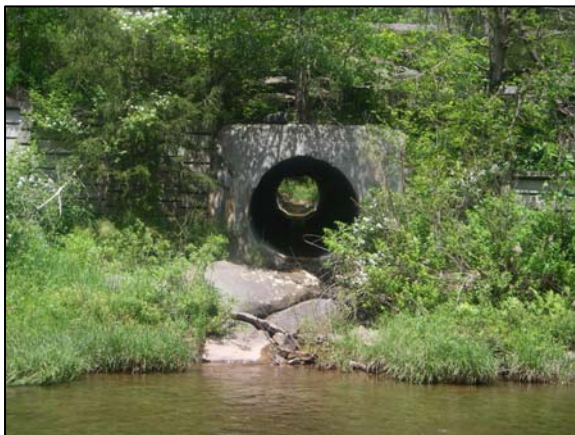
Culvert and Tributary at Station 80800

providing a good example of interplanted revetment. At the middle of this rip-rap, an unnamed *tributary* entered the Schoharie Creek (Station 80800). This tributary drained the mountain on the opposite side of County Route 23A, before passing under the road and joining the Schoharie Creek through a large concrete culvert. The New York State Department of Environmental Conservation classifies streams and rivers based on their

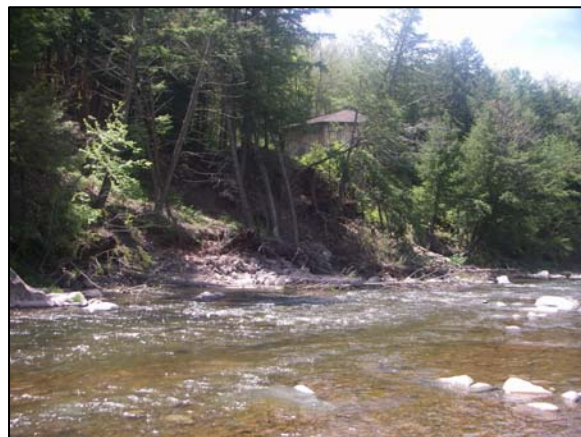
Along the outside meander of this bend the *thalweg*, or deepest part of the stream channel, flowed up against the left streambank causing significant bank erosion (Station 78900). Streambank erosion often occurs on the outside of meander bends where the stream velocity is greatest during high flows. A 19,823ft² area of streambank had been left unvegetated, exposing a glacial lake silt/clay deposit. Fine sediment inputs from eroding bank can be a water quality concern because they increase *turbidity* and can act as a transport mechanism for other pollutants and pathogens. Sheet piling had

Bank erosion at 78900

been installed along 30ft of this bank in efforts to protect a home on the streambank (Station 78760). This home could be threatened in the future if this bank continues to erode.

A bank erosion monitoring site (BEMS) was installed along this bank to study this erosion (Station 78870). A cross-section and long profile survey were conducted to collect baseline *morphology* data. In the future this cross-section can be resurveyed to calculate the bank's erosion rate. If the erosion rate accelerates significantly, full restoration to address property loss and water quality threats should be considered for this site. This would likely involve establishment of a well-vegetated bench on the right bank with rock vanes to direct stream flows away from the bank, regrading and then revegetation of the bank face, and establishment of channel geometry throughout the unit to more effectively convey the *sediment load*.

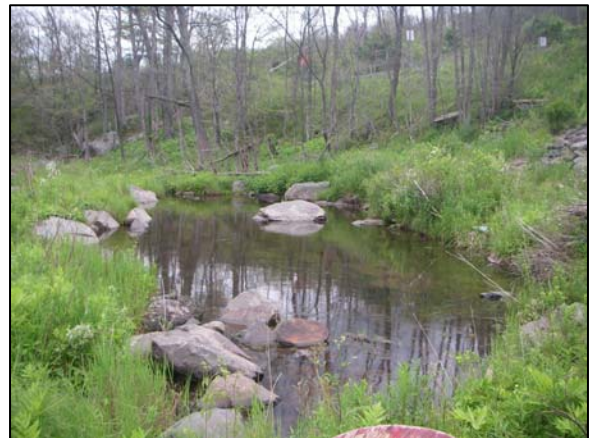
At the next downstream meander bend, the stream was once again pushed against the County Route 23A embankment. Rip-rap had been installed along 312ft of this embankment and was in good structural condition with shrub and herbaceous vegetation growing throughout (Inset B, Station 76900). Several hillside seeps, along with road drainage, entered Schoharie Creek along this bank. A small detention pond designed to retain stormwater runoff, and remove sediment within the stormwater by settling, had been installed on the streambank terrace (Station 76700).

Detention basin at Station 76700

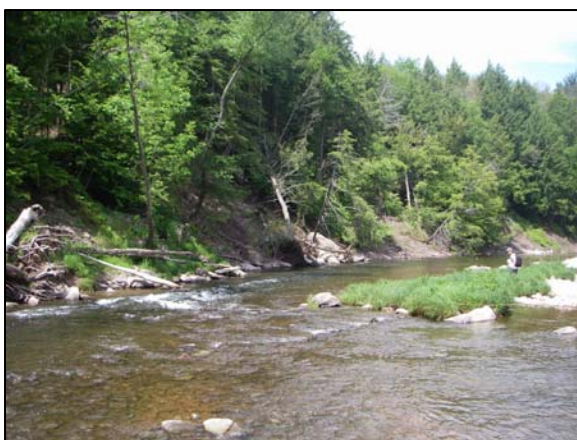
Bank erosion at Station 73100

At the next meander bend downstream, the channel flowed up against the valley wall on the left bank causing a 40,613ft² mass failure (Station 73100). The *thalweg* pushed up against the high hillslope which caused toe erosion that resulted in the loss of the mature forested vegetation, leaving much of the streambank unvegetated. The exposed *mixed till* soils had a high silt and clay content, which likely contributed a significant sediment load during high flows.
