Schoharie Creek Management Unit 10

Towns of Jewett and Lexington – County Route 17 (Station 70652) to
Bush Road Bridge (Station 63446)

Figure 4.10.1 Management Unit 10 - 2006 aerial photography with stream feature inventory

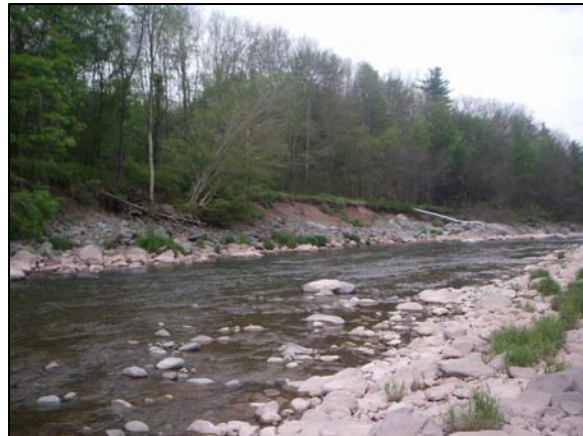
Bank erosion at Station 70450

Just downstream, along the outside meander of this bend the *thalweg*, or deepest part of the stream channel, flowed up against the left streambank causing significant bank erosion (Station 70450). Streambank erosion often occurs on the outside of meander bends where the stream velocity is greatest during high flows.

Many mature trees had fallen from the top of the bank and a 10,876ft² area of streambank had been left unvegetated. This site may stabilize on its own over time. It appeared that a low bench had begun to develop at the toe of the eroding bank which may act to reduce flood water velocities near the bank. As the bank stabilizes native vegetation will reestablish. A bank erosion monitoring site (BEMS) was installed along this bank to study this erosion (Station 70230). A cross-section and long profile survey were conducted to collect baseline *morphology* data. In the future, this cross-section can be resurveyed to calculate the bank's erosion rate and document its potential recovery.

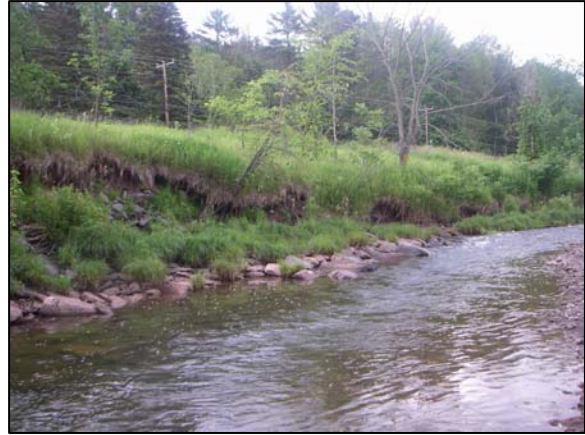
Bank erosion at Station 69050

The right streambank on the side channel along the Route 23A embankment had suffered erosion along a 2,258ft² area. Revetment including 1,209ft of rip-rap and 641ft of T-wall had been installed along the right streambank downstream (Inset A, Station 68700). Although some vegetation had established along this revetment, additional plantings of native trees and shrubs along both the eroding and revetted bank would increase bank stability and improve the aquatic habitat by providing shade, resulting in cooler water temperatures.

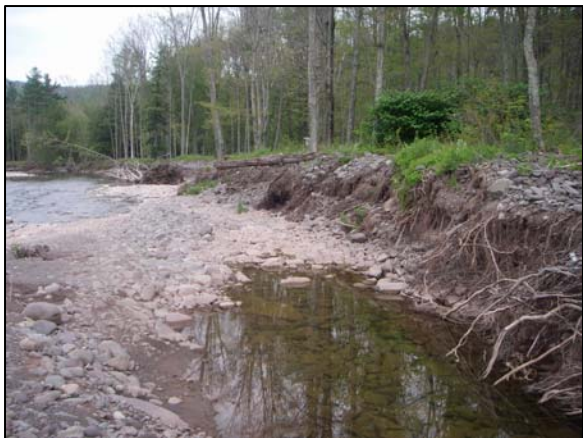
Bank erosion at Station 68900

Downstream at the right streambank was a NYS DEC public fishing access with a parking area at the top of the bank. These access points allow the public to wade and walk along the streambed and banks for the purpose of fishing. Rip-rap had been installed along 335ft of this embankment. Native vegetation had established on this revetment.

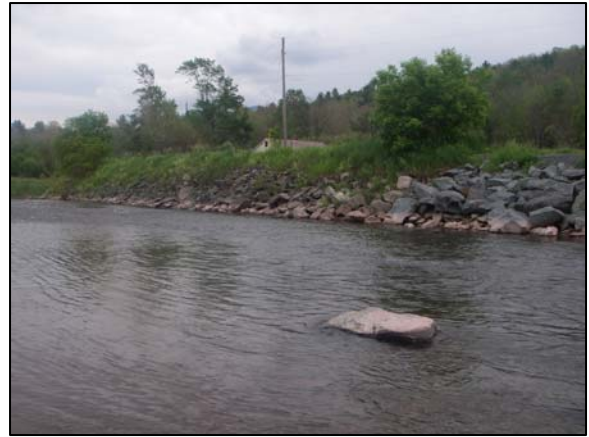
Rip-rap at Station 68300

Beginning at Station 90100 there was an active flood chute on the right streambank along Van Road. According to historic aerial photos this flood chute dates back to at least 1959. The flood chute was part of the *floodway*, or the land most severely affected by flooding and must be able to carry and discharge floodwaters. If this chute were to be cut off, it would reduce the available floodplain and likely increase erosion during high flow events. Although the upstream half of this chute was dry, the downstream end did contain base flow. At the downstream end of this chute rip-rap had been installed along 763ft of the left streambank protecting the Van Road embankment (Station 68300). While rip-rap and other hard controls may provide temporary relief from erosion, they are expensive to install, degrade habitat, and require ongoing maintenance or may transfer erosion problems to upstream or downstream areas. Alternate stabilization techniques should be explored for streambanks whenever possible. Native shrub and sedge species should be interplanted through the rip-rap and along the toe of this streambank to help strengthen the revetment and enhance aquatic habitat.

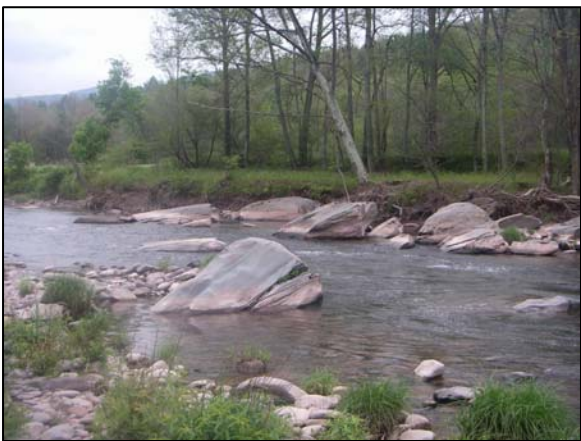
Bank erosion at Station 67300 - looking upstream

As the flood chute and mainstem stream channel converged, the left streambank had been scoured along the streambank toe. This type of erosion is common and part of natural stream process. In stable watersheds, the rate of erosion is slow and a natural healing process usually follows. Excessive sediment deposition was observed as the two stream channels reunited into one (Station 66800).

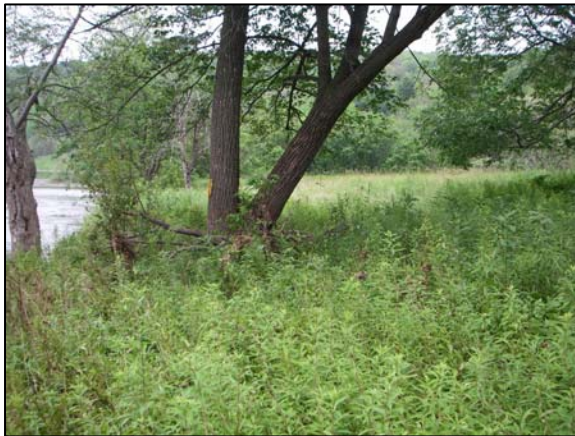
Planting site at Station 66250 – right streambank

Downstream the riparian buffer beyond both the streambanks was comprised of a few mature trees with herbaceous fields to the edge of the bank (Station 66250). Buffer width

should be increased along these banks by the greatest amount agreeable to the landowners, but increasing the forested buffer width by at least 100 feet would increase buffer functionality, such as filtering nutrients and pollutants, if any, from the adjacent fields.

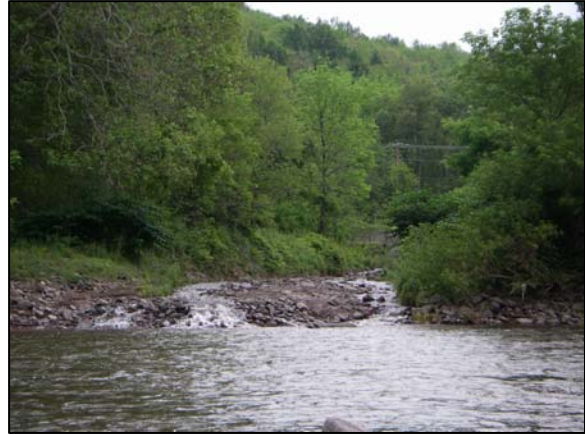
John Chase Brook confluence at Station 65700

John Chase Brook entered from the right streambank (Station 65700). This tributary drained the slopes of Tower Mountain before it reached the flatter topography of the valley floor where it entered the Schoharie Creek. As a result of this change in stream slope, the tributary lost its ability to transport sediment gathered from the mountain slopes, and began to deposit sediment at its mouth and into the more gently sloped Schoharie Creek. This is a common feature of confluence areas, which often contain extensive sediment bars, function as important sediment storage areas, and are typically among the most dynamic and changeable areas in the stream system. This *tributary* was classified as C(t) by the NYS DEC, indicating that the best uses for this stream were the support of fisheries, including trout, and other non-contact activities (NYSDEC, 1994).

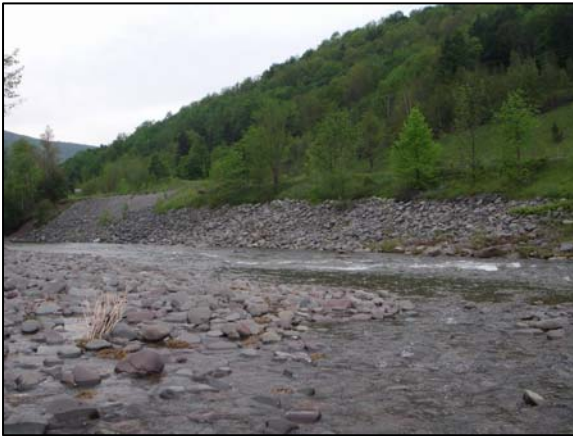
Rip-rap at Station 65200

rip-rap had been installed along the right streambank (Station 65200). Interplanting of the existing rip-rap, by inserting plantings into the soil between the rocks may help to strengthen and increase the longevity of this rip-rap. These plantings will also improve the aquatic habitat by providing shade, resulting in cooler water temperatures. Along this rip-rap an unnamed tributary entered the Schoharie Creek through a concrete culvert

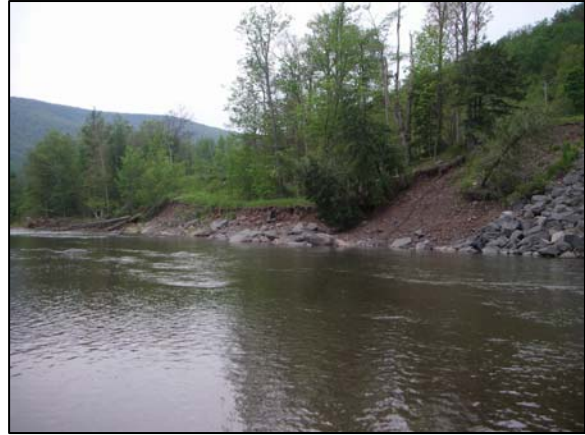
Bank erosion at Station 64580

As this rip-rap ended, erosion began (Station 64580). The hillslope was being undermined by toe erosion, resulting in the mass wasting of a 3,479 ft² area of the right streambank. This erosion left the face of the stream bank unvegetated. The exposed lodgement till soil had a high silt and clay content, contributing a significant suspended sediment load during rainfall events. In addition to the water quality threat associated with the clay exposed at this erosion site, conditions here also present a future hazard to the County Route 23A embankment which could be threatened if this bank continues to erode.

A bank erosion monitoring site (BEMS) was installed along this bank to study this erosion (Station 64315). If study of this streambank shows erosion rates accelerating significantly, full restoration to address property loss and water quality threats should be considered. This would likely involve establishment of a well-vegetated bench on the right bank with rock vanes to direct stream flows away from the bank, regrading and then revegetation of the bank face, and establishment of channel geometry throughout the unit to more effectively convey the *sediment load*.

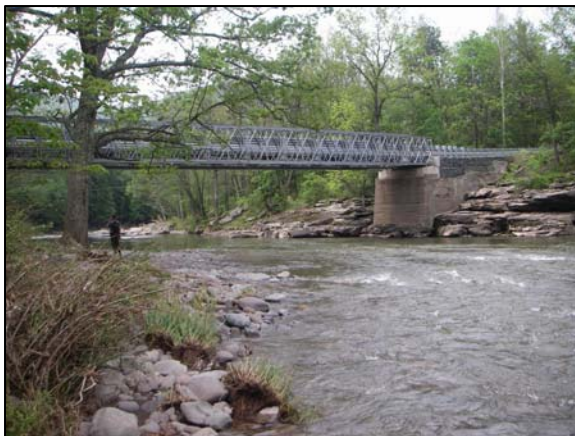
Bridge at Bush Road Station 63446

At the downstream end of this management unit the stream passed under the bridge at Bush Road (BIN 32012110). This bridge may constrict the floodplain at very high flows, as evidenced by aggradation at the left bridge abutment, but appeared to pass most flows effectively. Flood damage to

bridges is typically caused by inadequate hydraulic capacity of the bridge, misaligned piers and/or abutments, or accumulation of debris. As bridges are replaced over time, these issues should be evaluated and adjusted if necessary to lessen the probability of flood damage by providing a more effective conveyance channel that promotes water and sediment flow through the bridge opening.
