Schoharie Creek Management Unit 11

Town of Lexington – Bush Road Bridge (Station 63446) to County Route 42 Bridge (Station 55350)

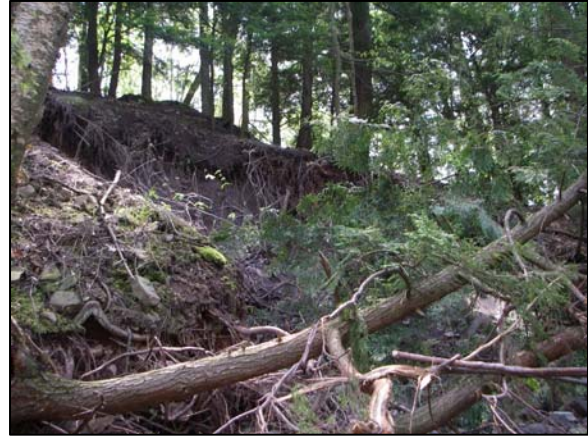
The *thalweg*, or deepest part of the stream channel, flowed up against the left streambank causing the first significant bank erosion in the management unit (Inset D, Station 62100). This *mass failure* had resulted in an erosion area of approximately 11,248 ft², exposing areas of mixed till as well as compromising mature trees at the top of the bank. Streambank erosion often occurs on the outside of meander bends where the stream velocity is greatest during high flows.

Bank erosion at Station 62100

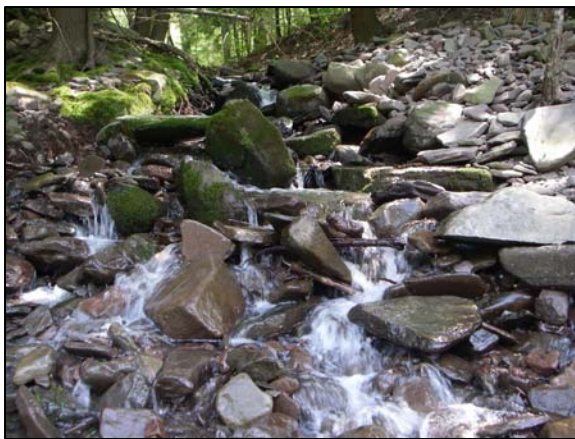
Tributary at Station 60900

they entered the Schoharie Creek. As a result of this stream slope change, the tributary lost its ability to transport sediment gathered from the mountain slopes, and began to deposit sediment at its mouth and into the more gently sloped Schoharie Creek. This is a common feature of confluence areas, which often contain extensive sediment bars, function as important sediment storage areas, and are typically among the most dynamic and

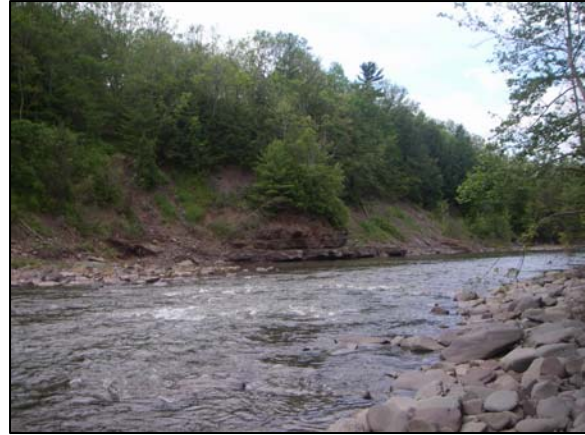
At the next downstream meander bend there was another erosion site (Inset B, Station 59100). The hillslope was undermined by toe erosion, resulting in the mass wasting of a 65,306 ft² area along 1,363 ft of the bank. This erosion had left the face of the streambank unvegetated. Throughout the bank *lacustrine clay* deposits were exposed. Clay inputs into a stream are a serious water quality concern because they increase *turbidity*, degrade fish habitat, and can act as a carrier for other pollutants and pathogens. This bank may introduce significant amounts of suspended sediment and woody debris during rainfall events. While woody debris is valued as a feature of good fish habitat, in some instances it can present a threat to infrastructure. This site may stabilize on its own over time. It appeared a low bench may have started to develop at the toe of the eroding bank which may act to reduce flood water velocities near the bank. A bank erosion monitoring site (BEMS) could be installed along this bank to study this bank's erosion rate and document its potential recovery. In-depth survey and design would be necessary to effectively restore this erosion site.

Bank erosion at Station 59100

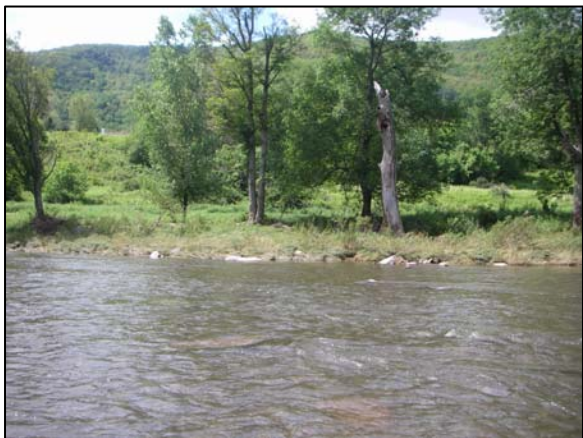
Planting site at Station 57100

As the stream gained access to the floodplain on the left streambank the riparian buffer was composed primarily of herbaceous vegetation (Station 57100). A buffer of native trees and shrubs should be planted along the streambank and corridor. Buffer width should be increased by the greatest amount agreeable to the landowner, but increasing the buffer

width by at least 100 feet will increase the buffer functionality, such as slowing the flow of run-off from the floodplain and allowing sediment and its attached pollutants, if any, to settle out before reaching the stream.

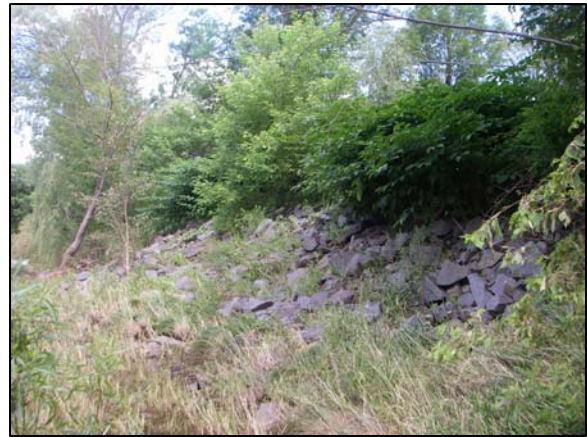
As residential properties started to line the right streambank, revetment including 833 ft of rip-rap (Station 56600) and 165 ft of stacked rock wall (Station 55600) had been installed. The rip-rap appeared to have been dumped between existing streamside vegetation, which may help to stabilize this bank and enhance aquatic habitat.

Rip-rap at Station 56600

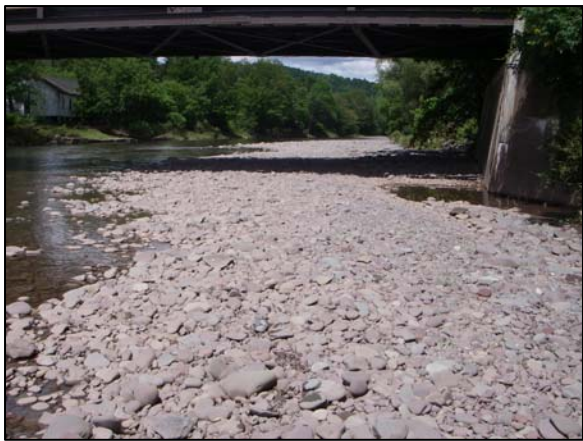
*Aggradation at County Route 42 bridge
Station 55350*

high flows, as evidenced by aggradation at the right bridge abutment, but appeared to pass most flows effectively. Higher flows appeared to backwater, resulting in upstream channel widening and aggradation. A large gravel bar had formed along the right streambank indicating inadequate sizing of the bridge opening. An undersized bridge opening causes water to back up upstream of the bridge, reducing stream velocity, which

results in sediment deposition. As bridges are replaced over time, these issues should be evaluated and adjusted if necessary to lessen the probability of flood damage by providing a more effective conveyance channel that promotes water and sediment flow through the bridge opening.
