Schoharie Creek Management Unit 12

Town of Lexington – County Route 42 Bridge (Station 55350) to Station 48154

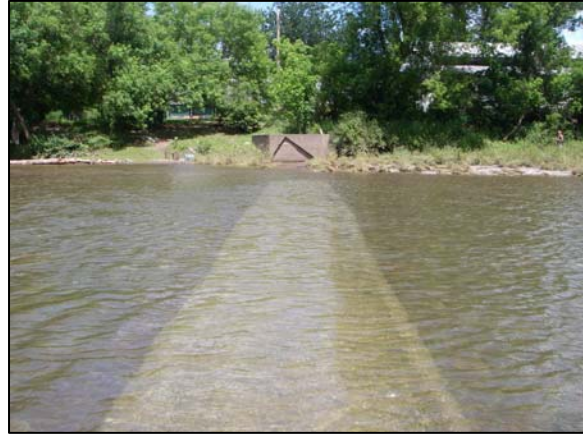
The stream channel downstream from the bridge was over-wide and aggrading (Inset D). This condition was exacerbated by a 6 ft wide concrete sill across the stream channel. In the past, wooden barriers were placed into this sill to pond water for a swimming area. Although this has not occurred in many years the concrete sill remains. Conducting a study of the effect of removing this sill or cutting a low flow channel into the sill is recommended. Creation of a low flow channel may reduce deposition and create aquatic habitat through the development of stream features, which are currently lacking. In-depth survey and design would be necessary to study the upstream and downstream effects of a restoration project.

Concrete sill at Station 54480

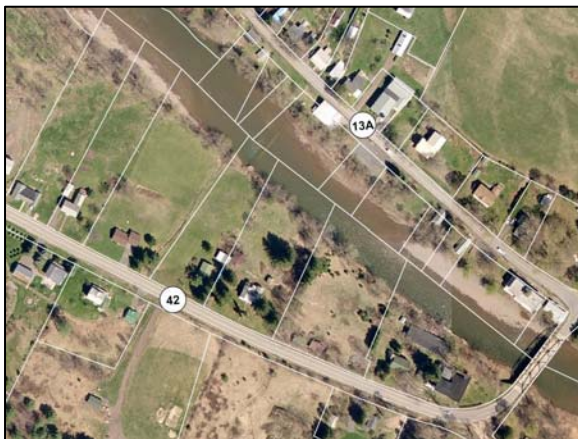
Planting site at Station 54350 – left streambank

Downstream, residential properties lined both streambanks. On the left streambank, several properties with homes along County Route 42 had large lawn areas within the 100-year floodplain mown to the stream edge (Station 54350). A buffer of native trees and shrubs should be planted along the streambank and corridor. Buffer width should be increased by the greatest amount agreeable to the landowner, but

increasing the buffer width by at least 100 feet will increase the buffer functionality, such as

slowing the flow of run-off from the floodplain and allowing sediment and its attached pollutants, if any, to settle out before reaching the stream. Along the right streambank the lawn was also mowed to the stream edges and the streambank toe showed signs of scour (Inset C, Station 54200). Native trees and shrubs should be planted on the face of stream bank. To provide protection against toe erosion, willow *fascines* and sedges should be planted along the toe of the stream bank. These planting can be spaced to retain views of the creek.

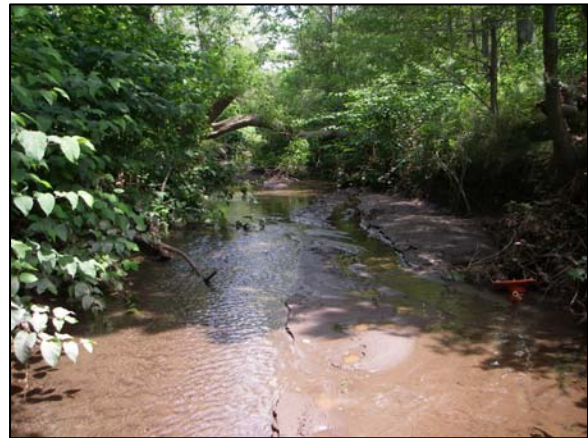
An unnamed tributary entered the Schoharie Creek from the right streambank (Station 53700). This tributary drained the steep slopes of Patterson Ridge, before it reached the flatter topography of the valley floor where it entered the Schoharie Creek. As a result of this stream slope change, the tributary lost its ability to transport sediment gathered from the mountain slopes, and began to deposit sediment at its mouth and into the more gently sloped Schoharie Creek. This is a common feature of confluence areas, which often contain extensive sediment bars, function as important sediment storage areas, and are typically among the most dynamic and changeable areas in the stream system. This tributary was classified C by the NYSDEC (NYSDEC, 1994).

Tributary at Station 53700 – looking upstream

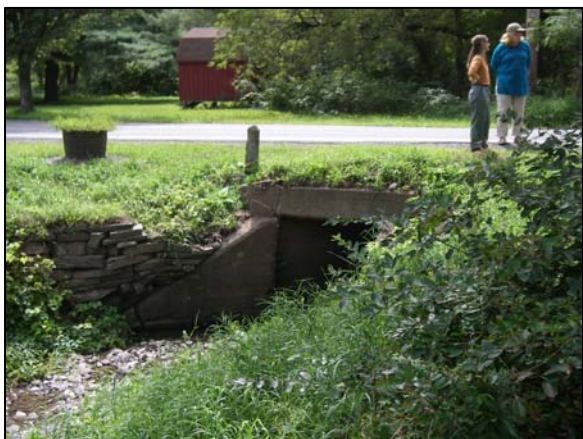
Culvert in need of replacement on County Rt. 13A

The tributary passed under County Route 13A through a culvert before entering the Schoharie Creek. During flood events this culvert is unable to pass flows and backwaters, leading to flooding of the roadway and adjacent residential properties. Repeated flooding in this area had resulted in expensive roadway repair work. To protect public and private infrastructure this culvert

should be replaced with a larger realigned culvert able to pass flood flows. The new culvert should also be ecologically friendly with an open bottom to provide passage for biota. Installation of flood plain drainage on the adjacent lawn could provide an outlet for any excess flood waters.

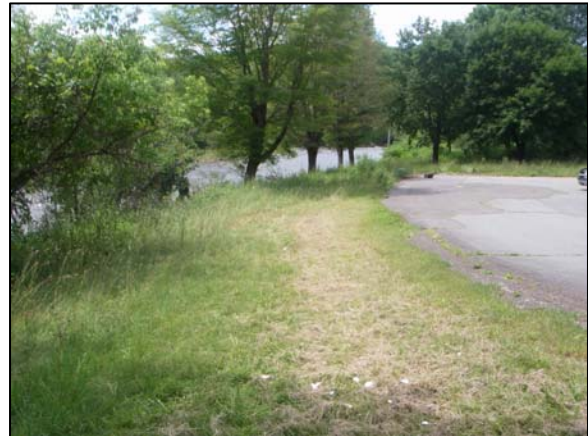
Downstream on the right streambank there was a NYSDEC public fishing access with a parking area at the top of the bank (Station 53500). These access points allow the public to wade and walk along the streambed and banks for the purpose of fishing. Rip-rap had been installed along 72 ft of this embankment.

Planting site at DEC Parking Area – Station 53500

To demonstrate creation of a high quality riparian buffer, native trees, shrubs, and sedges should be planted along this streambank and upland area. Buffer enhancement would not only increase bank stability but would also improve aquatic habitat by providing shade, resulting in cooler water temperatures. An educational kiosk at the DEC parking area could provide a description of the project and the importance of forested streamside buffers. Information explaining other restoration projects that may occur in the area, such as the proposed CR13A culvert replacement, could also be displayed.

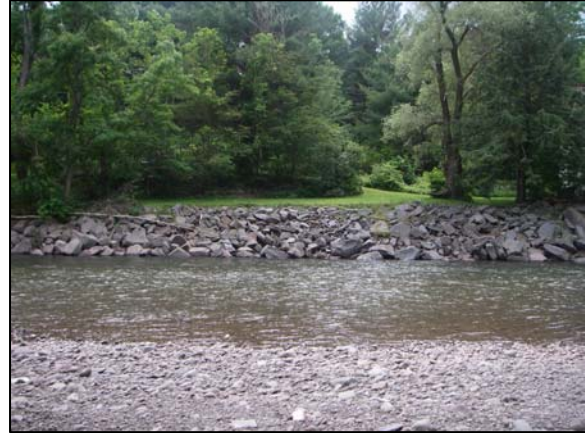
As the stream flowed directly toward County Route 42, rip-rap had been installed on approximately 729 ft of the left streambank (Station 52600-51700). While rip-rap and other hard controls may provide temporary relief from erosion, they are expensive to install,

Rip-rap at Station 52120

degrade habitat, and require ongoing maintenance or may transfer erosion problems to upstream or downstream areas. Alternate stabilization techniques should be explored for streambanks whenever possible.

Interplanting of this rip-rap, by inserting native shrub plantings into the soil between the rocks, would strengthen and increase its longevity. These plantings would also improve aquatic habitat by providing shade,

resulting in cooler water temperatures. To provide protection against toe erosion, sedges or willows could be planted along the toe of the streambank.

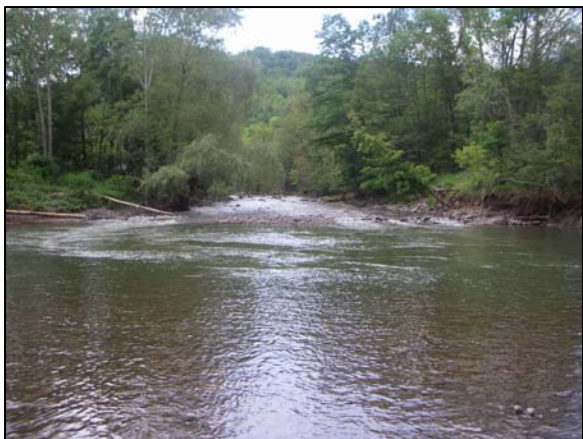
West Kill confluence at Station 51650
looking upstream

confluence. The West Kill watershed drains approximately 31.2 mi² and is closely surrounded by the steep mountains of the Catskills. As evidenced by the large amount of deposition upstream and downstream of the confluence, the West Kill delivered a significant amount of sediment into the Schoharie Creek. The West Kill was classified as C(ts) by NYSDEC, indicating that the best uses for this stream were the support of fisheries, including trout spawning

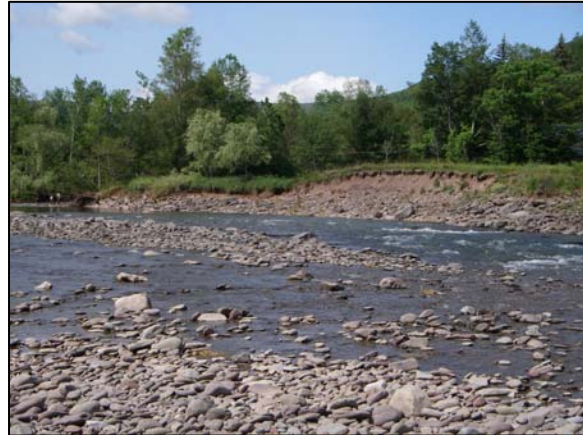
Immediately downstream of this confluence both streambanks had eroded, likely due to the increased drainage area and sediment load from the West Kill. Erosion was documented along 1,171 ft of the left streambank, exposing an estimated area of 6,191 ft²

Bank erosion on left streambank at Station 51600

(Station 51600). Restoration recommendations for this streambank include creation of a low bench at the toe of the eroding bank which may act to reduce flood water velocities near the bank and grading of the eroding bank to reduce its slope. The reshaped streambank should be planted with native trees, shrubs, and sedges. Installation of a 100 ft buffer along the adjacent stream corridor may also act to filter nutrients and pollutants, if any, from the adjacent fields.

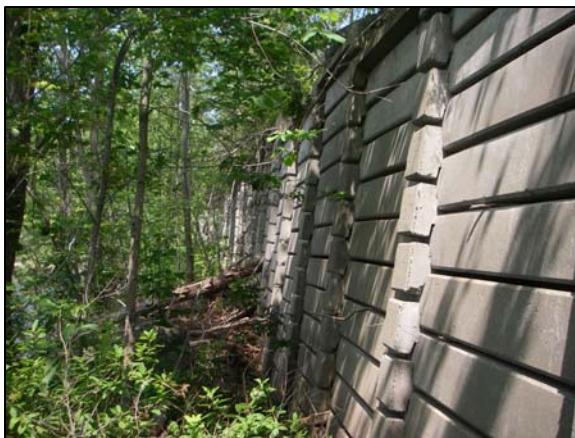
T-wall at Station 49450

As the stream flowed against the County Route 23A embankment revetment had been installed, including 1,308 ft of rip-rap (Station 50100) and 285 ft of concrete T-wall (Station 49450). A large amount of

native vegetation was growing throughout this revetment.
