Schoharie Creek Management Unit 13

Town of Lexington – Station 48154 to Mosquito Point Bridge (Station 41722)

Schoharie Creek Management Unit 13 Stream Feature Inventory

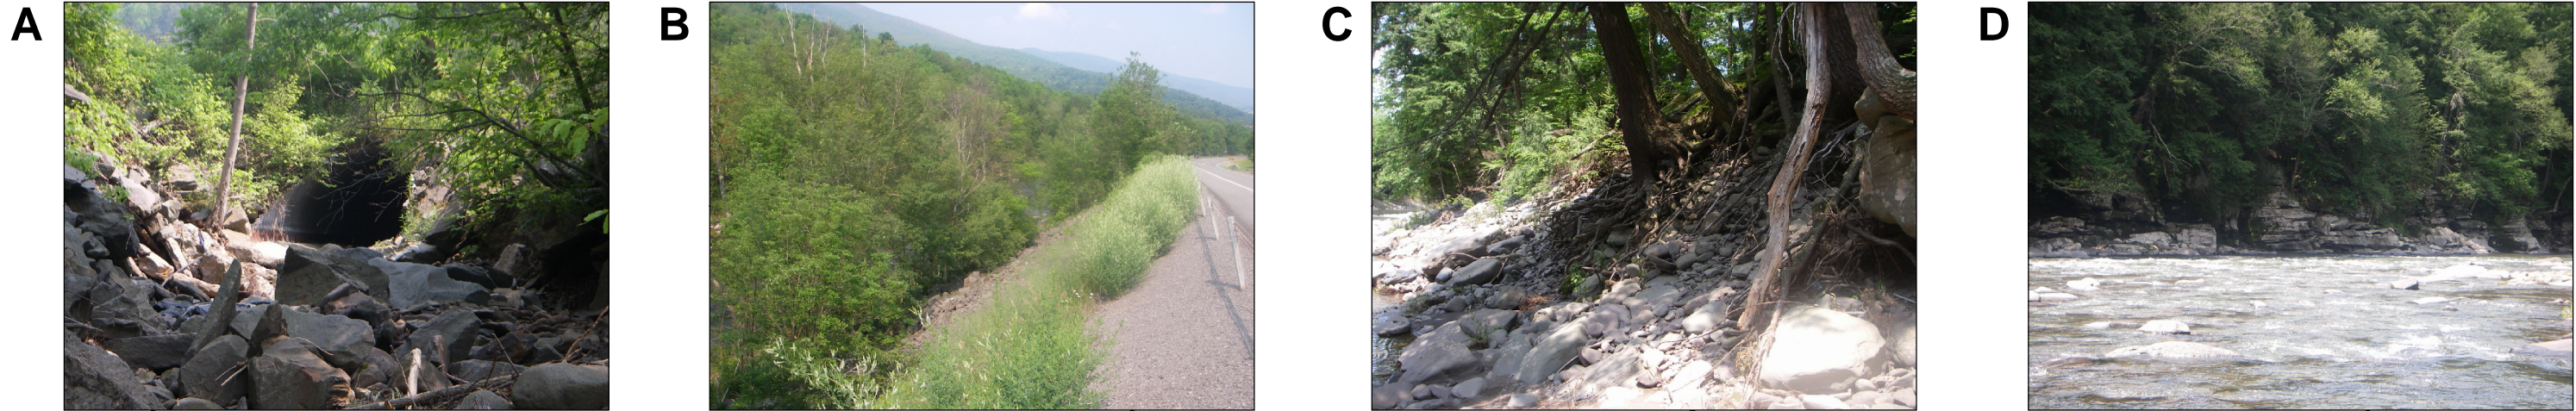
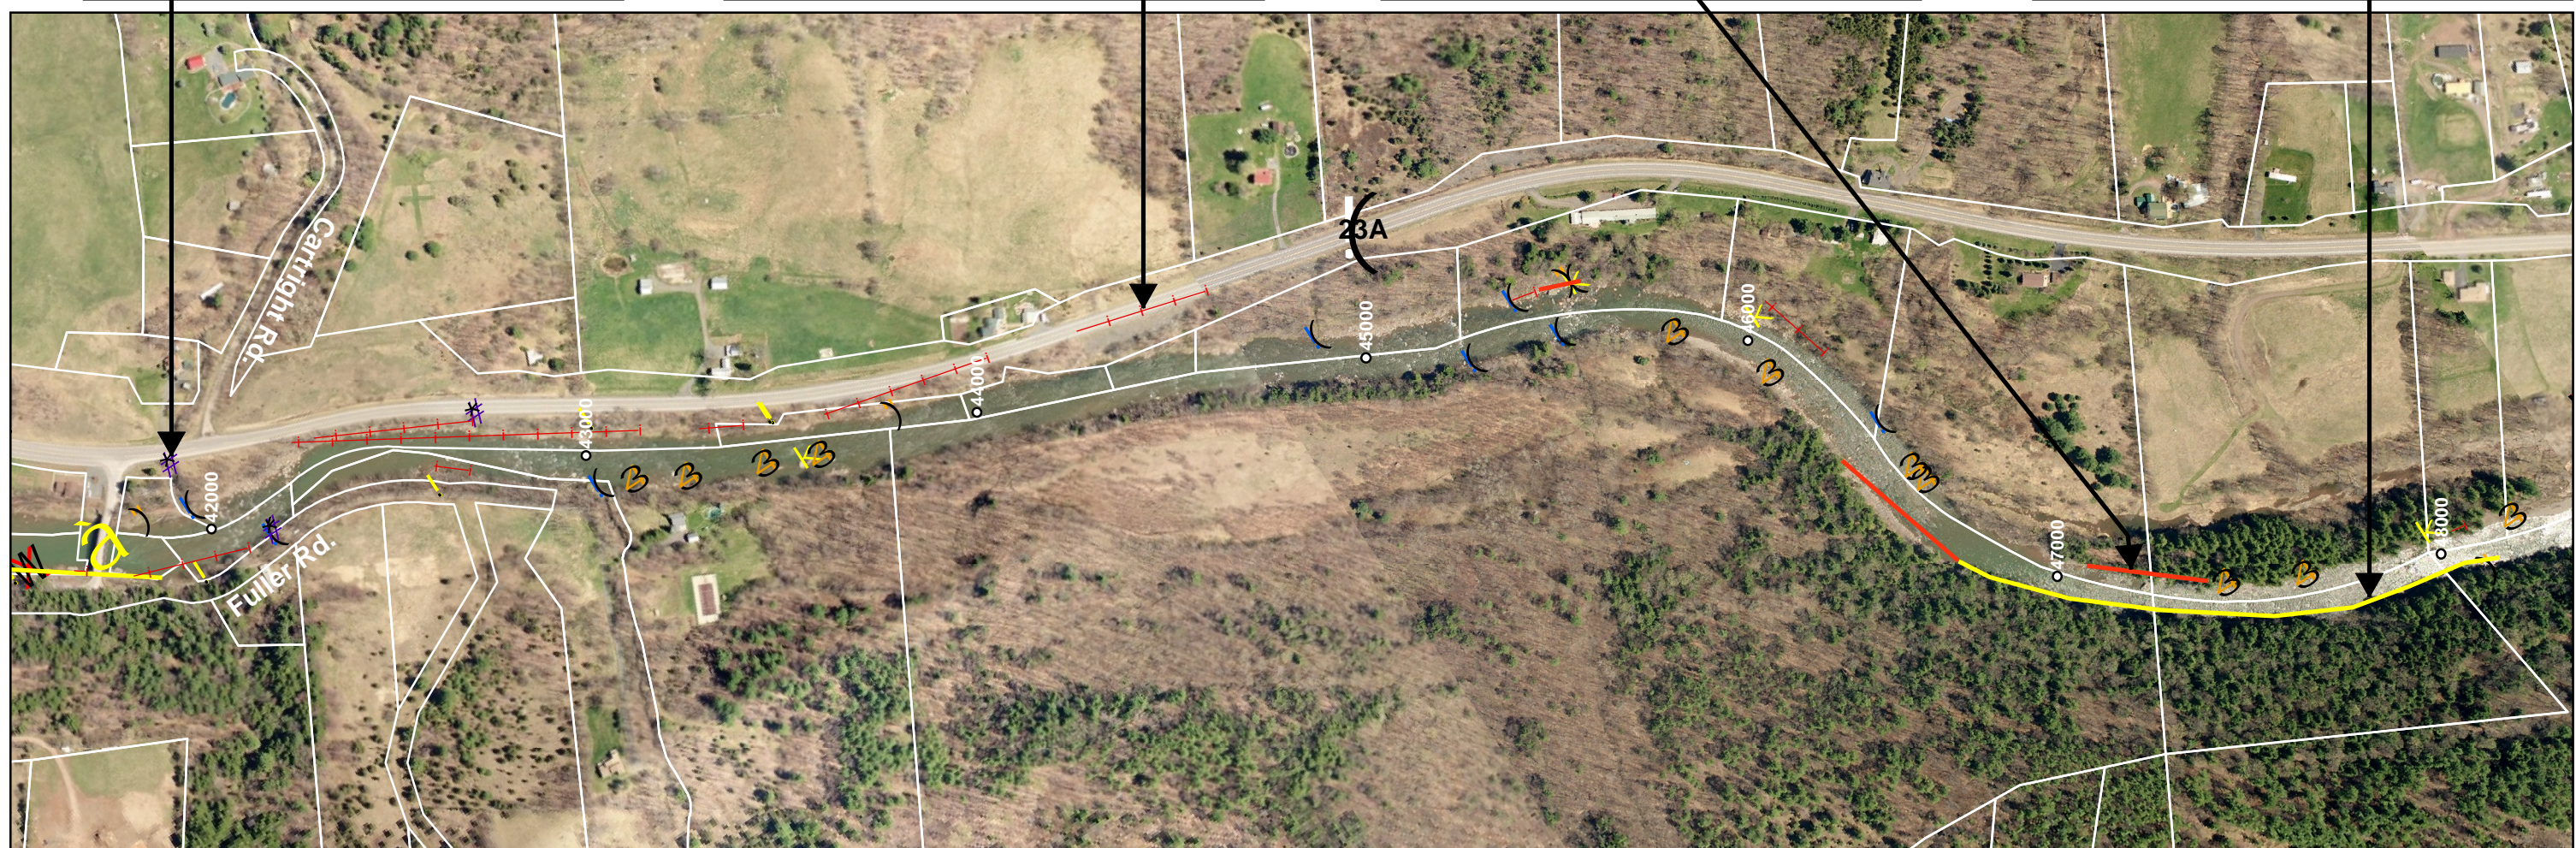
Figure 4.13.1 Management Unit 13 - 2006 aerial photography with stream feature inventory

The 2006 stream feature inventory revealed that 6.3% (806 ft) of the streambanks exhibited signs of active erosion along the 12,864 ft of total channel length in the unit (Figure 4.13.1). The total surface area of active erosion totaled approximately 33,005 ft². *Revetment* had been installed on 22.1% (2,844 ft) of the streambanks. No *berms* were identified in this management unit at the time of the stream feature inventory.

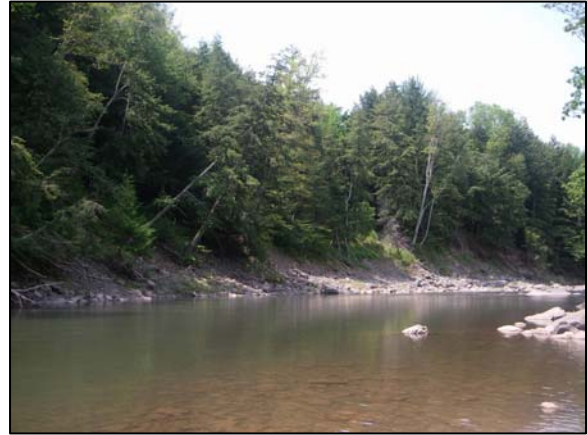
Bank erosion at Station 46750

As the bedrock protecting the left streambank ended, erosion began (Station 46750). Along the outside meander of this bend the *thalweg*, or deepest part of the stream channel, flowed up against the left streambank causing significant bank erosion. Streambank erosion often occurs on the outside of meander bends where the stream velocity is greatest during high flows. Many mature trees had fallen from the top of the bank and a 24,063ft² area of streambank had been left unvegetated. This site may stabilize on its own over time. It appeared a low bench had begun to develop at the toe of the eroding bank which may act to reduce flood water velocities near the bank. As the bank stabilizes native vegetation should reestablish.

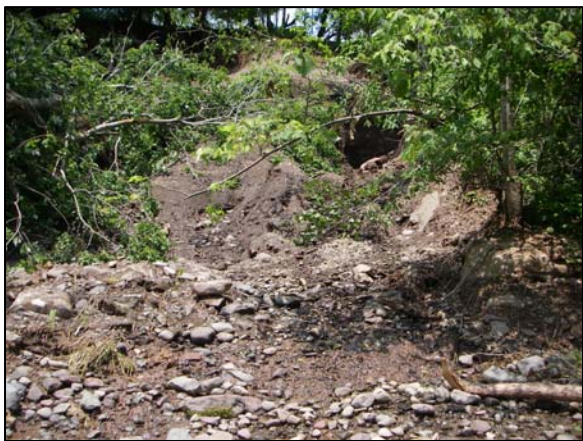
Bank erosion at Station 45560

Downstream, the hillslope on the right streambank was undermined by toe erosion, resulting in the mass wasting of the bank (Station 45560). This erosion had resulted in a loss of vegetation on a 4,287 ft² area of streambank. The exposed soil has a high silt and clay content, contributing sediment through *wet ravel* and may yield a significant suspended sediment load during rainfall events. An entrenched tributary flowing over

the bank and many seeps have exacerbated this erosion.

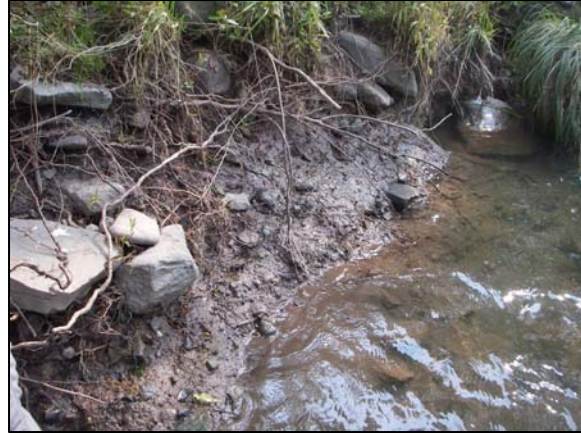
Clay exposure at Station 43800

As the stream flowed up against the County Route 23A embankment much of the right streambank had been hardened. Rip-rap had been installed along 778 ft of this embankment (Inset B, Station 44640 & Station 44050). While rip-rap and other hard controls may provide temporary relief from erosion, they are expensive to install, degrade habitat, and require ongoing maintenance or may transfer erosion problems to upstream or downstream areas. Alternate stabilization techniques should be explored for streambanks whenever possible. Along this rip-rap, the streambank toe had scoured exposing a 15 ft long section of clay and silt (Station 43800). Native shrub and sedge species should be interplanted through the rip-rap and along the toe of this streambank to help strengthen the revetment and enhance aquatic habitat.

Summary of Recommendations Management Unit 13	
Intervention Level	Passive, Assisted Self-Recovery
Stream Morphology	No recommendations at this time
Riparian Vegetation	Interplanting of rip-rap at Station 43800 & 42050
Infrastructure	No recommendations at this time
Aquatic Habitat	Watershed Aquatic Habitat Study
Flood Related Threats	No recommendations at this time
Water Quality	No recommendations at this time
Further Assessment	No recommendations at this time

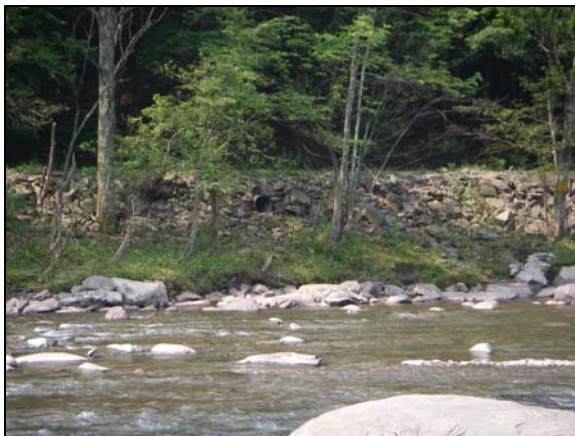
Rip-rap at Station 42050

Approximately 298 ft of rip-rap had been installed along the Fuller Road embankment on the left streambank (Station 42050). High flows have started to scour this bank. Native shrub and sedge species should be interplanted along the toe of this streambank to help strengthen the revetment, while enhancing aquatic habitat. A combination of trees and shrubs should also be

planted along the streambank to increase bank stability and protect the road embankment.

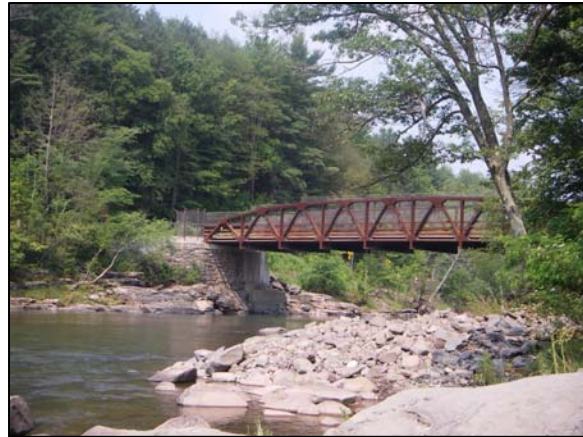
Mosquito Point bridge at Station 41722

At the downstream end of this management unit the stream passed under the Mosquito Point bridge (Station 41722, BIN 3302930). This bridge may constrict the floodplain at very high flows, but appeared to pass most flows effectively. Flood damage to bridges is typically caused by inadequate hydraulic capacity of the bridge, misaligned piers and/or abutments, or accumulation of debris. As bridges are replaced over time, these issues should be evaluated and adjusted if necessary to lessen the probability of flood damage by providing a more effective conveyance channel that promotes water and sediment flow through the bridge opening.
