# Schoharie Creek Management Unit 14

Town of Lexington – Mosquito Point Bridge (Station 41722) to Station 34336

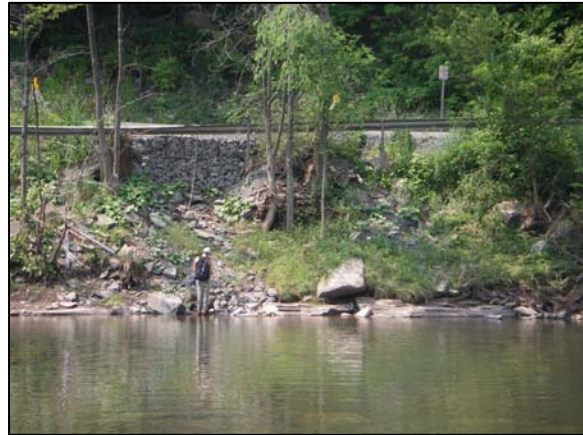
Starting at the Mosquito Point bridge, Little West Kill road runs parallel to the stream along the left streambank for approximately 4,822 ft (Station 41722-36900). This embankment has suffered repetitive flood damage due to its location within the 100-year floodplain. Elevating and relocating portions of this roadway is recommended to address flooding issues.

*Little West Kill Road embankment*

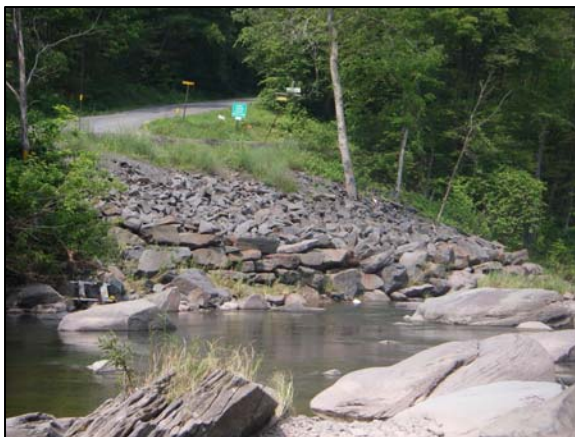
*Rip-rap at Station 41200*

Due to damage from high flow events and stormwater runoff, rip-rap had been installed along 114 ft of the left stream embankment (Station 41200). While rip-rap and other hard controls may provide temporary relief from erosion, they are expensive to install, degrade habitat, and require ongoing maintenance or may transfer erosion problems to upstream or downstream areas. Alternate stabilization techniques

should be explored for streambanks whenever possible. Interplanting of this rip-rap, by

inserting native tree and shrub plantings into the soil between the rocks, would strengthen and increase its longevity. These plantings would also improve the aquatic habitat by providing shade, resulting in cooler water temperatures. A 60 ft<sup>2</sup> *lacustrine* clay exposure was documented at the toe of this revetment (Station 41150). Fine sediment inputs into a stream increase *turbidity* and can act as a transport mechanism for other pollutants and pathogens. To provide protection against toe erosion, sedges or willows could be planted along the toe of the streambank.

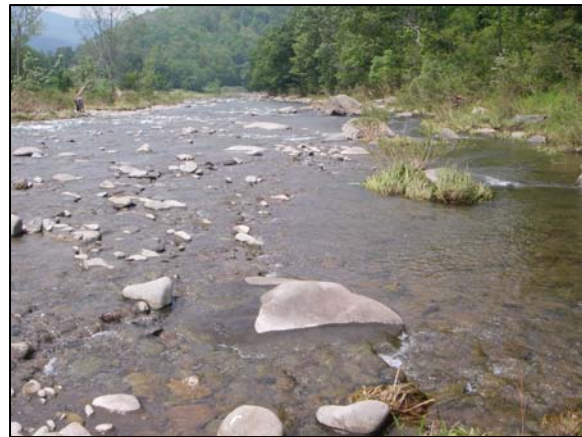
Downstream the stream channel became overwide and shallow causing a significant amount of *aggradation* (Station 40900-37700). Deposition of bed materials is common in

*Aggrading stream reach (Station 40900-37700)*

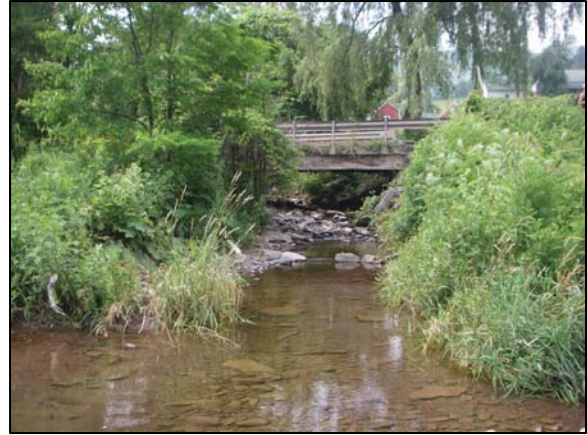
An unnamed tributary entered the Schoharie Creek from the left streambank (Station 40300). This tributary drained the steep slopes of Vly Mountain, before it reached the flatter topography of the valley floor where it entered the Schoharie Creek. As a result of this stream

slope change, the tributary lost its ability to transport sediment gathered from the mountain slopes, and began to deposit sediment at its mouth and into the more gently sloped Schoharie Creek. This is a common feature of confluence areas, which often contain extensive sediment bars, function as important sediment storage areas, and are typically among the most dynamic and changeable areas in the stream system. This tributary was classified C by the NYSDEC (NYSDEC, 1994).

*Tributary at Station 40300 - looking upstream*

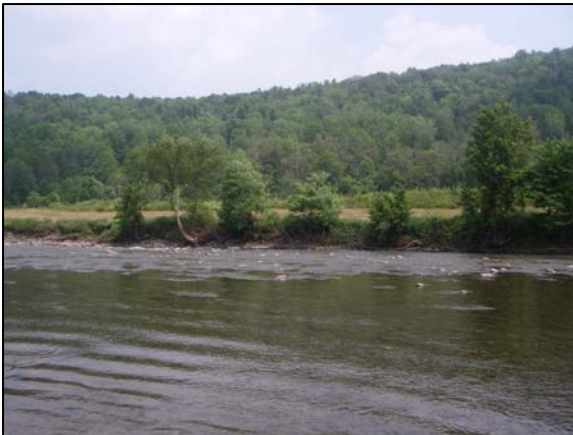
On the opposite bank, 433 ft of the County Route 23A embankment had suffered minor erosion during high flow events (Station 40300). The terrace at the top of the embankment had herbaceous vegetation in the riparian zone. Mown lawn or pasture does not

*Bank erosion and planting site at Station 40300*

provide as much resistance to streambank erosion as the deep and dense root structure found in streamside forest. The complex root systems of trees may also act to filter nutrients and pollutants, if any, from stormwater runoff. Areas where the riparian zone has been maintained in pasture or lawn present opportunities to improve the streamside buffer with tree plantings in order to promote a more mature vegetative community along the streambank and in the floodplain. The

stability of this streambank could be improved with plantings of willow *fascines* and sedges along the toe of the bank coupled with trees and shrubs along the bank and upland area.

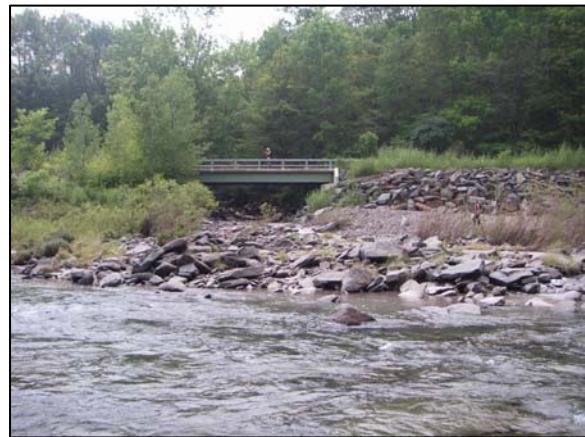
*Little West Kill tributary at Station 36900*

The Little West Kill watershed drains approximately 8.2mi<sup>2</sup> and is closely surrounded by Roundtop, Bearpen, and Vly Mountains. As evidenced by the large amount of deposition upstream and downstream of the confluence, the Little West Kill delivers a significant amount of sediment to the Schoharie Creek. A stream feature inventory to identify sediment sources from this tributary is recommended. At the confluence, rip-rap had been installed on 97 ft of the left streambank (Station 36900). Interplanting of this rip-rap, by inserting native tree and shrub plantings into the soil between the rocks, would strengthen and increase its longevity.

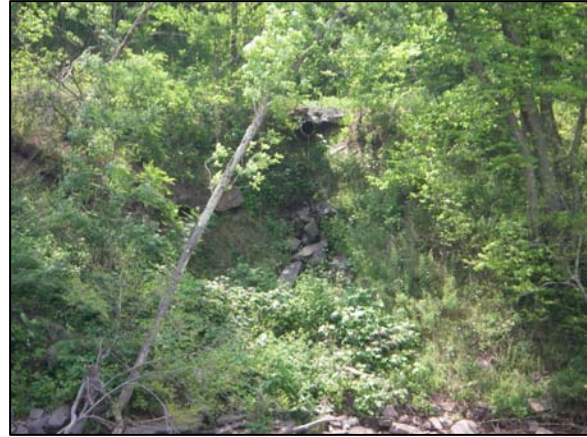
*Stormwater outfall at Station 36350*
