Schoharie Creek Management Unit 16

Town of Prattsville – Station 31388 to County Route 23 (Station 19376)

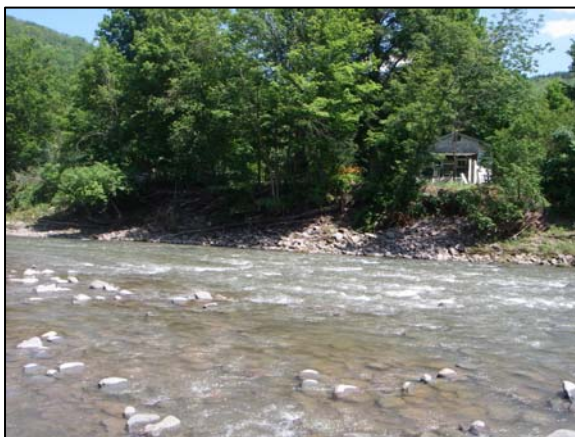
Bank erosion at Station 30600

At the upstream end of this management unit 200 ft of the right streambank had eroded a residential property (Station 30600). To increase bank stability, native shrubs and sedges should be planted along the streambank and toe. On the opposite bank 245 ft (Station 30260) had scoured during high flow events. This type of erosion is common and part of natural stream process. In stable watersheds, the rate of

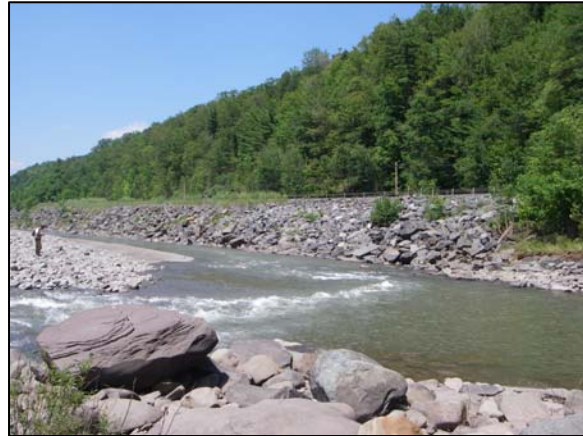
As the stream flowed directly into the County Route 23A embankment, rip-rap had been installed along 2,498 ft of the right streambank (Station 29750) and 1,339 ft along the left streambank (Station 29500). While rip-rap and other hard controls may provide temporary relief from erosion, they are expensive to install, degrade habitat, and require ongoing maintenance or may transfer erosion problems to upstream or downstream areas. Alternate stabilization techniques should be explored for streambanks whenever possible. Interplanting of this rip-rap, by inserting native tree and shrub plantings into the soil between the rocks, would increase its strength and increase its longevity. These plantings would also improve the aquatic habitat by providing shade, resulting in cooler water temperatures.

Rip-rap at Station 29750

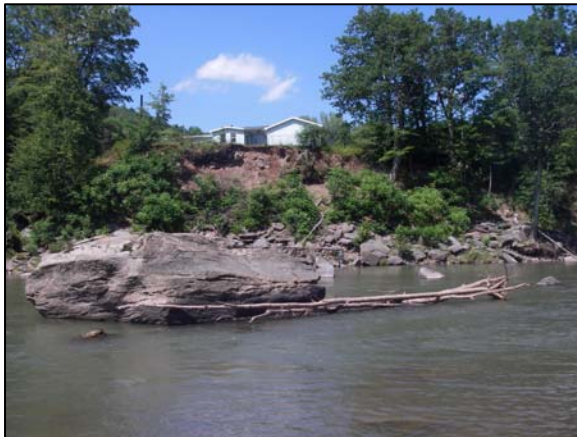
Downstream along this meander bend the *thalweg*, or deepest part of the stream channel, flowed up against the right streambank causing significant bank erosion (Station 28100). Streambank erosion often occurs on the outside of meander bends where the stream velocity is greatest during high flows. The home at the top of this bank could be threatened in the future if this bank continues to erode. Rip-rap had been installed along the toe of the bank.

Bank erosion at Station 28100

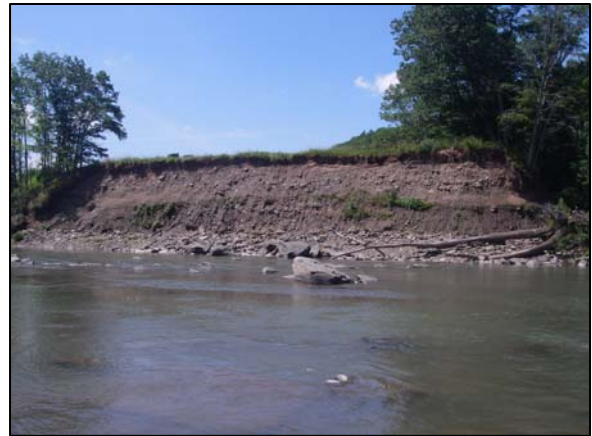
Downstream of the tributary, the erosion continued for an additional 477 ft, leaving a 8,265 ft² area of streambank unvegetated and exposing a large amount of bare soil (Station 27950). A bank erosion monitoring site (BEMS) was installed along this bank to study this erosion (Station 27840). A cross-section and long profile survey were conducted to collect baseline *morphology* data. In the future this cross-

Bank erosion at Station 27950

section can be resurveyed to calculate the bank’s erosion rate. If the erosion rate accelerates significantly, full restoration to address property loss of the adjacent agricultural fields should be considered for this site. This would possibly involve establishment of a well-vegetated bench at the bank toe with rock vanes to direct stream flows away from the bank, regrading and then revegetation of the bank face, and establishment of channel geometry throughout the unit to more effectively convey the *sediment load*.

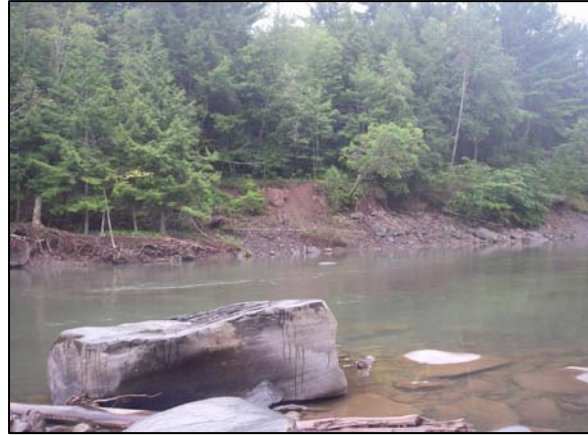
Just downstream, a 37,263 ft² area of eroding streambank had exposed a significant glacial lake silt/clay deposit throughout the entire bank (Station 26260). Fine sediment inputs from eroding banks can be a water quality concern because they increase *turbidity* and can act as a transport mechanism for other pollutants and pathogens. Another bank erosion monitoring site (BEMS) was installed near the downstream end of this erosion (Station 25340). If the erosion rate accelerates significantly, full restoration to address water quality threats from clay exposures should be considered.

Bank erosion at Station 26260

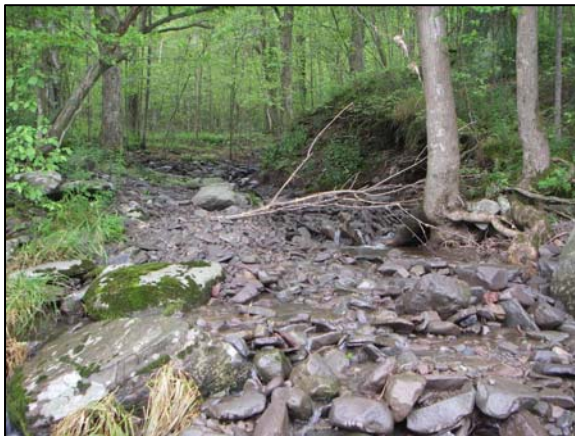
On the left streambank an unnamed tributary entered the Schoharie Creek (Station 23930). This tributary drained Roundtop Mountain, before it reached the flatter topography of the valley floor where it entered the Schoharie Creek. As a result of this stream slope

Tributary at Station 23930 - looking upstream

change, the tributary lost its ability to transport sediment gathered from the mountain slopes, and began to deposit sediment at its mouth and into the more gently sloped Schoharie Creek. This is a common feature of confluence areas, which often contain extensive sediment bars, function as important sediment storage areas, and are typically among the most dynamic and changeable areas in the stream system. This

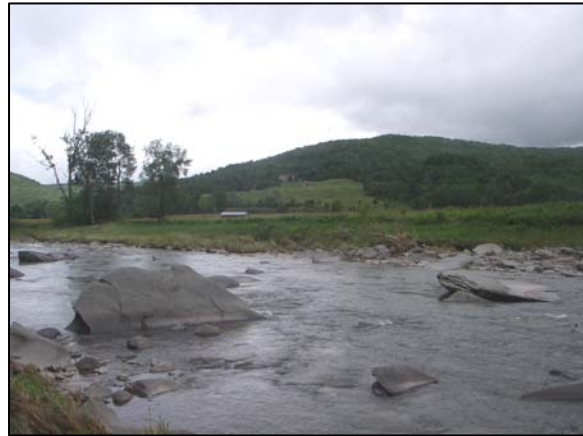
Planting site at Station 22900

Proceeding downstream, the land use on the right streambank changed from forested to agricultural with fields to the edge of the stream (Station 22900). A riparian buffer of native trees and shrubs should be planted along this streambank and corridor. Buffer width should be increased by the greatest amount agreeable to the landowner, but increasing the buffer width by at least 100 feet will increase the buffer functionality, such as filtering nutrients and pollutants, if any, from the agricultural fields. Buffer enhancement would also increase bank stability and improve aquatic habitat by providing shade, resulting in cooler water temperatures.

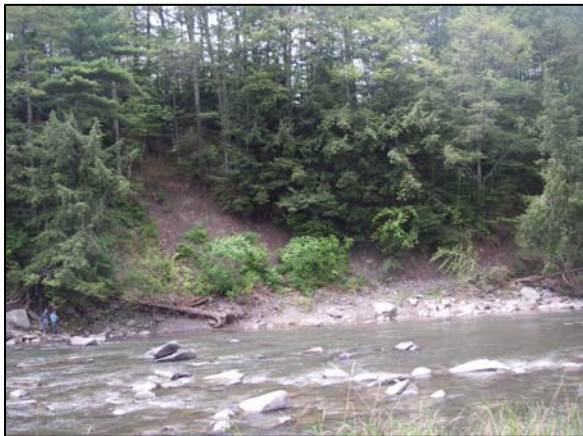
Bank erosion at Station 22800

The hillslope along left streambank had been undermined by toe erosion, resulting in 8,207 ft² bank failure along 205 ft of the bank (Station 22800). Many mature trees had been lost from the bank. However, this site may stabilize on its own over time. It appeared a low bench may have begun to develop at the toe of the eroding bank which may act to reduce flood water velocities near the bank.

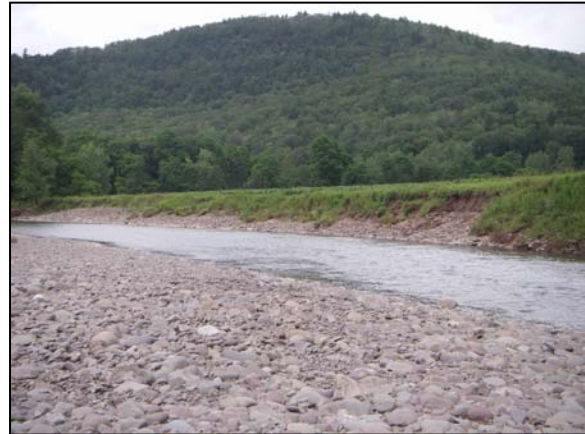
On the right streambank, erosion continued for an additional 741 ft, exposing clay deposits along 75 ft of the bed and bank (Station 20300). A bank erosion monitoring site (BEMS) was installed near the downstream end of this erosion (Station 19770). If the erosion rate accelerates significantly, full restoration to address water quality threats from clay exposures and property loss should be considered for this site. Streambank and buffer plantings are also recommended to slow erosion at this site. This management unit came to an end just upstream of the confluence with Batavia Kill.

Bank erosion at Station 20300
