Schoharie Creek Management Unit 17

Town of Prattsville – Station 19376 to NYS Route 23 Bridge (Station 10486)

This management unit began at the confluence with Batavia Kill (Station 19376), and continued approximately 8,890 ft to the NYS Route 23 Bridge (Station 10486) in the Town of Prattsville.

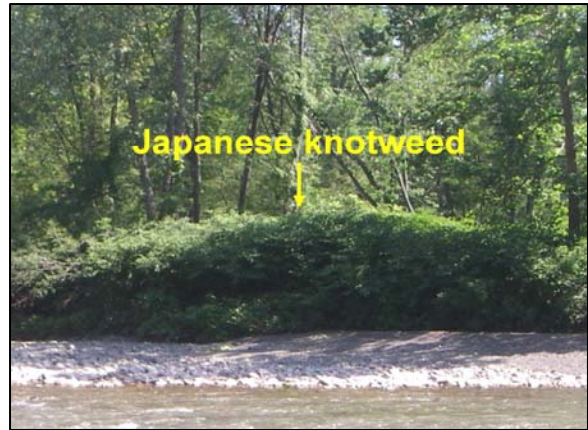
A 356 ft long stand of Japanese knotweed (*Fallopia japonica*) had established along the right streambank downstream from the Batavia Kill confluence. Japanese knotweed is an

invasive non-native species which does not provide adequate erosion protection due to its very shallow rooting system, and also its rapid growth rate crowds out more beneficial streamside vegetation. Large Japanese knotweed stands were documented throughout the management unit with Japanese knotweed present on almost half of the streambanks.

Japanese knotweed at Station 19300

This significant increase in Japanese knotweed is likely due to the introduction of rhizome fragments from the Batavia Kill, which has a high percentage Japanese knotweed on its banks. Once knotweed has established itself in the riparian area, it is able to spread downstream after disturbances caused by beaver activity or by high flows scouring the streambank. Such disturbances often cause stems and rhizomes to break off and float downstream where fragments may establish themselves on streambanks that were previously unaffected by knotweed. Exposed streamside areas such as sediment deposits or disturbed banks with eroded soils lacking vegetation are particularly vulnerable to invasion by knotweed. While it may prove impossible to eradicate Japanese knotweed from all streambanks, it is important to recognize this issue and take action to prevent further spread (See Section 2.7 Riparian Vegetation).

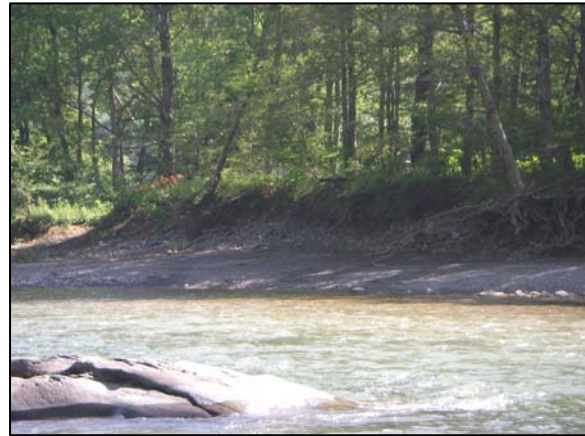
The right streambank had scoured during high flow events along 211 ft (Station 19100). This type of erosion is common and may revegetate on its own with time. To speed up this process and increase bank stability native shrubs and sedges could be planted along the streambank and toe. In stable watersheds, the rate of erosion is slow and a natural healing process usually follows.

Bank erosion at Station 19100

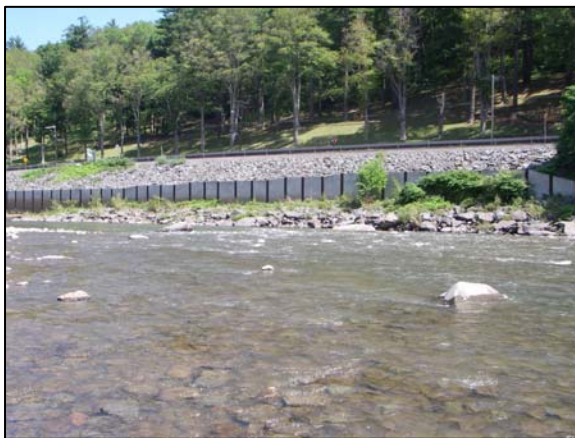
Revetment at Station 16400

As the stream flowed directly into the NYS Route 23 road embankment, rip-rap and a concrete wall and been installed along 577 ft of the right streambank (Station 16400). Interplanting of this rip-rap, by inserting native tree and shrub plantings into the soil between the rocks, would strengthen and increase its longevity and also improve the aquatic habitat by providing shade, resulting in cooler water temperatures. Plantings of

Interplanting of this rip-rap, by inserting native tree and shrub plantings into the soil between the rocks, would strengthen and increase its longevity and also improve the aquatic habitat by providing shade, resulting in cooler water temperatures. Plantings of shrubs and sedges on the lower half bank below the concrete wall would provide additional protection for the streambank toe.

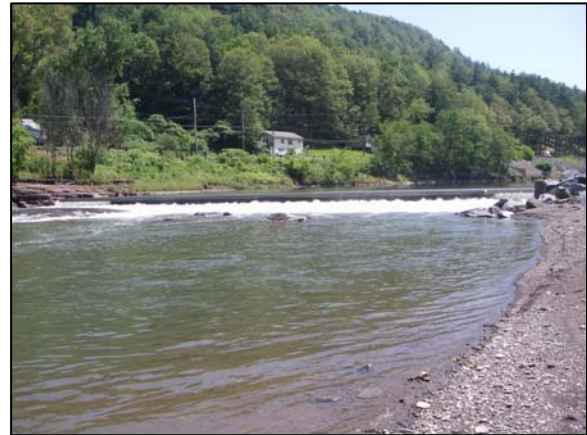
Dam at Station 15280 - looking upstream

smallmouth bass populations over time (NYSDEC, 1993). The large pool created downstream by this structure serves as a popular swimming spot for residents. The concrete abutment had caused erosion on the left streambank upstream and downstream from the dam. Rip-rap had been installed along 66 ft of this bank but is unlikely to prevent future erosion at this site (Station 15300).

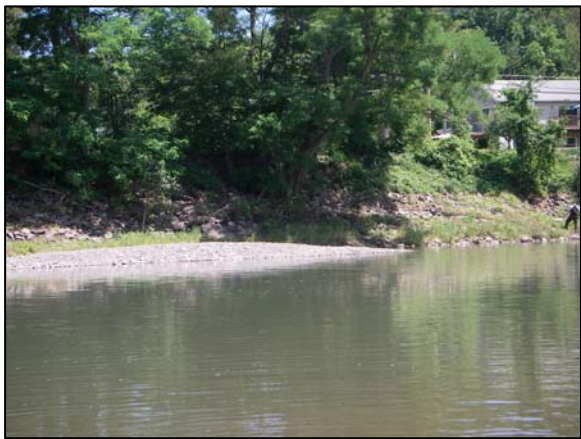
Rip-rap at Station 15150 - looking upstream

Downstream the adjacent land use changes from agricultural and forested to residential and commercial. Many of the homes and businesses along the right streambank suffer flooding due to their location within the 100-year floodplain, or the area which has a 1% chance of being inundated in any given year. Rip-rap had been installed along 704 ft of the right streambank (Station 15150)

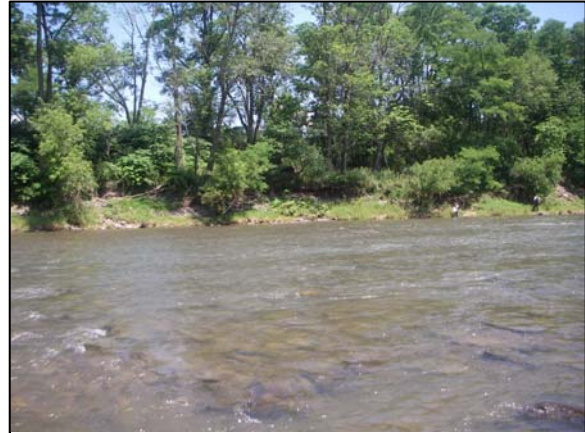
On the opposite bank 434 ft (Station 14400) had scoured during high flow events. This type of erosion is common and part of natural stream process. In stable watersheds, the rate of erosion is slow and a natural healing process usually follows. The stability of this streambank might be improved with plantings of willow *fascines* and sedges.

Bank erosion at Station 14400

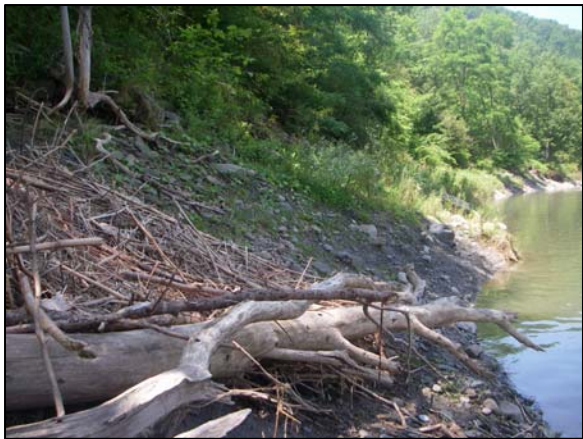
Bank erosion at Station 13650

Just downstream, along the outside meander bend the left streambank had scoured during high flow events along 599 ft (Station 13650). Streambank erosion often occurs on the outside of meander bends where the stream velocity is greatest during high flows. Vegetation had been stripped from the lower bank, but regrowth of vegetation had already begun. This erosion had exposed lacustrine clay deposits along 1,040 ft of the streambed

and bank (Inset B, Station 13770).

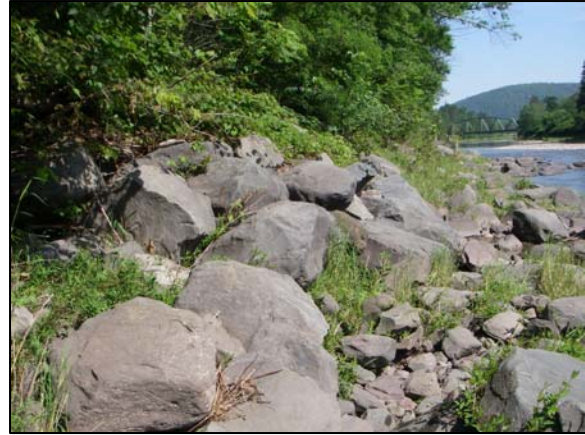
Beginning at Station 12100 downstream to the NYS Route 23 bridge in Prattsville, rip-rap had been installed along 1,035 ft of the County Route 2 road embankment on the left streambank. While some vegetation was established above this rip-rap, additional plantings of native trees and shrubs is recommended at this site. Plantings of shrubs and sedges along the toe of the bank may also provide additional protection against erosion.

Rip-rap at Station 12100

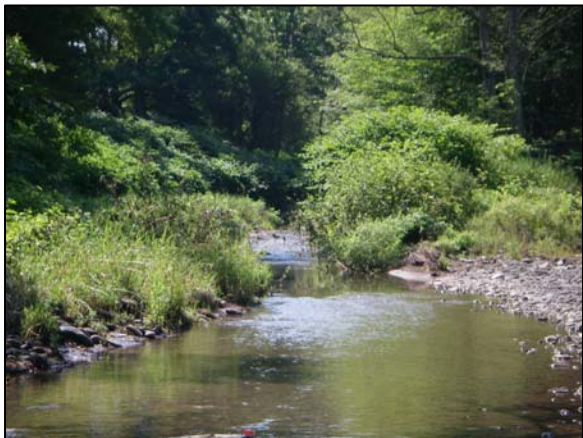
Huntersfield Creek confluence at Station 11800

Huntersfield Creek watershed drains approximately 7.9 mi². As evidenced by deposition upstream and downstream of the confluence, Huntersfield Creek delivers a significant amount of sediment to the Schoharie Creek. A stream feature inventory to identify sediment sources from this tributary is recommended.

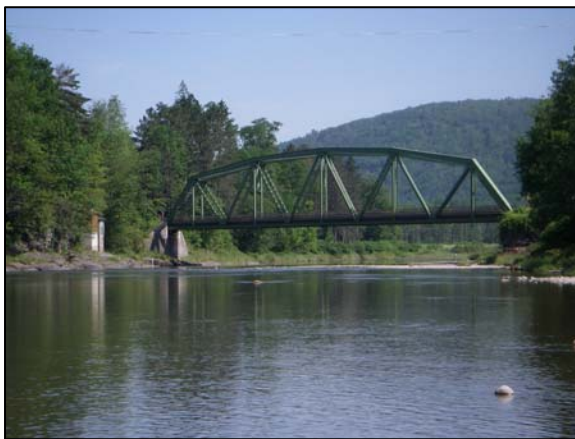
At the downstream end of this management unit the stream passed under the NYS Route 23 bridge in Prattsville (Station 10486). Gravel deposits upstream and downstream of the bridges were noted. Deposits such as these are commonly caused by inadequate sizing of

State Route 23 bridge in Prattsville - Station 10486

the bridge opening. This deposition may also be partly due to the Schoharie Reservoir impoundment downstream. An undersized bridge opening causes water to back up upstream of the bridge, reducing stream velocity, which results in sediment deposition. While bankfull flows may flow freely through this bridge, higher flows backwater, resulting in the upstream aggradation. Flood damage to bridges is typically caused by inadequate

hydraulic capacity of the bridge, misaligned piers and/or abutments, or accumulation of

debris. As bridges are replaced over time, these issues should be evaluated and adjusted if necessary to lessen the probability of flood damage by providing a more effective conveyance channel that promotes water and sediment flow through the bridge opening.
