Schoharie Creek Management Unit 18

Town of Prattsville – County Route 23 Bridge (Station 10486) to Station 0

This management unit began at the County Route 23 Bridge (Station 10486), and continued approximately 10,486 ft to Station 0 in the Town of Prattsville.

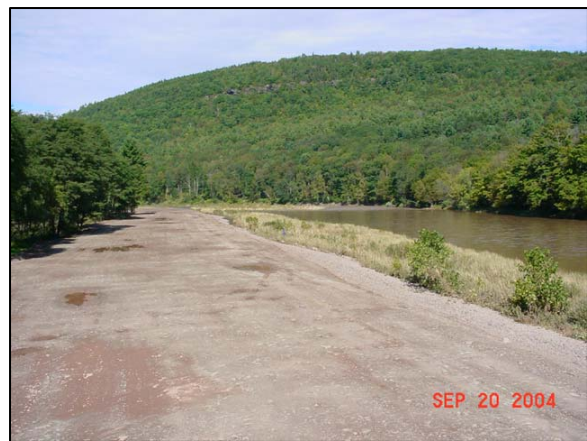
In 1979, a 10 ft high gravel berm had been constructed along the left streambank (Station 9300). This berm restricted flood waters from accessing the available floodplain and appeared to exacerbate ice jamming on the Schoharie Creek, causing flooding problems within the hamlet of Prattsville. The berm also had caused stream channel entrenchment and an increase in channel width to depth ratio which promoted deposition in the reach. Deposition can trigger the lodging and adhesion of ice to the bed and formation of ice jams. The top of the berm was at an elevation higher than the road and homes on the east side of the stream causing flood water to encroach on the adjacent homes and roadway before flowing onto its natural floodplain on the west side of the creek.

*Prattsville flood redemption project
post construction*

To address flooding issues, several conceptual plans were generated for the project area, including a proposal for complete geomorphic restoration of the area. After reviewing the conceptual plans, constructability, and corresponding cost estimates for construction, a simplified alternative of removing the berm and regrading the material was selected as the most appropriate and cost effective alternative.

In 2004, the GCSWCD and the Prattsville Highway Department completed a flood-reduction project by re-grading the berm to match the elevation of the existing floodplain in order to allow flood waters to access the natural floodplain. The natural floodplain can also act as an ice storage area during large seasonal flow events and provide a release for flood waters in the event of a localized ice jam. Construction encompassed approximately 2,200 feet of streambank along the western floodplain of the Schoharie Creek.

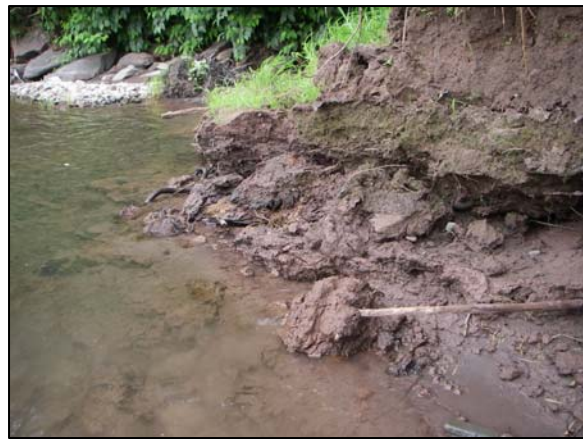
Downstream, the stream split into two channels, flowing around both sides of a large center bar (Station 7900-6700). During high flow events, the *thalweg*, or deepest part of the stream channel, was forced to flow against the right stream bank, undermining the toe of the bank along 591 ft (Inset C, Station 7900). Numerous areas of exposed of glacial lake silt/clay were documented along the bed and banks of the right streambank (Station 7600-5850). Fine sediment inputs into a stream can be a serious water quality concern because they increase *turbidity*, degrade fish habitat, and can act as a transport mechanism for other pollutants and *pathogens*. At the downstream end of the silt/clay a 237 ft stacked rock wall had been installed along the edge of the water.

Clay exposure at Station 7600-5850

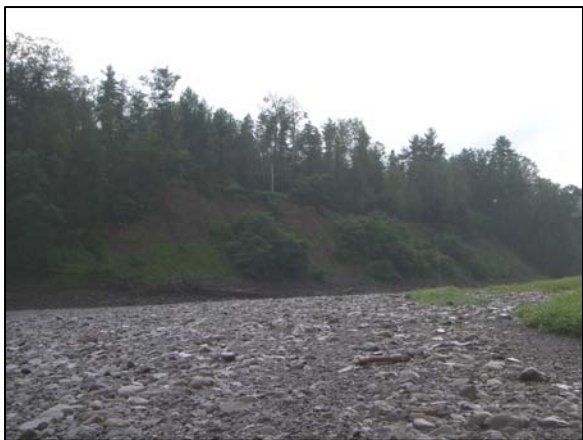
Bank erosion at Station 2250

At the meander bend downstream, the hillslope was undermined by toe erosion, resulting in the mass wasting of a 53,285 ft² area of the left streambank (Station 2250). This erosion left the face of the stream bank

unvegetated. The exposed lodgement till soil had a high silt and clay content, and appeared to contribute a significant suspended sediment load during rainfall events.

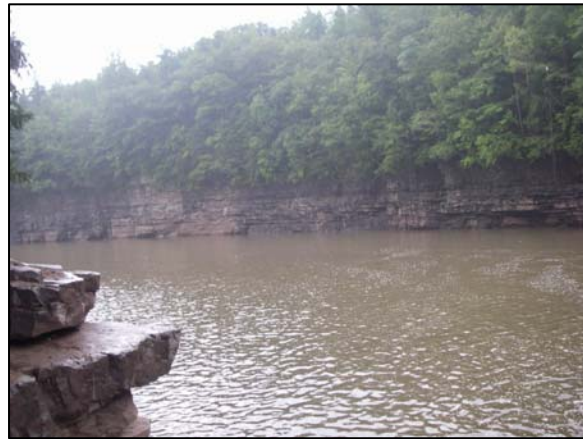
Near the end of this management unit the stream flowed over Devasago Falls (Inset A, Station 1700). These falls are usually submerged but due to low water levels in the Schoharie Reservoir for upgrades to the Gilboa dam, the falls were visible. Downstream of the falls the streambanks were lined with bedrock into the Schoharie Reservoir where this management unit ended. The Schoharie Reservoir contributes approximately 15% of NYC water annually (Joint Venture, 2004).

Bedrock along streambanks downstream from falls
