Schoharie Creek Management Unit 2

Town of Hunter – Dale Lane (Station 151439) to Bunny Lane (Station 148641)

Figure 4.2.1 Management Unit 2 - 2006 aerial photography with stream feature inventory

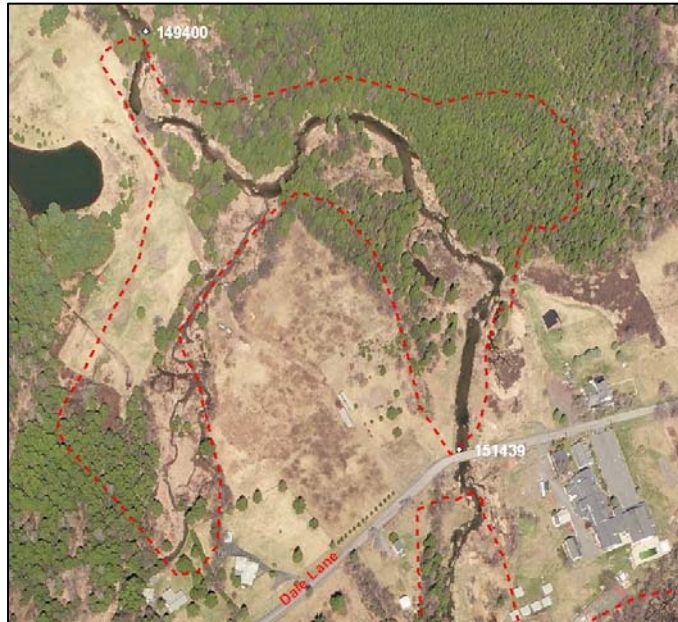
The upstream half of this management unit was dominated by a large wetland (Station 151439-149400). Wetlands are important features in the landscape that provide numerous beneficial functions including protecting and improving water quality, providing fish and wildlife habitats, storing floodwaters, and maintaining surface water flow during dry periods. This wetland is approximately 17 acres in size, including some areas of open water (see Section 2.6 for detailed wetland type descriptions). There were four beaver dams within this wetland area.

*Wetland located at beginning of MU (Station 151439-149400)
Approximate wetland boundary delineated by NYSDEC*

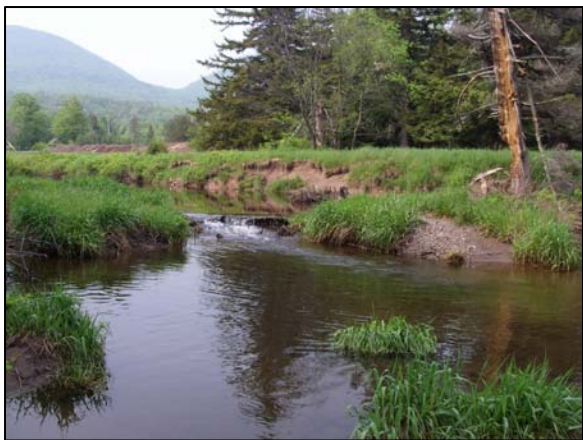
*Bank erosion and beaver dam at Station 151100
looking upstream*

The stream channel was well defined throughout this wetland. The first 400ft of stream in this management unit was fairly straight with three minor erosion occurrences located on the left streambank totaling 1,045 ft² in eroded area (Station 151100). To prevent future erosion, vegetation plantings are recommended for these streambanks, including vegetative protection of the toe. Reshaping these streambanks by grading may be necessary prior to planting.

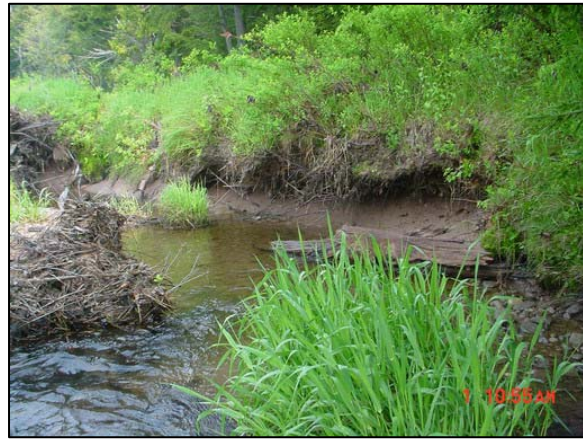
Further downstream, along the right bank, the stream undercut the bank exposing a 90ft² area of glacial lake silt/clay (Station 150740). Fine sediment inputs into a stream can be a serious water quality concern because they increase *turbidity*, degrade fish habitat, and can act as a transport mechanism for other pollutants and *pathogens*. Immediately downstream was a second 20ft² glacial lake silt/clay exposure (Station 150500).

Clay exposure at Station 150740

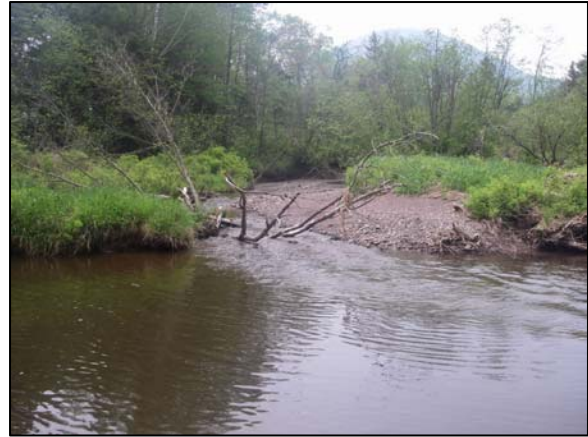
Downstream a sizable unnamed *tributary* enters from the left streambank (Station 150035). This tributary drains the slopes of Sugarloaf and Twin Mountains before it reaches the flatter topography of the valley floor where it enters the Schoharie Creek. As a result of this stream slope change, the tributary loses its ability to transport sediment gathered from the mountain slopes, and began to deposit sediment at its mouth and into the more gently sloped Schoharie Creek. This is a common feature of confluence areas, which often contain

Tributary at Station 150035 - looking upstream

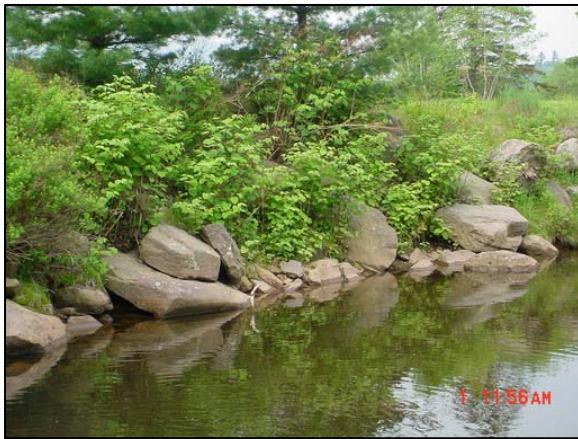
Japanese knotweed on rip-rap at Station 149530

As the land use on the left streambank changed from forested to residential, the buffer thinned and rip-rap was installed to protect the bank (Station 149530, Inset B). This old rip-rap was approximately 184ft in length, and while only in fair condition still provided some protection of the streambank toe. Japanese knotweed (*Fallopia japonica*) has colonized the disturbed area above the rip-rap. This was the first occurrence of Japanese knotweed on the Schoharie Creek mainstem. Knotweed is an invasive non-native species.

Removal of Japanese knotweed is recommended at this site because it does not provide adequate erosion protection due to its very shallow rooting system, and it grows rapidly to crowd out more beneficial streamside vegetation (See Section 2.7 Riparian Vegetation). It is also recommended to interplant native shrub and sedge species through the rip-rap and along the toe of this streambank. This planting will help to strengthen the revetment, while enhancing aquatic habitat.

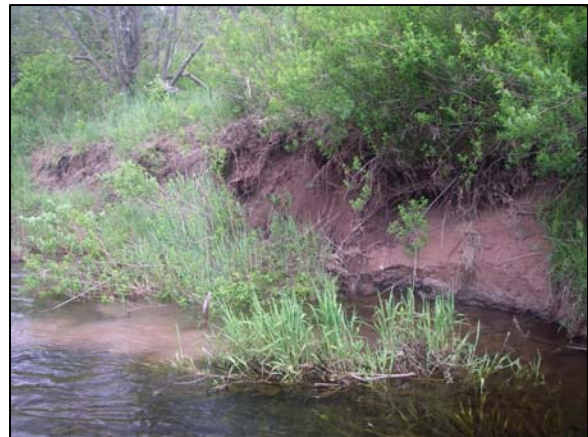
The stream channel widened as it approached the bridge at Bunny Lane. On the right streambank and bed there was a 100 ft² area of exposed clay (Station 148740). This clay exposure was composed of a mixture of both *lacustrine* clay beds and glacial till deposits with a high clay component.

Clay exposure at Station 148740

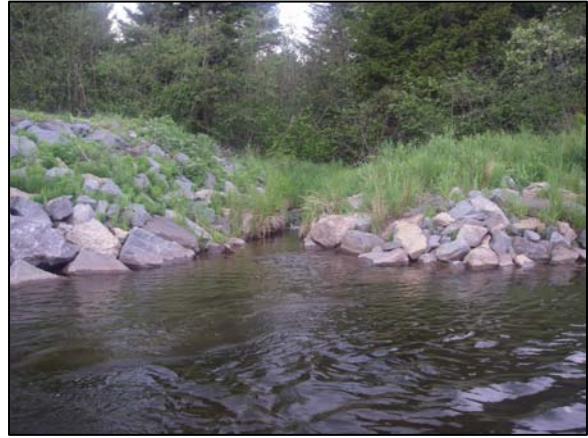
Through the middle of the right bank rip-rap, a small unnamed tributary entered the Schoharie Creek (Station 148690). Originating across Platte Clove Road, this stream drains the lower slopes of Roundtop Mountain. As the stream crossed under the road, the slope flattened and the stream passed through a large forested wetland before entering the Schoharie Creek in a small, slightly entrenched channel. This tributary is classified as C by the NYS DEC, indicating that the best uses for this stream are supporting fisheries and other non-contact activities (NYSDEC, 1994).

Tributary at Station 148690 - looking upstream

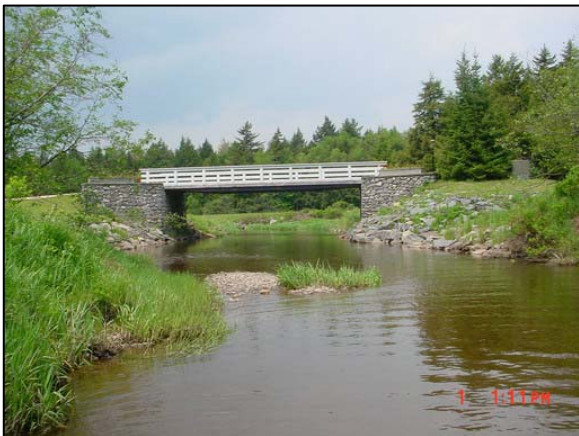
Bridge at Bunny Lane

At the downstream end of this management unit the stream passed under the private bridge at Bunny Lane. This bridge may constrict the floodplain at very high flows, but passes most flows effectively. The bridge had concrete wing walls and rip-rap to protect the abutments from scour.

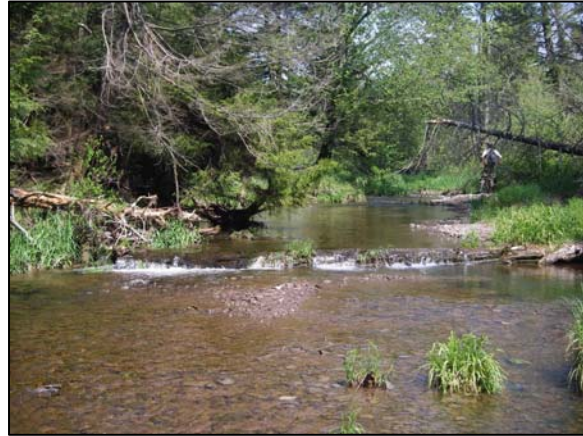
Habitat structure

general, due to the horizontal, channel spanning design, they cause water to back up on the upstream side of the structure which can increase sediment deposition. Because most of these structures do not include an area for concentrated flow that provides for sediment transport, sediment deposition often occurs downstream from an initial scour area under the structure. This can cause widening of the channel, which further decreases sediment transport. In some settings, this can promote lateral channel migration, increase stream channel width-to-depth ratios and result in bank erosion up- or downstream. In wild streams, these functions – both positive and negative – are performed to a large extent by large woody debris. It is recommended that an aquatic habitat study be conducted on the Schoharie Creek with particular attention paid to springs, tributaries and other potential thermal refuge for cold water fish, particularly trout. Once identified, efforts should be made to protect these thermal refugia locations in order to sustain a cold water fishery throughout the summer.
