Schoharie Creek Management Unit 4

Town of Hunter - Station 138610 to Station 124311

2006 Stream Feature Statistics

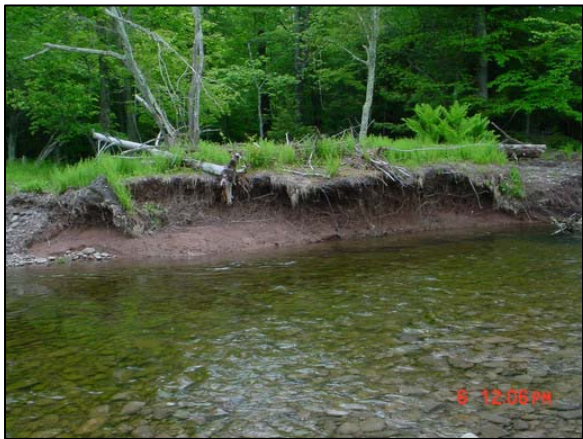
Clay exposure and bank erosion at Station 138500

At the beginning of the unit the stream channel was wide and shallow. Approximately 500ft of the left streambank was experiencing scour during high flow events (Inset A, Station 138500). As a result two areas totaling 92ft² of glacial lake silt/clay had been exposed. Fine sediment inputs into a stream can be a serious water quality concern because they increase turbidity, degrade fish habitat, and can act as

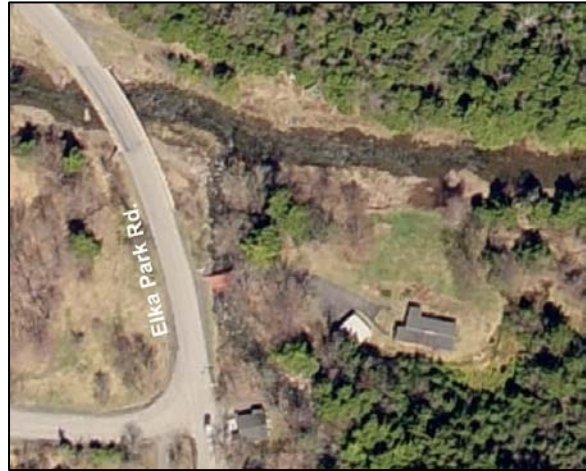
Beginning at Station 134700, the stream channel became confined by the valley form. At Station 134440, there was an approximately 173 ft² area of scour on the left streambank of a residential property. The top of the bank consisted of mown lawn which does not provide as much resistance to streambank erosion as the deep and dense root structure found in streamside forest. Recommendations for this site include planting native trees and shrubs along the edge of the streambank and increasing the

Planting site at Station 134440

upland area buffer width by the greatest amount agreeable to the landowner. To provide protection from future erosion, native willows and sedges should be planted along the streambank toe.

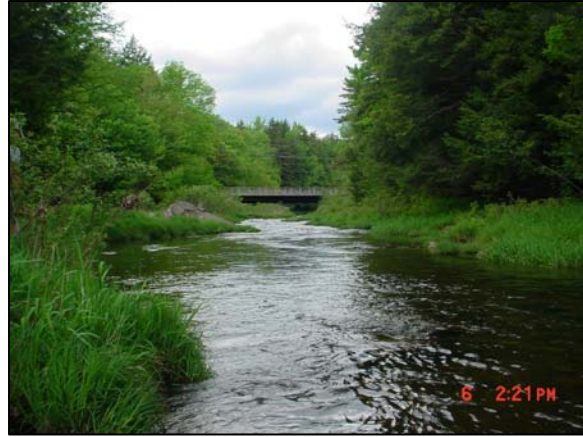
At Station 134100, the stream passed under the Elka Park Rd. Bridge (BIN 3201010). This bridge may constrict the floodplain at very high flows, but appeared to pass most flows effectively. The bridge appeared to be in both good structural and functional condition. Flood damage to bridges is typically caused by inadequate hydraulic capacity of the bridge, misaligned piers and/or abutments, or accumulation of debris. As bridges are replaced over time, these issues should be evaluated and adjusted if necessary to lessen the probability of flood damage by providing a more effective conveyance channel that promotes water and sediment flow through the bridge opening.

Bridge at Elka Park Road at Station 134100

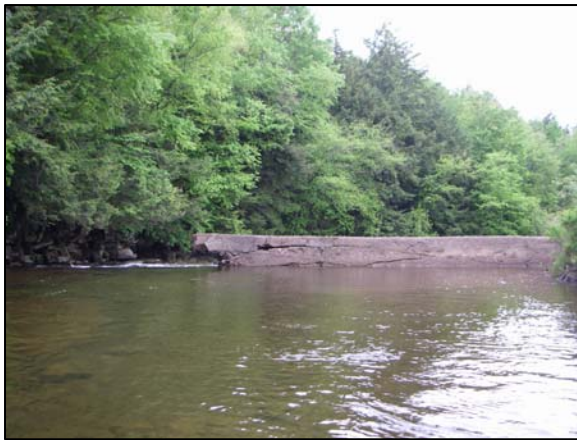
Approximately 400ft downstream there was a failed dam across the Schoharie Creek (Inset C, Station 133700). According to a local landowner, a saw mill was built on this site in the late 1800's. Sometime prior to the 1920's the mill disappeared but the dam

Dam remnants at Station 133700

could be pumped directly up to the reservoir, allowing it to be filtered and sanitized before use. A flood event in the late 1980's broke the dam, but a large section of the concrete sill jutting out from the right streambank across approximately 75% of the active stream channel remained. Stream flow was forced to the left side of the stream channel before it flowed over the large bedrock waterfall.

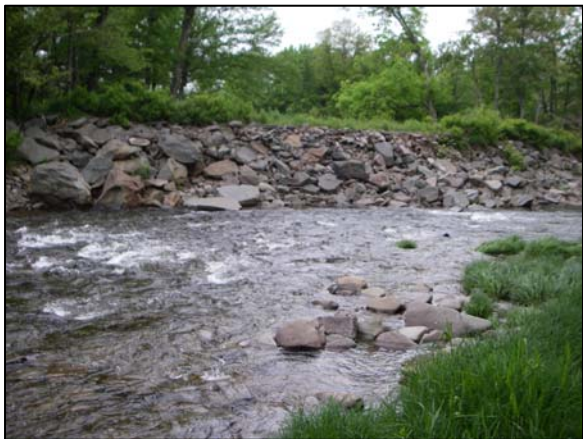
At Station 130850 rip-rap had been installed along 119ft of the left streambank. While rip-rap and other hard controls may provide temporary relief from erosion, they are

Rip-rap at Station 130850

expensive to install, degrade habitat, and require ongoing maintenance and may transfer erosion problems to upstream or downstream areas. Alternate stabilization techniques should be explored for stream banks whenever possible. Interplanting of this rip-rap, by inserting native shrub plantings into the soil between the rocks, could strengthen and increase its longevity.

These plantings would also improve the aquatic habitat by providing shade, resulting in cooler water temperatures. To provide protection against toe erosion, sedges or willows could be planted along the toe of the streambank.

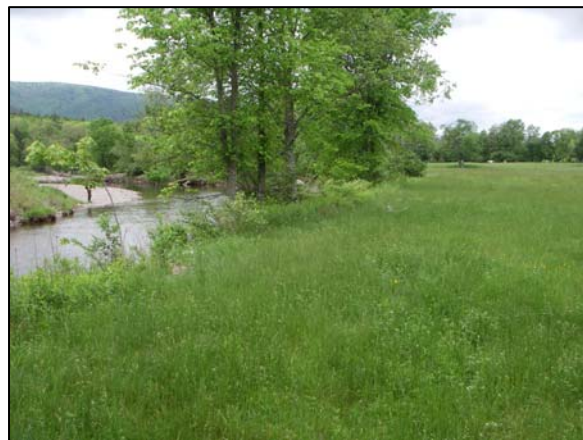
As the land use on the right streambank changed from forested to residential, *herbaceous* vegetation replaced mature trees in the riparian zone (Station 129200). Mown lawn or pasture does not provide as much resistance to streambank

Planting site at Station 129200

erosion as a streamside forest. The complex root systems of trees may also act to filter nutrients and pollutants, if any, from the adjacent fields. Areas where the riparian zone has been maintained in pasture or lawn present opportunities to improve the streamside buffer with tree plantings in order to promote a more mature vegetative community along the streambank and in the floodplain. Recommendations for this site include planting native trees and shrubs along the edge of the streambank and the upland area. Buffer width should be increased by the greatest amount agreeable to the landowners, but increasing the buffer width by at least 100ft will increase the buffer functionality.

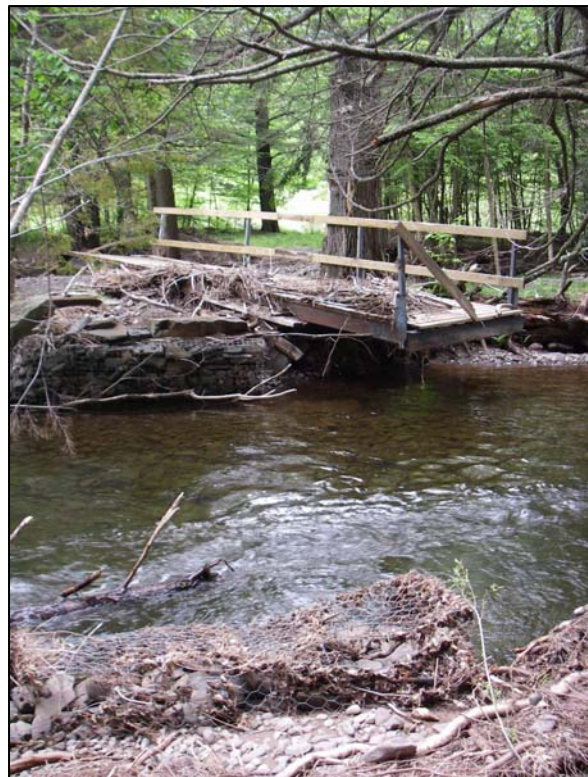
Downstream, the stream channel splits into two separate channels, both of which experienced erosion during high flow events. In the right stream channel a small private bridge had been destroyed (Station 128070). This bridge was undersized and could not convey flood flows. Gabion baskets had been installed as abutments. Rock-filled gabions are not generally recommended because have a tendency to be unsightly and when installed incorrectly, they frequently blow out of the bank and scatter rocks and cages downstream. Their correct use requires professional installation. Further downstream a smaller foot bridge had also been destroyed and was partially buried in the stream channel.

Bridge at Station 128070

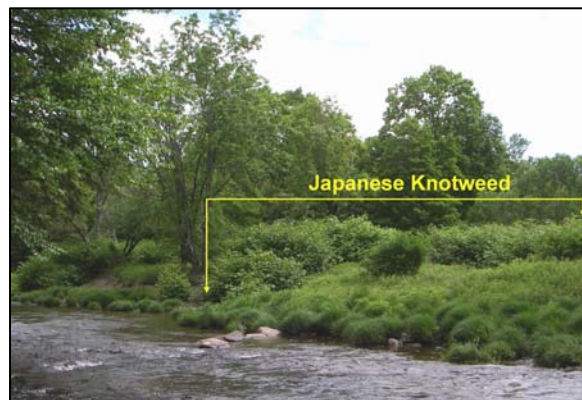
A large stand of Japanese knotweed (*Fallopia japonica*) had established along the right streambank upstream and downstream from the Gooseberry Creek confluence (Station 12600). Japanese knotweed is an invasive non-native species which does not provide adequate erosion protection due to its very shallow rooting system and also grows rapidly to crowd out more beneficial streamside vegetation. Although small Japanese Knotweed

Japanese Knotweed at Station 126000

plants were documented throughout the management unit, this large stand is of greater concern because this area is prone to scour during high flows and may act as a source to spread Japanese Knotweed downstream. Removal of this Japanese Knotweed plant is recommended to prevent the spread of this invasive species (See Section 2.7 Riparian Vegetation).

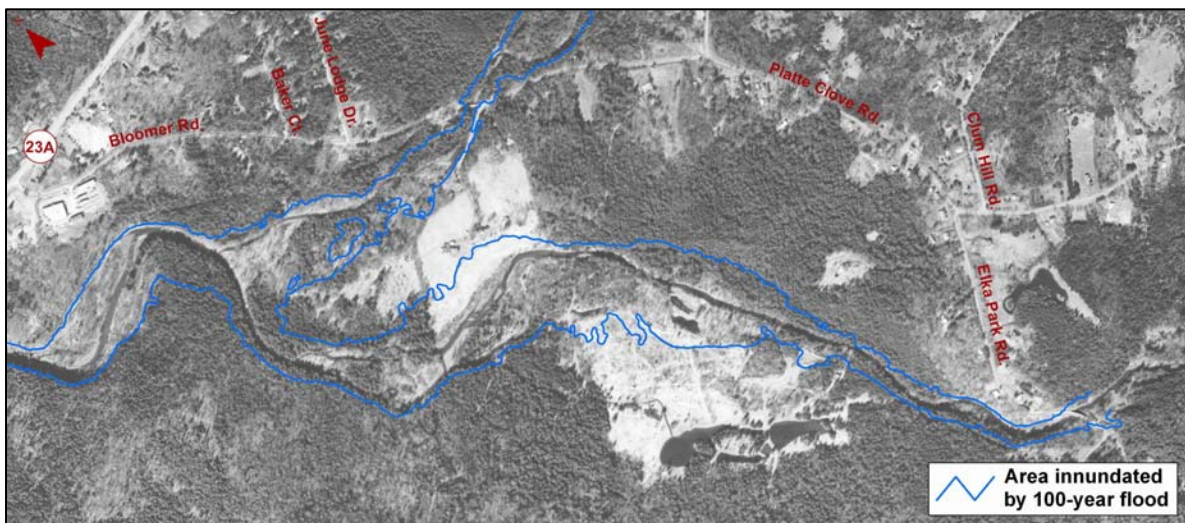
100-year floodplain boundary map beginning at Elka Park Rd. bridge

Floodplain maps are not available for the entire management unit (below). The FIRM maps for the Schoharie Creek begin at Elka Park Road and continue downstream to the Schoharie Reservoir. It is recommended that a hydraulic analysis be completed to create floodway and floodplain maps from Elka Park Road upstream to Prediger Road. In 2006, existing structures in this unit appeared to be situated out of the estimated 100-year floodplain. The 100-year floodplain is that area predicted to be inundated by floods of a magnitude that is expected to occur once in any 100-year period, on the basis of a statistical analysis of local flood record. Most communities regulate the type of development that can occur in areas subject to these flood risks.
