Manor Kill Management Unit 5

Town of Conesville – Station 24315 to Station 19795

This management unit began at Station 24315, and continued approximately 4,520 ft to Station 19795 in the Town of Conesville.

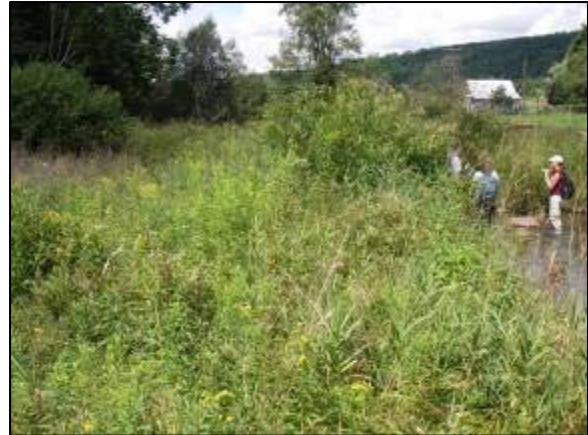
Riparian Planting Site at Stations 24315-23905

Management unit 5 began as the stream valley broadened and gently meandered to the left. There was a proposed riparian planting site (Stations 24315 – 23905) along the left streambank for approximately 410 feet. This site was the first of seven proposed planting sites within this unit, with successional old field to the edge of the stream. Recommendations for this site

include planting native trees and shrubs along the streambank and the upland area. Buffer width should be increased by the greatest amount agreeable to the landowners. At this site, there was a narrow forested buffer beyond the successional old field, followed by maintained herbaceous agricultural fields. By planting this site from the stream's edge to the forested area, a 100 foot buffer would be created. Increasing the buffer width to at least 100 feet will increase the buffer functionality and protect the stream from nearby land uses. Along this planting site, there was a stream channel crossing (Figure 4.5.1, Inset D, photograph orientation looking at, Station 24253) that appeared to be used for recreational purposes.

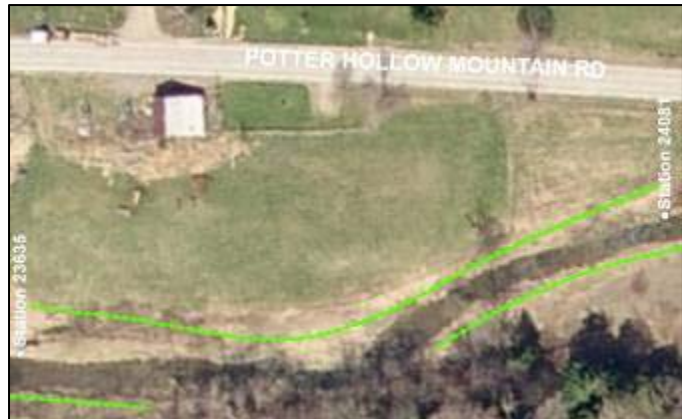
Riparian Planting Site at Stations 24081 - 23835

Continuing downstream, there was a proposed riparian planting site (Stations 24081 – 23835) along the right streambank. There was mowed lawn to the top of the bank and herbaceous vegetation with a few shrubs and young trees along the

streambank. Recommendations for this site include discontinued mowing to the top of the bank, allowing succession to proceed with natural regeneration of shrub and early successional tree species, and augmentation of the existing buffer with the planting of additional native trees and shrubs along the streambank and the upland area. As with the previous planting site, buffer width should be increased to 100 feet or by the greatest amount agreeable to the landowners.

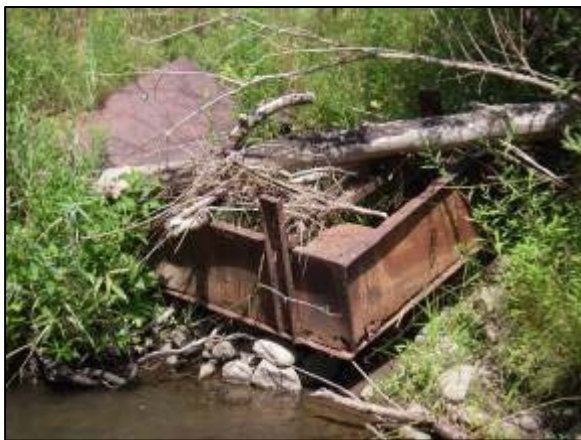
Dump Site at Station 24025

Along this planting site, there was a dump site (Station 24025) with old farm equipment and metal scraps, with some woody debris that had accumulated on the equipment. This dump site did not appear to be active or to pose an immediate threat to people or the environment. However, this material was along the stream's edge and could be mobilized during future high flows, posing a potential threat to downstream areas.

Removal of this dumped material is recommended.

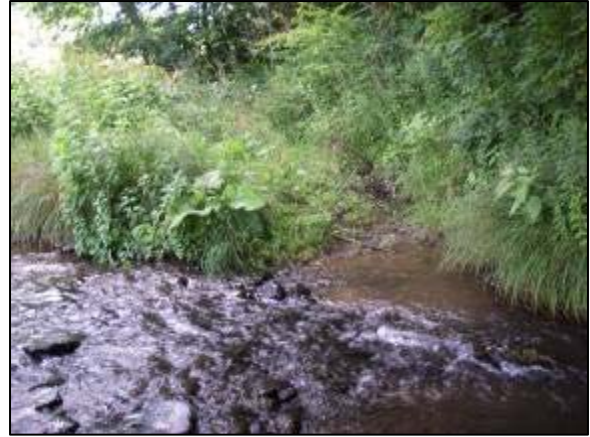
Convergence at Station 23828

Continuing downstream, there was a *convergence* (Station 23828) where a flood chute joins the main channel. The location of the channel *divergence*, where the flood chute split from the main channel was not observed or recorded at the time of the assessment.

Flood chutes convey flow through a secondary channel during periods of high flows. Just downstream of the secondary channel's confluence with the main channel, there was a *transverse bar* (Stations 23827 – 23808), a location within the stream channel in which sediment accumulates diagonally, occupying much of the channel. This bar directed flow towards the left, and contributed to minor erosion (Stations 23811 – 23733) of the left streambank for approximately 78 feet. There was a narrow wooded buffer between the stream channel and the adjacent agricultural fields. A few shrubs and young trees were compromised due to exposed roots along the face of the streambank. The source of the transverse bar should be identified and remedied if a long-term solution is desired for this relatively minor erosion.

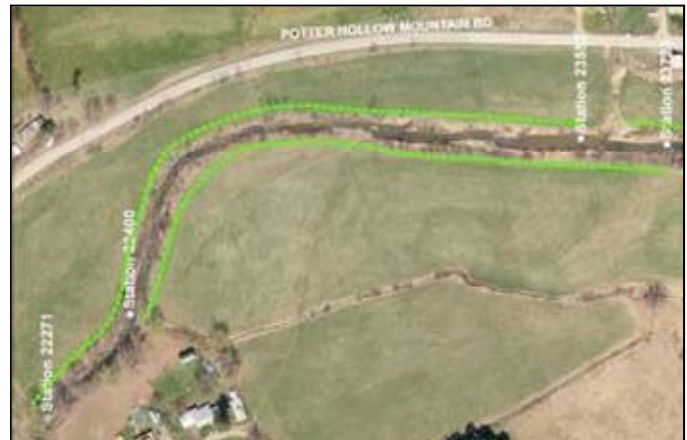
Riparian Planting Sites at Stations 23723 – 22400 and 23552 - 22271

Further downstream, there were two proposed riparian planting sites, one that stretched for approximately 1,293 feet along the left streambank (Stations 23723 – 22400), and one that stretched for approximately 1,436 feet along the right streambank (Stations 23552 – 22271). Along portions of both streambanks, there was a narrow buffer of shrubs, willows and a few trees between the stream

channel and the adjacent agricultural fields. A vigorous buffer with mature trees is important at this site to protect water quality by slowing stormwater runoff and filtering nutrients and pollutants caused by the nearby land use. Recommendations for this site include augmentation of the existing buffer with the planting of additional native trees and shrubs along the streambank and the upland area, increasing the buffer width to 100 feet or the greatest amount agreeable to the landowners. Along the upstream portion of these planting sites, there was approximately 30 feet of full channel *aggradation* (Station 23494), the

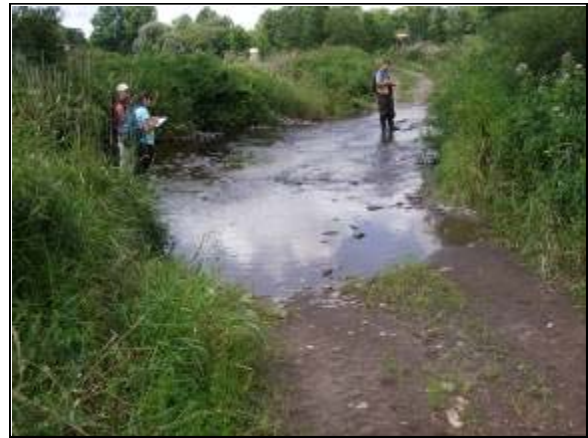
Channel Crossing at Station 23177

Continuing downstream along the proposed planting sites, there was a well maintained channel crossing (Station 23177) that provided access to the agricultural fields on both sides of the streams. Due to maintenance of the crossing, there was full channel aggradation for approximately 35 feet of the stream channel.

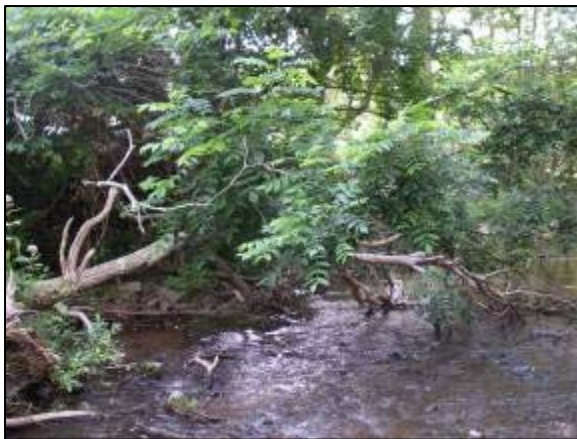
Woody Debris at Station 22356

Further downstream, there was a fallen tree (Station 22356) from the left streambank that caused a minor obstruction to flow. At higher flows, it may pose a more significant obstruction. However, woody debris is beneficial to a stream system, it provides critical habitat for fish and insects, and adds essential organic matter that will benefit organisms downstream.

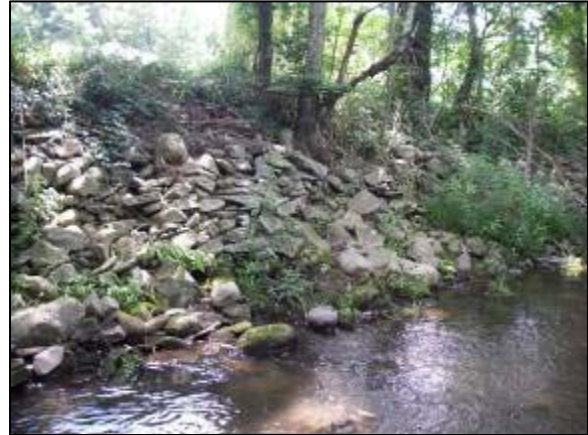
Revetment at Stations 22333

As the stream gently meandered to the right, approximately 104 feet of the left streambank was stabilized with *revetment* (Stations 22333 – 22229). Although the revetement was in poor structural condition, it was in good functional condition. It appeared as though the revetement began as a stacked rock wall, portions of which had collapsed, and were now functioning as rip rap.

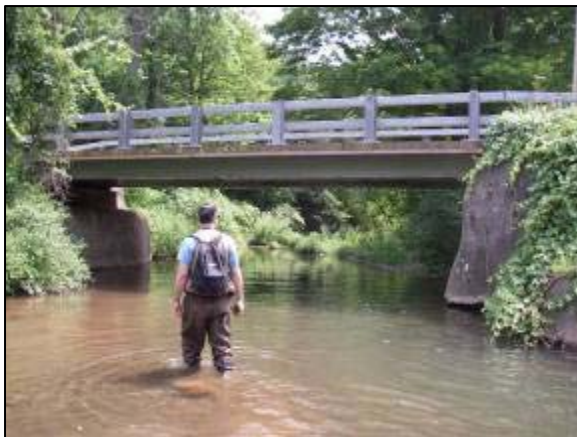
Champlin Road Bridge at Station 21930

Continuing downstream, the Manor Kill flowed under the Champlin Road Bridge (Station 21930, Bridge # 2228540). This bridge may constrict the floodplain at very high flows but appeared to pass most flows effectively. There have been multiple permits issued for repair of the bridge abutments; flood damage to bridges is typically caused by inadequate hydraulic capacity of the bridge, misaligned piers and/or abutments, or accumulation of

debris. As bridges are replaced over time, these issues should be evaluated and adjusted if necessary to lessen the probability of flood damage by providing a more effective conveyance channel for water and sediment. The bridge appeared to contribute to downstream aggradation, with a side bar along approximately 84 feet of the right stream bed (Stations 21906 – 21822).

Summary of Recommendations Management Unit 5	
Intervention Level	Assisted Self-Recovery
Stream Morphology	No recommendations at this time.
Riparian Vegetation	Treat, remove and prevent the spread of Japanese knotweed where feasible. Plant a buffer of trees and shrubs along proposed planting sites and increase width of riparian buffer in appropriate locations.
Infrastructure	When bridges are replaced, construct with the appropriate height and width to allow conveyance of flood flows.
Aquatic Habitat	Watershed Aquatic Habitat Study
Flood Related Threats	Flood proof the structures within 100 year floodplain; possibly plan for potential flood buyout program.
Water Quality	Removal of dump site; building owners adjacent to the stream should inspect their septic systems annually to make sure they are functioning properly, and participate in the CWC septic programs.
Further Assessment	Consider hydraulic analysis of bridge opening.

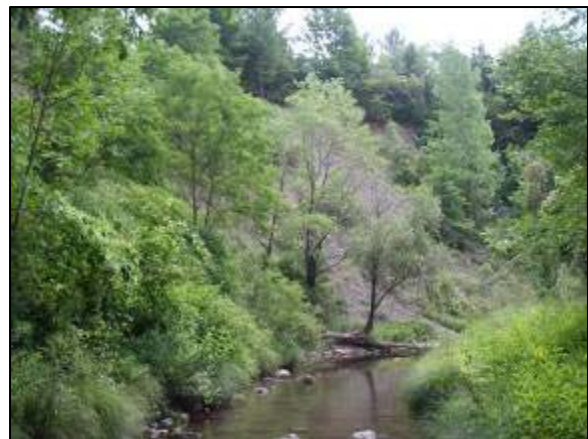
Mass Failure at Stations 21660 - 21519

As the stream meandered to the right, there was a mass failure (Stations 21660 – 21519) along the left streambank for approximately 141 feet. Streambank erosion often occurs on the outside of meander bends where the stream velocity is greatest during high flows. Along this section of stream, the *thalweg*, or deepest part of the stream channel, flows up against the toe of the bank undermining the steep slope, resulting in an erosion area of approximately 8,439 ft² and compromising mature trees along the bank. The fallen trees caused localized scour, thereby contributing to erosion along this site. At the top of the streambank, there was a thin line of trees followed by agricultural fields; the face of the bank was exposed with some herbaceous vegetation and shrubs re-establishing along portions of the bank. There was also a small dry channel carved down the face of the bank. During heavy precipitation this channel drains the adjacent fields; it appeared to exacerbate the erosion along this mass failure.

Recommendations for this site include allowing succession to proceed with natural regeneration of shrub and early successional

tree species to provide a wider buffer at the top of the bank. The site should be monitored to determine if additional measures are required, but it appeared to be stabilizing over time.

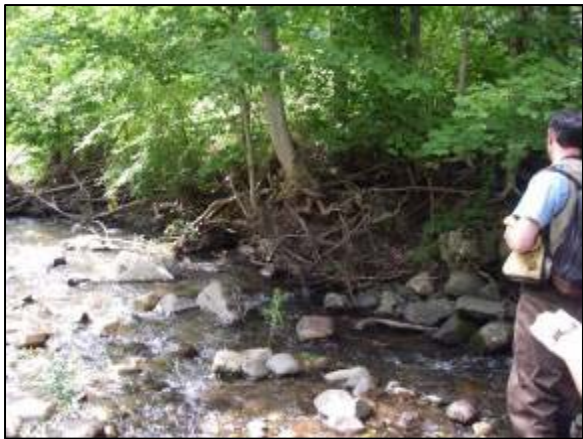
Erosion at Stations 21520 - 21386

Continuing downstream, there was erosion (Stations 21520 – 21386) along the right streambank for approximately 134 feet. There was a narrow wooded buffer at the top of the bank, followed by a mowed field. Along this stretch of stream, a proposed riparian planting site (Stations 21561 – 21351) was identified. Recommendations for this site include augmentation of existing buffer with the planting of additional native trees and

shrubs along the streambank and the upland area. Buffer width should be increased by the greatest amount agreeable to the landowners. Increasing the buffer width to at least 100 feet will increase the buffer's functionality. Prior to proceeding with any work, this site may require a more detailed site assessment; and the eroding conditions should be given careful consideration when identifying the appropriate species and locations for plantings. Also along this stretch of stream, and continuing downstream, there were multiple aggradational areas and small patches of Japanese knotweed.

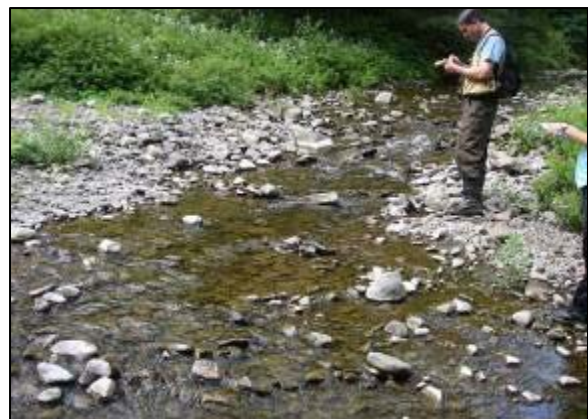
Tributary at Station 21024

Downstream, the Bear Kill entered from the right streambank (Station 21024).

This tributary drains the slopes of High Knob and Hubbard Hill Mountains before it reaches the flatter topography of the valley floor where it enters the Manor Kill. As a result of this stream slope change, the tributary loses its ability to transport sediment gathered from the mountain slopes, and began to deposit sediment at its mouth and into the more gently sloped Manor Kill forming a delta (Station

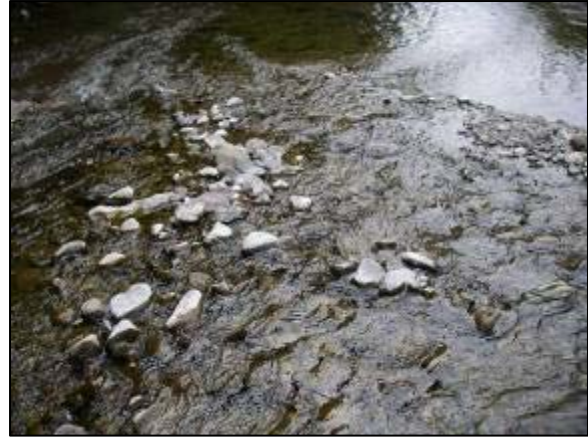
Delta Deposition at Station 21024

21024) at its confluence. There was also a significant side bar (Figure 4.5.1, Inset B, Stations 21022 – 20748) along approximately 274 feet of the right channel bed, just downstream of the tributary. Sediment deposition is a common feature of confluence areas, which often contain extensive sediment bars, function as important sediment storage areas, and are typically among the most dynamic and changeable areas in the stream system. This tributary was classified C(ts) by the NYS DEC, indicating that the best uses for this stream are supporting fisheries, including trout spawning, and other recreational activities.

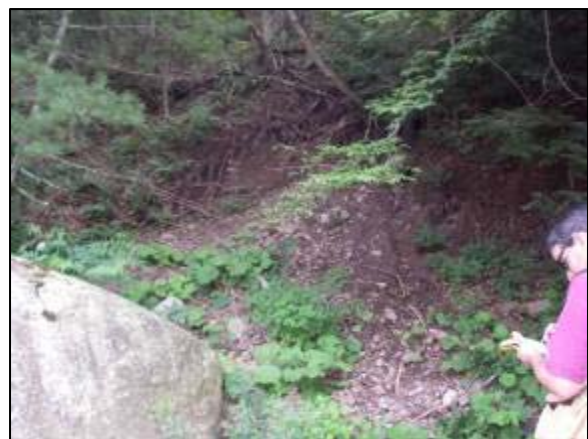
Erosion at Stations 20809 - 20763

Further downstream, the left streambank was eroding (Stations 20809 – 20763) for approximately 46 feet, with

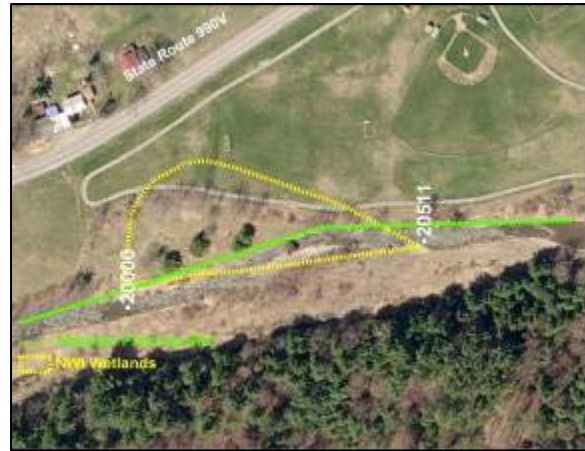
*Riparian Planting Site at Stations 20755 – 19826
Wetland boundary approximately delineated by NWI
Stations 20511 - 20000*

exposed roots, compromising mature trees. Opposite the eroding streambank there was a proposed riparian planting site (Stations 20755 – 19826) along the right streambank for approximately 929 feet; this planting site is on the Town of Conesville’s property.

Along this proposed planting site, there was a 1.4 acre federally designated wetland (Stations 20511 – 20000). Wetlands are important features in the landscape that provide numerous beneficial functions

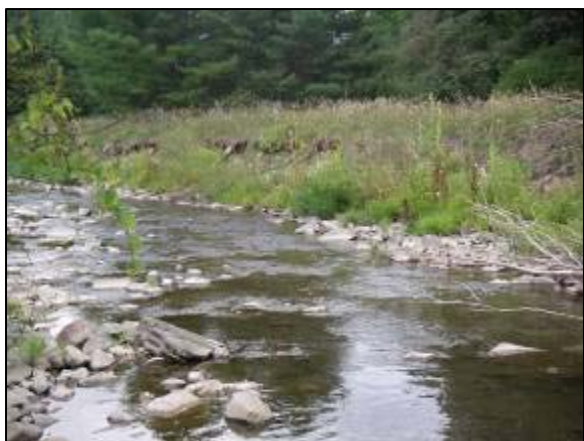
Erosion at Stations 20335 - 20124

Along the middle portion of this planting site, there were two areas of erosion. The first erosion site (Figure 4.5.1, Inset A, Stations 20484 – 20374) stretched along approximately 110 feet of the right bank and resulted in an erosion area of 1,318 ft² with exposed roots, fallen trees and overhanging bank material. Some of the fallen trees and associated woody debris contributed to localized scour of the channel bed and toe of the streambank. The second erosion site (Stations 20335 – 20124), was less significant, although

it stretched along approximately 211 feet of the right bank. There was herbaceous vegetation to the stream’s edge and along the lower terrace of the streambank. In the fall 2008, a portion of this proposed riparian planting site, including the terrace along the length of this erosion site, was planted with native shrubs and trees by the New York City Department of Environmental Protection (NYCDEP), Schoharie County Soil and Water

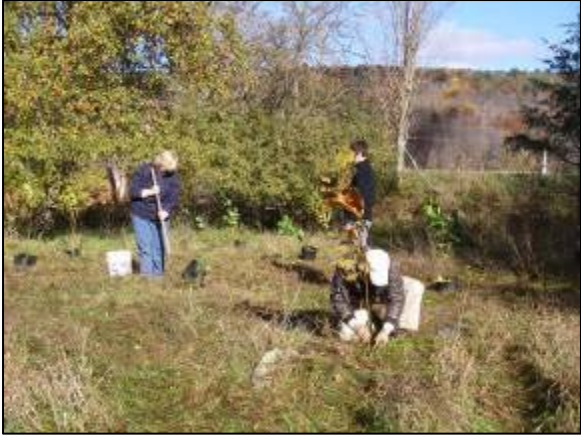
*Planting efforts along
Riparian Planting Site at Stations 20755 - 19826*

Conservation District (SCSWCD), and students from the Gilboa School District. The planting project covered approximately 0.32 acres along 235 feet of streambank length, and it included the planting of 87 trees and 170 willow stakes. Recommendations for the unplanted portions of this site are consistent with the recommendations for previously mentioned planting sites. Prior to proceeding with any additional plantings, the conditions along the first erosion site (Stations 20484 –

20374) should be considered when identifying the appropriate species and locations for plantings; further assessment may be necessary. Excess sediment deposition continued along this stretch of stream including, multiple side and point bars.

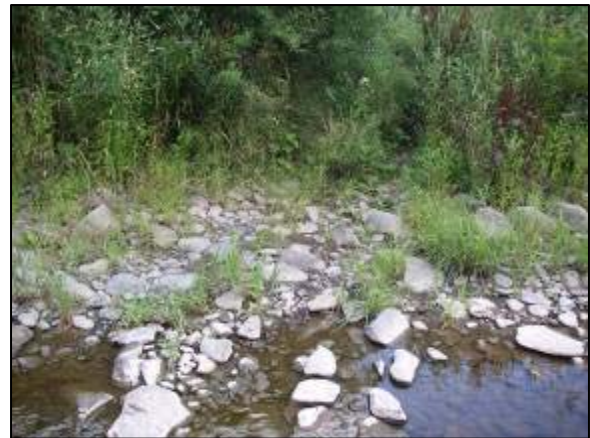
Channel Crossing at Station 19975

Just before this management unit ended, there was a stream channel crossing (Station 19975) that appeared to be used for recreational purposes including, all terrain vehicle (ATV) usage. This management unit ended at Station 19795.

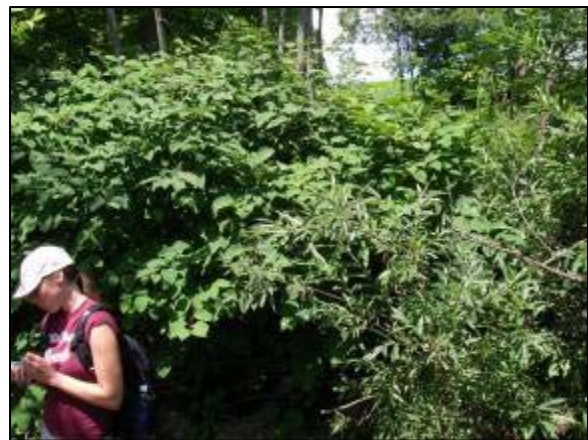
Japanese Knotweed at Station 22925

Some plant species that are not native can create difficulties for stream management, particularly if they are invasive. Japanese knotweed (*Fallopia japonica*), for example, has become a widespread problem in recent years. Knotweed shades out other species

with its dense canopy structure (many large, overlapping leaves), but stands are sparse at ground level, with much bare space between narrow stems, and without adequate root structure to hold the soil of streambanks. The results can include rapid streambank erosion and increased surface runoff leading to a loss of valuable topsoil. Japanese knotweed locations were documented as part of the stream feature inventory conducted during the summer of 2008 (Riparian Vegetation Mapping, Section 2.7). In total, 17 Japanese knotweed occurrences, covering an estimated length of 80 feet, were documented during the stream feature inventory. The best means for controlling knotweed is prevention of its spread, therefore, efforts should be made to ensure that all fill brought into the area is clean and does not have fragments of knotweed or other invasive plants. If Japanese knotweed sprouts or small stands are observed, they should be eradicated immediately to avoid further spread within this unit and to downstream management units.
