Manor Kill Management Unit 6

Town of Conesville – Station 19795 to Station 15492

This management unit begins at Station 19795 continuing approximately 4,303 ft to Station 15492 in the Town of Conesville.

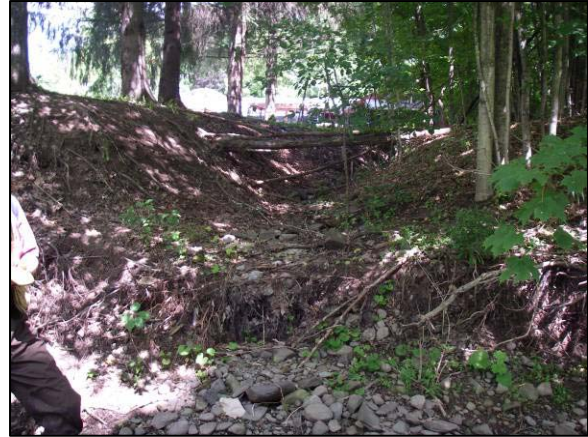
Tributary at Station 19752

Just downstream of the start of Management Unit 6 an unnamed tributary (Station 19752) entered along the right streambank. The tributary may have originated at a culvert near State Route 990V, providing stormwater drainage. At the time of the assessment, there was no flow; there was minor scour of the right streambank at its confluence with the Manor Kill.

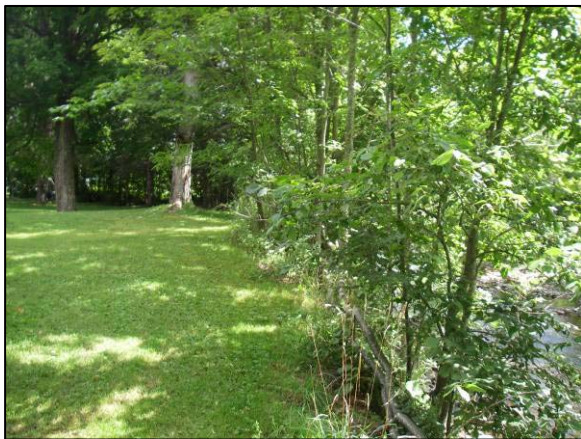
Riparian Planting Site at Stations 19719 - 19622

Downstream of the tributary, there was a proposed riparian planting site (Stations 19719 – 19622) covering approximately 97 feet of the right streambank. There was minor erosion along this bank; at the top of the bank there is a thin line of young trees and shrubs followed by mowed lawn. Enhancing the quality of the buffer and increasing the buffer width to at least 100 feet will help to stabilize the stream bank and protect water quality through this reach by slowing stormwater runoff and filtering pollutants associated with the nearby land use. Recommendations for this site include discontinued mowing to the top of

the bank, allowing succession to proceed with natural regeneration of shrub and early successional tree species, and augmentation of the existing buffer by planting additional native trees and shrubs along the streambank and the upland area. Buffer width should be increased by the greatest amount agreeable to the landowners. Although the erosion at this site was relatively minor, this site may require

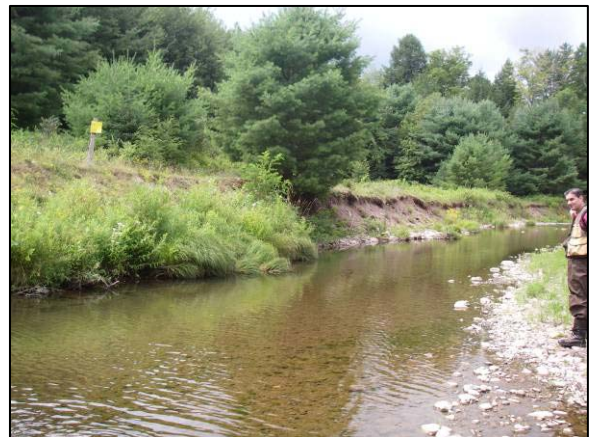
Erosion at Stations 19405 - 19009

Along the meander bend, there was erosion (Stations 19405 – 19009) for approximately 397 feet of the left streambank. Streambank erosion often occurs on the outside of meander bends where the stream velocity is greatest during high flows. There was herbaceous vegetation with few trees along this bank. Along the upstream portion of the erosion, there were fallen and compromised trees that appeared to contribute to upstream aggradational conditions and localized scour. Portions of this erosion site appeared to be self-recovering with herbaceous vegetation becoming re-established on the face of the bank. Recommendations for this site include discontinued mowing to the stream's edge,

allowing natural regeneration of shrub and early successional tree species.

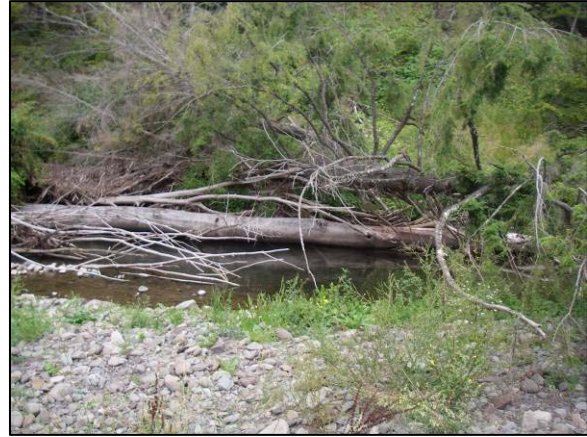
Woody Debris at Station 19000

Continuing along this meander bend, the *thalweg*, or deepest part of the stream channel, flowed up against the left streambank causing the first mass failure (Figure 4.6.1, Inset D, Stations 19015 – 18872). This mass failure resulted in an erosion area of approximately 7,174 ft², exposing roots and compromising mature trees along the bank. During the field assessment, this bank was identified as a proposed Bank Erosion Monitoring Site (BEMS) to study erosion along this reach. To monitor BEMS, a cross-section and long profile may be conducted to collect baseline data. Once the baseline data has been collected, this cross-section can be resurveyed in the future to calculate the bank's erosion rate. Along this erosion site, multiple large trees (Stations 19000 and 18918) had fallen across the stream channel contributing to upstream aggradation and localized scour of the channel bed and toe of the streambank. The first woody debris obstruction contributed to scour that created large, deep pools. Woody debris such as this, is beneficial to a stream system, it provides critical habitat for fish and insects, and adds essential organic matter that will benefit organisms downstream.

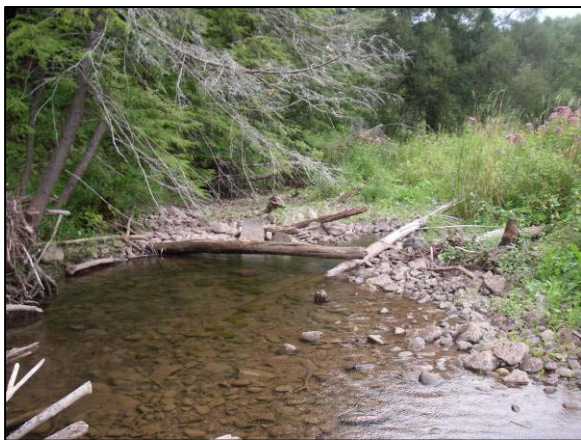
Channel Divergence at Station 18897

As the stream gently meandered to the left, there was a channel *divergence* (Station 18897) along the left, where a flood chute split off from the main channel. Flood chutes

convey flow through a secondary channel during periods of high flows; this flood chute flows behind a point bar (Stations 18882 – 18828) and converges (Station 18378) with the main channel approximately 519 feet downstream. Point bars commonly form on the inside of meander bends, where stream velocity is slower during high flows, allowing

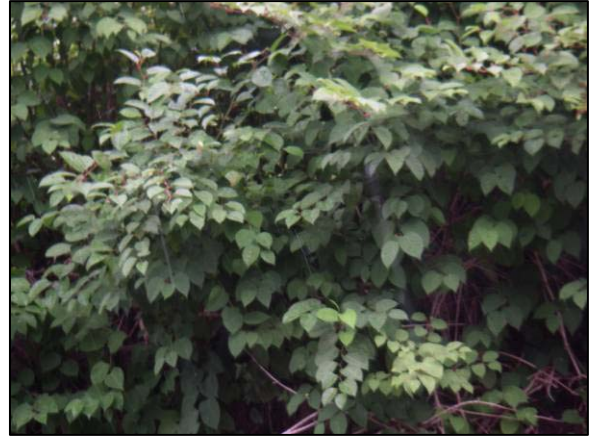
Japanese Knotweed at Station 18760

Further downstream, there was the first significant stand of Japanese knotweed in this unit (Station 18760, there were smaller patches further upstream in this unit).

Japanese knotweed is an invasive non-native species which does not provide adequate erosion protection due to its very shallow rooting system; knotweed also grows rapidly

and tends to crowd out more beneficial streamside vegetation. The best means for controlling knotweed is prevention of its spread. Therefore, effort should be made to ensure that existing stands are not fragmented via unnatural processes (i.e. mowing without removal of all mowed material) and transported into downstream areas. Small stands should be eradicated immediately to avoid further spread within this unit and downstream management units. There are removal methods that may be used for larger stands (see Section 2.7); these methods should be used with caution and carefully executed to avoid further spread of Japanese knotweed.

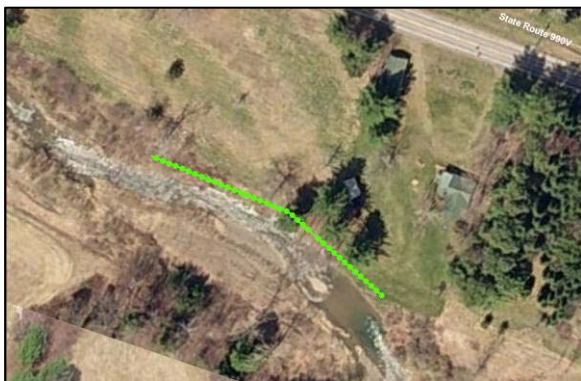
Riparian Planting Site at Stations 18713 - 18413

Continuing downstream, there was erosion (Stations 18771 – 18410) along the right streambank for approximately 361 feet. Along the upstream portion of the erosion site, lacustrine clay was exposed (Stations 18718 - 18607) in the channel bed and toe of the streambank. Clay inputs into a stream are a serious water quality concern because they increase *turbidity*, degrade fish habitat, and can act as transport for, or mask the presence of,

other pollutants and pathogens. There was little to no riparian buffer along much of this erosion site, and it was located along a proposed riparian planting site (Stations 18713 – 18413). Recommendations for this site include discontinued mowing to the stream's edge to allow succession to proceed, and establishing and enhancing the buffer

through the planting of native shrub and tree species. Reinforcing the toe of the streambank with native sedge species is also recommended. Buffer width should be increased by at least 100 feet or the greatest amount agreeable to the landowners. Prior to proceeding with any vegetative plantings, a more detailed assessment may be necessary and the eroding conditions should be given careful consideration when identifying the

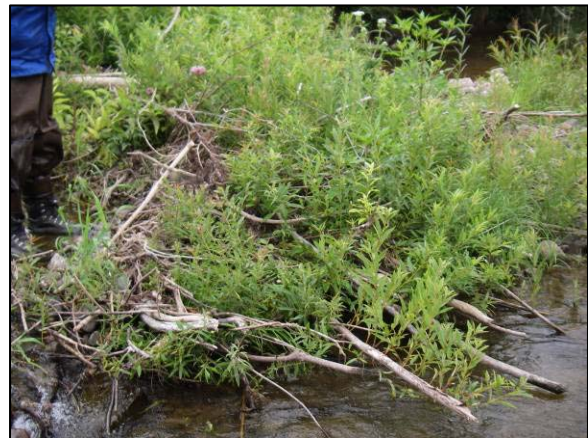
Beaver Dam at Station 18281

Continuing downstream, there was an old beaver dam (Station 18281) causing a partial obstruction of the left portion of the stream channel. This beaver dam appeared to contribute to upstream and downstream aggradational conditions. There was a second old beaver dam (Station 18168) further downstream across the full channel that also posed a partial obstruction to stream flow and contributed to localized aggradational conditions.

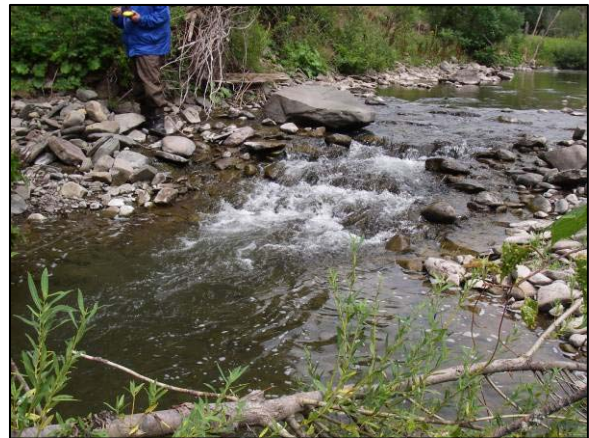
Head Cut at Station 17788

Just upstream of the tributary confluence, there was a *head cut* (Station 17788). A head cut is a marked change in stream bed slope, as in a step or waterfall, which is unprotected or of greater height than the stream can maintain. The stream was actively eroding the streambed downward to a new base level; there was a drop in channel elevation of approximately six feet.

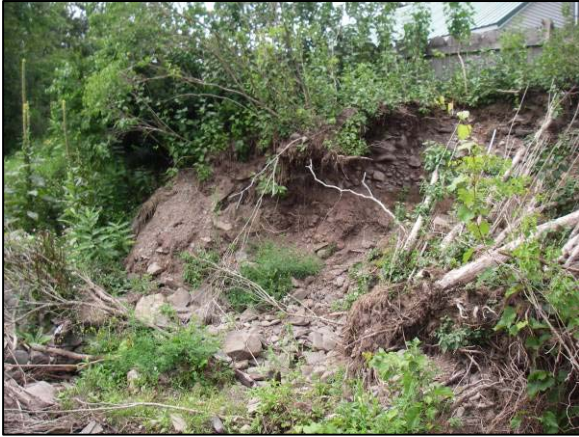
Erosion at Stations 17782 - 17690

Continuing downstream, there was erosion (Stations 17782 – 17690) along the right streambank for approximately 92 feet. The erosion had compromised several young trees and caused a large tree to fall across the stream channel; the fallen woody debris was posing an obstruction to flow that appeared to contribute to upstream aggradational conditions and localized scour of the channel bed and toe of the streambank. At the top of the bank, a fence was undercut, beyond which there was a house. If this bank continues to actively erode, both the fence and home may be in danger.

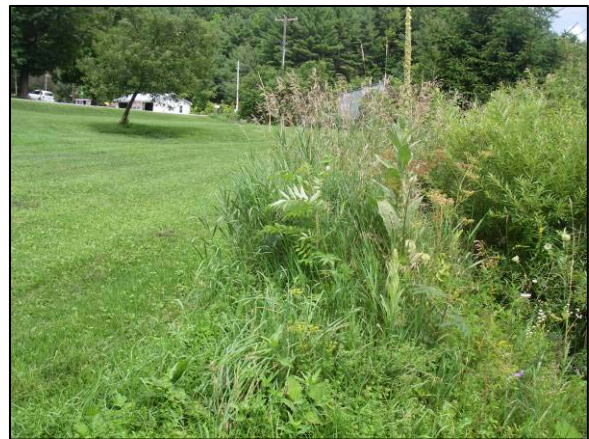
Riparian Planting Site at Stations 17618 - 17440

Further downstream, there were two additional proposed riparian planting sites. The first site stretched along the left streambank (Stations 17693 – 17418) for approximately 275 feet. There was herbaceous vegetation to the stream’s edge with a few willows and sedges along the bank. At the top of the bank, there was a fence surrounding a maintained field. Recommendations for this site include establishing a woody buffer by planting native tree and shrub species. The second riparian planting site (Stations 17618 – 17440) stretched along the right streambank for approximately 178 feet. This site had a mix of herbaceous vegetation and shrubs along the face of the streambank, with mown lawn to the top of the bank. In addition to augmenting the existing buffer with native plantings, recommendations for this site include discontinued mowing to the top of the

streambank, allowing succession to proceed with natural regeneration of shrub and early successional tree species. It is recommended that buffer width for both sites be increased to at least 100 feet or the greatest amount agreeable to the landowners. There were two small stands of Japanese knotweed along this stretch of stream which should be removed.

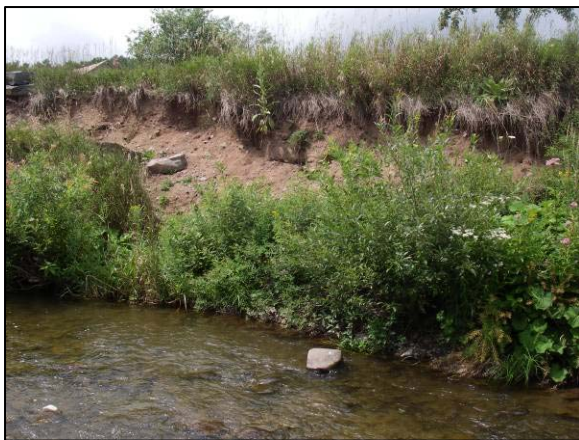
Erosion at Stations 17200 - 17010

establishing a wooded buffer with native vegetation at least 100 feet wide or the greatest width agreeable to the landowner. There were areas of erosion along this site. One of the erosion sites (Stations 17200 – 17010) had resulted in an erosion area of approximately 2,094 ft² along approximately 190 feet of the right streambank. This bank was nearly vertical and had some herbaceous

vegetation and willows at the toe of the bank. Prior to proceeding with any vegetative plantings, the eroding conditions should be given careful consideration when identifying the appropriate species and locations for plantings; a more detailed site assessment and bank grading may be necessary.

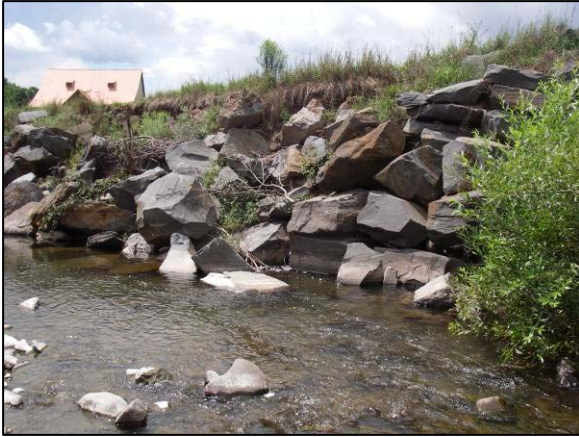
Revetment at Stations 17146 - 16971

Along portions of this erosion site, the right streambank was reinforced with rip rap (Stations 17146 – 16971) comprised of large rocks, stacked nearly vertical, for approximately 175 feet. Sections of the revetment had failed structurally; it was in poor functional condition and did not provide adequate scour protection. It is likely that the revetment will continue to fail during future high flows. The bank may need to be graded to lessen the slope of the revetment; interplanting the rip rap and reinforcing the toe of this streambank with native shrub and sedge species is recommended. Such plantings may help to strengthen the revetment, while enhancing aquatic habitat. The risk to bank stability can be minimized by maintaining mature trees along the critical 100 foot buffer zone. Aggradational conditions persisted through this stretch of stream including, multiple side bars, a point bar and a transverse bar.

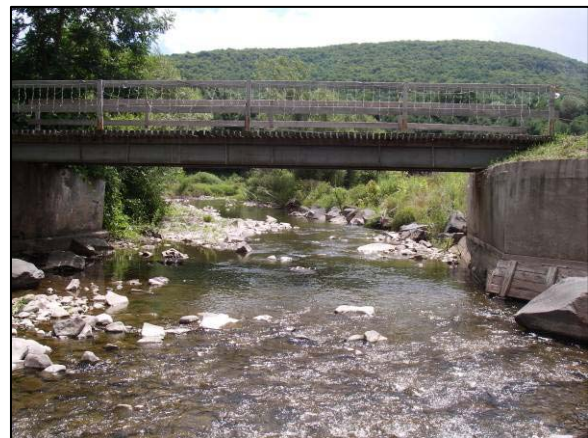
Bridge at Station 16957

Continuing downstream, the Manor Kill flowed under a private bridge (Station 16957). Gravel deposits upstream and downstream of the bridge were noted. Deposits such as these are commonly caused by inadequate sizing of the bridge opening. An undersized bridge opening causes water to back up upstream of the bridge, reducing stream velocity, which results in sediment deposition. There has been damage to the abutment on both sides of the bridge; in 1998 a streambank disturbance permit was issued to repair the damage. Flood damage to bridges is typically caused by inadequate hydraulic capacity of the bridge, misaligned piers and/or abutments,

or accumulation of debris. As bridges are replaced over time, these issues should be evaluated and adjusted if necessary to lessen the probability of flood damage by providing a more effective conveyance channel that promotes water and sediment flow through the bridge opening.

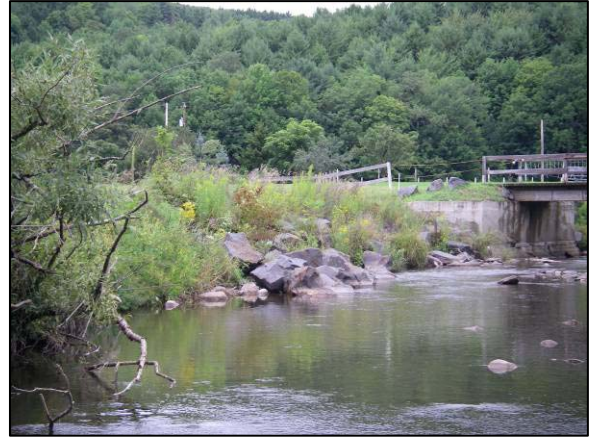
Revetment at Stations 16944 - 16874

Downstream of the bridge, the right streambank was reinforced with rip rap (stations 16944 – 16874) for approximately 70 feet. It was in fair structural and functional condition and didn't appear to provide adequate scour protection. As with the rip rap upstream of the bridge, a planting site continues along here and interplanting the revetment and reinforcing the toe of this streambank with native shrub and sedge species is recommended.

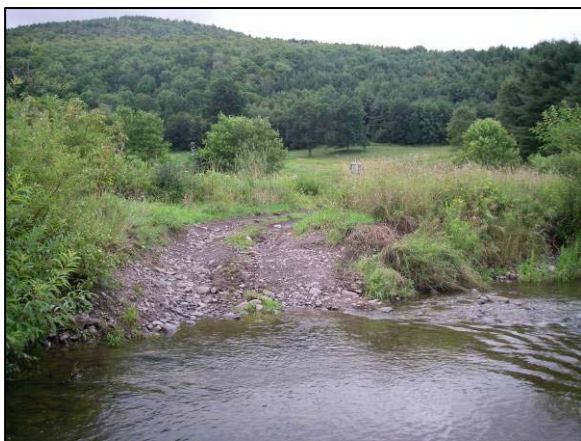
Channel Crossing at Station 16693

Continuing downstream, there was a channel crossing (Station 16693) to provide access to the agricultural fields along the left side of the stream. Maintenance of the crossing

appeared to contribute to upstream and downstream aggradational conditions. Along the left streambank, there was minor erosion (Stations 16710 – 16695) just upstream of the crossing for approximately 15 feet. Erosion (Stations 16677 – 16296) continued downstream of the crossing for approximately 381 feet along the left. Both of these erosion sites had herbaceous vegetation to the top of

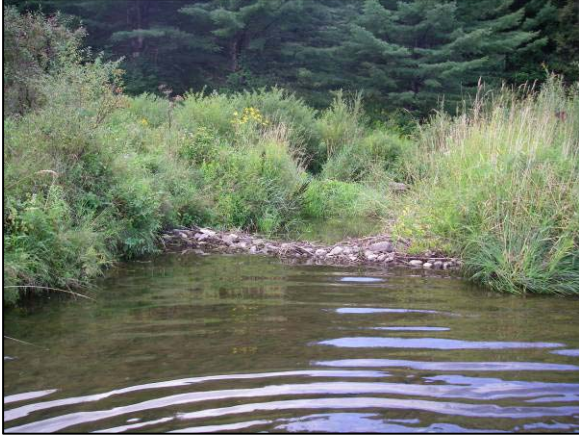
Beaver Dam at Station 16432

Along the downstream portion of this erosion site, there was a beaver dam (Station 16432) occupying the left portion of the stream channel, from the left streambank to a well vegetated center bar (Stations 16432 – 16293). The stream channel was over wide through this stretch of stream. The beaver dam appeared to contribute to upstream and localized aggradational conditions. Just downstream of the beaver dam, an unnamed tributary (Station 16407) entered along the left streambank. The flow through this tributary appeared to be affected by beaver activity, with multiple deep pools, including one at its confluence with the Manor Kill. Further downstream, there was a more substantial beaver dam (Figure 4.6.1, Inset B, Station 16370) also stretching from the left streambank to the center bar (Stations 16432 – 16293), occupying the left portion of the stream channel. This dam caused backwater upstream of the dam and appeared to contribute to excess sediment deposition upstream and downstream of the dam. Through this section of the stream, the channel was over wide and there were multiple areas and types of aggradational conditions including, center, side, point and transverse bars. These conditions seem to be maintained by abundant beaver activity.

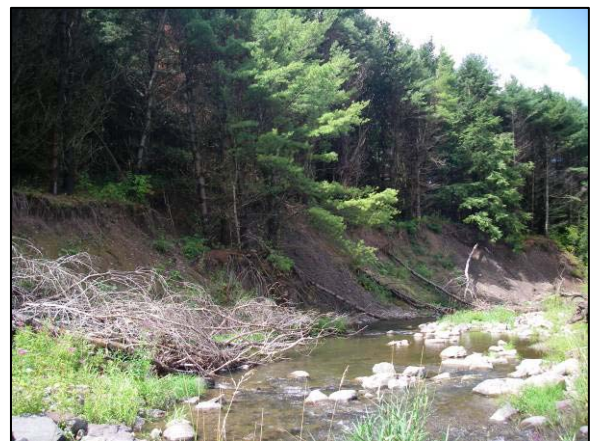
Mass Failure at Stations 16317 - 16052

As the stream meandered downstream, the *thalweg* flowed up against the toe of the left bank, undermining the steep slope and causing a mass failure (Stations 16317 – 16052). During the field assessment, this

bank was identified as a proposed Bank Erosion Monitoring Site (BEMS) to study erosion along this reach. Collection of baseline data, including a cross-section and long profile, is recommended. Once the baseline data has been collected, this cross-section can be resurveyed in the future to calculate the bank's erosion rate. At the time of the assessment, this mass failure had resulted in an erosion area of approximately 6,621 ft², exposing areas of lacustrine clay (Station 16315) and compromising mature trees. The fallen trees were in multiple locations along the streambank (Stations 16283, 16153 and 16052) and were contributing to upstream aggradation and localized scour of the channel bed and toe of the streambank, including scour of a deep pool along the downstream end of the erosion site. Excess sediment deposition resulted in the formation of side, point, transverse and center bars along this meander bend. There were also multiple small patches of Japanese knotweed through this stretch of stream.

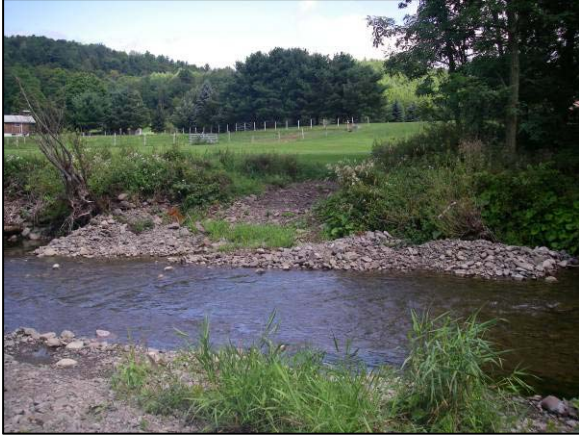
Channel Crossing at Station 15966

Continuing along this meander bend, there was a stream channel crossing (Station 15966) that appeared to serve primarily as a stream access point. It appeared as though channel material was placed upstream and

downstream of the access point to help maintain the crossing and to protect the streambank. The channel material used for bank protection is not likely to withstand significant stream velocities. During future high flows, this material will likely be mobilized and carried to downstream locations. This type of channel modification is not recommended. The NYS DEC Protection of Waters Program requires a permit for stream bed or bank disturbance including excavating gravel material and placing fill along streambanks.

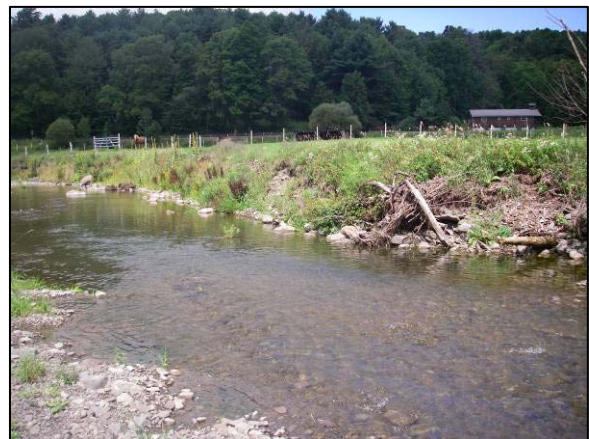
Riparian Planting Site at Stations 15969 - 15716

Downstream of the channel crossing, there was a proposed riparian planting site (Stations 15969 – 15716) along the right streambank for approximately 254 feet. Recommendations for this site include discontinued mowing to the stream’s edge, allowing succession to proceed with natural regeneration of shrub and early successional tree species, and establishing a wooded buffer with plantings of native shrub and tree species.

The risk to bank stability can be minimized by maintaining mature trees along the critical 100 foot buffer zone. Buffer width should be increased by the greatest amount agreeable to the landowners. A vigorous riparian zone with deep-rooted native trees and shrubs would increase buffer functionality such as filtering nutrients and pollutants, if present, from the nearby land use. This site will

require a more detailed site assessment, and the erosion would need to be addressed prior to proceeding with any riparian plantings.

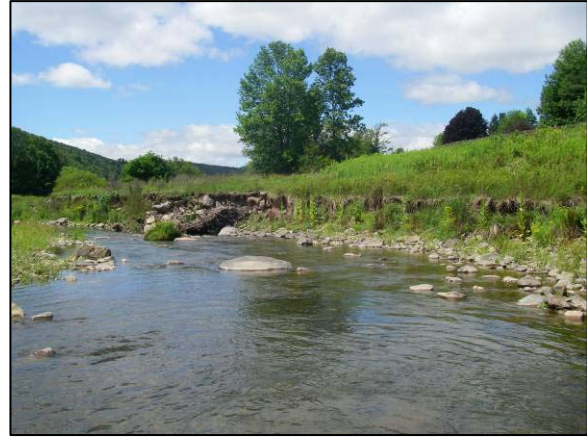
*Erosion at Stations 15962 -15500
(downstream portion)*

Along the planting site, and continuing downstream, the right streambank was eroding (Stations 15962 – 15463) for approximately 499 feet. There was mown lawn to the top of the bank along the upstream portion of the erosion site, beyond which there was a fence surrounding a horse pasture.

Continued erosion along this bank may compromise a portion of the fence. The erosion continues downstream of the pasture; this portion of the erosion site has old field or periodically maintained herbaceous vegetation to the top of the bank. The bank height and severity of the erosion also appeared to worsen moving downstream. Along the downstream end of the erosion site, there were remains of an old foundation that appeared to contribute to localized scour of the channel bed and toe of the streambank, and caused upstream backwater and aggradational conditions. The channel was over wide along this stretch of the stream. This site may benefit from the installation of *bioengineering* techniques that utilize live vegetation, either alone or in combination with harder materials such as rock or (dead) wood, to stabilize soils associated with stream banks or hillslopes. Roots stabilize the soil, while stems, branches and foliage slow high velocity water, reducing erosion and encourage deposition of fine sediment. If bioengineering techniques are going to be considered for streambank stabilization through this reach, an in-depth survey, a thorough morphological assessment and a project design may be required. Management unit 6 ended just downstream of this erosion site.

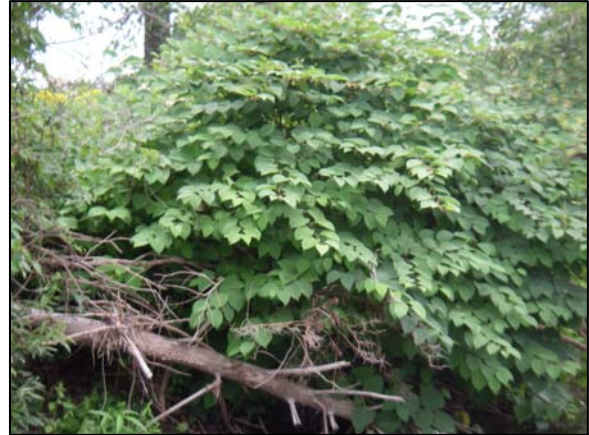
Japanese knotweed at Station 17973

Some plant species that are not native can create difficulties for stream management, particularly if they are invasive. Japanese knotweed (*Fallopia japonica*), for example, has become a widespread problem in recent years. Knotweed shades out other species with its dense canopy structure (many large, overlapping leaves), but stands are sparse at ground level, with much bare space between narrow stems, and without adequate root structure to hold the soil of streambanks.

The results can include rapid streambank erosion and increased surface runoff leading to a loss of valuable topsoil. Japanese knotweed locations were documented as part of the stream feature inventory conducted during the summer of 2008 (Riparian Vegetation Mapping, Section 2.7). In total, 10 Japanese knotweed occurrences covering an estimated length of 32 feet were documented during the stream feature inventory. The best means for controlling knotweed is prevention of its spread, therefore, effort should be made to ensure that all fill brought into the area is clean and does not have fragments of knotweed or other invasive plants. If Japanese knotweed sprouts or small stands are observed, they should be eradicated immediately to avoid further spread within this unit and to downstream management units.
