Manor Kill Management Unit 7

Town of Conesville – Station 15492 to Station 9805

This management unit begins at Station 15492, continuing approximately 5,687 ft to Station 9805 in the Town of Conesville.

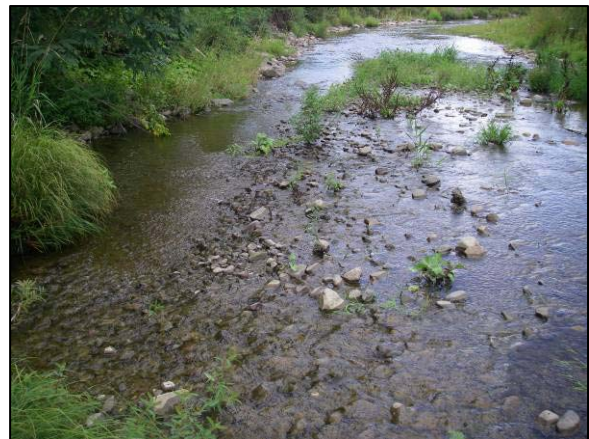
Along the right streambank, there was a piped outfall (Station 15368) that appeared to receive intermittent flow. This drainage pipe did not have outfall protection. Continuing downstream, there were multiple areas of channel *aggradation*, the process by which streams are raised in elevation by the deposition of material eroded and transported from other areas. These areas included transverse, point and center bars. During low flows, the transverse, or diagonal, bar (Station 15294 – 15262) directs flow toward the left streambank.

Transverse Bar at Stations 15294 - 15262

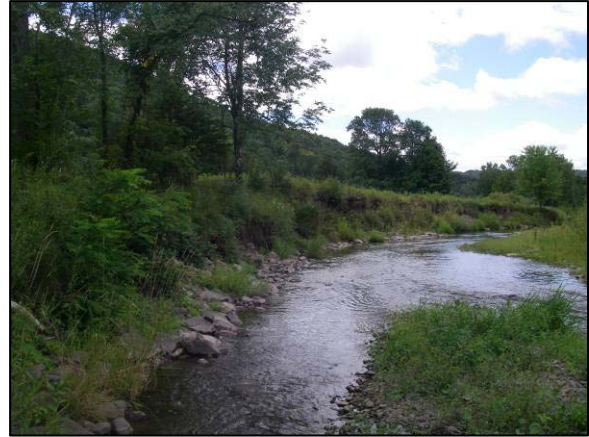
As the stream meandered to the right, there was erosion (Stations 15274 – 14944) along the left streambank for approximately 330 feet. Streambank erosion often occurs on the outside of meander bends where the stream velocity is greatest during high flows. Along the upstream portion of the erosion, there was a thin line of trees at the top of the bank; along the remainder of the eroding bank, there was a successional old field to the edge of the stream. This area was identified as a proposed riparian planting site (Stations 15127 – 14683). Recommendations for this site include the planting native trees and shrubs along the streambank and the upland area. Enhancing the quality of the buffer with woody vegetation, and increasing the overall buffer width, will help to protect water quality through this reach by slowing stormwater runoff and filtering pollutants associated with nearby land uses. Buffer width should be increased by the greatest amount agreeable to the landowners.

Erosion at Stations 15274 - 14944

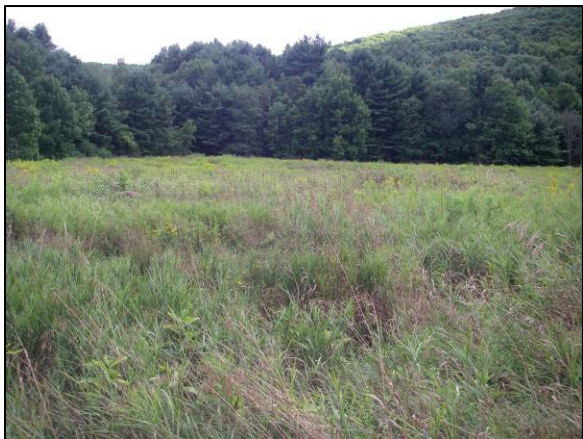
Riparian Planting Site at Stations 15127 - 14683

Increasing the buffer width to at least 100 feet will increase the buffer’s functionality. The eroding conditions along the upstream portion of the proposed planting site should be given careful consideration when identifying the appropriate species and locations for plantings. Prior to proceeding with any vegetative plantings, a more detailed site assessment may be necessary to determine whether stream bank grading will be required.

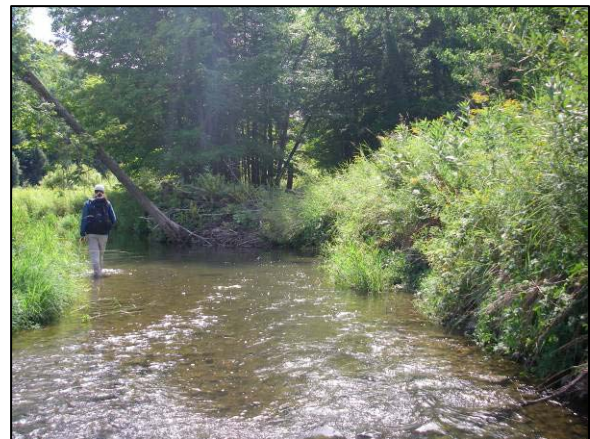
Along the first wetland, there was erosion (Stations 14431 - 14271) on the right streambank for approximately 160 feet. The upstream portion of the erosion had herbaceous vegetation to the edge of the

Erosion at Stations 14431 - 14271

stream; this vegetation was primarily successional old field with a few willows. Allowing natural succession to proceed along this bank is recommended in order to gain a woody vegetative buffer that may help to improve streambank stability. Also along this eroding bank, there was a compromised tree and a beaver lodge (Station 14366) with abundant woody debris accumulated behind the lodge; this beaver lodge did not appear to be active. Continuing downstream along the erosion, there was a young forest that provided a wooded buffer from the adjacent agricultural fields.

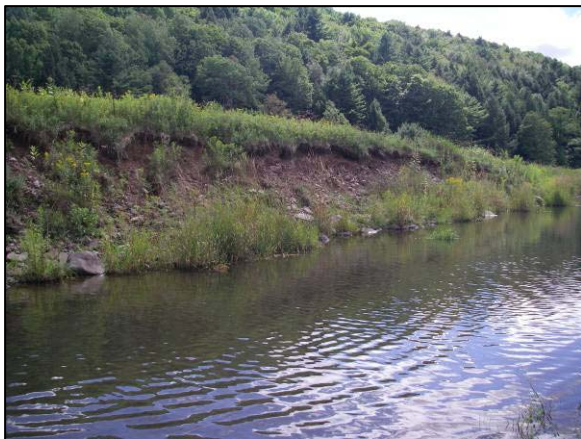
Continuing downstream, there was erosion (Stations 14180 – 14043) along the left streambank for approximately 137 feet. There was a successional old field to the top of the

Erosion at Stations 14180 - 14043

streambank; the face of the bank was exposed with herbaceous vegetation becoming established along the toe of the bank. Recommendations for this site include refraining from periodic mowing or maintenance of the field, allowing succession to proceed with natural regeneration of shrub and early successional tree species. Over time this site may self-recover.

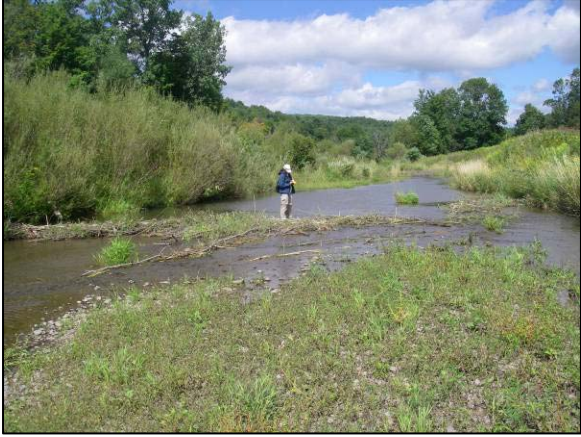
Beaver Dam at Station 14007

Further downstream, there was a beaver dam (Station 14007) that was actively being constructed or maintained, with evidence of fresh beaver damage to the willows upstream and downstream of the dam along the right streambank. This dam contributed to upstream backwater and downstream aggradational conditions, including a center bar followed by a transverse bar. Behind the willow vegetated

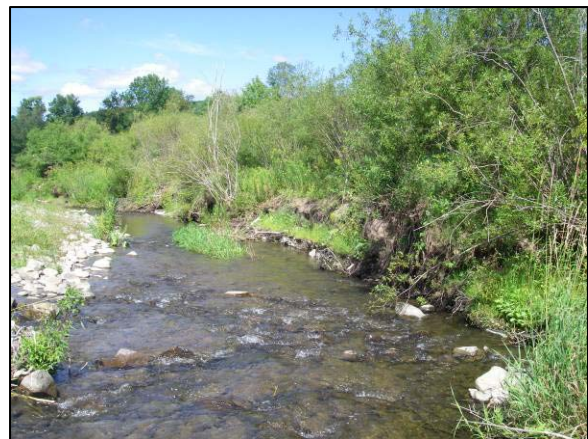
Further downstream, there was erosion (Station 13464) along the right streambank that started at the confluence of the back water channel and continued for approximately 293 feet. The erosion along this bank was relatively minor, with exposed roots and a mix of herbaceous and shrubby vegetation to the stream's edge. Along this stretch of stream, there was a channel *divergence* (Station 13393), where a flood chute split off from the

Erosion at Station 13464

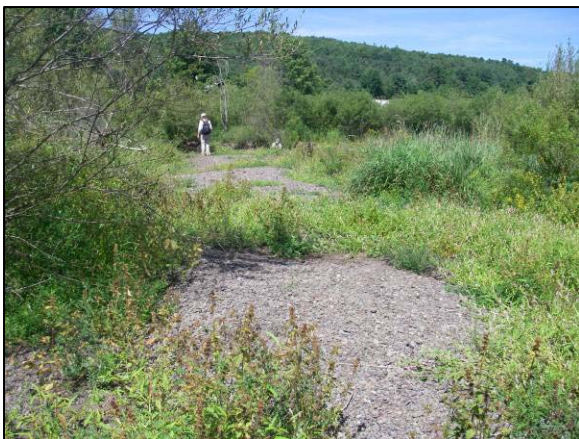
*Full Channel Aggradation at Stations 13380-13225, Secondary Channel
Photograph Orientation, Looking Upstream*

At the time of the assessment, there was no surface flow along the upstream portion of the secondary channel. There was excess sediment deposition beginning at the channel divergence and continuing for much of the secondary channel. This included full channel aggradation (Stations 13380 – 13225) for approximately 155 feet, followed by multiple point bars.

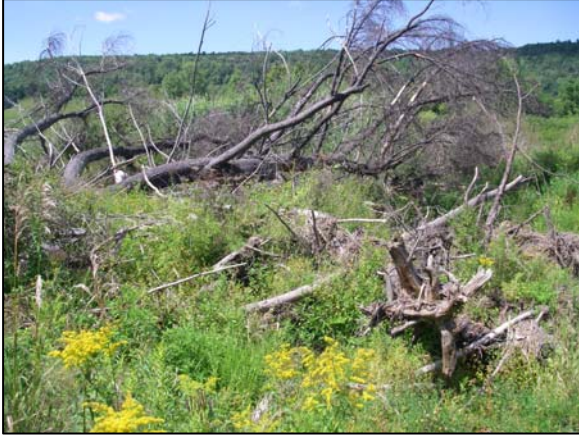
*Woody Debris at Station 13050
Secondary Channel*

the secondary channel, it appeared as though much of this excess sediment deposition was caused by a large fallen tree and accumulated woody debris (Station 13050) that posed a significant obstruction to channel flow. Downstream of the fallen tree, there was surface flow, additional woody debris, and the aggradational conditions persisted.

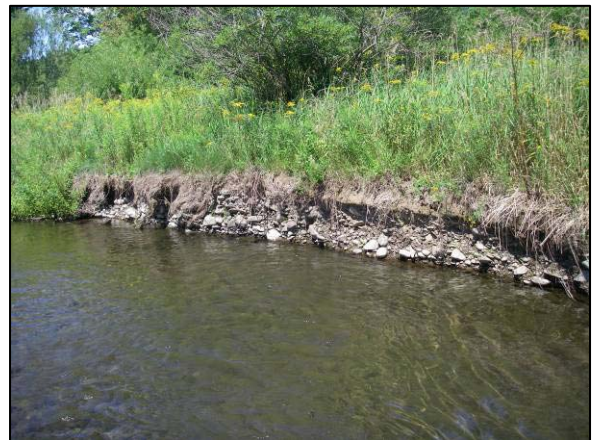
Erosion at approximate Stations 13050-12960

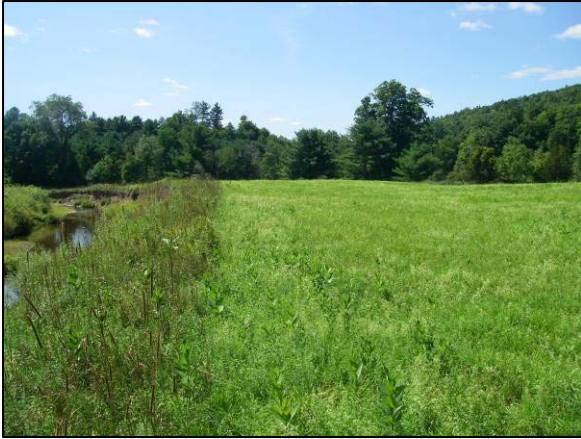
Proposed Planting Site Stations 12627-12201

and 12627-12201) were identified along the right bank. These planting sites were separated by a thin row of trees that ran perpendicular to the stream.

Recommendations for these sites include planting native trees and shrubs along the streambank and the upland area. Buffer width should be increased by the greatest amount agreeable to the landowners. Increasing the buffer width to at least 100 feet will increase

the buffer's functionality. Portions of both proposed planting sites are experiencing erosion; therefore, prior to proceeding with any vegetative plantings careful consideration should be given to identifying the appropriate species and locations for plantings. A more detailed site assessment may be necessary to determine whether stream bank grading will be required.

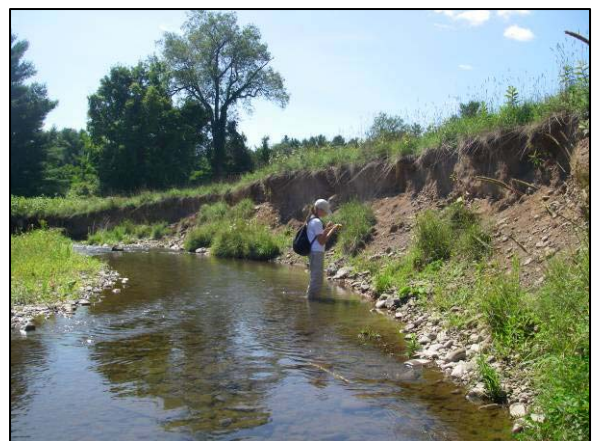
During the field assessment, the right bank along the second planting site was identified as a proposed Bank Erosion Monitoring Site (BEMS) to study erosion along this reach. To monitor BEMS, a cross-section and long profile may be conducted to collect baseline data. Once the baseline data has been collected, this cross-section can be resurveyed in the future to calculate the bank's erosion rate. Improving the riparian buffer along this site is important however, other stream bank stabilization techniques may be required to reinforce the bank and to minimize any loss of planted vegetation. Toward the end of this erosion site, clay was exposed (Figure 4.7.1, Inset B, Stations 12300-12172) along the streambank and channel bed for approximately 166 feet. Clay inputs into a stream are a serious water quality concern because they increase turbidity, degrade fish habitat, and can act as a carrier for other pollutants and pathogens.

BEMS at Stations 12637-12169

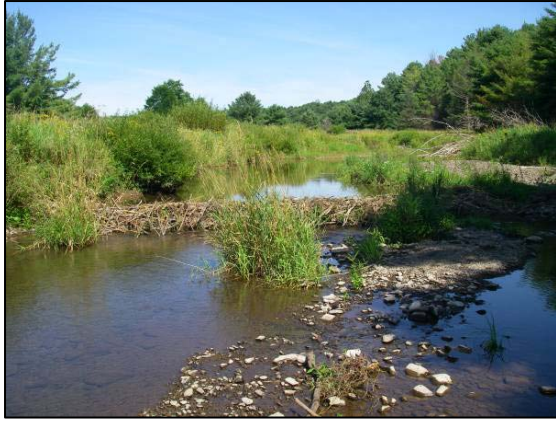
Beaver Dam at Station 11769

downstream a beaver dam (Station 11769) had been constructed across the stream channel. The dam appeared to be actively maintained and contributed to backwater and downstream aggradational conditions as well as scour along both banks downstream of the dam. While beaver impoundments can sometimes be a nuisance, beavers have historically played a beneficial and ecologically important role in the

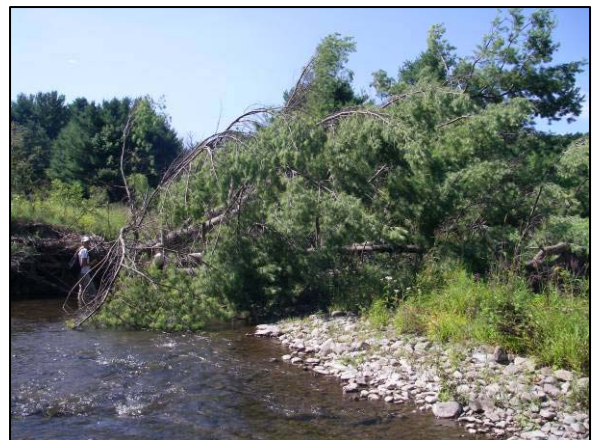
stream system. Beaver activity adds organic debris (trees, leaves, etc. which provide the base of the food chain), reduces water velocities and flood-related hazards downstream, and creates wetland areas that filter sediment and release water to the stream and groundwater slowly throughout the year. Excess deposition persisted throughout this stretch of stream including multiple point, center and transverse bars. Along the left streambank a convergence (Station 11725) of a secondary channel was observed. This convergence appeared to contribute to localized downstream aggradational conditions. Opposite of the convergence, a divergence (Station 11713) was observed along the right bank. This divergence rejoined the main channel approximately 250 feet downstream. Along the left streambank, hydraulic erosion (Stations 11688-11500) was observed for 208 feet where herbaceous vegetation had been maintained to the edge of the bank. A large tree had fallen from the upstream end across the stream channel contributing to upstream and downstream aggradational conditions, as well as localized scour of the channel and left bank. Along the downstream end of the erosion, two large pines also appeared to be compromised as the bank continued to erode.

Obstruction at Station 11653

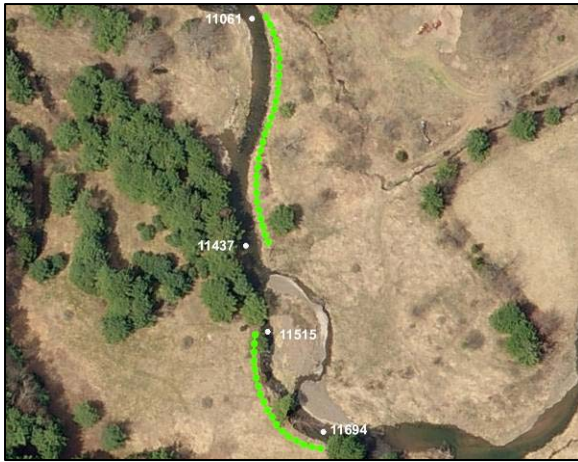
Proposed Planting Sites at Stations 11694-11515 and 11437-11061

This erosion was along a proposed riparian planting site (Stations 11694-11515). Recommendations for this site include discontinued mowing to the stream's edge to allow succession to proceed with natural regeneration of shrub and early successional tree species. Buffer width should be increased by the greatest amount agreeable to the landowners; however erosion along this site may need to be addressed prior to proceeding with any riparian plantings of native sedge,

shrub and tree species. A more detailed site assessment may be necessary to determine whether stream bank grading will be required. Downstream along the right streambank an additional proposed riparian planting site was identified (Stations 11437-11061). This site included a successional old field with few shrubs and trees. Recommendations include continuing to allow succession to proceed by not mowing, and planting native trees and shrubs along the streambank and the upland area, increasing the buffer width to at least 100 feet.

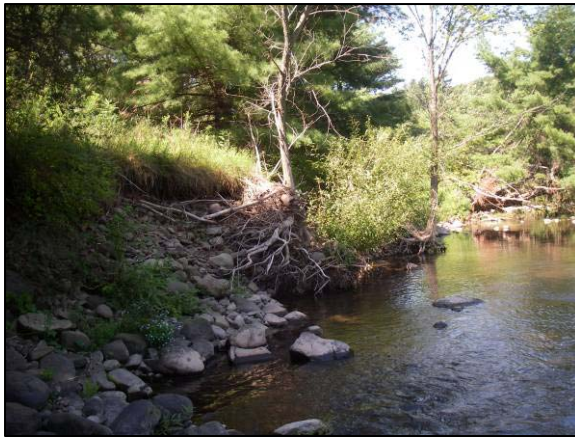
Erosion at Stations 10630-10266

Continuing downstream there was erosion (Stations 10630-10266) along the left streambank for 365 feet. Along this erosion, vegetation was a mix of grasses, shrubs and trees. The woody vegetation had been compromised along the undercut banks, with exposed roots and one tree that had fallen along the downstream portion of the erosion site (Figure 4.7.1 Inset A, Station 10505).

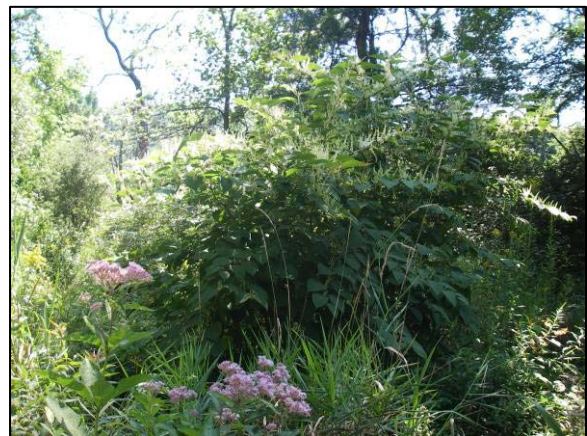
As the stream meandered to the left, Japanese knotweed (Station 10056) was observed on the left bank. This was the first and only observation of knotweed in this management unit. Japanese knotweed is an invasive non-native species which does not provide adequate erosion protection due to its very shallow rooting system, and also grows rapidly to crowd out more beneficial streamside vegetation. The best means for controlling knotweed is prevention of its spread. Therefore, effort should be made to ensure that existing stands are not fragmented via unnatural processes (i.e. mowing without removal of all mowed material) and transported into downstream areas. Small stands should be eradicated immediately to avoid further spread within this unit and to

Japanese Knotweed at Station 10056

downstream management units. There are removal methods that may be used for larger stands (see Section 2.7), these methods should be used with caution, and carefully executed to avoid further spread of Japanese knotweed.

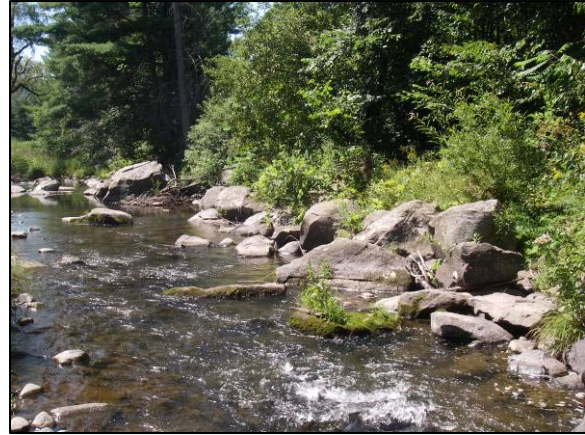
Revetment at Stations 9900-9779

As the stream meandered toward State Route 990V, the right streambank had been reinforced with rock rip-rap (Stations 9900-9779) along the toe of the bank for approximately 90 feet in Management Unit 7 and continued into Management Unit 8 for an additional 40 feet. The rip-rap appeared to be old and consisted of natural large boulders, was in fair functional condition and poor structural condition; however it appeared to provide adequate scour protection. Vegetation along the revetment was a mixture of grasses, shrubs and trees. Management Unit 7 ended at Station 9805.
