# Manor Kill Management Unit 8

Town of Conesville – Station 9805 to Station 4523

This management unit began at Station 9805 and continued approximately 5,282 ft to Station 4523 in the Town of Conesville.

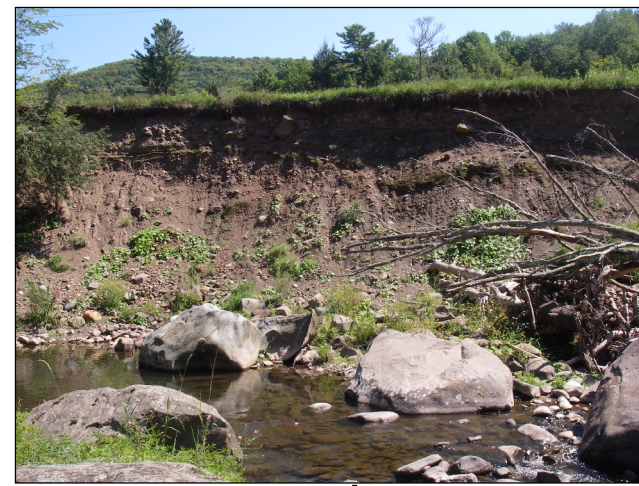
**C**

As the stream meandered to the right, the *thalweg*, or deepest part of the stream channel, flowed up against the left streambank causing a mass failure (Figure 4.8.1, Inset C, Stations 8388 – 8269). This mass failure resulted in an erosion area of approximately 3,956 ft<sup>2</sup>, exposing roots and compromising

mature trees along the upstream and downstream portions of the bank. The vegetation along this site had been mowed to the edge of the bank. During the field assessment, this bank was identified as a proposed Bank Erosion Monitoring Site (BEMS) to study erosion along this reach. To monitor BEMS, a cross-section and long profile may be conducted to collect baseline data. Once the baseline data has been collected, this cross-section can be resurveyed in the future to calculate the bank's erosion rate.

Along this erosion clay was exposed in the bed and bank for approximately 10 feet. Clay inputs into a stream are a serious water quality concern because they increase turbidity, degrade fish habitat, and can act as a transport mechanism for other pollutants and pathogens. Large boulders in the stream contributed to aggradation as well as the scouring of pools along the erosion. Multiple large trees (Stations 8346) had fallen into the stream channel contributing to minor scouring and deposition. Woody debris such as this is beneficial to a stream system; it provides critical habitat for fish and insects, and adds essential organic matter that will benefit organisms downstream.

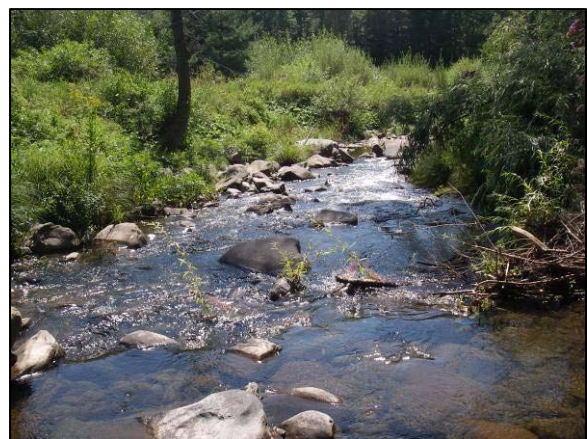
Downstream of the divergence, there was a *head cut* (Station 9725). A head cut is a marked change in stream bed slope that is unprotected, or of greater height than the stream can maintain (similar to a step). The stream was actively eroding the streambed downward to a new base level.

Head Cut at Station 9725

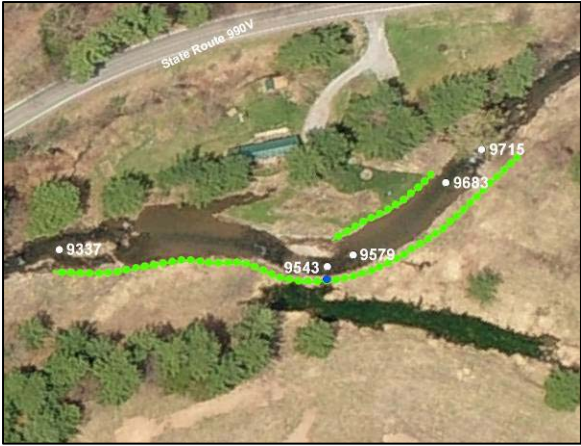
Continuing downstream, a proposed riparian planting site was identified along the left streambank. This site was a successional

*Riparian Planting Sites at Stations 9715-9337 and 9683-9579; Tributary at Station 9543*

old field with shrubs and a few trees. Recommendations for this site include planting native trees and shrubs along the streambank and the upland area. Enhancing the quality of the buffer with woody vegetation, and increasing the overall buffer width, will help to protect water quality through this reach by slowing stormwater runoff and filtering pollutants associated with nearby land use. Buffer width should be increased by the greatest amount agreeable to

the landowners. Increasing the buffer width to at least 100 feet will increase the buffer's functionality. About midway along the site, an unnamed tributary (Station 9543) entered from the left bank. This tributary appeared to receive its waters from upstream wetlands. Throughout this section of stream there were multiple areas of channel *aggradation*, the process by which streams are raised in elevation by the deposition of material eroded and transported from other areas. These areas include point, center and side bars that were vegetated with grasses and sedges.

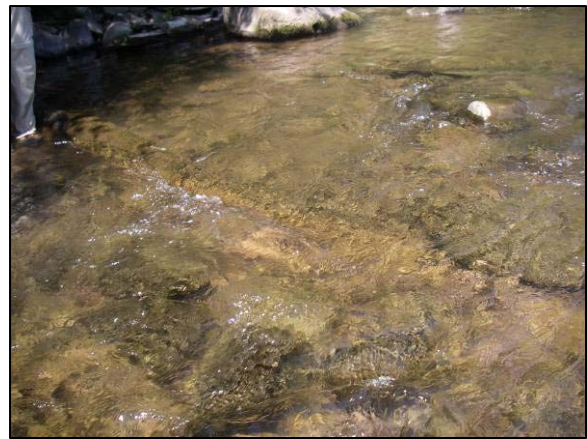
Further downstream it appeared that two logs had been placed perpendicular to the stream to serve as a habitat structure (Station 9245). Habitat structures are generally placed in an effort to create scour pools that offer deeper holding habitat as well as create spillways that raise the amount of dissolved oxygen in the water. In general, due to the channel spanning design, they cause water to back up on the upstream side of the structure which can increase sediment deposition. These logs were placed approximately 10 feet apart and spanned the width of the channel, however portions of both logs were buried and neither seemed to have a significant impact on the stream.

*Habitat Structure at Station 9245*

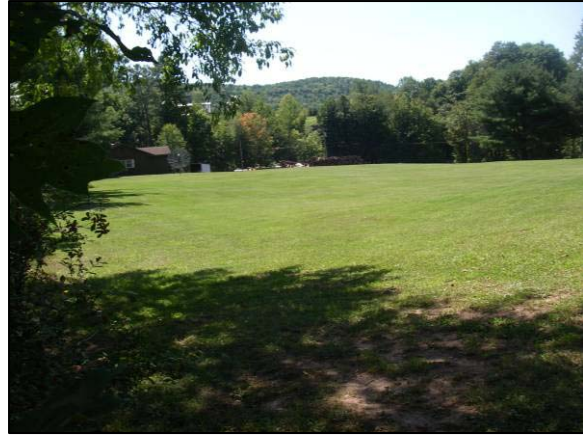
As the stream meandered to the left, a proposed riparian planting site was identified along the right bank. Lawn was mowed to the edge of the stream with shrubs and trees on the face of the bank. Recommendations for this site include planting native trees and shrubs along the streambank and the upland area. Buffer width should be increased by the greatest amount agreeable to the landowners.

*Planting Site at Stations 9036-8852*

Increasing the buffer width to at least 100 feet will increase the buffer's functionality and protect the stream from nearby land uses.

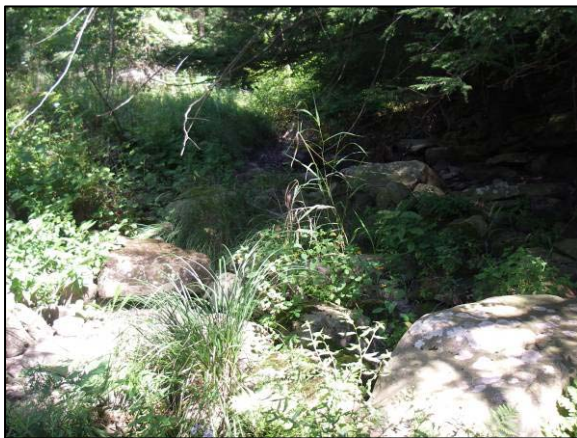
*Flood Chute at Station 8426*

At Station 8426 a flood chute converged with the main channel along the left streambank. The divergence of this flood chute was not observed during field assessment. This flood chute was lined with medium and large boulders; there was no flow at the time of the assessment. Additionally, this flood chute appeared to receive water from upland drainage.

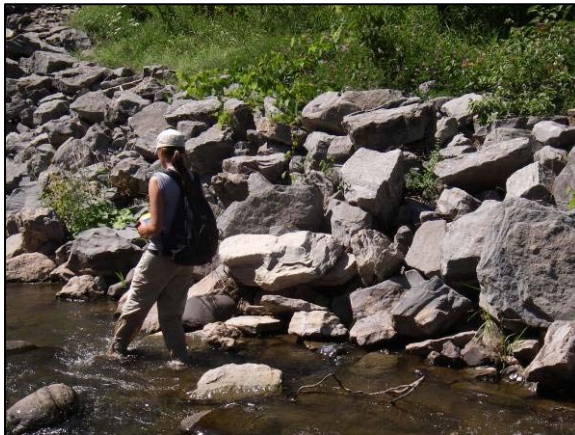
*Revetment at Stations 8260-8165*

Along the right streambank, rip rap had been installed for approximately 83 feet. This rip rap provided scour protection and appeared to be in good structural and functional condition. Interplanting native

shrub and sedge species through the rip rap and along the toe of this streambank is recommended. This planting will help to strengthen the revetment, while enhancing aquatic habitat.

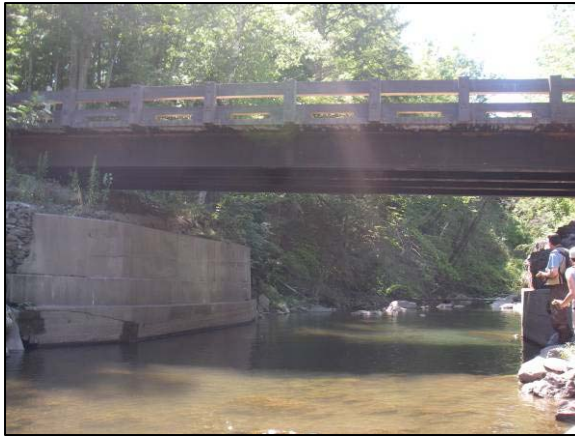
*Bridge at Station 8167*

Continuing downstream, the Manor Kill flowed under Pangman Road Bridge, ID 2228550 (Station 8167). In 1994 a permit was issued by the NYSDEC to Schoharie County for the replacement of this bridge. This bridge appeared to be in good structural and functional condition, conveying most flows freely; however some damage to the toe of the abutments was noted. Flood damage to bridges is typically caused by inadequate

hydraulic capacity of the bridge, misaligned piers and/or abutments, or accumulation of debris. As bridges are replaced over time these issues should be evaluated and adjusted if necessary to lessen the probability of flood damage by providing a more effective conveyance channel for water and sediment. Gabion baskets had been placed on and upstream of the bridge abutments to provide additional scour protection. Rock-filled gabions, or large wire-mesh baskets, are not generally a recommended management practice. They have a tendency to be unsightly, and when installed incorrectly they frequently blow out of the bank and scatter rocks and cages downstream, particularly following ice flows. Their correct use requires professional installation and maintenance.

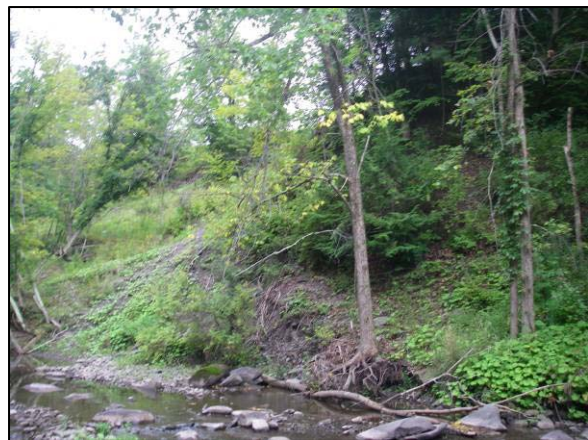
Downstream of the bridge, the stream meandered to the right and the thalweg flowed up against the left streambank causing a second mass failure. The face of this erosion was vegetated with some grasses and trees while vegetation along the erosion was mowed to the edge. This mass failure resulted in an approximate erosion area of 9,215 ft<sup>2</sup> exposing roots and

*Mass Failure at Stations 8123-7800*

compromising trees. Clay was exposed for the length of the erosion along the toe and into the bed of the stream. Opposite the mass failure a point bar had formed along the right streambank. Point bars commonly form on the inside of meander bends, where stream velocity is slower during high flows, allowing sediment to drop out of the water column and settle along the streambed.

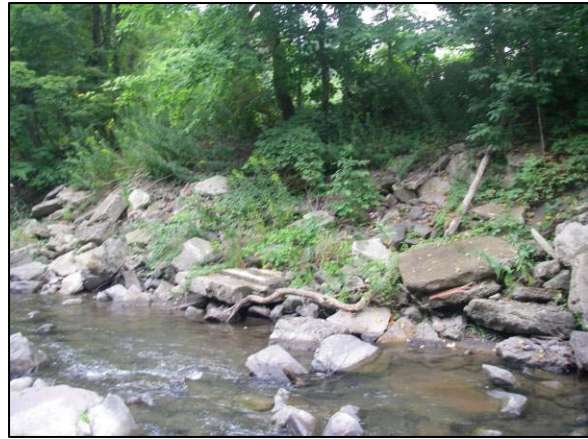
Following the mass failure, rip rap (Stations 7792-7657) had been installed along the right streambank for approximately 135 feet. The upstream portion of this riprap consisted of cobble and some small boulders; continuing downstream large pieces of concrete had been placed with some smaller rock. This rip rap appeared to be in fair functional and structural condition, providing some scour protection.

*Revetment at Stations 7792-7657*

A thin line of trees separated the revetment from Pangman Road. Interplanting native shrub and sedge species through the rip-rap and along the toe of this streambank is recommended to help to strengthen the revetment, while enhancing aquatic habitat. Continuing from the rip rap, there was erosion (Station 7657) for approximately 134 feet along the right streambank. The bank was overhanging along a portion of this site, exposing roots and compromising trees. Along this section of stream there were several aggradational features including side, transverse and point bars.

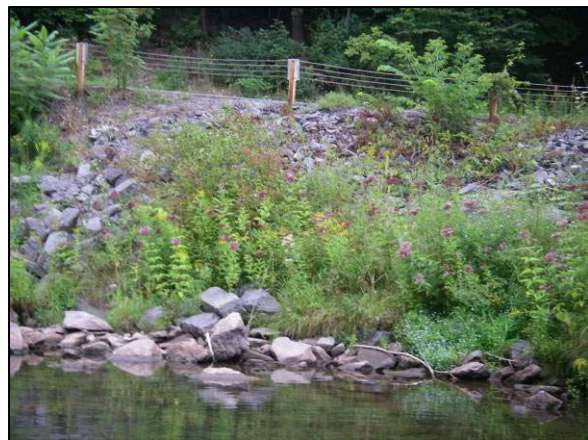
As the stream flowed directly into State Route 990V, rip rap covered the bank and toe of the right streambank for approximately 33 feet. This revetment appeared to provide scour protection and be in good structural and functional condition. Some herbaceous vegetation had grown along the rip rap, and it is recommended that additional native shrub and sedge species be

*Revetment at Stations 7400-7367*

interplanted into the rip rap. As the stream turned sharply to the left, bedrock (Figure 4.8.1, Inset B, Stations 7368-6336) extended from the top of the bank along State Route 990V into the channel of the right streambank and bed for approximately 1,032 feet. This bedrock at times covered the full bed of the stream channel. The bedrock provides lateral control along the right bank by limiting stream bank erosion; it provides grade control for the channel by preventing degradation or downcutting of the stream, the process by which streambeds and floodplains are lowered in elevation by eroding downward into the stream bed over time.

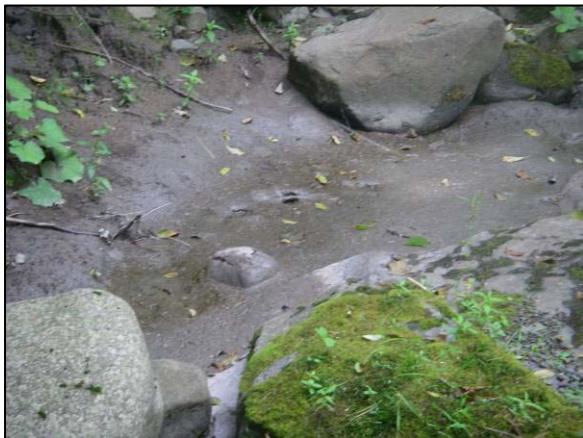
*Clay Exposure at Station 6475*

6821) along the bank for approximately 316 feet. This bank was undercut and slumping in areas exposing roots and compromising some trees. Clay was also exposed along the length of the erosion. It appears that during high flows water flows behind the side bar contributing to the erosion. Approximately 287 feet downstream of the erosion there was an additional 8 foot clay exposure along the left bank.

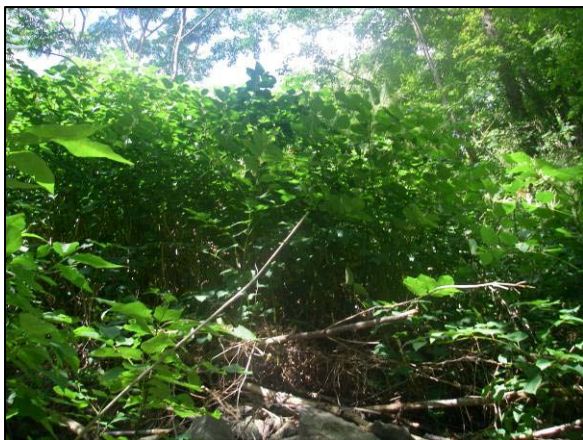
Along the right bank the first stand of Japanese knotweed was observed in this management unit. Japanese knotweed is an invasive non-native species which does not provide adequate erosion protection due to its very shallow rooting system; knotweed also grows rapidly and tends to crowd out more beneficial streamside vegetation. The best means for controlling knotweed is prevention of its spread. Therefore, efforts should be taken to

*Japanese Knotweed at Station 4555*

ensure that existing stands are not fragmented via unnatural processes (i.e. mowing without removal of all mowed material) and transported into downstream areas. Small stands should be eradicated immediately to avoid further spread within this unit and to downstream management units. There are removal methods that may be used for larger stands (see Section 2.7), but these methods

should be used with caution and carefully executed to avoid further spread of Japanese knotweed. Downstream a flood chute flowed behind a well-vegetated side bar along the right streambank for approximately 200 feet.

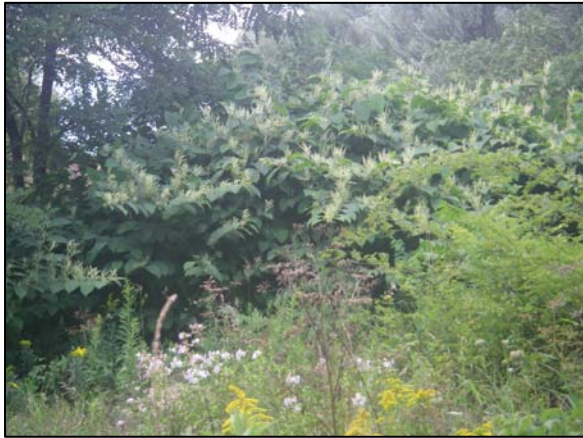
*Japanese knotweed at Station 4567*

Some plant species that are not native can create difficulties for stream management, particularly if they are invasive. Japanese knotweed (*Fallopia japonica*), for example, has become a widespread problem in recent years. Knotweed shades out other species with its dense canopy structure (many large, overlapping leaves), but stands are sparse at ground level, with much bare space between narrow stems, and without adequate root

structure to hold the soil of streambanks. The result can include rapid streambank erosion and increased surface runoff leading to a loss of valuable topsoil. Japanese knotweed locations were documented as part of the stream feature inventory conducted during the summer of 2008 (Riparian Vegetation Mapping, Section 2.7). In total, two Japanese knotweed occurrences, covering an estimated length of 55 feet, were documented during the stream feature inventory. The best means for controlling knotweed is prevention of its spread, therefore, efforts should be made to ensure that all fill brought into the area is clean and does not have fragments of knotweed or other invasive plants. If Japanese knotweed sprouts or small stands are observed, they should be eradicated immediately to avoid further spread within this unit and to downstream management units.
