Manor Kill Management Unit 9

Town of Conesville – Station 4523 to Station 1775

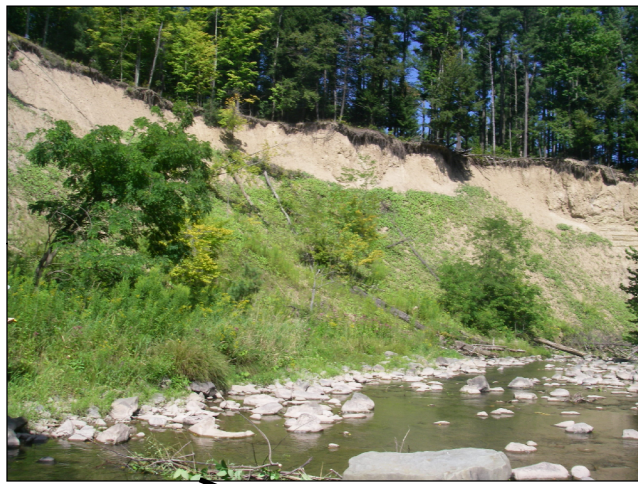
A

As the stream meandered to the right, the thalweg, or deepest part of the stream channel, flowed up against the left streambank causing a second mass failure (Figure 4.9.1, Inset A, Stations 2289 – 1906). This mass failure resulted in an erosion area of approximately 12,547 ft², exposing roots and compromising mature trees. Land was forested from the top of the erosion to Prattsville Road – a distance of approximately 300 feet. Along the erosion, multiple trees had fallen into the stream contributing to localized scour and aggradation.

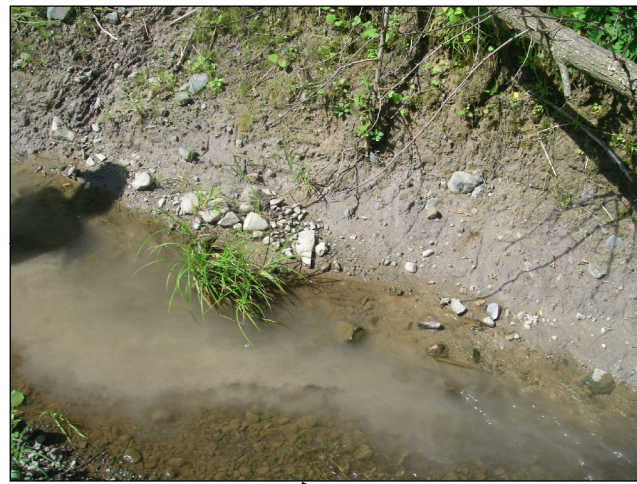
**B**

Along the erosion there were multiple obstructions including woody debris and beaver dams that contributed to scouring and aggradation. At Station 2630 large fallen trees had accumulated additional woody debris causing a deep scour pool adjacent to the debris (Figure 4.9.1, Inset B, Station 2630). These trees also appeared to contribute to localized upstream and downstream aggradation as well as multiple smaller scour pools. Additional beaver dams and woody debris contributed to aggradational conditions along a large center bar (Station 2602) which had multiple channels flowing through. Beaver dams in the stream

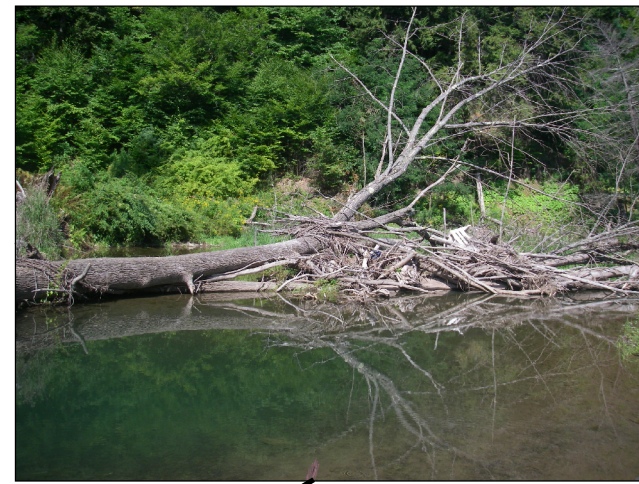
**C**

Following the hydraulic erosion along the left bank, there was a mass failure (Stations 2552-2411) resulting in an erosion area of approximately 6,662 ft², exposing areas of lacustrine clay (Figure 4.9.1, Inset C, Stations 2497-2420) and compromising mature trees along the bank. Fallen trees were in multiple locations along the streambank. The mass failure was forested at the top of the bank with herbaceous vegetation on the face of the upstream portion of the bank.

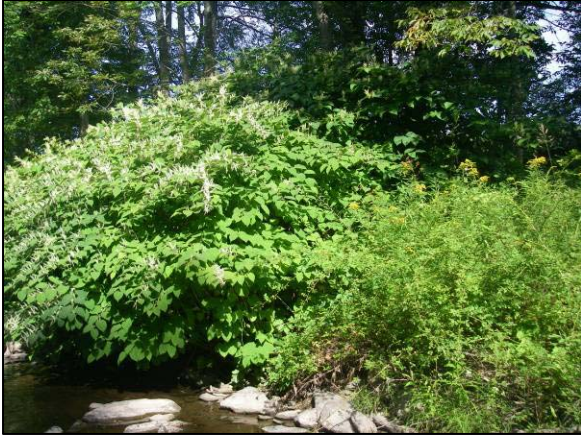
Management Unit 9 began just downstream of a tributary confluence. Along the right bank, two stands of Japanese knotweed were observed. Japanese knotweed is an invasive non-native species which does not provide adequate erosion protection due to its very shallow rooting system; knotweed also grows rapidly and tends to crowd out more beneficial

Japanese Knotweed at Station 4304

streamside vegetation. The best means for controlling knotweed is prevention of its spread. Therefore, efforts should be taken to ensure that existing stands are not fragmented via unnatural processes (i.e. mowing without removal of all mowed material) and transported into downstream areas. Small stands should be eradicated immediately to avoid further spread within this unit and to downstream management units. There are removal methods that may be used for larger stands (see Section 2.7); these methods should be used with caution and carefully executed to avoid further spread of Japanese knotweed.

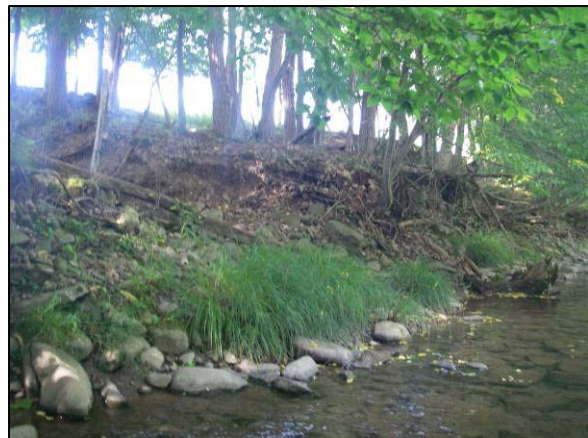
Erosion at Station 4304

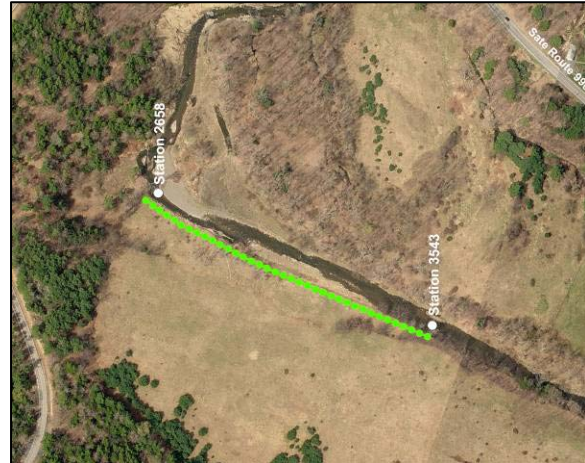
Continuing downstream, a riparian planting site (Station 3543) was proposed for approximately 885 feet along the left streambank. This site was a successional old field with herbaceous vegetation to the edge of the stream. Recommendations include continuing to allow succession to occur with natural regeneration of shrub and early successional tree species. This would be accomplished by not mowing, as well as planting native trees and shrubs along the streambank and the upland area. Buffer width should be increased by the greatest amount agreeable to the landowners. Increasing the buffer width to at least 100 feet will help to stabilize the stream bank and protect water quality through this reach by slowing stormwater runoff and filtering pollutants associated with nearby land use. Portions of the streambank along the planting site were experiencing erosion; therefore prior to proceeding with any vegetative plantings, a more detailed assessment may be necessary. The eroding conditions should be given careful consideration when identifying the appropriate species and locations for plantings.

Planting Site at Stations 3543-2658

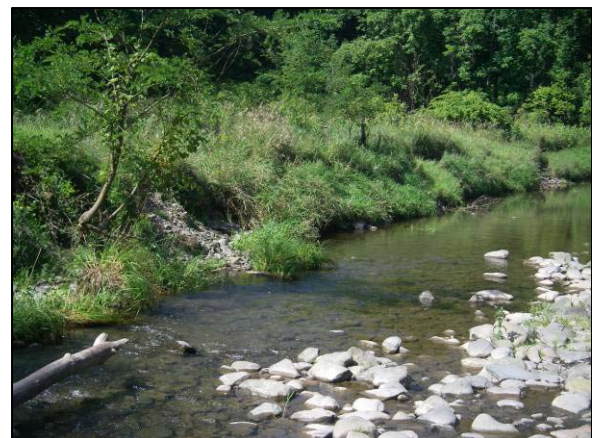
As the stream meandered to the right, hydraulic erosion began along the downstream portion of the proposed planting site and extended 374 feet (Stations 2888-2552). The erosion was approximately 6 feet in height; much of the bank material had slumped over the face of the bank, exposing roots. Opposite the erosion, a point bar had

Erosion at Stations 2888-2552

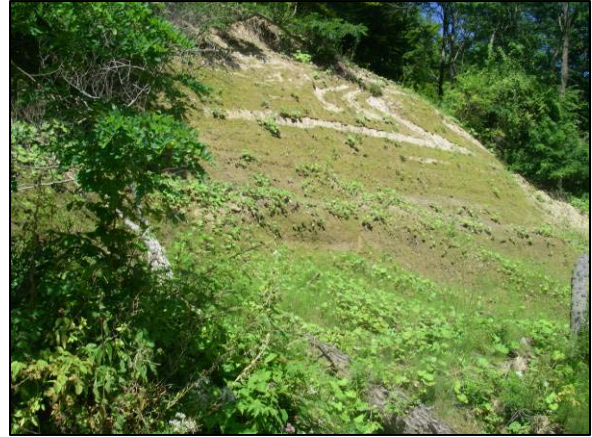
Mass Failure at Stations 2552-2411

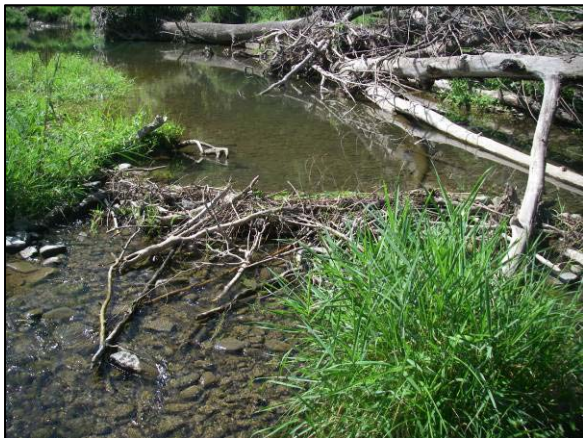
Beaver Dam at Station 2600

extended from center bar to center bar (Station 2600), and from center bar to the right bank, (Station 2579) also contributing to aggradation and backwatering. While beaver impoundments can sometimes be a nuisance, beavers have historically played a beneficial and ecologically important role in the stream system. Beaver activity adds organic debris (trees, leaves, etc. which provide the base of

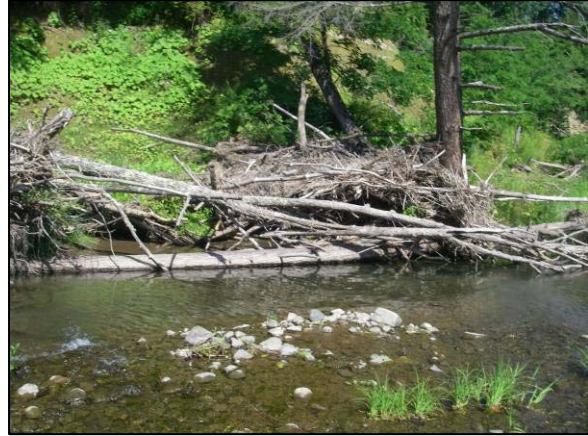
Further downstream trees that had fallen from the mass failure caused an additional obstruction accumulating woody debris and contributing to a localized scour pool as well as upstream and downstream aggradation (Station 2462). Woody debris is beneficial to a stream system as it provides critical habitat for fish and insects, and adds essential organic matter that will benefit organisms downstream. However, if the debris becomes a hazard it may need to be cut or removed.

Woody Debris at Station 2462

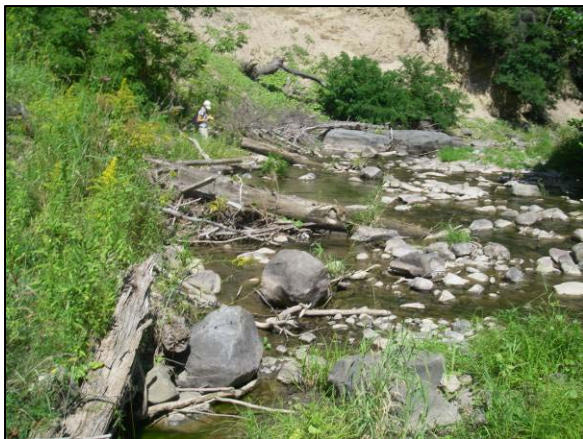
Woody Debris at Station 2134

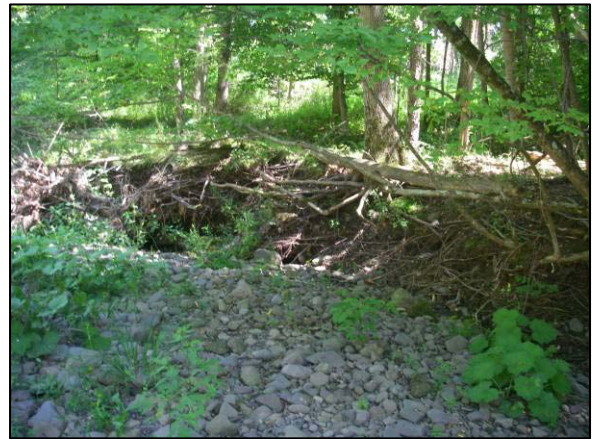
Continuing downstream, there was a channel divergence (Station 2056) along the right streambank where an additional secondary channel split off from the main channel and flowed behind a side bar for approximately 165 feet. At the time of the assessment flow was subsurface. The convergence of this channel appeared to contribute to hydraulic erosion (Stations 1961-1891) along the right bank. This erosion exposed roots and compromised trees of a young forest. At Station 1890 a tributary entered from the right bank which also appeared to contribute to downstream erosion.

Erosion at Stations 1961-1891

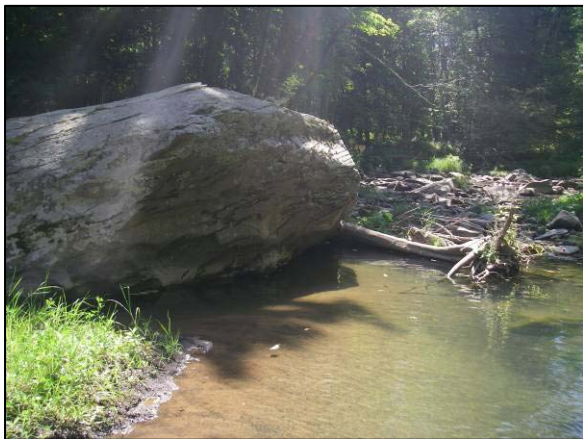
Woody debris obstructions continued further downstream at Stations 1847 and 1787 where trees had fallen into the stream and contributed to localized scouring and deposition. At Station 1812 a large boulder in the center of the stream caused additional woody debris to

Boulder at Station 1812

accumulate; the boulder appeared to contribute to upstream and downstream aggradation as well as localized scouring of the bed along its sides. Just downstream of the boulder, a center bar extended from Station 1812 into Management Unit 10, Station 1714. This center bar was composed of cobble and gravel with some herbaceous vegetation. Management Unit 9 ended at Station 1775.

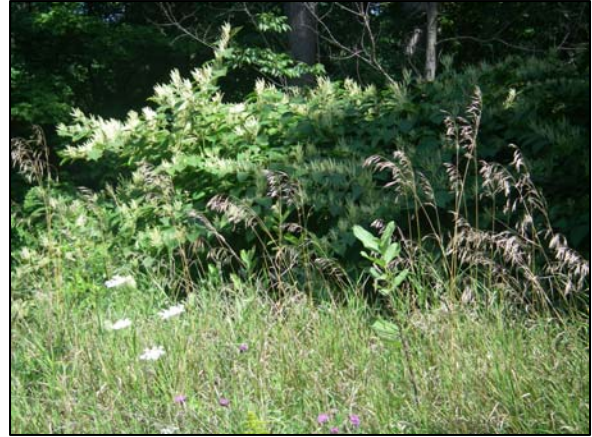
Knotweed at Station 3074

structure to hold the soil of streambanks. The results can include rapid streambank erosion and increased surface runoff leading to a loss of valuable topsoil. Japanese knotweed locations were documented as part of the stream feature inventory conducted during the summer of 2008 (Riparian Vegetation Mapping, Section 2.7). In total, three Japanese knotweed occurrences, covering an estimated length of 55 feet, were documented during the stream feature inventory. The best means for controlling knotweed is prevention of its spread, therefore, effort should be made to ensure that all fill brought into the area is clean and does not have fragments of knotweed or other invasive plants. If Japanese knotweed sprouts or small stands are observed, they should be eradicated immediately to avoid further spread within this unit and downstream management units.
