Manor Kill Management Unit 10

Town of Conesville –Station 1775 to Station 0

This management unit begins at Station 1775, continuing approximately 1,775 ft to Station 0, at Manor Kill’s confluence with the Schoharie Reservoir, in the Town of Conesville.

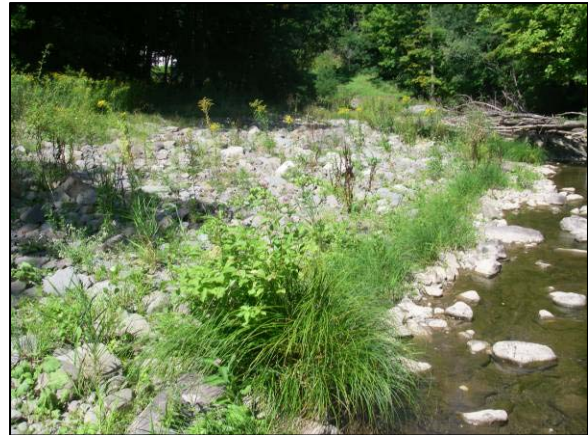
As the stream meandered to the left, a point bar had formed along the left streambank (Station 1758). Point bars commonly form on the inside of meander bends, where stream velocity is slower during high flows, allowing sediment to drop out of the water column and settle along the stream bed. This point bar extended approximately 174 feet and was mainly comprised of cobble and gravel and some vegetation.

Point Bar at Station 1758

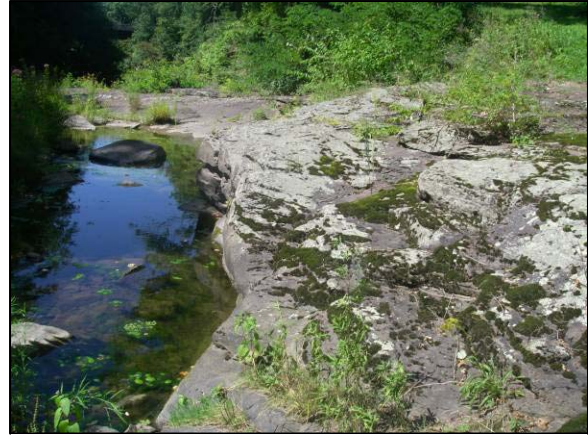
Continuing downstream, the slope of the streambed began to steepen. The stream channel became confined as bedrock lined the banks and bed of the channel (Figure 4.10.1, Inset D, Stations 1437-0). The stream approached a series of breaks in the elevation of the bedrock resulting in a multi-tiered waterfall; steep vertical banks were on both sides of the stream, with a mature forest along the top of the left bank and a mixture of forest and buildings along the right. The bedrock provides lateral control by limiting stream bank erosion; it provides grade control for the channel by preventing degradation or downcutting of the stream, the process by which streambeds and floodplains are lowered in elevation by eroding downward into the stream bed over time. This bedrock began at Station 1437 and continued beyond Manor Kill's confluence with the Schoharie Reservoir.

Bedrock Beginning at Station 1437

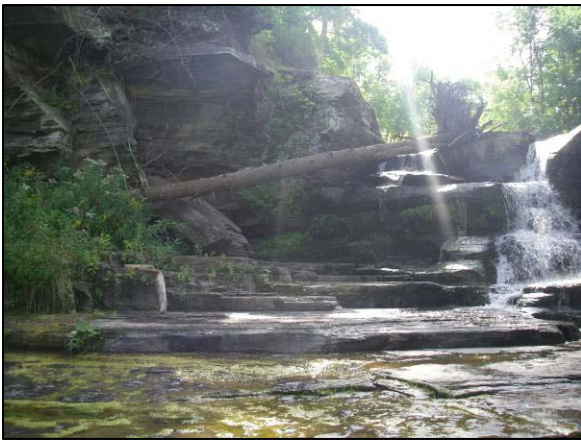
Tree at Station 1248

and woody debris that had been deposited along the left streambank (Station 1328). The remains of an old stacked rock foundation was also observed along the left bank at Station 1305. Along the right bank there was an additional woody debris obstruction. A large tree with its root wad extended from the top of the waterfalls to the lower tier.

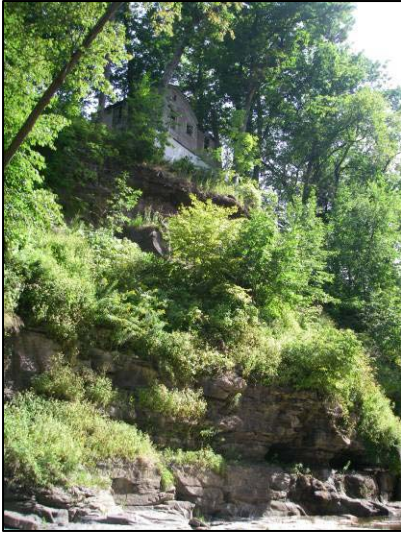
Waterfall House at Station 1100

Along the right bank there was old stacked rock along the bedrock which may have been part of a foundation or a staircase the led toward The Waterfall House at the top of the bank. The Waterfall House, which is currently a bar and restaruant, has been a landmark in West Conesville for over 50 years.

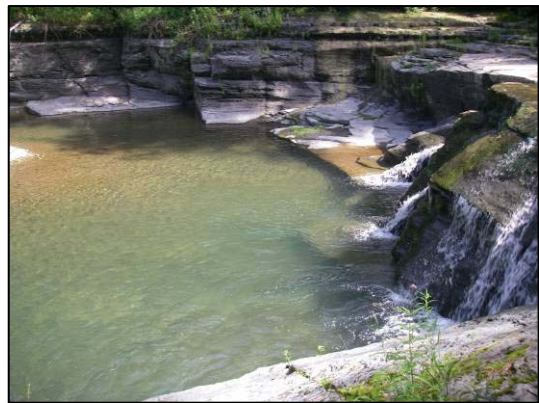
At Station 1154 the stream flowed over a second tier dropping approximately 10 feet into a large, deep pool.

Pool at Station 1154

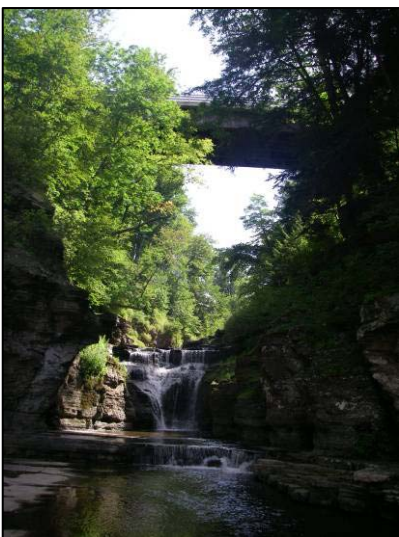
Waterfall & Bridge at Station 800

Continuing downstream, the stream flowed over a fourth tier; cascading over a series of rock steps and dropping approximately 43 feet into a large, deep pool.

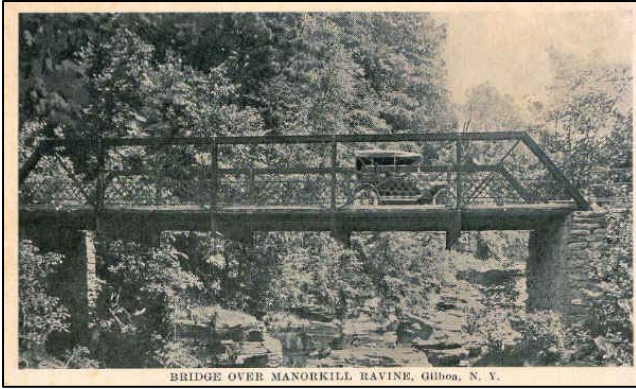
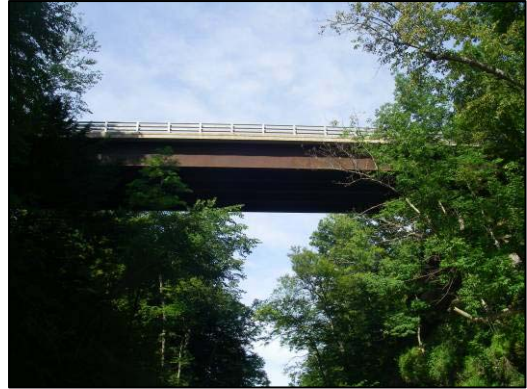
County Route 39/Prattsville Road Bridge (ID 00000002264080) spanned approximately 160 feet across the Manor Kill at Station 800. This bridge, originally built in 1930, was replaced by NYCDEP in 2003. It appeared to be in good functional and structural condition; the abutments

*Postcard of Original Bridge (ca .1930) & Picture of Current Bridge (2008)
Postcard Photo Credit: The Catskill Vintage Views*

showed no signs of scour and the bridge appeared to pass stream flows effectively. Under the bridge, a seep entered the stream over vegetated bedrock along the left bank. Management Unit 10 ended as the stream exited the pool downstream of the fourth tier and flowed into the Schoharie Reservoir. (Figure 4.10.1, Inset A, Station 0). The Schoharie Reservoir contributes approximately 15% of NYC water annually (Joint Venture, 2004).

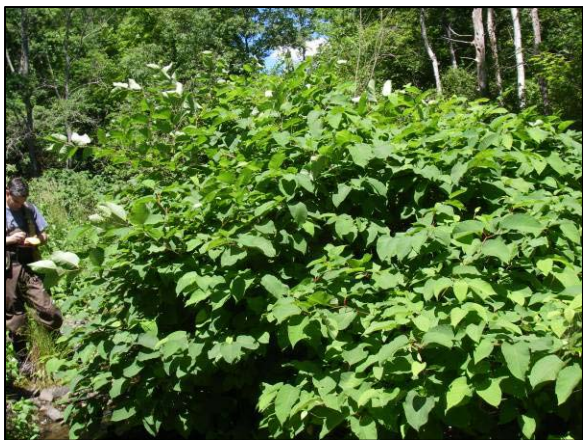
Japanese knotweed at Station 42469

years. Knotweed shades out other species with its dense canopy structure (many large, overlapping leaves), but stands are sparse at ground level, with much bare space between narrow stems, and without adequate root structure to hold the soil of streambanks. The result can include rapid streambank erosion and increased surface runoff leading to a loss of valuable topsoil. Japanese knotweed locations were documented as part of the stream feature inventory conducted during the summer of 2008 (Riparian Vegetation Mapping, Section 2.7). There were no Japanese knotweed occurrences documented during the stream feature inventory. The best means for controlling knotweed is prevention of its spread, therefore, efforts should be taken to ensure that all fill brought into the area is clean and does not have fragments of knotweed or other invasive plants. If Japanese knotweed sprouts or small stands are observed, they should be eradicated immediately to avoid further spread within this unit.
