Manor Kill Management Unit 1

Town of Conesville – Station 53,637 to Manor Creek Road (Station 45,598)

Manor Kill Management Unit 1 Stream Feature Inventory

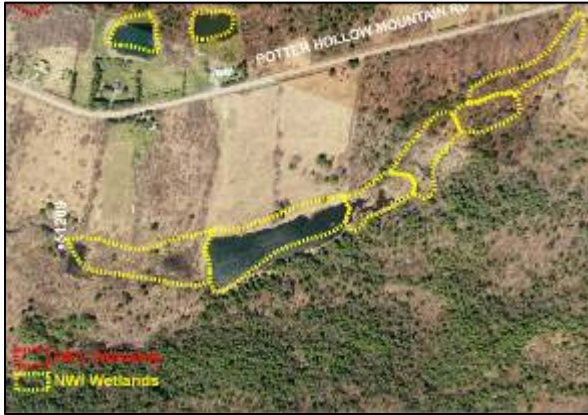
*Wetland complex in headwaters of Manor Kill
Approximate wetland boundaries delineated by NWI*

At the beginning of this management unit, there was a large open water wetland with a beaver dam, which was part of a federally designated wetland complex (near Station 53000) comprised of five wetland types, totaling approximately 10 acres. The wetland types include PEM1E, *palustrine, emergent, persistent, seasonally flooded/saturated*, PUBHh, *palustrine, unconsolidated bottom, permanently flooded, diked/impounded*, PSS1Eh, *palustrine, scrub-shrub, broad-leaved deciduous, seasonally flooded/saturated, diked/impounded*, PSS1E, *palustrine, scrub-shrub, broad-leaved deciduous, seasonally flooded/saturated*, and PSS1Eb, *palustrine, scrub-shrub, broad-leaved deciduous, seasonally flooded/saturated, beaver*.

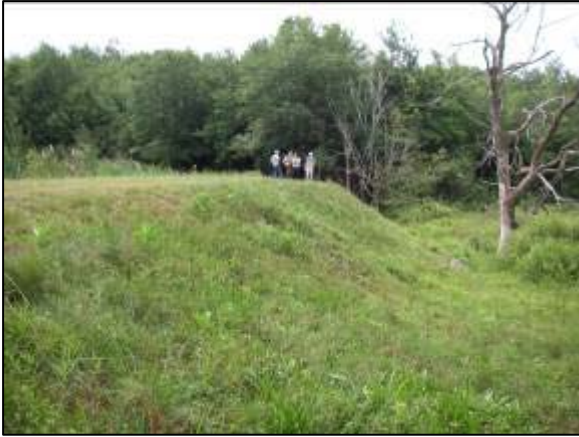
Private dam, Station 52058)

Continuing downstream, there was a private earth dam (NY00832, Station 52058) that was completed in 1977 to form a recreational pond (Figure 4.1.1, Inset D, looking downstream, Station 52800-52071). It measures 15 feet high and approximately 230 feet in

length. The drainage area of the dam is 0.05 mi². The maximum storage space in the reservoir is 64 acre-feet and the maximum discharge that the dam was designed for is 62 cu ft/sec. According to the National Inventory of Dams, the downstream hazard potential is considered low, which is defined by the ACOEs as a dam “where failure or misoperation results in no probable loss of

human life and low economic and/or environmental losses. Losses are principally limited to the owner’s property.” Bedrock lined much of the left bank of the pond while the right bank was mowed to the edge. The bedrock provides lateral control along the left by limiting bank erosion. The right bank should be planted with trees and shrubs to increase bank stability and habitat. There was a dam spillway along the right bank lined with large rock and maintained herbaceous vegetation. Downstream of the dam, there was a wetland complex with herbaceous and shrubby vegetation and areas of open water with a beaver dam (Station 51344) at the downstream end.

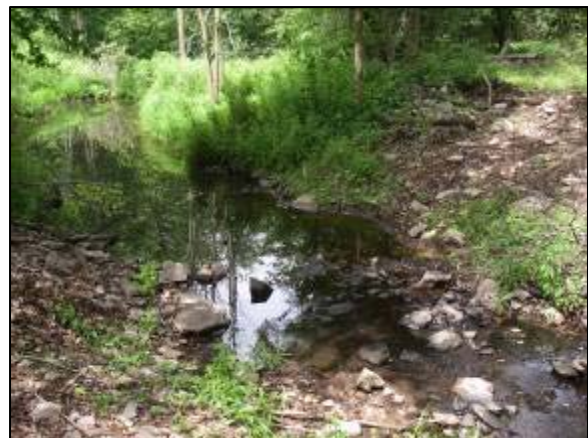
Channel Crossing at Station 51040

The rock wall provided lateral control and was further stabilized by herbaceous vegetation and vines that had grown through and along the stacked rock. Just downstream of the rock wall there was a stream channel crossing (Station 51040) that appeared to be maintained for recreational purposes.

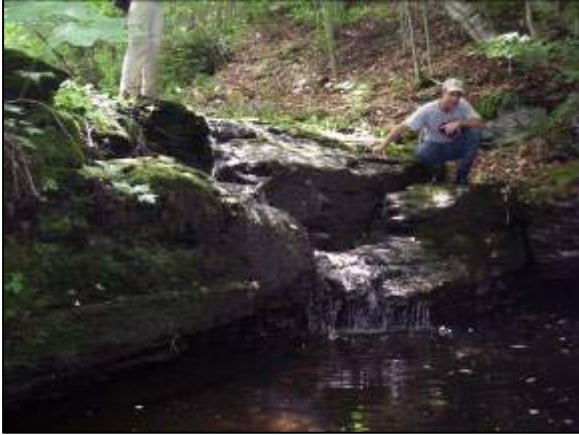
Bedrock Stations 50763 - 50553

As the stream meandered to the right, there was bedrock (Station 50763) along the left stream bank and bed, gradually covering the full bed of the stream channel, for approximately 210 feet. The bedrock provides lateral control along the upstream portion of the bedrock by limiting stream bank erosion; and it

provides grade control for the channel by preventing *degradation* or *downcutting* of the stream. This is the process by which streambeds and floodplains are lowered in elevation by eroding downward into the stream bed over time. The bedrock channel had multiple drops in elevation with a small waterfall entering a significant pool. At the time of the assessment, multiple trout were

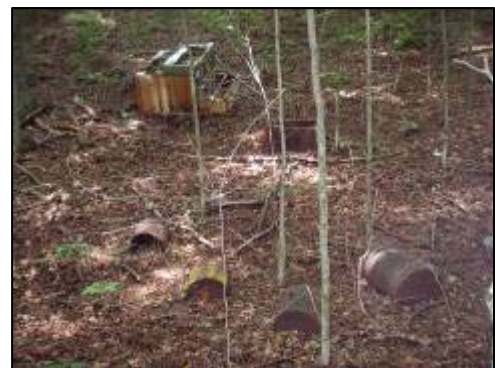
Dump site at Station 49722

during high flows. The second dump site (Station 49722) was located in the *floodplain* along the right bank and contained old farm equipment, refrigerators, metal scraps and some glass. The dump did not appear to be actively used or to pose an immediate hazard. During higher flows some of the material at the dump site may be mobilized and brought further downstream. It is recommended that both dump sites be removed to eliminate the potential safety and pollution hazards associated with the dumped material.

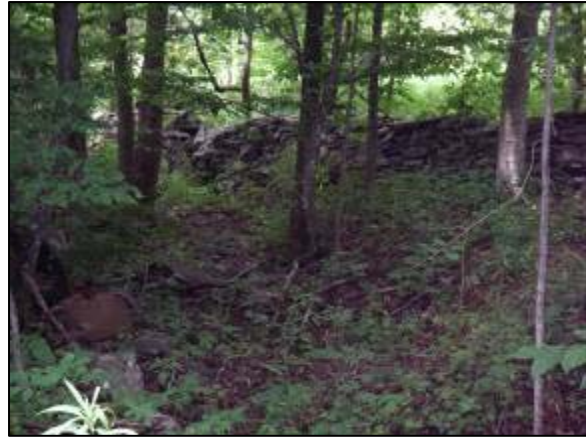
Rock Wall, Stations 49481 - 49381

Further downstream, set back from the right stream bank, there was a stacked rock wall for approximately 100 feet (Stations 49481 – 49381). The wall appeared to be in good structural and functional condition. There was also a short section of bedrock (Station 49385) providing grade control in the bed of the stream and lateral control along the left bank for approximately five feet.

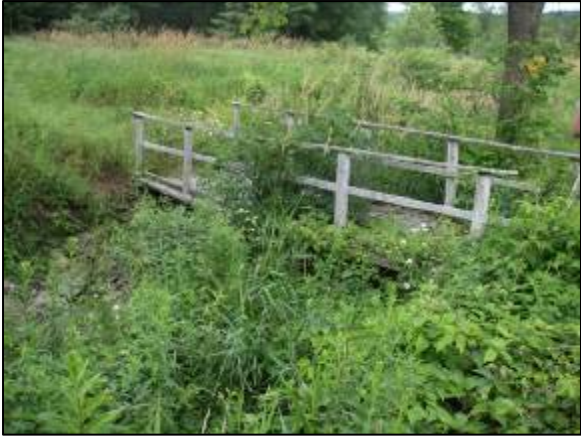
Bridge at Station 48807

As the stream gently meandered to the right, there was an old wooden foot bridge (Station 48807) in poor structural and functional condition. Starting approximately 400-500 feet upstream of the bridge, flow was subsurface at the time of the assessment. The bridge opening did appear to provide an adequate span for very low flows; however, the bridge may pose an obstruction during

higher flows. The bridge appeared to contribute to minor erosion just upstream.

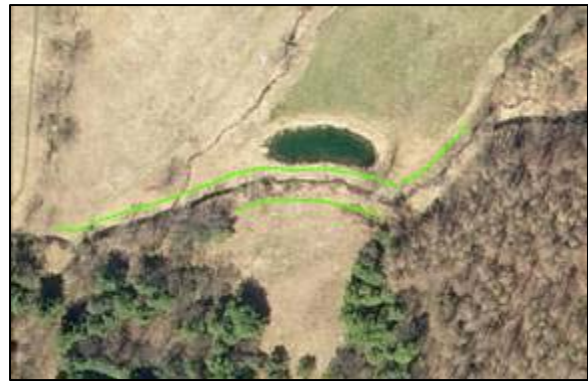
Planting sites near Station 48700

Along both sides of the stream, there were proposed planting sites. Land use changed from forested to maintained herbaceous vegetation. Recommendations for this site include

planting native trees and shrubs along the streambank and the upland area (Station 48700). Buffer width should be increased by the greatest amount agreeable to the landowners. Increasing the buffer width to at least 100 feet will increase the buffer functionality. A vigorous buffer with mature trees is important at these sites because it may also filter nutrients and pollutants, if any,

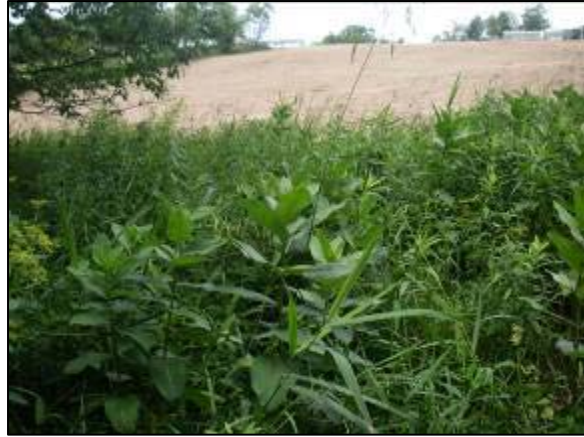
Planting site, Stations 48413 - 48140

Continuing downstream, there was a proposed planting site (Stations 48413 – 48140) along the right streambank. This site was an active hayfield with a narrow area of unmowed herbaceous vegetation between the hayfield and the stream's edge. This narrow buffer had some shrubs and few trees. As with the previous planting sites, recommendations include planting native trees and shrubs along the streambank and the upland area. Buffer width should be increased by the greatest amount agreeable to the landowners. Enhancing the quality of the buffer with woody vegetation and increasing the overall buffer width will help to protect water quality through this reach by slowing stormwater runoff and filtering pollutants associated with nearby land use. This site may be eligible for the USDA's Conservation Reserve Enhancement Program.

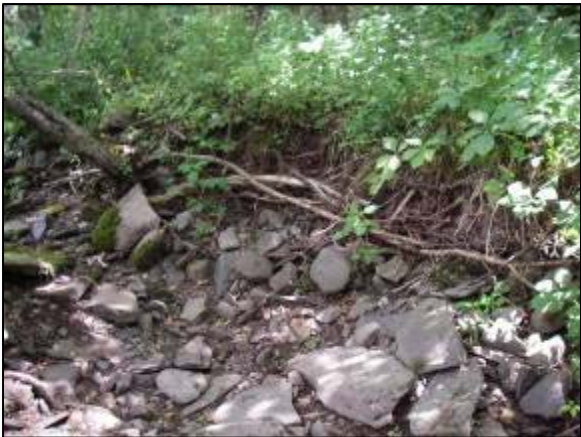
Eroding bank, Stations 48259 -48181

Opposite the planting site, there was minor erosion (Stations 48259 – 48181) along approximately 78 feet of the left streambank. The face of the bank had some exposed roots, with herbaceous vegetation, shrubs and trees at the top of the bank. The area was well vegetated with a forested floodplain.

Maintaining the forested cover along this bank is important, and may help the bank to recover naturally over time.

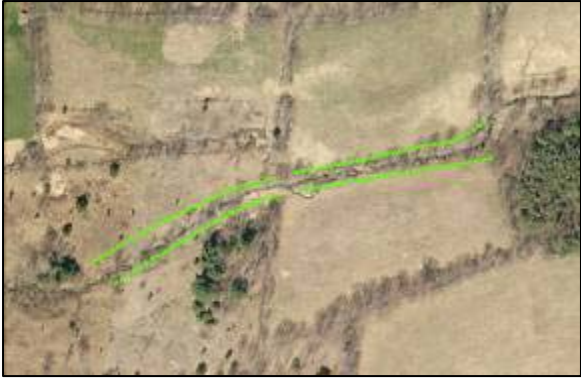
Proposed Planting Sites, Stations 48082 - 47347

As the stream meandered to the left, there was a stacked rock wall (Station 48082) that started along the right streambank and extended perpendicularly into the adjacent fields along a hedgerow. The rock wall was in good structural and functional condition. Just downstream of the rock wall, there were four additional proposed planting sites along approximately 735 feet of stream channel (between Stations 48082 and 47347). Each of

the planting sites had a narrow buffer of shrubs and trees. Along the right bank, the first planting site was a mowed field that did not appear to be in agricultural production. There was a stacked rock wall (Stations 47780 – 47685) in good structural and functional condition along the downstream portion of the first planting site. The other planting sites, one on the right bank and two on the left bank, were successional old fields that may be periodically mowed to maintain the open field. Through this stretch of stream, recommendations include augmentation and widening of the existing buffers by 100 feet or more through the planting of additional native trees and shrubs along the streambank and the upland area on both the right and left banks. Along the downstream planting sites, there was a private wooden bridge (Station 47585) that was in poor structural and functional condition. At the time of the assessment, flow continued to be subsurface. This bridge did not appear to be an adequate height or width for most levels of stream flow. If this bridge is replaced in the future, it is recommended that it be constructed with the appropriate bridge width that will provide the capacity to convey flood flows through the opening. Downstream of the bridge flow became surface at the time of the assessment.

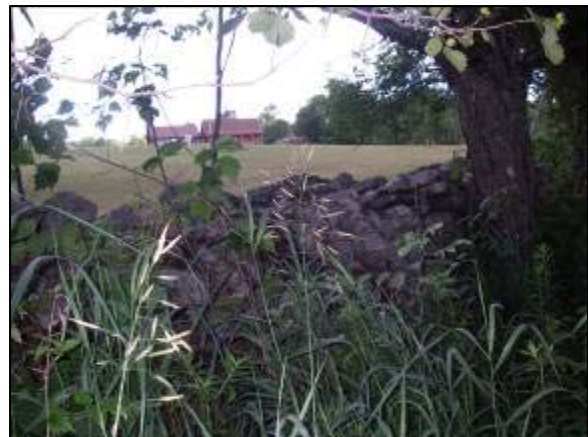
Berm at Stations 46900 - 46760

46987) with the main channel approximately 152 feet downstream. Continuing downstream, there was a stone berm (Stations 46900 – 46760) along approximately 140 feet of the right streambank. There was a thin line of trees between the berm and the stream's edge; beyond the berm there was a large mowed lawn. Berms tend to raise flood elevations and increase the erosive power of the stream.

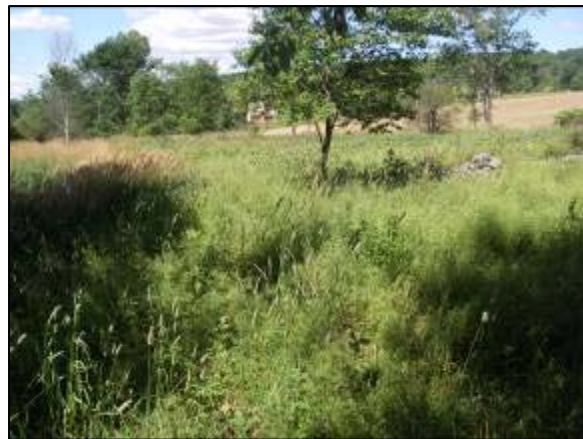
Planting Site, Stations 46719 -46540

Both the left and right streambanks were experiencing minor erosion (Stations 46719 – 46540) for approximately 179 feet downstream of the bridge. There was also a proposed planting site (Stations 46719 – 46540) along the right bank. Increasing the buffer width to at least 100 feet will help to stabilize the stream bank and protect water quality. Recommendations for this site include planting native trees and shrubs along the streambank and the upland area. A tributary (Station 46454) entered along the right streambank. This tributary was classified C by the NYS DEC, indicating that the best uses for this stream are supporting fisheries and other recreational activities. Also along this stretch of stream multiple small channels were observed; the braided channel converged with the main channel (Station 46468) downstream of the planting sites.

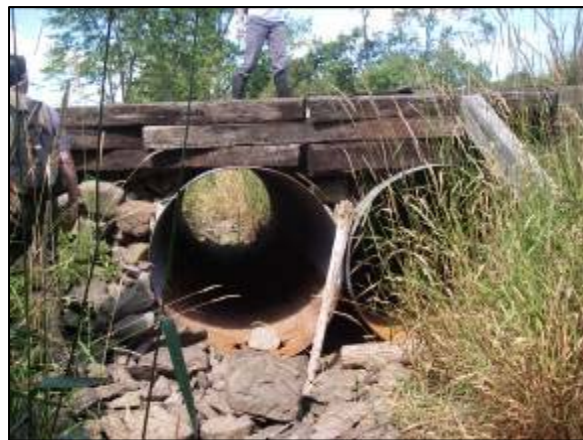
Bridge and Culverts at Station 46395

Further downstream, a private road crossed the Manor Kill. At this road crossing, there was a bridge with two metal culverts (Station 46395) that convey flow

under the bridge. The bridge and culverts appeared to be in fair structural and functional condition. Sediment deposition and accumulation of woody debris upstream of the bridge was noted. Deposits such as these are commonly caused by inadequate sizing of the bridge opening. An undersized bridge opening causes water to back up upstream of the bridge, reducing stream velocity, which results in sediment deposition. While low flows may flow freely through this bridge, higher flows may backwater, resulting in the upstream aggradation and woody debris accumulation. If this bridge is replaced in the future, it is recommended that a hydraulic analysis be conducted in order to determine the appropriate bridge width that will provide the capacity to convey flood flows through the opening.

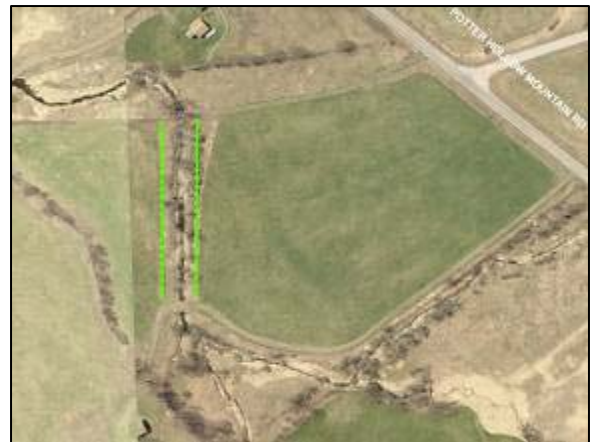
Planting Sites, Stations 46452 - 46035

Continuing downstream, there was a proposed planting site along both the right and left streambanks (between Stations 46452 and 46035). Each site has a narrow buffer, with trees and shrubs along the right, and herbaceous and shrubby vegetation along the left bank; beyond the narrow buffers are hay fields. For each of these proposed planting sites, recommendations include augmentation and widening of existing buffer with the planting of additional native trees and shrubs along the streambank and the upland area. Buffer width should be increased by the greatest amount agreeable to the landowners.

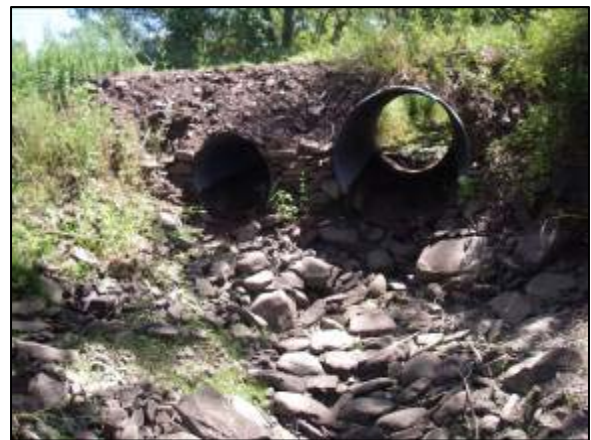
Downstream, there was a channel divergence followed by a bridge with two culverts (Station 46033) for conveying stream flow. The bridge was in fair structural and functional condition. On the upstream side of the bridge, there were stacked rock abutments and stacked rock between the culverts. The larger culvert conveys flow from the main channel, while the smaller culvert conveys flow

*Bridge and Culverts at Station 46033
Photo looking upstream*

from a secondary channel. The two channels converged at the downstream end of the culverts. The culverts appeared to be in good structural and functional condition. While low flows may flow freely through this bridge, higher flows may be constricted, potentially contributing to backwater and excess sediment deposition. If this bridge is replaced in the future, it is recommended that it be constructed with the appropriate bridge width that will provide the capacity to convey flood flows through the opening.

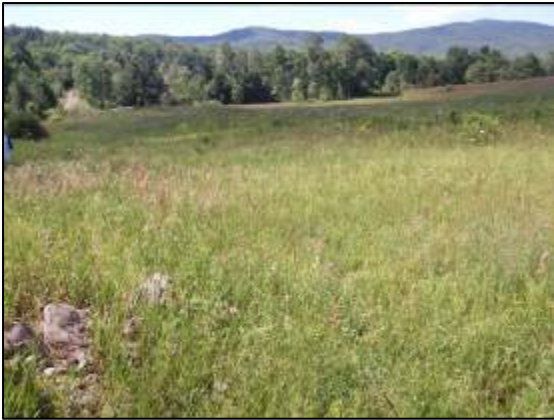
Planting Site, Right Bank, Station 46375

Downstream of the bridge, there were additional proposed planting sites on both the left and right streambanks. Both sides of the stream had herbaceous vegetation to the edge of the stream; primarily old field with some maintained herbaceous vegetation beyond the old field along the left bank. As with previous planting sites, recommendations include planting native trees and shrubs along the

streambank and the upland area to provide a buffer at least 100 feet wide, or the greatest width agreeable to the landowners.

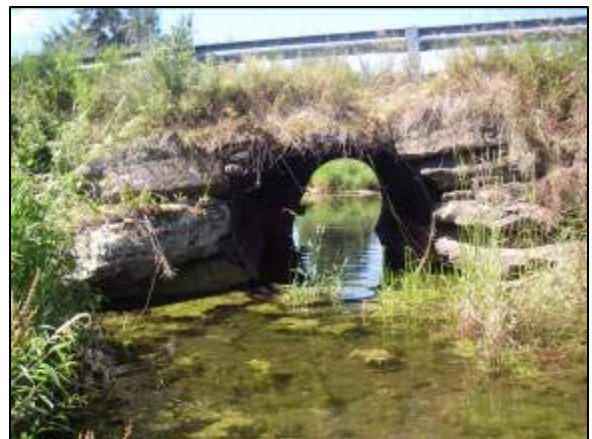
Culvert and Bridge at Station 45598

Management Unit 1 ended at the Manor Creek Road bridge (Station 45598). One large culvert conveyed flow under the private bridge; it was supported by boulder sized stack rock abutments. There was water ponding upstream and downstream of the bridge at the time of the assessment, with no flow beyond the downstream pond. The pond downstream of the bridge appeared to have been dredged and maintained. While most flows may flow freely through this bridge, flood flows may be constricted, potentially contributing to backwater. If this bridge is replaced in the future, it is recommended that it be constructed with the appropriate bridge width that will provide the capacity to convey flood flows through the opening.
