Manor Kill Management Unit 2

Town of Conesville – Manor Creek Rd. (Station 45598) to Beaver Hill Rd. (Station 38909)

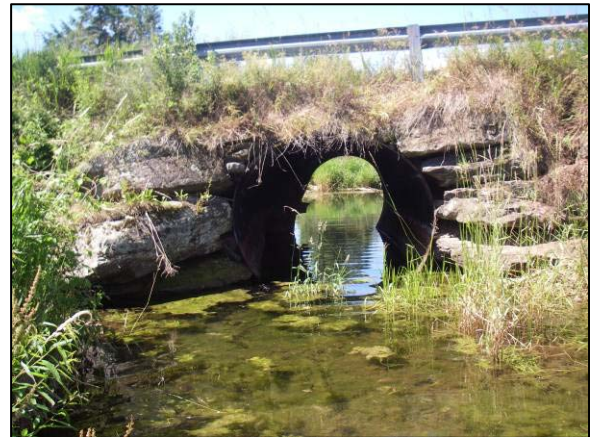
Culvert and Bridge at Station 45598

This management unit began at the Manor Creek Road bridge (Station 45598). One large culvert conveyed flow under the private bridge; it was supported by boulder sized stacked rock abutments. There was water ponding upstream and downstream of the bridge at the time of the assessment, with no flow beyond the downstream pond. The pond downstream of the bridge appeared to have been dredged and maintained. While most flows may pass freely through this bridge, flood flows may be constricted, potentially contributing to backwater. If this bridge is replaced in the future, it is recommended that it be constructed with the appropriate bridge width that will provide the capacity to convey flood flows.

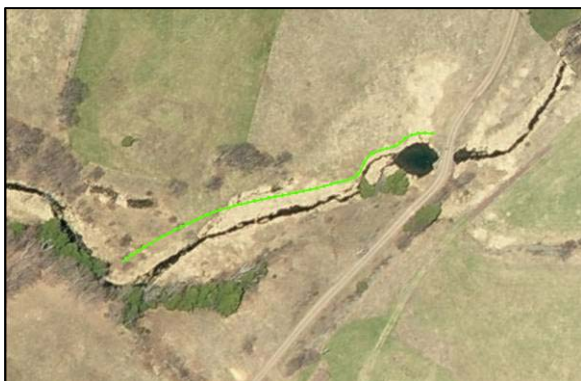
Riparian Planting Site at Stations 45580-45072

Also downstream of the bridge, there was a proposed riparian planting site (Stations 45580 - 45072) along approximately 510 feet of the right streambank. This site had herbaceous vegetation to the edge of the stream, and appears to be maintained as a hay field. At the time of the assessment, subsurface flow became surface flow along the upstream portion of this planting site. A vigorous buffer with mature trees is important

at this site because it may also filter nutrients from the adjacent fields. Nutrient inputs appear to be a threat to water quality along this stretch of stream as evidenced by the significant algal growth (Station 45348) within the stream channel. Recommendations for this site include planting native trees and shrubs along the streambank and the upland area. Buffer width should be increased by the greatest amount agreeable to the landowners. Increasing the buffer width to at least 100 feet will increase the buffer functionality and protect water quality through this reach by slowing stormwater runoff and filtering pollutants associated with nearby land uses. Along this planting site, a small unnamed intermittent tributary (Station 45217) entered along the right streambank providing drainage for the adjacent agricultural field.

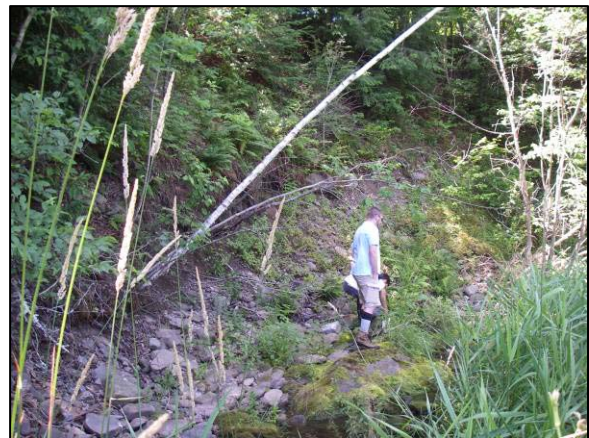
Erosion at Stations 45083 - 44941

As the stream meandered to the right, there was erosion (Stations 45083 - 44941) on the left bank. Streambank erosion often occurs on the outside of meander bends where the stream velocity is greatest during high flows. Along this section of stream, during high flows the toe of the bank is undermined, which has compromised the steep slope and resulted in an erosion area of approximately 3,525 ft². There are several mature trees that have been compromised or have fallen along this erosion site. At the top of the bank, there was an open field with a narrow wooded

buffer. Although this bank was a significant erosion site, it appeared to be slowly recovering, with herbaceous vegetation, including grasses and ferns, becoming established on the face of the bank. However, without deep-rooted shrub and tree species, it is likely that this bank will continue to erode during future high flows. This erosion site may be a good candidate for remediation using vegetative toe and bank protection. Prior to proceeding with any work, this site would require a more detailed site assessment.

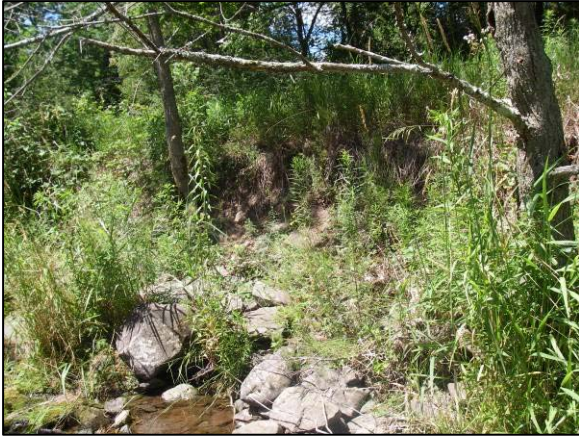
Erosion at Stations 44794 - 44741

As the stream meandered to the left, there was minor hydraulic erosion (Stations 44794 - 44741) along the right streambank. The streambank had a mixture of herbaceous and woody vegetation along the face of the bank, and a mature forested buffer at the top of the bank. This site may self-recover over time. Downstream of the eroding bank there was a center *bar*: a location within the stream channel in which sediment accumulates and occupies a significant portion of the channel. The center bar, with well-established herbaceous vegetation, stretched for approximately 25 feet within the stream channel.

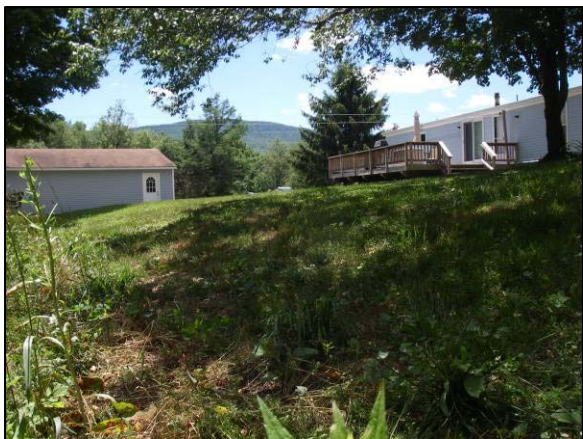
Riparian Planting Site at Stations 43623 - 43479

Continuing downstream, there was a proposed riparian planting site along the right streambank. Along the upstream portion of the planting site (Stations 43623 - 43479), there was minor erosion (Station 43586) for approximately 20 feet, where herbaceous vegetation is mowed to the edge of the stream. Along the downstream end of the site, there was a small

dam (Station 43539), constructed of cobble. The dam appeared to be maintained in order to create a shallow pool adjacent to the yard, and was contributing to upstream scour of the streambank. Recommendations for this site include discontinued mowing to the stream’s edge, planting native sedges along the toe of the bank, and planting native trees and shrubs along the streambank and the upland area. Buffer width should be increased by the

greatest amount agreeable to the landowners.

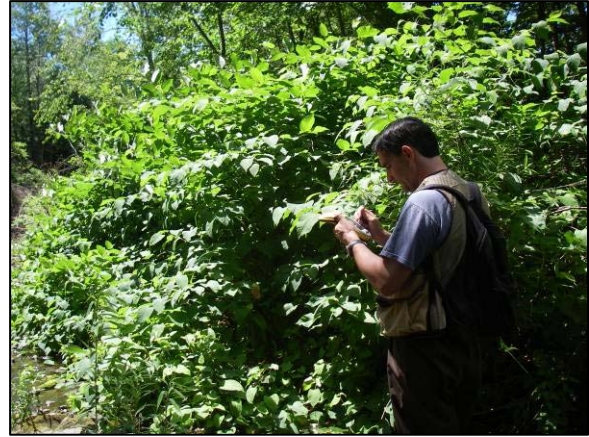
Japanese knotweed at Station 43195

Further downstream, the first occurrence of Japanese knotweed (Station 43291) on the Manor Kill was observed. Continuing downstream there were additional stands of Japanese knotweed along approximately 46 feet of the right stream bank (Stations 43195 - 43149) and approximately 76 feet of the left streambank (Stations 43112

- 43036). Japanese knotweed is an invasive non-native species which does not provide adequate erosion protection due to its very shallow rooting system; knotweed also grows rapidly and tends to crowd out more beneficial streamside vegetation. The best means for controlling knotweed is prevention of its spread. Therefore, effort should be made to ensure that existing stands are not fragmented via unnatural processes (i.e. mowing without removal of all mowed material) and transported into downstream areas. Small stands should be eradicated immediately to avoid further spread within this unit and downstream management units. There are removal methods that may be used for larger stands (Section 2.7), these methods should be used with caution and carefully executed to avoid further spread of Japanese knotweed.

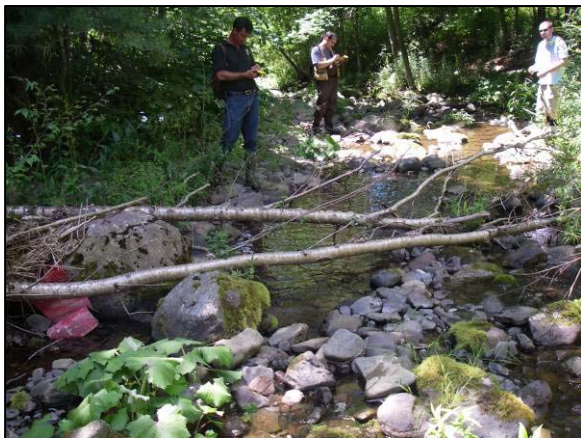
Woody Debris at Station 43016

Along this section of stream, the *thalweg* flows up against the toe of the bank undermining the steep slope, resulting in an erosion area of approximately 6,786 ft², exposing mixed till and compromising mature trees along the bank. Along the downstream portion of the mass failure, a young tree had fallen across the stream channel causing a minor obstruction (Station 43016) at low

flows. During higher flows, it likely poses a more significant obstruction contributing to backwater and upstream *aggradation*, or excess sediment deposition.

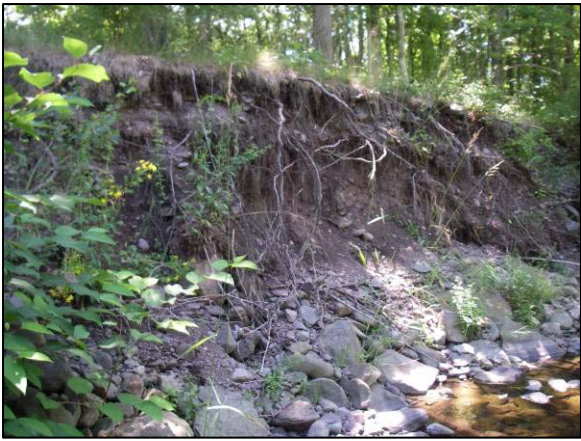
Erosion at Stations 42815 - 42692

Further downstream, there was erosion (Stations 42815 - 42692) along approximately 123 feet of the left streambank. Along the upstream portion of the erosion there was a successional old field along the top of the bank; continuing downstream the top of the bank was forested. The toe of the bank was undermined causing the top of the bank to slump over, exposing roots and compromising trees. Along the downstream portion of the erosion site there was a fallen tree across the channel, which was not causing an obstruction at low flow, but may pose a more significant obstruction during higher flows. There were multiple stands of knotweed along the left and right banks along this stretch of stream.

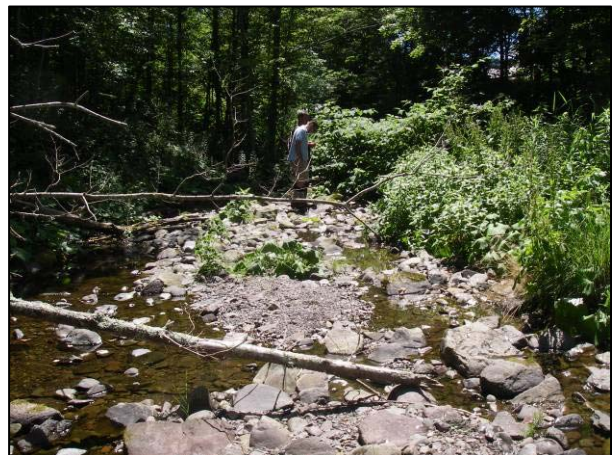
Center Bar at Stations 42347 - 42300

transported from other areas, and a center bar (Station 42347 to 42300) had formed within the stream channel. Just downstream of the center bar, an intermittent tributary (Station 42237) entered along the right bank. This tributary was classified C by the NYS DEC, indicating that the best uses for this stream are supporting fisheries and other non-contact activities. The tributary confluence with the Manor Kill was

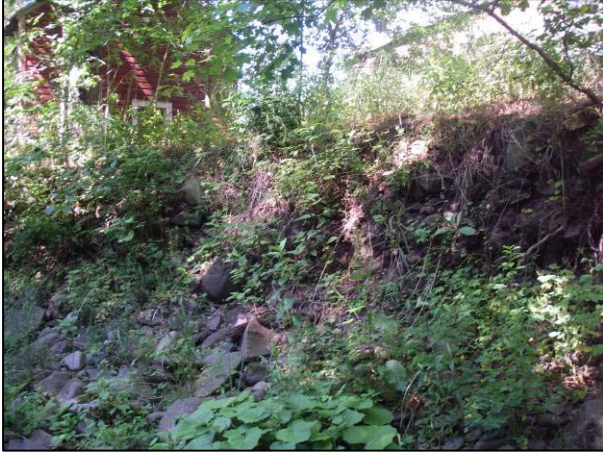
Erosion at Stations 42216 - 42164

relatively steep and appeared to contribute to downstream erosion (Stations 42216 - 42164) along approximately 52 feet of the right streambank. There was herbaceous vegetation on the face of the bank and a few young trees at the top of the bank, beyond which there was mown lawn and a barn. Although this site was not identified as a proposed planting site, recommendations for this site include the discontinuation of mowing to the stream's edge and planting native trees and shrubs along the upland area to augment the existing buffer. Prior to proceeding with any vegetative plantings, the condition of the eroding bank should be given careful consideration when identifying the appropriate species and locations for plantings.

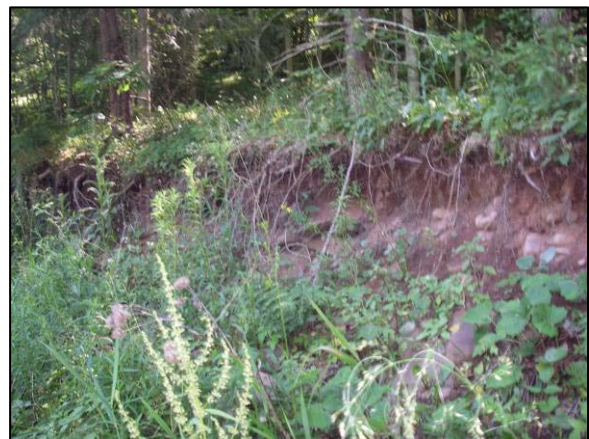
Erosion at Stations 41805 - 41651

Just downstream, there was more significant erosion (Station 41805 – 41651) of

the left streambank for approximately 154 feet. Along the upstream portion of the erosion site, the bank was undercut, roots were exposed and some young trees had fallen; it was forested at the top of the bank. There was herbaceous vegetation at the toe of the bank and some on the face of the bank. Japanese knotweed persisted through this stretch of stream, and there were aggradational conditions (center bar) within the stream channel.

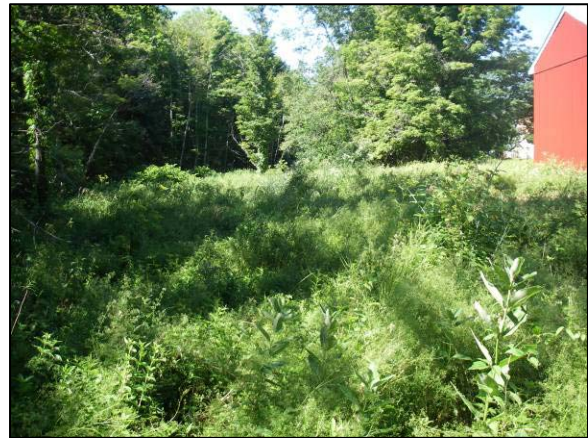
Riparian Planting Site at Stations 42094 - 41763

Opposite the erosion sites, there was a proposed riparian planting site (Stations 42094 - 41763); a successional old field with a thin line of trees providing a narrow buffer between the field and the stream's edge.

Recommendations for this site include augmentation of existing buffer with the planting of additional native trees and shrubs along the streambank and the upland area. Buffer width should be increased by the greatest amount agreeable to the landowners.

Increasing the buffer width to at least 100 feet will increase the buffer functionality and protect the stream from nearby land uses. Just downstream, along approximately 170 feet of the right streambank, there was an erosion site (Stations 41705 - 41534) with mowed lawn to the top of the bank; some areas had a thin line of trees and shrubs. There was also a small rock wall at the top of the bank for approximately seven feet.

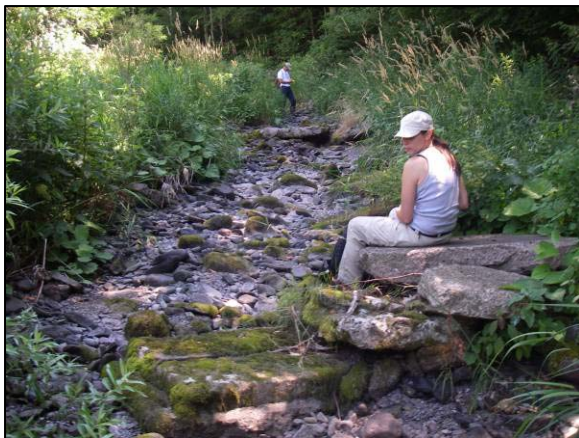
Concrete obstruction at Stations 41233 - 41178

was a dump site (Station 41291) with remnants of a concrete foundation and scrap metal. This dump site was relatively close to the stream's edge, and the stream may mobilize some of the metal material during high flows. It is recommended that the scrap metal and any additional hazardous material be removed from the dump site.

Along the left streambank, there were large concrete pieces dumped along the toe of the streambank, with herbaceous vegetation established throughout. Downstream of this revetment (Stations 41239 - 41184), concrete remnants had washed into the channel; these concrete blocks appeared to contribute to upstream aggradation causing stream flow to go subsurface. Water reappeared further downstream where the stream bed consisted primarily of natural material.

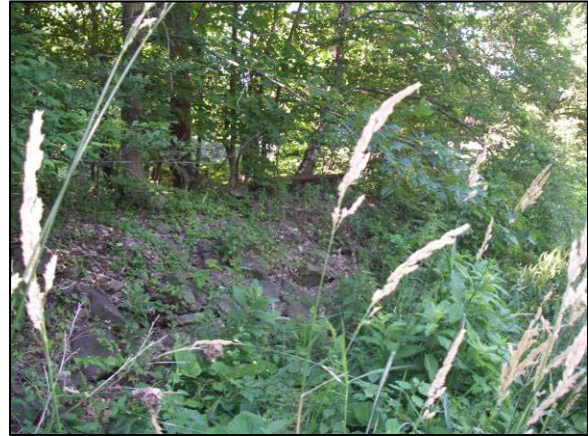
Berm at Stations 41184 - 41040

As the stream meandered to the right, there was a berm (Stations 41184 - 41040) along approximately 144 feet of the left streambank. Generally, it is recommended that berms be evaluated for their influence on floodplain connectivity and stream entrenchment. Removal should be considered where there is significant negative impact. This berm appears to be relatively old with trees and shrubs established along the length of the berm, therefore removal is not recommended.

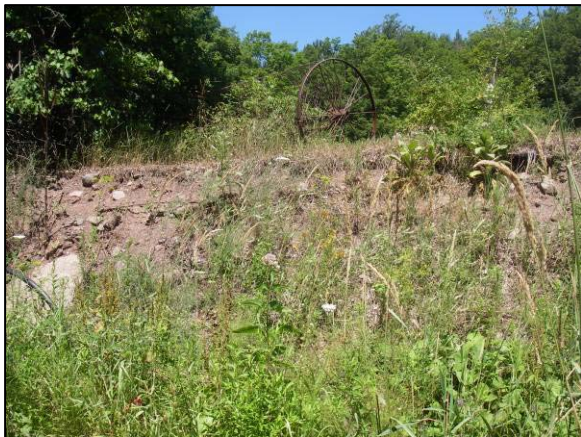
Erosion at Stations 40950 - 40787

Continuing downstream, there was erosion (Station 40950 to Station 40787) along approximately 163 feet of the right streambank. There was herbaceous vegetation along the eroding bank with a parking lot at the top of the streambank beyond a narrow herbaceous buffer. There was also a utility crossing (Station 40898) along the eroding bank.

Recommendations for this site include discontinued mowing to the top of the streambank and

planting of native trees and shrubs along the upland area to create a deep-rooted wooded buffer to filter runoff from the parking lot and provide increased stability to the streambank. Prior to proceeding with any vegetative plantings, the condition of the eroding bank should be given careful consideration when identifying the appropriate species and locations for plantings.

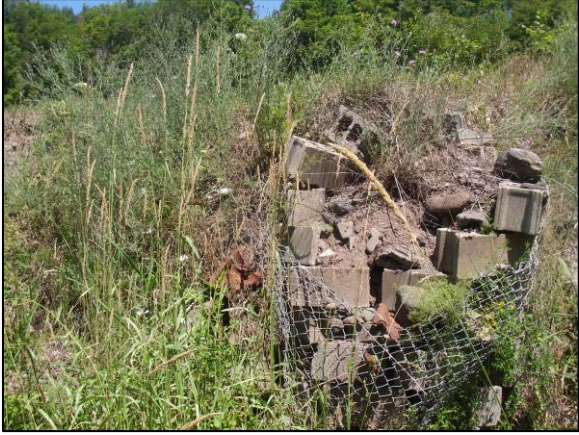
Dump Site at Station 40863

Along this eroding bank, concrete was dumped in the stream channel (Station 40861) and a mixture of concrete, metal and other debris was dumped along the streambank (Station 40863). The concrete within the stream channel posed an obstruction to flow and caused upstream aggradation.

Discontinuing to actively dump material along the bank and within the stream channel is

recommended. Recommendations also include removal of all hazardous material and any material along the streambank that may be mobilized during a flood.

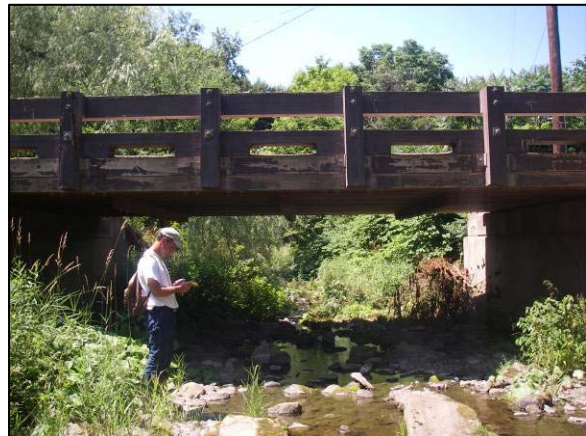
Bridge at Station 40631

Further downstream, there was a bridge (Station 40631), with excess sediment deposition upstream of the bridge. Aggradation such as this is commonly caused by inadequate sizing of the bridge opening. An undersized bridge opening causes water to back-up upstream of the bridge, reducing stream velocity, which results in sediment deposition. While bankfull flows may flow freely through this bridge, higher flows may backwater, resulting in the upstream aggradation. If this bridge is replaced in the future, it is recommended that a hydraulic analysis be conducted in order to determine the appropriate bridge width that will

provide the capacity to convey flood flows through the opening.

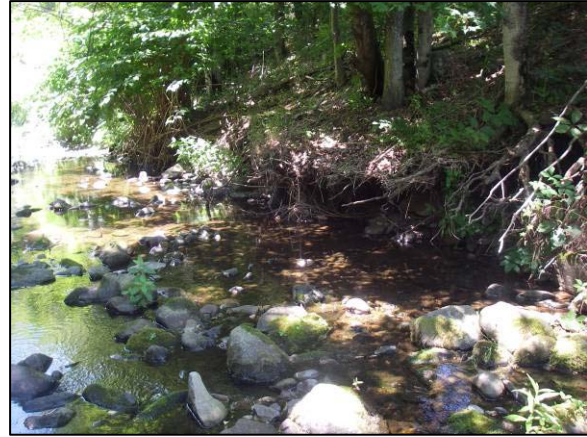
Erosion at Stations 40494 - 40454

Downstream of the bridge there was erosion (Stations 40494 - 40454) along the right streambank. Flow through here had caused undercut banks, exposing roots and compromising mature trees. Opposite this erosion site, there was minor erosion (Stations 40493 - 40388) along the left streambank.

Both of these streambanks had a narrow wooded buffer between the adjacent mown lawn and residential trailers.

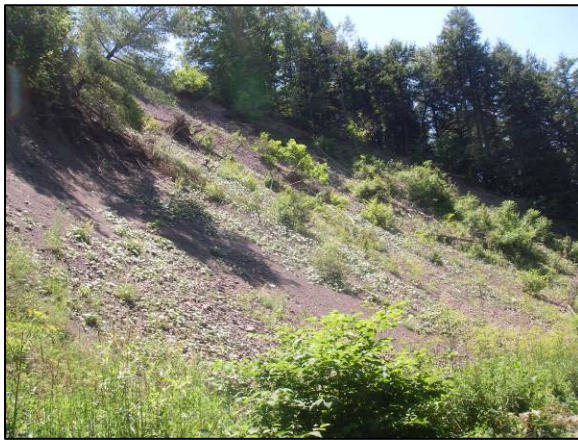
Mass Failure at Stations 40414 - 40265

As the stream meandered to the right, the minor hydraulic erosion on the left streambank was followed by a *mass failure* (Stations 40414 - 40265). Streambank erosion often occurs on the outside of meander bends where the stream velocity is greatest during high flows; along this section of stream, the thalweg flows up against the toe of the bank undermining the steep slope, resulting in an erosion area of approximately 7,431 ft², exposing

mixed till and compromising mature trees along the bank. At the top of the bank, there was a gravel mine. Along the upstream and downstream portions of the erosion site, there was a narrow wooded buffer between the gravel mine and the eroding bank; however, the majority of the eroding bank has no buffer or a thin line of trees. Continued mining activity may contribute to the streambank instability along this site.

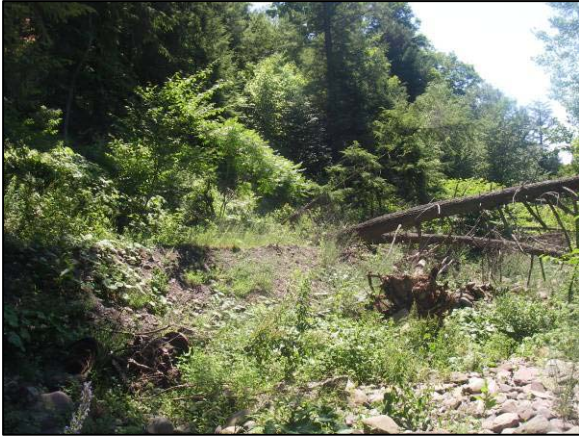
Erosion near Station 39900

Downstream of the mass failure, there was a channel *divergence* (Station 40207) where a secondary channel (Figure 4.2.1, Inset B) split off from the main channel; it converges (Station 39662) with the main channel approximately 545 feet downstream. There was Japanese knotweed along both banks of the secondary channel. Along the left streambank of the secondary channel, there was erosion (near Station 39900) that had

compromised mature trees causing them to fall across the channel. These trees would pose a significant obstruction during high flows. At the time of the assessment, there was subsurface flow along the upstream portion of the secondary channel; surface flow began at the woody debris obstruction. Flow in the main channel was also subsurface downstream of the mass failure. Along this erosion site, a low terrace with herbaceous and shrubby vegetation had formed, evidence that the bank may be starting to self-recover. However, above the terrace, the streambank continued to slump. There is a forested buffer, approximately 150 – 200 feet wide, between the gravel mine and the eroding streambank. Loss of this buffer and continued mining activity may contribute to further instabilities along this stretch of stream.

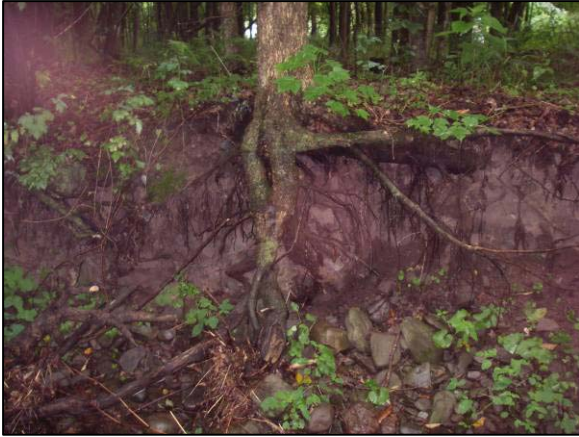
Erosion at Stations 39838 to 39801

Just downstream, there was another erosion site (Stations 39838 - 39801) along approximately 37 feet of the right streambank, exposing roots and compromising trees. It appeared as though the channel along this erosion site had been historically managed through dredging of the streambed material and deposition of the dredged material along

both sides of the stream channel. Japanese knotweed persisted along this stretch of the stream. Downstream of the eroding bank, flow returned to the channel at the time of the assessment.

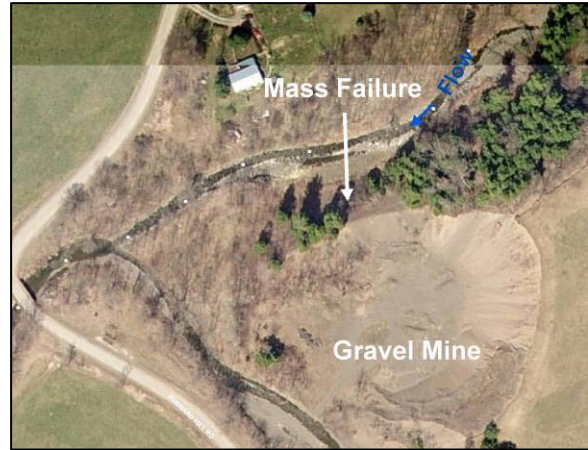
Mass Failure at Stations 39532 - 39316

Continuing downstream, there was a channel divergence (Station 39568) along the left, where a flood chute split off from the main channel. Flow was subsurface for much of the channel length; along the downstream portion of the flood chute flow returned to the surface. This secondary channel converged (Station 39395) with the main channel approximately 173 feet downstream from the channel divergence. At this location, the flood chute continued with a second divergence from the main channel that converged (Station 39174) approximately 221 feet downstream. Along the left bank of the secondary channel there was a mass failure (Figure 4.2.1, Inset A, Stations 39532 - 39316). This resulted in an erosion area of approximately 6,490 ft² that had compromised mature trees along the bank.

Although this bank was a significant erosion site, it appeared to be slowly recovering, with herbaceous vegetation, shrubs and young trees becoming established on the face of the bank. However, if this secondary channel became the main channel or carried significant flow during high flood events, it would further compromise the mass failure. The instability along this stretch of stream was also

influenced by the adjacent gravel mine. It is recommended that mining of gravel close to the stream's edge be discontinued, allowing a vegetated buffer to regenerate naturally. Opposite the mass failure and continuing downstream, the right streambank was experiencing hydraulic erosion in three locations totaling approximately 388 feet.

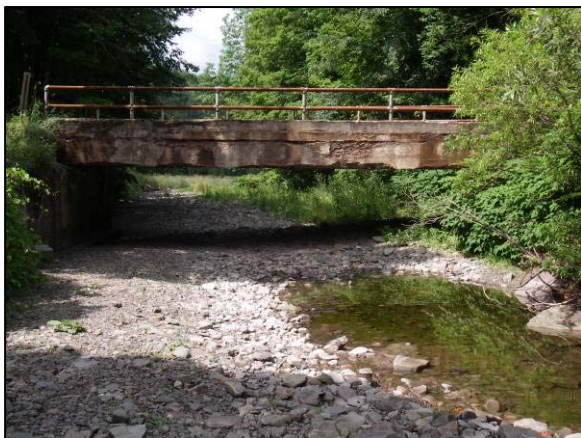
Bridge and Aggradation at Stations 38909 & 39020

Management Unit 2 ended at the Beaver Hill Road bridge (Station 38909). Downstream of the tributary and upstream of the bridge, full channel aggradation (Station 39020) was observed. While the bridge opening seemed to provide an adequate span for low flows, higher flows appear to backwater, reducing stream velocity, which results in upstream

aggradation. If this bridge is replaced in the future, it is recommended that it be constructed with the appropriate bridge width that will provide the capacity to convey flood flows through the opening. Hydraulic analysis should be conducted in order to determine the appropriate bridge width that will provide the capacity to convey water and sediment flow through the opening.
