Manor Kill Management Unit 3

Town of Conesville – Beaver Hill Rd. (Station 38909) to Station 26995

This management unit begins at Beaver Hill Road, continuing approximately 11,914 ft to Station 26995 in the Town of Conesville.

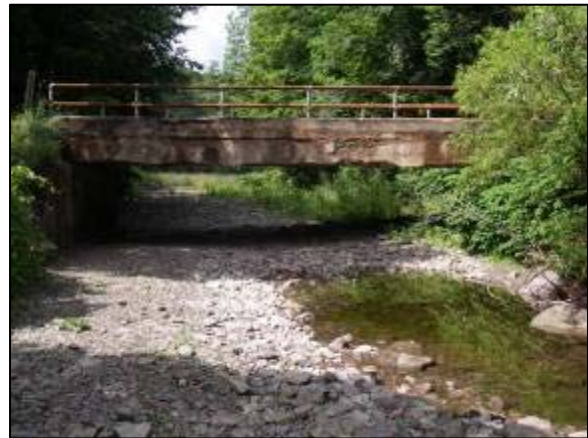
Management Unit 3 began at the Beaver Hill Road bridge (Station 38909). Upstream of the bridge, full channel aggradation (Station 39020) was observed. While the bridge opening seemed to provide an adequate span for low flows, higher flows appear to backwater, reducing stream velocity, resulting in upstream aggradation. If this bridge is replaced in the future, it is

Bridge and Aggradation at Stations 38909 & 39020

recommended that a hydraulic analysis be conducted in order to determine the appropriate bridge width capable of conveying the available water and sediment. At the time of the assessment flow was subsurface downstream of the bridge.

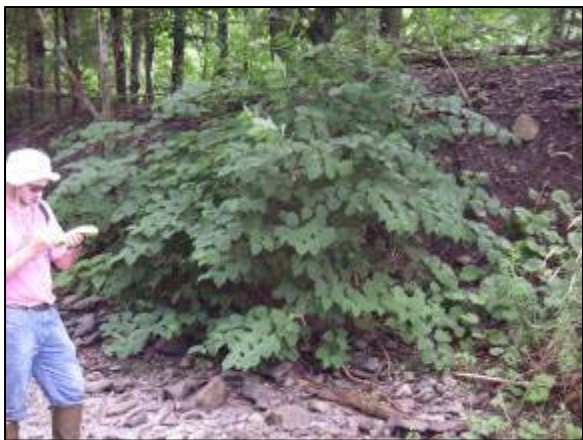
Just downstream of the bridge, there was a well-vegetated berm (Stations 38884 – 38677), with shrubs and young trees, along approximately 207 feet of the left streambank. Berms such as this, while created with the best of intentions, tend to raise flood elevations and increase the erosive power of the stream. It is recommended that berms be evaluated for

Japanese knotweed along Berm at Station 38796

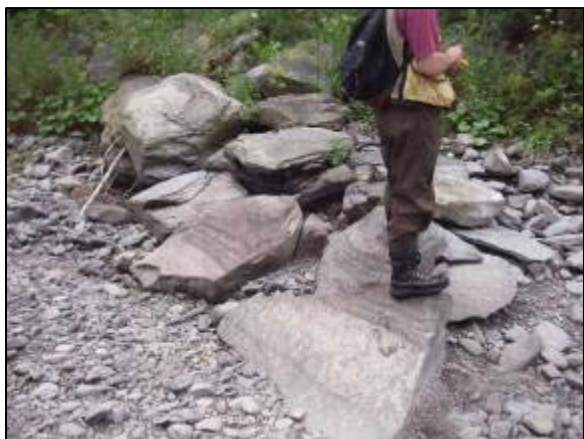
Rock vane at Station 38660

structure. However, this rock vane had failed structurally and was no longer functional.

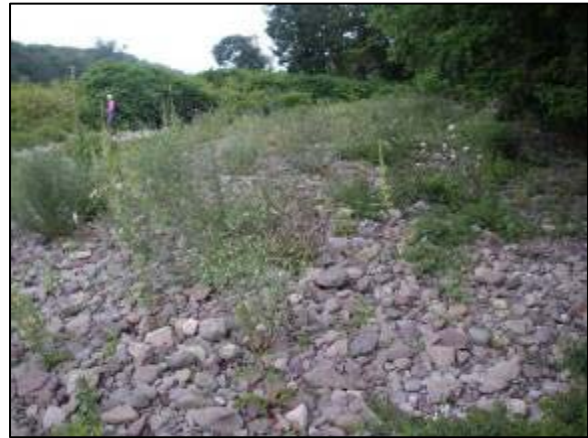
Through this section of stream, there was channel *aggradation*, the process by which streams are raised in elevation by the deposition of material eroded and transported from other areas. The main channel appeared to be along the left of a vegetated center bar (Stations 38564 – 38341).

Center Bar at Stations 38564 - 38341

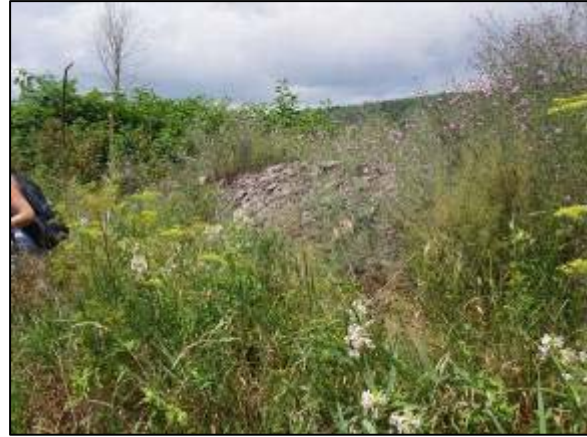
Berm at Stations 37622 -37536

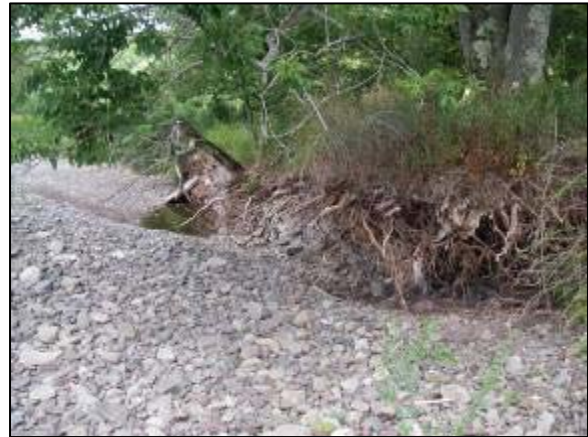
As the stream gently meandered to the left, there was erosion (Stations 36800 – 36580) along the right streambank and a proposed planting site for approximately 220 feet. With the exception of a thin wooded buffer along the upstream portion of the erosion site, there was herbaceous vegetation to the edge of the stream. The woody vegetation had been compromised along the undercut banks, with exposed roots and one tree that had fallen along the erosion site.

Erosion at Stations 36800 - 36580

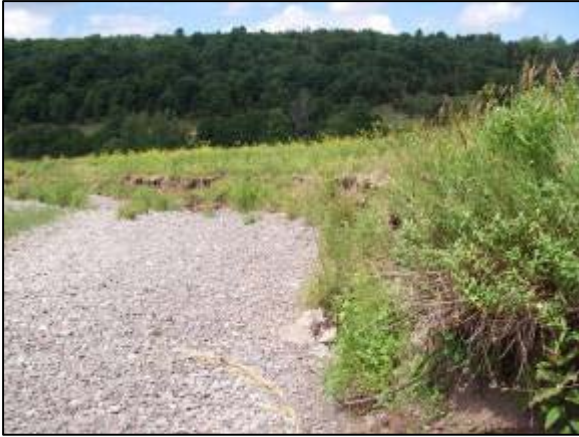
Erosion at Stations 36183 - 34909

mentioned planting sites, recommendations for these sites include establishing a buffer where none exists and augmentation of the existing buffered areas by planting native trees and shrubs along the streambank and the upland area. Buffer width should be increased to 100 feet or by the greatest amount agreeable to the landowners. Portions of both proposed planting sites are experiencing erosion in multiple locations along the streambank. Therefore, prior to proceeding with any vegetative plantings, these conditions should be given careful consideration, and additional assessment may be necessary.

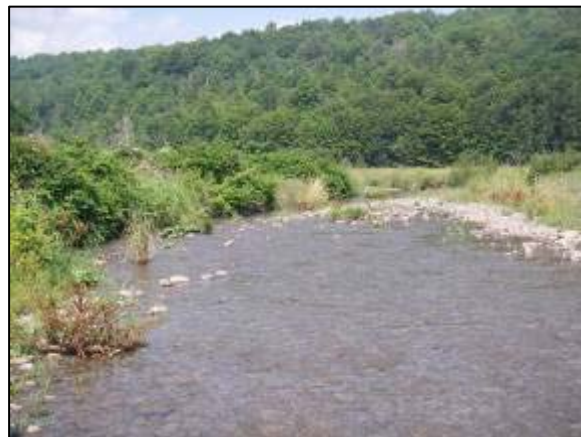
Continuing along the riverine wetland and proposed planting sites, there was erosion (Stations 35374 – 35173) along approximately 201 feet of the left streambank. Starting just upstream of the eroding bank there was a transverse bar (Stations 35415 – 35175) that directed flow at the toe of the left bank, contributing to the erosion at this site.

Transverse Bar at Stations 35415 - 35175

Japanese knotweed persisted along this stretch of stream. This erosion site may be a good candidate for remediation using vegetative toe and bank protection. In addition to the planting recommendations for the proposed riparian planting site, planting native sedge species along the toe of the bank is recommended to reinforce and help stabilize the streambank. As mentioned previously, additional site assessment may be necessary prior to proceeding with any work along this stretch of stream.

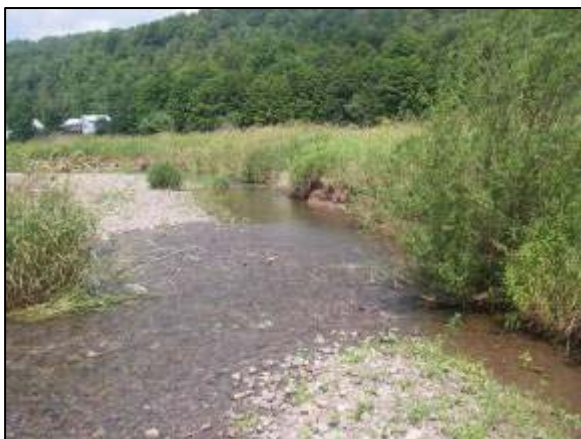
*Erosion at Stations 35202 – 34891
and Transverse Bar at Stations 35150 - 35125*

the toe of the right streambank, contributing to approximately 1,245 square feet of erosion (Stations 35202 – 34891) along 311 feet of the streambank. With only herbaceous vegetation to the edge, and without deep-rooted shrub and tree species, it is likely that this bank will continue to erode during future high flows. The hydraulic erosion had caused the first significant clay exposure (Station 35120) within this management unit; clay was

exposed along the streambank and channel bed for approximately 12 feet. Clay inputs into a stream are a serious water quality concern because they increase *turbidity*, degrade fish habitat, and can act as transport for other pollutants and pathogens.

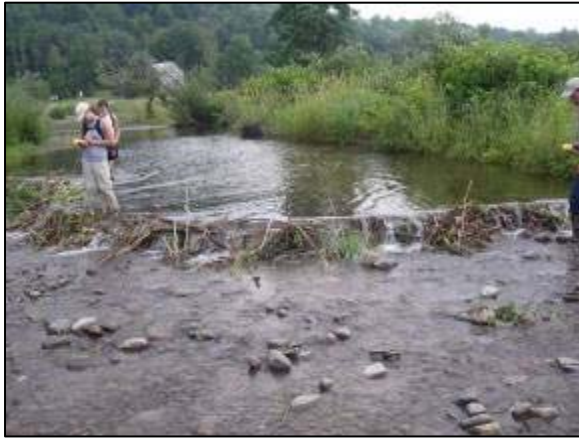
Beaver Dam at Station 34903

Continuing downstream of the erosion site, there was a beaver dam across the stream channel. The dam appeared to be actively maintained and contributed to backwater and downstream aggradational conditions. While beaver impoundments can sometimes be a nuisance, beavers have historically played a beneficial and ecologically important role in the stream system. Beaver activity adds organic debris (trees, leaves, etc. which

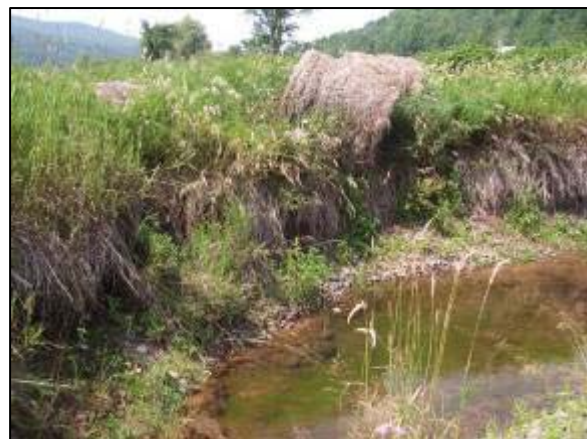
Erosion at Stations 34658 - 34547

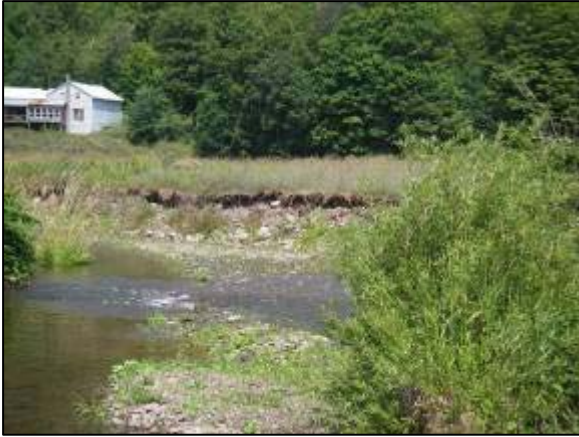
Erosion at Stations 34597 - 34159

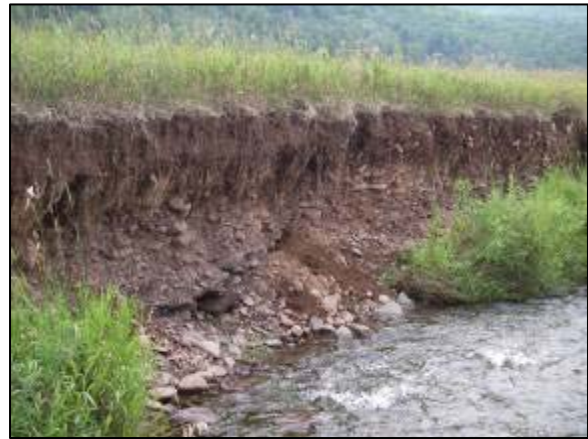
Erosion at Stations 34100 - 33881

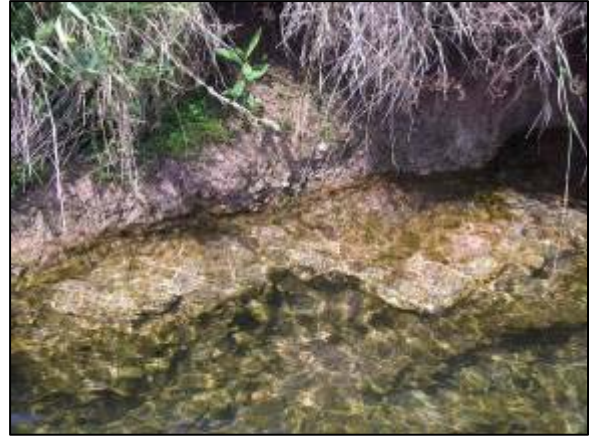
gently meandered to the left, there was erosion (Stations 33670 – 33398) along approximately 272 feet of the right streambank. Portions of the eroding bank were overhanging and slumping into the stream channel and portions of an old wire fence were compromised. There were two lacustrine clay exposures (Stations 33554 and 33486) stretching approximately 10 and 12 feet respectively, along the eroding

Clay Exposure at Station 33554

streambank. Herbaceous vegetation was maintained to the stream's edge. Although this section of the stream channel was not identified as a proposed planting site during the assessment, a wooded buffer with deep rooted vegetation is critical for providing streambank stabilization and protecting water quality from potential nutrient and pollutant inputs associated with the agricultural activity on the adjacent lands. Recommendations for this site include discontinue mowing to the stream's edge, allowing succession to proceed with natural regeneration of shrub and early successional tree species. Buffer width should be increased by the greatest amount agreeable to the landowners. The erosion and clay along this site may need to be addressed prior to proceeding with any riparian plantings of native sedge, shrub and tree species.

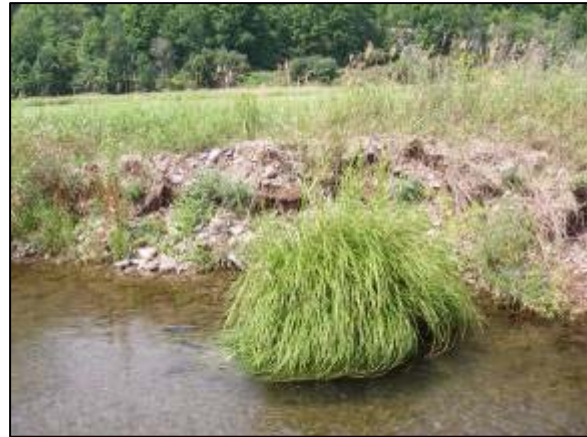
Erosion at Stations 33109 -33010

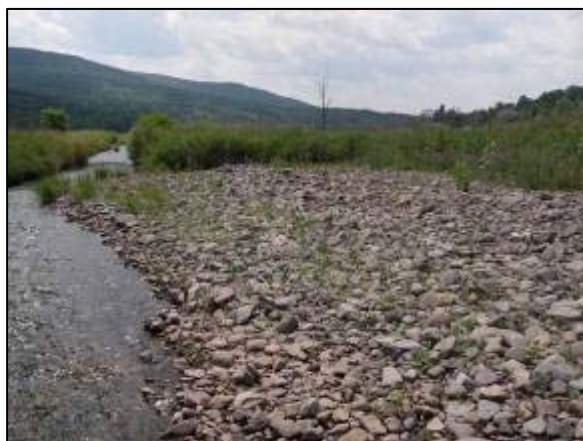
Continuing downstream, there were multiple areas with excess sediment deposition. The depositional features appeared to be caused by, or added to through channel modifications. Through this stretch of stream, it was evident that material was dredged from the stream bed and deposited along the toe of both streambanks, contributing to the formation of a point bar (Stations 33058 – 32925) along the left bank and a side bar (Stations 32967 – 32877) along the right bank. It appeared as though this material was being used to create a berm to provide streambank protection. However, due to the size of the material, it is likely

Side Bar at Stations 32967 - 32877

that much of it will be mobilized during future high flows. This type of channel modification is not recommended. The NYS DEC Protection of Waters Program requires a permit for stream bed or bank disturbance including excavating gravel material and placing fill along streambanks to provide stabilization.

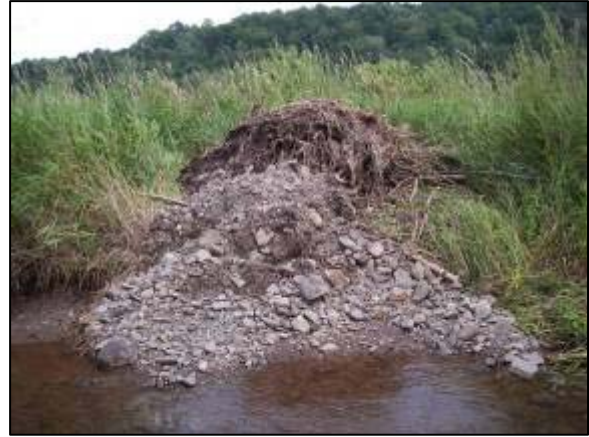
This tributary was classified C(TS) by the NYS DEC, indicating that the best uses for this stream are supporting fisheries and other recreational activities, including trout spawning. The channel of the tributary, and the Manor Kill at the tributary confluence, had been dredged. The dredged material was deposited along the Manor Kill on the right streambank downstream of the tributary and on the left streambank, opposite the confluence.

Dredged material from Tributary at Station 32604

This type of channel modification requires a NYSDEC issued permit, and is not recommended, especially due to the trout spawning activity that may take place in this tributary and along the Manor Kill. Further downstream, another unnamed tributary that drains the adjacent fields (Figure 4.3.1b, Inset D, Station 32487) entered along the left streambank. This tributary was not classified by NY DEC.

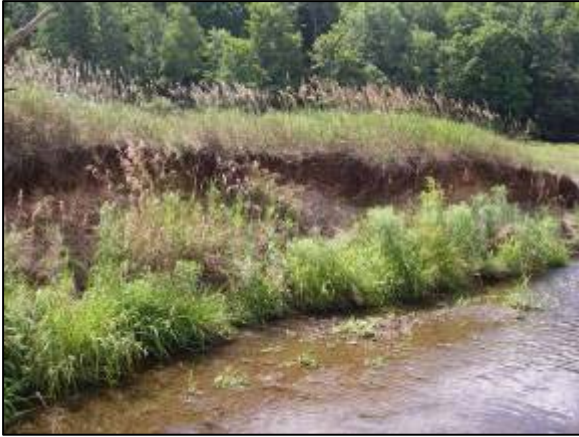
Erosion at Stations 31303 - 31180

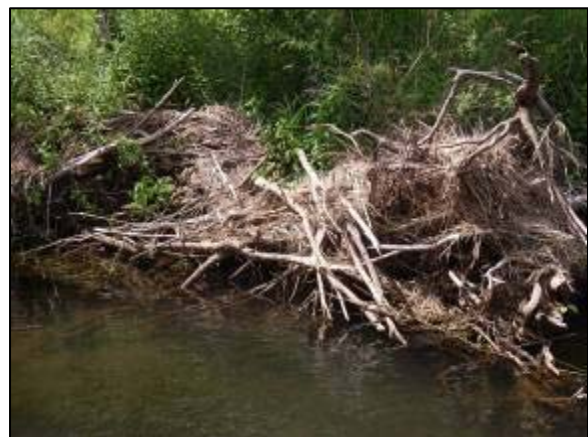
There were multiple woody debris obstructions (Station 30619) along the left and right streambanks downstream. The woody debris obstructions were caused by the removal of a beaver dam from the main channel and placement of the dam materials along each side of the stream. The remaining debris appeared to contribute to upstream sediment deposition and rerouting of the stream. Along this stretch of stream, and continuing downstream aggradational conditions persisted and there were multiple stands of Japanese knotweed. There were also three additional clay exposures (Stations 30541, 30427 and 30405) totaling approximately 33 feet. A fallen tree from the left bank was partially buried along

Woody Debris at Station 30619

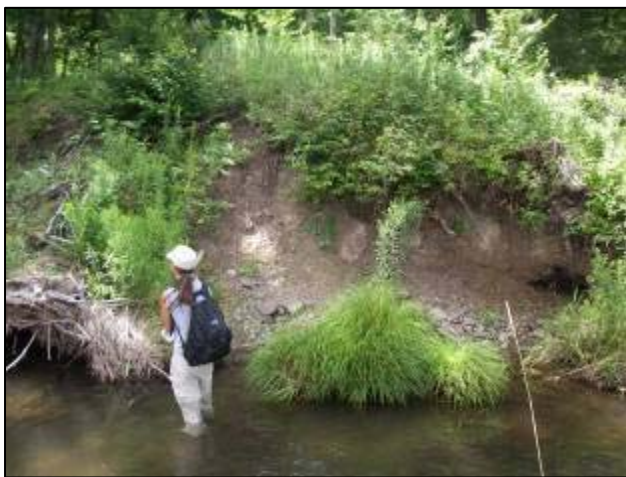
Further downstream, aggradational conditions persisted, including multiple point and transverse bars. Along the left streambank, multiple trees had fallen from the left bank across the channel to the right bank causing an obstruction (Station 30011) at all flows. The obstruction appeared to contribute to upstream aggradation and to localized scour along the

Erosion at Stations 30011 - 29959

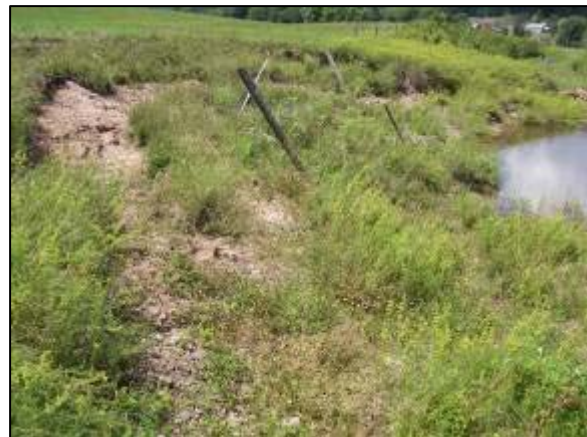
As the stream gently meandered to the right, hydraulic erosion (Stations 29682 – 29664) on the left streambank was followed by the first *mass failure* in this management unit. Streambank erosion often occurs on the outside of meander bends where the stream velocity is greatest during high flows; along this section of stream, the thalweg flows up against the toe, undermining the streambank. This resulted in an erosion area of approximately 1,724 ft², exposing lacustrine clay along the bed and banks and compromising a wire fence along the adjacent pasture. Although future high flows may continue to erode this bank, it did appear to be self-recovering and may be a good candidate for remediation using vegetative toe and bank protection including willow staking and planting sedges along the toe of the streambank. Prior to proceeding with any work, this site would require a more detailed site assessment.

Mass Failure at Stations 29682 - 29664

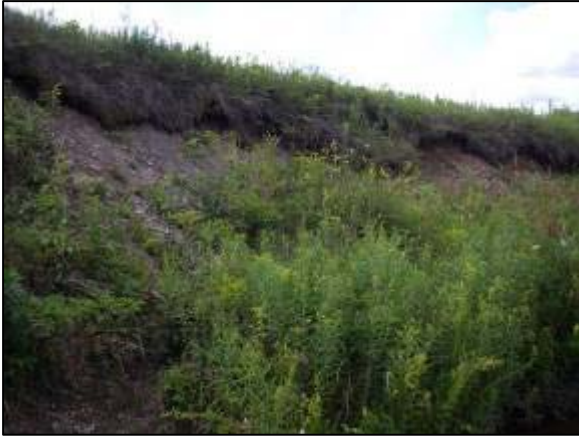
Further downstream, there was another eroding bank (Stations 29319 – 29201) along the left streambank for approximately 118 feet. This erosion site had herbaceous vegetation to the edge of the stream and along the toe of the streambank. Along the downstream portion of this site, there was a lacustrine clay

Erosion at Stations 29319 - 29201

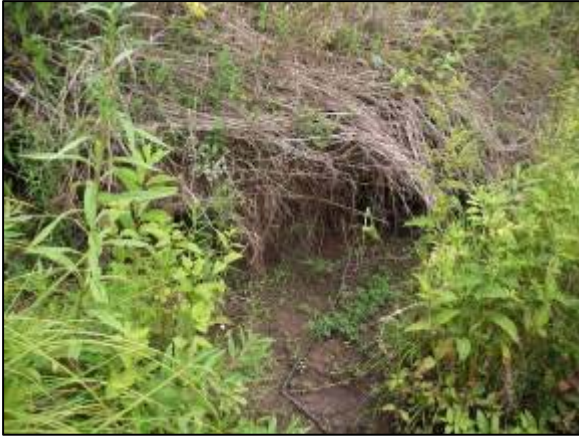
Erosion at Stations 28600 - 28585

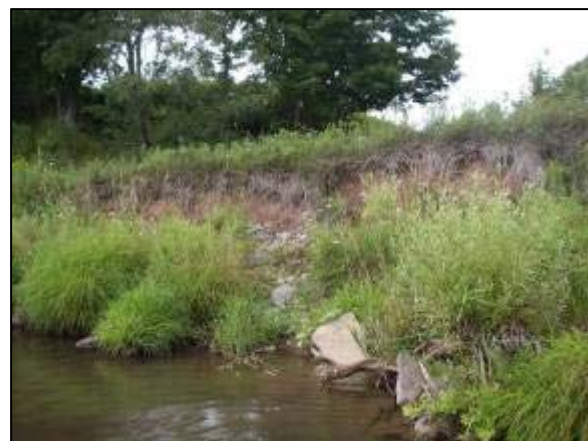
As the stream gently meandered to the left, the right streambank was reinforced with rip rap (Stations 28068 – 27939) for approximately 129 feet. At the time of the assessment, the rip rap had failed and was providing little to no streambank protection. Beginning behind the rip rap and continuing downstream, there was erosion (Stations 28011 – 27857) along approximately 154 feet of the right bank. During the field assessment, this bank was identified as a proposed Bank Erosion Monitoring Site

Erosion at Stations 28011 - 27857

(BEMS) to study erosion along this reach. To monitor bank erosion, a cross-section and longitudinal profile may be completed to collect baseline data. Once the baseline data has been collected, this cross-section can be resurveyed in the future to calculate the bank's erosion rate. Improving the riparian buffer along this site is important and has been recommended; however, other stream bank stabilization techniques may be required to reinforce the bank and to minimize any loss of planted vegetation. Opposite this erosion site, the left streambank was eroding (Stations 28006 -27778) for approximately 228 feet. A

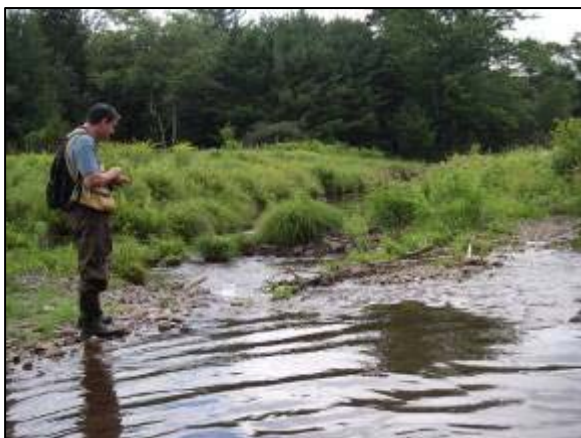
*Beaver Dam Remnants at Station 27600
Transverse Bar at Stations 27622 - 27581*

no longer being maintained, or had been partially removed in an attempt to restore channel flow. It appeared as though this dam had contributed to the erosion along the right streambank. The remnants of the beaver dam contributed to aggradational conditions that persisted through this stretch of stream, including a transverse bar (Stations 27622 – 27581), that was causing backwater along the right.

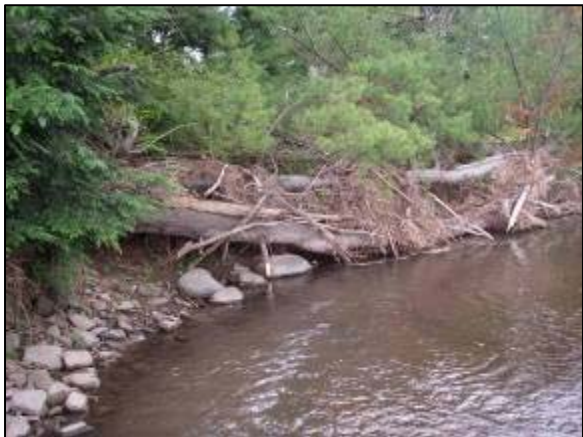
Woody Debris at Station 27290

causing exposed roots and compromising mature trees that had fallen along the streambank. There were two woody debris obstructions resulting from the erosion (Station 27290 and Figure 4.3.1b, Inset A, Station 27261). Both obstructions contributed to localized scour of the toe of the left streambank and the channel bed, and caused upstream aggradational conditions across the

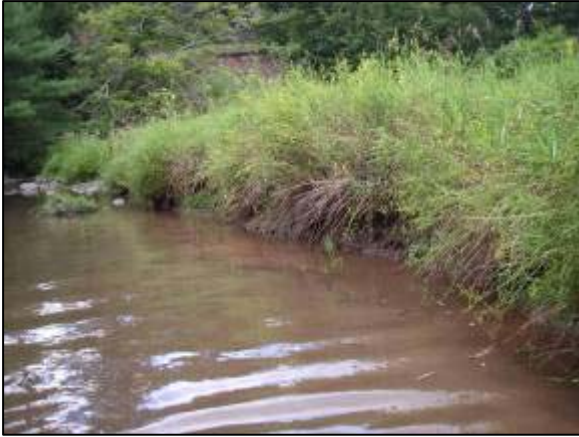
Erosion at Stations 27246 - 27183

full channel. Opposite this erosion the right streambank was eroding for approximately 63 feet. This minor erosion site (Stations 27246 – 27183) may be a good candidate for remediation using vegetative toe and bank protection. Reinforcing the toe of the streambank with native sedge species is recommended. A CREP site and proposed riparian planting site (Stations 27246 – 27183) continued along this erosion site.

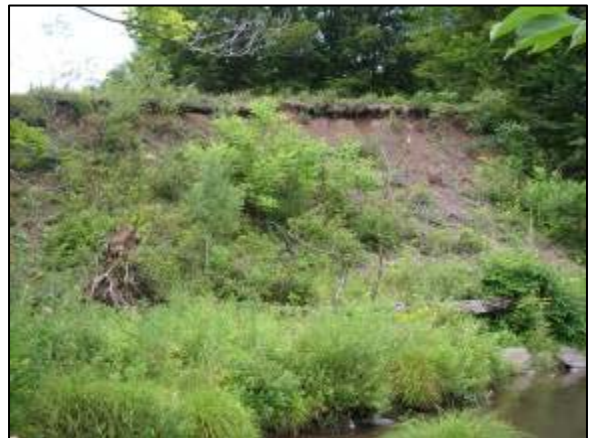
The depositional features and dam remnants all appeared to contribute to upstream backwater conditions. Also along this meander bend, there was a mass failure (Stations 27163 – 26938) on the left bank for approximately 161 feet in management unit 3 and then continued into management unit 4 for an additional 64 feet.

Mass Failure at Stations 27163 - 26938

There was a mixture of herbaceous vegetation and open forest along this mass failure; mature trees were compromised and had fallen along the streambank. The erosion appeared to be self-recovering, with sedges along the toe of the bank and herbaceous vegetation, shrubs and willows establishing along the face of the bank; although future high flows may result in continued erosion along this meander bend. There were multiple small patches of Japanese knotweed along this stretch of stream. Management Unit 3 ended at Station 26995.

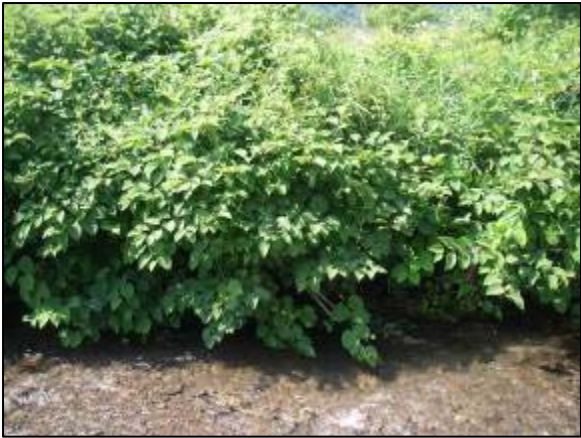
Japanese knotweed at Station 35300
