Manor Kill Management Unit 4

Town of Conesville – Station 26995 to Station 24315

This management unit begins at Station 26995, continuing approximately 2,680 ft to Station 24315 in the Town of Conesville.

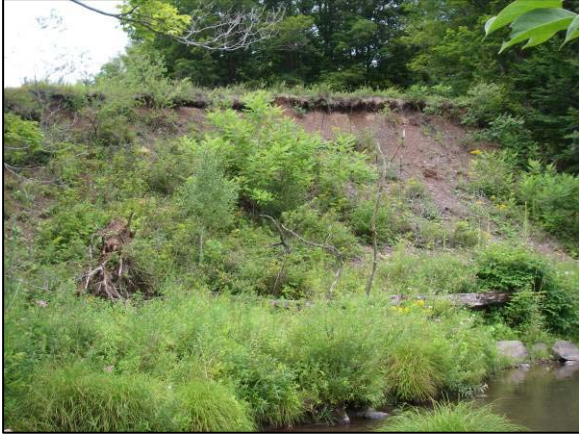
Mass Failure at Stations 27163 - 26938

Management unit 4 began as the stream valley narrowed and the adjacent vegetation along the left streambank changed from herbaceous to forested. As the stream meandered to the right, a *mass failure* (Stations 27163 – 26938) began in management unit 3 and continued downstream into this management unit. Streambank erosion often occurs on the outside of meander bends where the stream velocity is greatest during high flows. Along this section of stream, the *thalweg*, or deepest part of the stream channel, flows up against the toe of the bank undermining the steep slope, resulting in erosion along 64 feet in management unit 4 (161 feet of erosion in management unit 3). There was a mixture of herbaceous vegetation and open forest along this mass failure; mature trees were compromised and had fallen along the streambank. At the downstream portion of the mass failure the erosion had caused a lacustrine clay exposure (Station 26951) along the left channel bed. Clay inputs into a stream are a serious water quality concern because they increase *turbidity*, degrade fish habitat, and can act as a carrier for other pollutants and pathogens. The erosion site appeared to be self-recovering, with sedges along the toe of the bank and herbaceous vegetation, shrubs and willows establishing along the face of the bank. Although, future high flows may result in continued erosion along this meander bend.

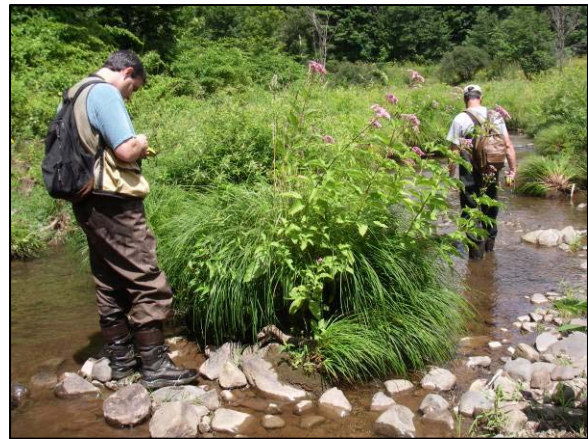
Center Bar at Station 26959

Continuing downstream, there was excess sediment deposition including, a small well-vegetated center bar (Station 26959), with sedges and other herbaceous species, and a side bar (Stations 26897 - 26867) stretching along approximately 30 feet of the left channel bed.

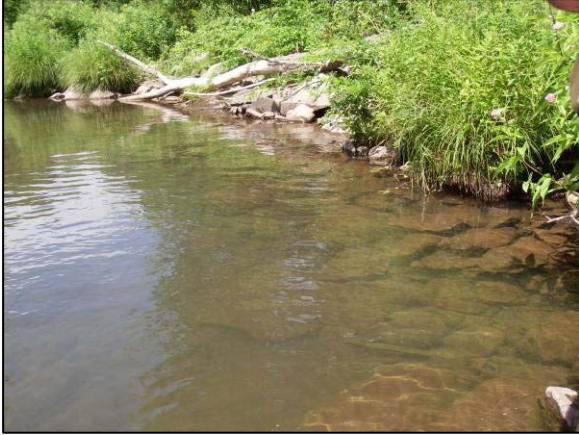
Revetment at Stations 26750 - 26712

structurally and was in poor functional condition.

As the stream meandered to the left, there was a rock wall (Station 26760) followed by rip rap (Stations 26750 – 26712) along the right streambank. Both areas of revetment appeared to be relatively old. The rock wall was in poor functional condition and fair structural condition, and had herbaceous vegetation established throughout. The rip rap appeared to have been dumped along the toe of the streambank, had failed

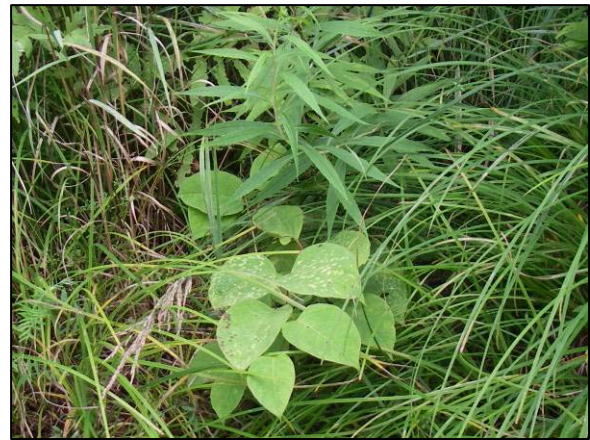
Japanese knotweed at Station 26626

Continuing downstream, the first occurrence of Japanese knotweed (Station 26626) in this management unit was documented; this was a very small patch. Japanese knotweed is a non-native invasive species which does not provide adequate erosion protection due to its very shallow rooting system; knotweed also grows rapidly

and tends to crowd out more beneficial streamside vegetation. The best means for controlling knotweed is prevention of its spread. Therefore, efforts should be made to ensure that existing stands are not fragmented via unnatural processes (i.e. mowing without removal

of all mowed material) and transported into downstream areas. Small stands should be eradicated immediately to avoid further spread within this unit and downstream management units. There are removal methods that may be used for larger stands (see Section 2.7), these methods should be used with caution and carefully executed to avoid further spread of Japanese knotweed.

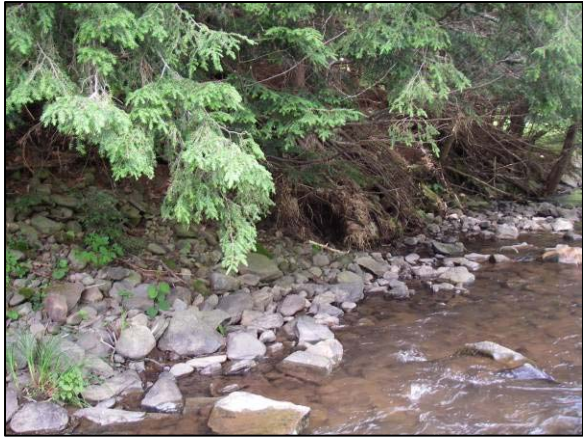
Erosion at Stations 26588 - 26432

Further downstream, the left streambank was eroding (Stations 26588 – 26432) for approximately 156 feet. The streambank and upland area were forested; the erosion caused undercut banks, exposing roots and compromising mature trees. Starting along the lower portion of the eroding bank and continuing downstream, there was a side bar (Station 26541) for approximately 40 feet along the left channel bed.

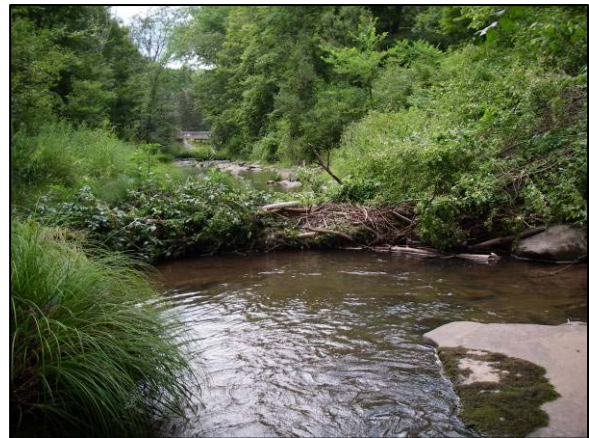
Beaver Dam at Station 26343

Downstream of the side bar, there was a beaver dam (Station 26343). While beaver impoundments can sometimes be a nuisance, beavers have historically played a beneficial and ecologically important role in the stream system. Beaver activity adds organic debris (trees, leaves, etc. which provide the base of the food chain), reduces water velocities and flood-related hazards downstream, and creates wetland areas that filter sediment and release water to the stream and groundwater slowly throughout the year. Although the dam is across the entire channel, water is able to flow underneath the dam. During higher flows, the dam poses a more significant obstruction to

flow; it appeared that higher water levels flowed along both sides of the beaver dam.

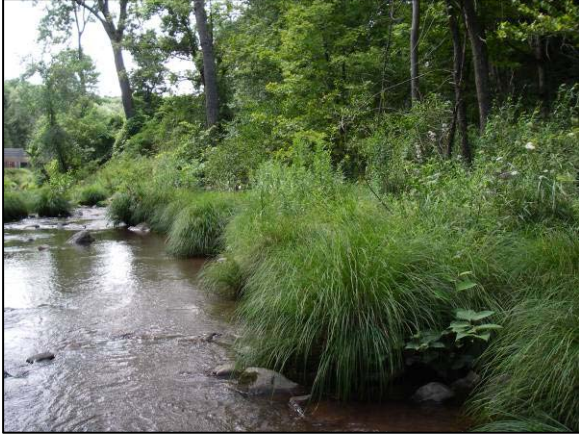
Side Bar at Stations 26149 - 26070

Further downstream, there were several more patches of Japanese knotweed (between Stations 26200 and 25900) along the left and right streambanks. There were also well-vegetated side bars along approximately 79 feet of the right channel bed (Stations 26149 – 26070) and 101 feet along the left channel bed (Stations 26080 - 25979). At the time of the assessment, there was flow through the sedges along and behind the side bar along the right streambank.

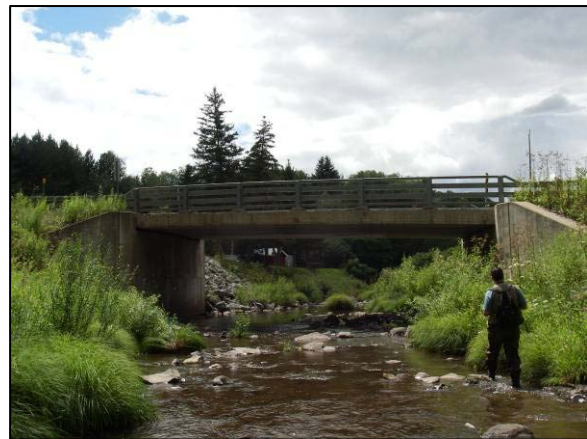
Bridge at Station 25880

Downstream, the Manor Kill flowed under South Mountain Road Bridge (Bridge # 3354990, Station 25880, also known as Haner Road). This bridge, which was replaced in 2000, was in good structural and functional condition, and appeared to have adequate height and width to convey most flows. There was rip rap along the bridge abutments upstream and downstream of the bridge.

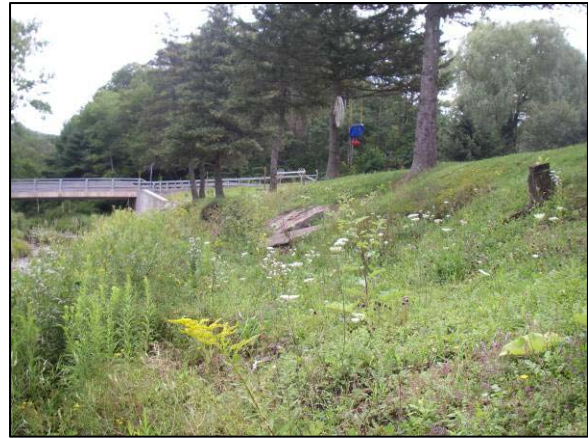
Riparian Planting Site at Stations 25833 - 25673

Along the left streambank, rip rap (Figure 4.4.1, Inset C, Stations 25833 – 25797) began at the bridge abutment and continued downstream for approximately 36 feet. The revetment was in good structural and functional condition and provided scour protection at the toe of the bank. Interplanting the rip-rap and reinforcing the toe of this streambank with native shrub and sedge species is

recommended. This planting will help to strengthen the revetment, while enhancing aquatic habitat. The riparian buffer beyond the rip-rap installation was sparse, with some mature trees and mown grass to the edge of the bank. The risk to bank stability can be minimized by maintaining mature trees along the critical 100 foot buffer zone. The buffer width should be increased by the greatest

amount agreeable to the landowners. In addition to interplanting the rip rap, recommendations for this proposed riparian planting site (Stations 25833 – 25673, photograph orientation looking upstream) include planting native trees and shrubs along the streambank and the upland area. Downstream of the revetment, and continuing along the proposed riparian planting site, the left streambank was eroding (Stations 25785 – 25632) for approximately 153 feet. At the downstream end of the erosion, there was a fallen tree (Stations 25632) with accumulated woody debris; it appeared to contribute to localized scour of the channel bed and the toe of the streambank. Prior to proceeding with any vegetative

plantings, a more detailed site assessment may be necessary. The conditions at this site should be given careful consideration when identifying the appropriate species and locations for plantings.

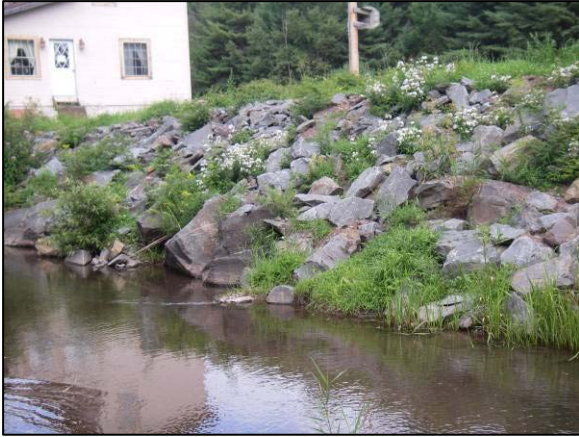
Rip rap at Stations 25485 - 25301

sediment deposition, including full channel aggradation (Station 25503) and a transverse bar (Stations 25337 – 25285). A small unnamed tributary (Station 25438) entered from the left streambank; there was a relatively large patch of Japanese knotweed just downstream of the tributary. Along this stretch of stream, the right streambank was reinforced with rip rap (Figure 4.4.1, Inset B, Stations 25485 – 25301) for approximately

184 feet. The rip rap was in good structural and functional condition and provided scour protection along the toe of the streambank. Along the upstream portion of the rip rap there was mowed lawn to the edge of the bank. Interplanting the rip-rap and reinforcing the toe of this streambank with native shrub and sedge species is recommended. Although this site was not identified as a proposed riparian planting site, planting native shrub and tree species along the upland area is recommended. As mentioned previously, a permit was issued for 100 feet of streambank rip rap repair, installation of new rip rap, and minor fill and grading in pre-disturbed lawn areas, in order to prevent the stream from undermining the adjacent home. This permit expires on September 30, 2009.

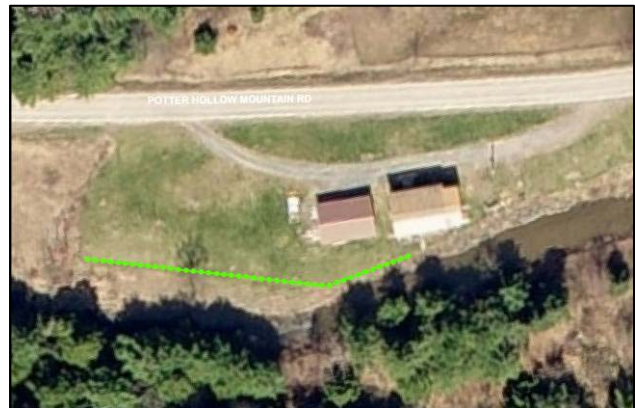
Riparian Planting Site at Stations 25345 - 25104

Beginning along the downstream portion of the revetment and continuing downstream, there was a proposed riparian planting site (Stations 25345 – 25104) for approximately 241 feet of the right streambank. Herbaceous vegetation was maintained to the edge of the stream for a portion of the site length; there were some areas with a few shrubs and trees that provided a thin wooded buffer. Recommendations for this site include discontinued mowing to the stream's edge, establishing a buffer where none exists, and augmentation of the existing buffered areas by planting native trees and shrubs along the streambank and

the upland area. Buffer width should be increased by the greatest amount agreeable to the landowners. Increasing the buffer width to at least 100 feet, where feasible, will increase buffer functionality and protect water quality by slowing stormwater runoff and pollutants associated with nearby land use.

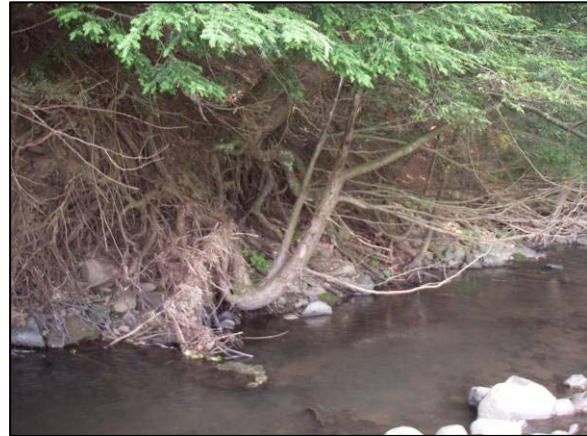
Erosion at Stations 25098 - 24981

Continuing downstream, there was erosion (Stations 25098 – 24981) along the left streambank for approximately 117 feet.

The streambank and upland areas were

forested; the erosion exposed roots, compromising mature trees and caused a fallen tree along the downstream portion of the erosion. There was a large boulder in the stream channel that directed flow toward the left bank, exacerbating the erosion at this site. There was also a side bar (Stations 25069 – 25004) along the right streambank for approximately 65 feet. Three small patches of Japanese knotweed (Stations 25072, 25047 and 24900) also grew along the right, and one on the left (Station 24900).

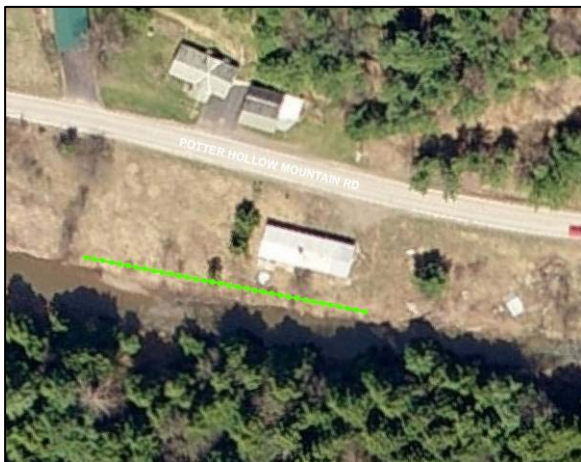
Riparian Planting Site at Stations 24639 - 24407

Further downstream, excess sediment deposition continued, including full channel aggradation (Station 24720), a transverse bar (24713 – 24662) and a point bar (Stations 24562 – 24393). The channel was over-wide starting where there was full channel aggradation and continuing downstream until it began to narrow along the point bar. Along the right streambank, there was a proposed riparian planting site (Stations 24639 – 24407) for

approximately 232 feet. There was mowed lawn to the top of the bank, and a mixture of herbaceous vegetation and shrubs along the face of the streambank. As with the previous planting site, recommendations for this site include discontinued mowing to the top of the bank, establishing a buffer where none exists, and augmentation of the existing buffered areas providing a buffer width of the greatest

amount agreeable to the landowner. There were two significant stands of Japanese knotweed (Station 24586, Figure 4.4.1, Inset D, and Station 24500) along this planting site. Prior to beginning planting efforts, these stands should be removed if feasible, or effort should be made to avoid spreading this invasive plant.

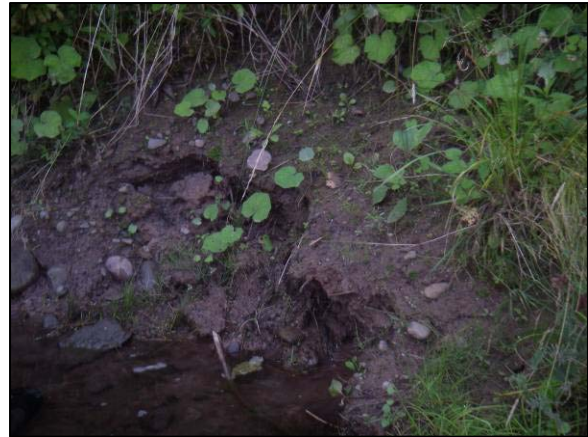
Clay Exposure at Station 24520

Opposite the proposed planting site, there was erosion along the left streambank that appeared to be self-recovering. This area was vegetated with a mature closed evergreen forest and herbaceous vegetation had reestablished along the face of the bank. However, there was a relatively small clay exposure (Station 24520) along the left channel bed and toe of the streambank for approximately three feet. This management unit ended just downstream at Station 24315.

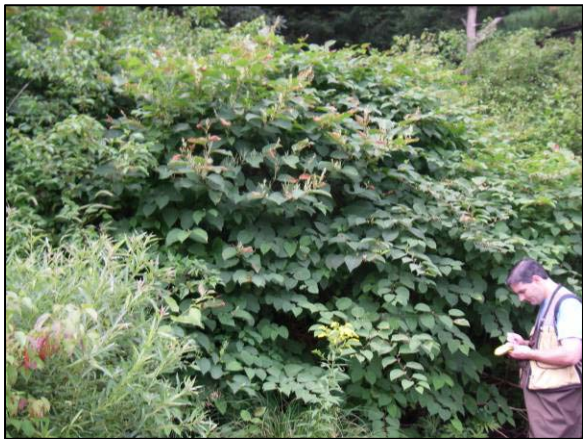
Japanese knotweed at Station 25434

Some plant species that are not native can create difficulties for stream management, particularly if they are invasive. Japanese knotweed (*Fallopia japonica*), for example, has become a widespread problem in recent years. Knotweed shades out other species with its dense canopy structure (many large, overlapping leaves), but stands are sparse at ground level, with much bare space between narrow stems, and without adequate root structure to hold the soil of streambanks. The result can include rapid streambank erosion and increased surface runoff leading to a loss of valuable topsoil. Japanese knotweed locations were documented as part of the stream feature inventory conducted during the summer of 2008 (Riparian Vegetation Mapping, Section 2.7). In total, 18 Japanese knotweed occurrences along an estimated length of 122.50 feet were documented during the stream feature inventory. The best means for controlling knotweed is prevention of its spread, therefore, effort should be made to ensure that all fill brought into the area is clean and does not have fragments of knotweed or other invasive plants. If Japanese knotweed sprouts or

small stands are observed, they should be eradicated immediately to avoid further spread within this unit and to downstream management units.
