Management Segment 2

C.D. Lane Park to Hensonville CR 65

**Batavia Kill Watershed
 Segment 2 Management Reaches**
 Map VI-3
 Greene County Soil & Water Conservation District
 Batavia Kill Stream Corridor Management Plan

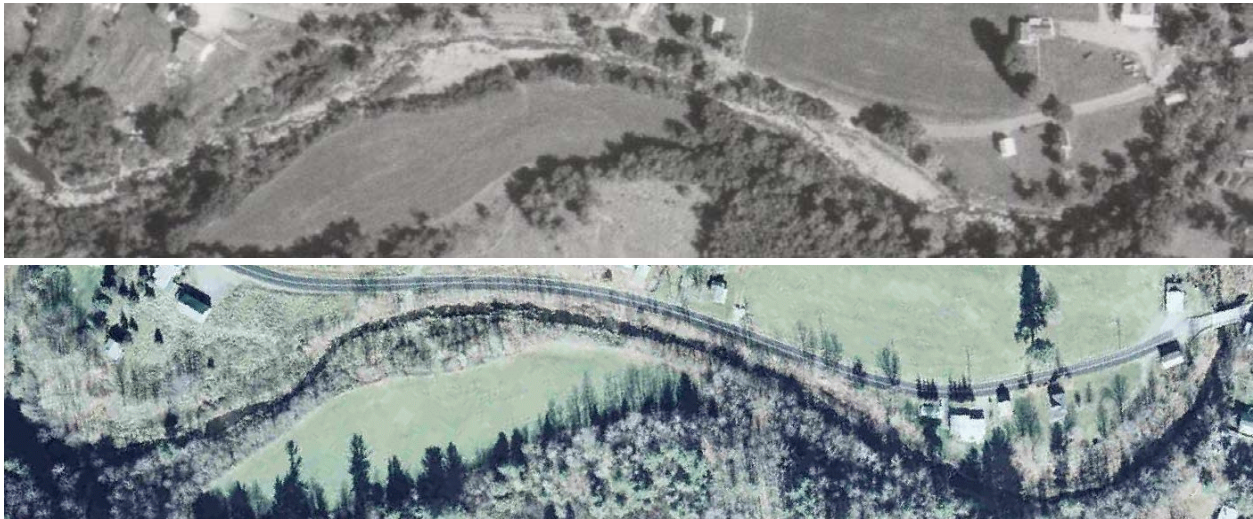
Figure VI-20: Review of aerial photographs from 1959 (top) and 2000 to assess flood control impacts on stream form and function.

By 2000 (bottom photo), these depositional features are notably absent, and the riparian vegetation has grown in streamside areas that were once too active to be colonized by vegetation. The absence of in-channel sediment features (such as point bars) is a classic response to impoundments because they capture and trap the natural sediment supply from above. The aerial photographs also indicate a clearly discernable change in overall channel stability. In the 1959 photo, the lack of riparian vegetation and active erosion can be seen in several areas. Because the flood control dam has limited higher flows through the segment, the channel is experiencing very little streambank erosion or other adjustment processes.

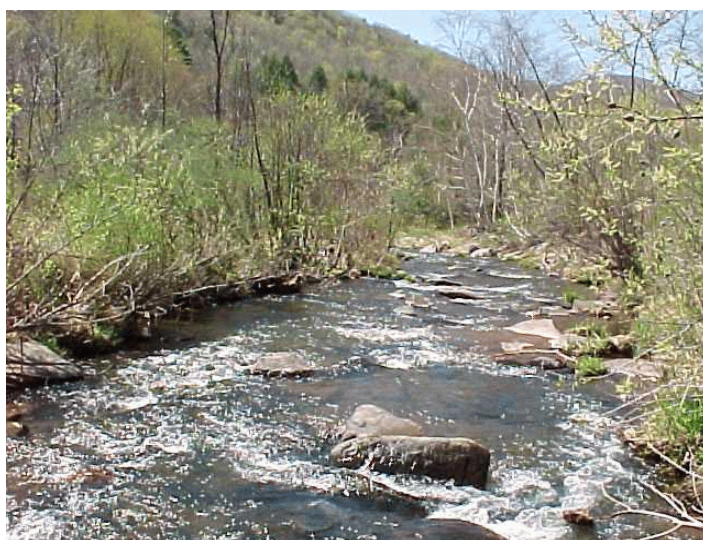
Figure VI-21: Riparian vegetation to the stream's edge.

As seen in **Figure VI-21**, the channel has good riparian vegetation and a stable and well imbricated streambed. The willows seen in the photo have colonized a depositional feature that is no longer actively scoured because CD Lane Park is holding back flows that would mobilize the sediments. MS-2 was further sub-divided into three (3) reaches to facilitate data collection and analysis (**Map VI-3**). In the following sections, the GCSWCD has summarized the stream condition, on-going stream processes, and recommendations for this segment.

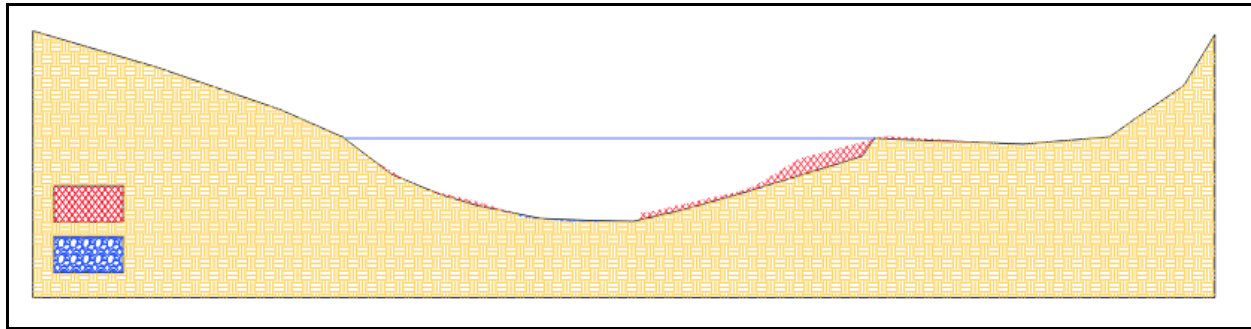
Figure VI-22: Overlay of 1998 and 2000 cross sections taken below CD Lane Park Flood Control Structure.

A single monumented cross section was installed below the CD Lane Park FCS for classification purposes in 1998 and was subsequently surveyed again in 2000 to determine if any stream changes had occurred as a result of the September 1999 flood event. (**Figure VI-23**). The cross section monitoring indicated that the channel has achieved a stable morphology which accommodates the modified water and sediment discharges from the FCS. Minimal erosion during the monitoring period validated the GCSWCD observation that the reach is highly stable.

Red = erosion. Blue = deposition

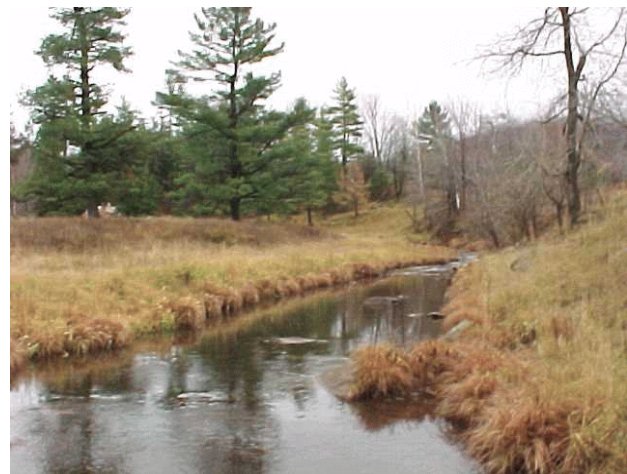
Figure VI-24: While grasses & forms provide stability, poor overhead cover reduces habitat value

The riparian community in reach 2a consists of moderate to low density mixed deciduous/coniferous overstory, with a brush/grass understory. The entire length of the reach is characterized by extensive growth of sedges and other herbaceous plants within the active channel and on the lower streambanks. Several sections of the riparian buffer are regularly mowed, but these activities do not appear to be having an impact on channel stability. The stream riparian community immediately below the dam consists of highly dense grasses and sedges with some low shrub growth (**Figure VI-23, photo A,B,C,D,E,F,G**). Between the dam and Slater road, the reach is dominated by herbaceous growth, with limited areas of forest. While the reach has excellent riparian vegetation from a stability standpoint, much of the reach exhibits fair to poor conditions in regards to buffer species which provide stream cover and thermal benefits (**Figure VI-22**). The lower reach transitions to a higher density of woody growth, with trees and shrubs supplementing the herbaceous communities. During the assessment phase, the GCSWCD

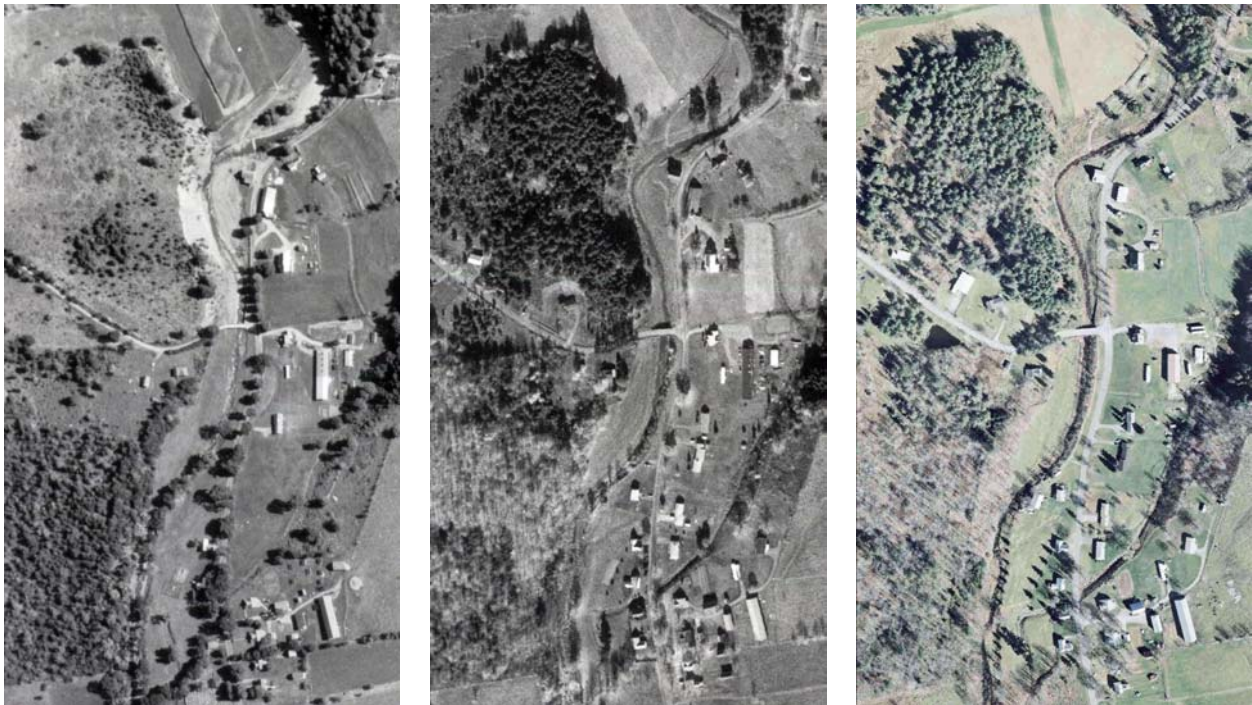
Figure VI-25: Aerial progression from 1959 (left), 1980 (middle) and 2000 right, note that the riparian condition has essentially remained the same over 40 years.

compared aerial photographs over a 41 year period from 1959 to 2000 which indicated that the riparian zone has remained essentially the same (**Figure VI-25**).

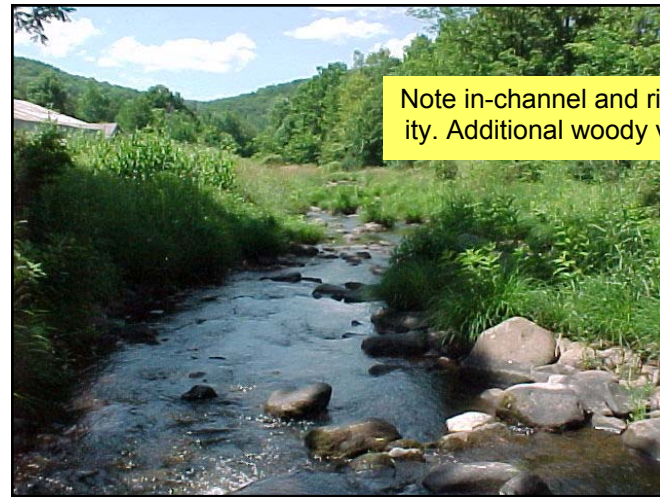
B

Note in-channel and riparian vegetation promote stability. Additional woody vegetation would improve habitat

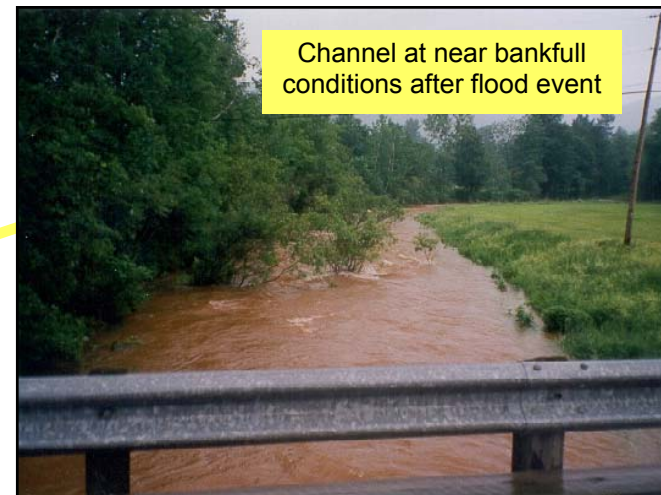
E

The reach also contains two (2) county bridges and a short segment of CR 56 which runs adjacent to the stream. The upper bridge, at Slater Road, is more than adequately sized for the modified flows from the flood contro structure. During flood events, the bridge easily passes its flow (**Figure VI-23b, photo E**) and the bridge span is large enough to have allowed for development of an effective bankfull channel under the bridge's span. Streambank stability upstream of the bridge is influenced by older rip rap. The lower bridge, at the bottom of the reach, also does not appear to be impacting the stream stability. Both bridges easily pass the reduced sediment load that is characteristic of this reach, and both have adequate hydraulic openings to pass the full range of discharges.

Channel at near bankfull conditions after flood event

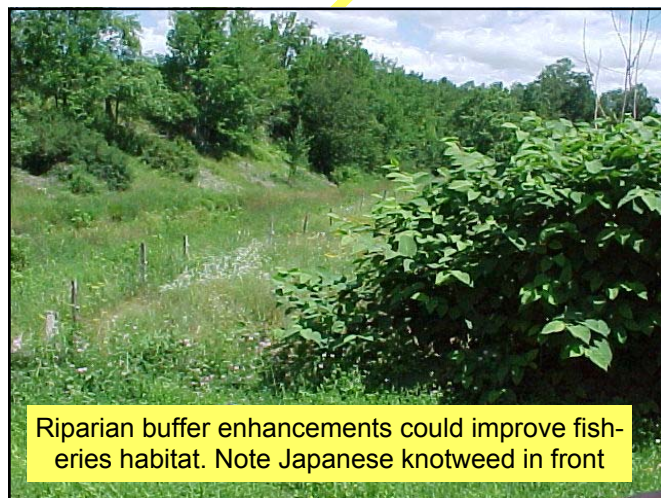
F

Riparian buffer enhancements could improve fisheries habitat. Note Japanese knotweed in front

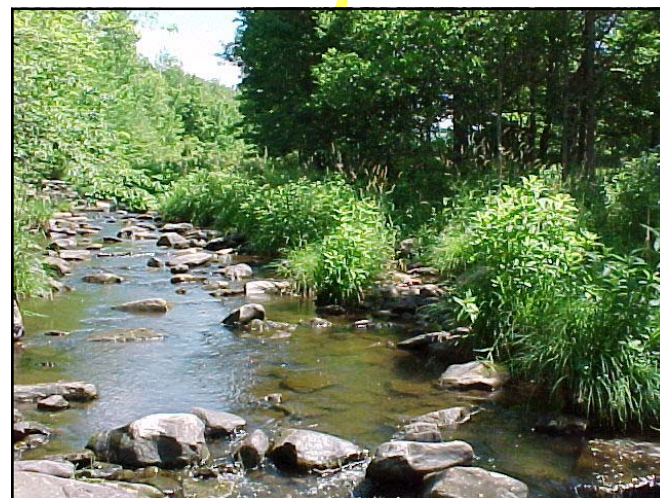
G

While not physically measured, during the assessment period the GCSWCD has noted active incisement of several of the smaller tributaries which contribute to the reach. The intermittent tributary that enters from the base of Thomas Cole Mountain (**Figure VI-23a, photo G**) and the tributary that enters from the north just below the dam (**Figure VI-23a, photo C**) both are to be actively degrading (downcutting). The tributary from Thomas Cole is especially extremely active below CR 56. The tributary passes through the Hitchcock property where it has incised substantially. The channel's banks have no cover and are mowed to their tops. Monitoring on the main stem Batavia Kill above the confluence has shown no vertical degradation. The vertical instability of the tributary is believed confined to the tributary itself.

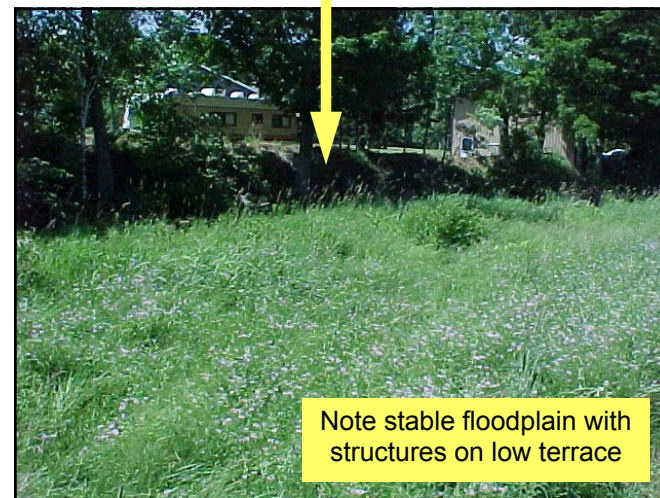
H

Note stable floodplain with structures on low terrace

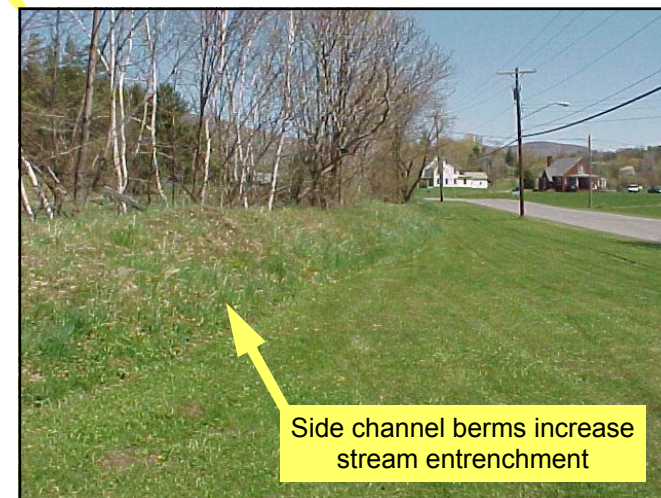
I

The central infrastructure feature within the reach is the outfall for the C.D.Lane flood control structure (**Figure VI-23a, photo I**) In the District's initial assessment of the reach, the primary concern was related to the typical "clear water" effects seen below similar dam structures (**see section V-C**). The completion of the flood control structure in 1976 effectively created a large a trap for sediment which significantly reduced the stream's sediment supply.

Side channel berms increase stream entrenchment

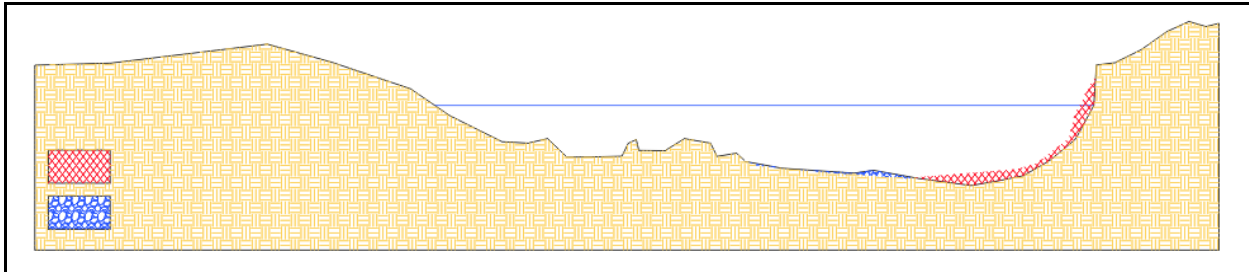
Figure 27: Overlay of 1998 and 2000 monitoring cross section showing erosion (red) and deposition (blue) indicating good stability over the monitoring period.

In 1998, a single cross section was measured in this sub-reach behind the Harp and Eagle in Hensonville. The cross section was used to obtain information about the stream's hydraulic geometry (width, depth, cross sectional area). This cross section was resurveyed in 2000 and the GCSWCD determined that it had remained stable over that time period (**Figure VI-27**).

The channel dimensions of width/depth and entrenchment at the cross section have remained essentially unchanged with only minor scour at the cross section. The channel scour is conceivably caused by a slow change in bed feature from a riffle to a pool and potentially results from the September 1999 flood event. The reach was reexamined after the September 1999 flood event and the reach appeared to have maintained its stability.

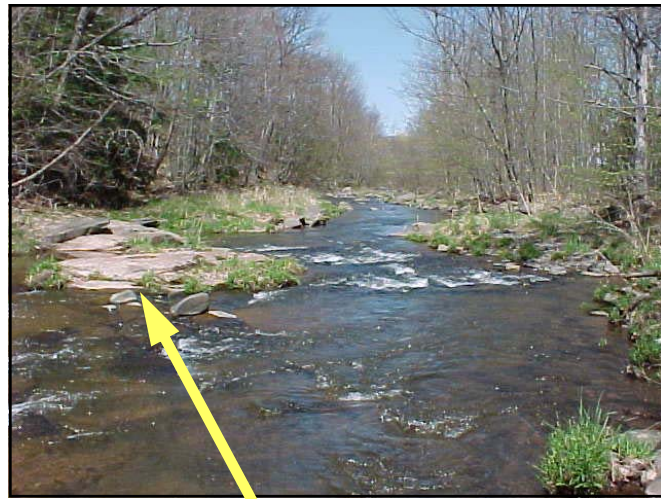
A

The Phase I Inventory and Assessment process characterized the reach as having very low streambank erosion with only 300 feet of stream bank erosion noted on the entire 1.9 mile long reach (**Figure VI-26a, Photo A,B,C,D,E,F**). Stream profile (the slope of the stream bed) is controlled by bedrock exposures at the top of the reach as well as near the bottom, and the remnants of an old K-Dam fisheries structure located near the top of the reach (**Figure VI-26a, photo G**) also appears to exert some control on the profile.

is a factor in the increased channel entrenchment (**Figure VI-26a, photo A,E**). This entrenchment also extends a short distance below the bridge, but, despite this entrenchment, the channel appears to be stable under the current flow regime.

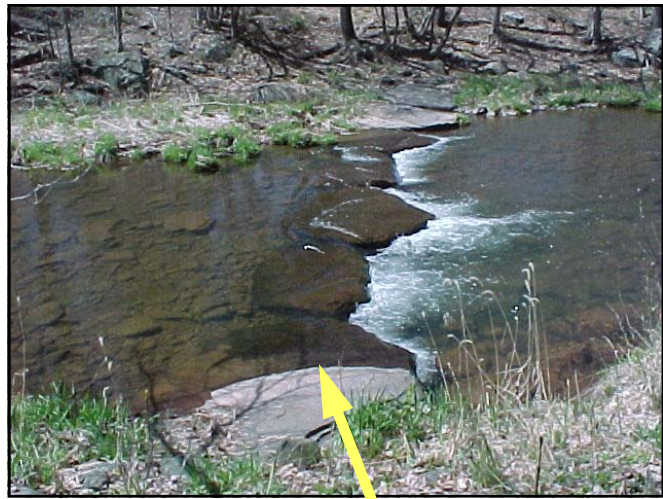
B

exerted by a timber K-dam and a boulder sill (**Figure VI-28, photo B,E**) both located just below the CR40 bridge (No. 3-30285-0). The K-dam is in poor to fair condition and has lost much of its scour pool function. These structures are common, having been installed by the NYSDEC, GCSWCD and others under state and federal conservation programs in the 1960s. The boulder sill was constructed in the early 1990 by the Town of Windham, under the technical assistance of the GCSWCD. The sill was constructed to provide grade control protection for a water service main which runs from the Town's well house to Hensonville under the stream. The rock sill has worked well, and survived the 1996 and 1999 flood events. There are no visual signs that either structure is impacting reach stability.

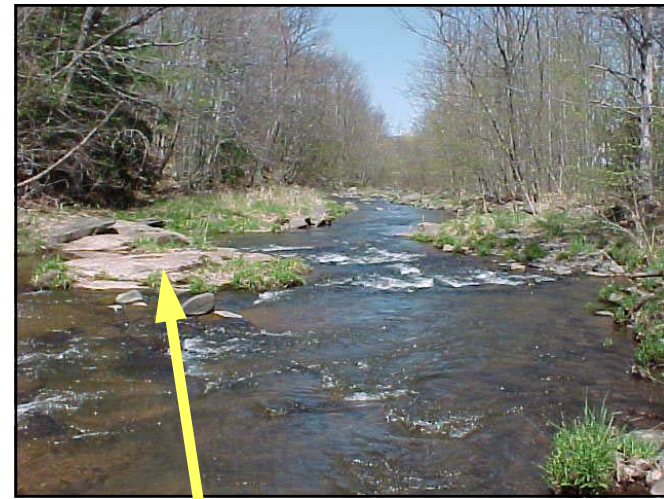
D

The riparian vegetation through the majority of the reach consists of a very thin buffer along CR 40 and CR65A. The buffer is composed of a mixed population of mature deciduous species, conifers and grasses on the reaches lower banks (**Figure VI-28, photo A,C,D**). Although the forest buffer is thinner than desired in places along CR65A, the canopy cover appears to be providing excellent shading of the stream channel through the reach and the vegetation is assumed to be a major factor in the stability of the reach. As noted in previous reaches in management segment 2, the stream channel is well vegetated with grasses and sedges (**Figure VI-28, photo D**).
