## Management Segment 3 (Hensonville CR 65- Windham CR 12 South Street)

**Batavia Kill Watershed  
 Segment 3 Management Reaches**  
 Map VI-4  
 Greene County Soil & Water Conservation District  
 Batavia Kill Stream Corridor Management Plan

## **Reach 3a (CR 65 Hensonville to Concrete Dam Above SR 296)**

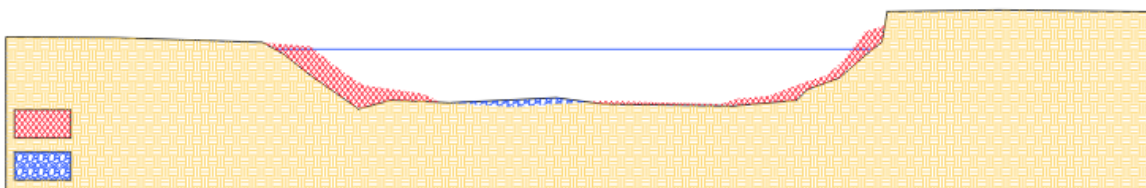
A detailed assessment of the channel stability was initiated in 1998 with the installation of two monumented cross sections. The cross section was placed to monitor observed lateral migration of the channel. The cross section is positioned immediately downstream of the Batavia Kill's confluence with the Silver Lake tributary at a drainage area of 21.3mi<sup>2</sup>. The stream at this cross section is classified as a C4 stream type, which is typical of the entire reach. During the monitoring period between 1998 and 2000, the bankful channel has widened by 4.5 feet, with aggradation of the streambed of approximately 0.8 feet (**Figure VI-29**).

**Figure VI-29:** Overlay of 1998 and 2000 cross sections taken downstream of the confluence with Silver Lake tributary. Red is erosion, blue deposition.

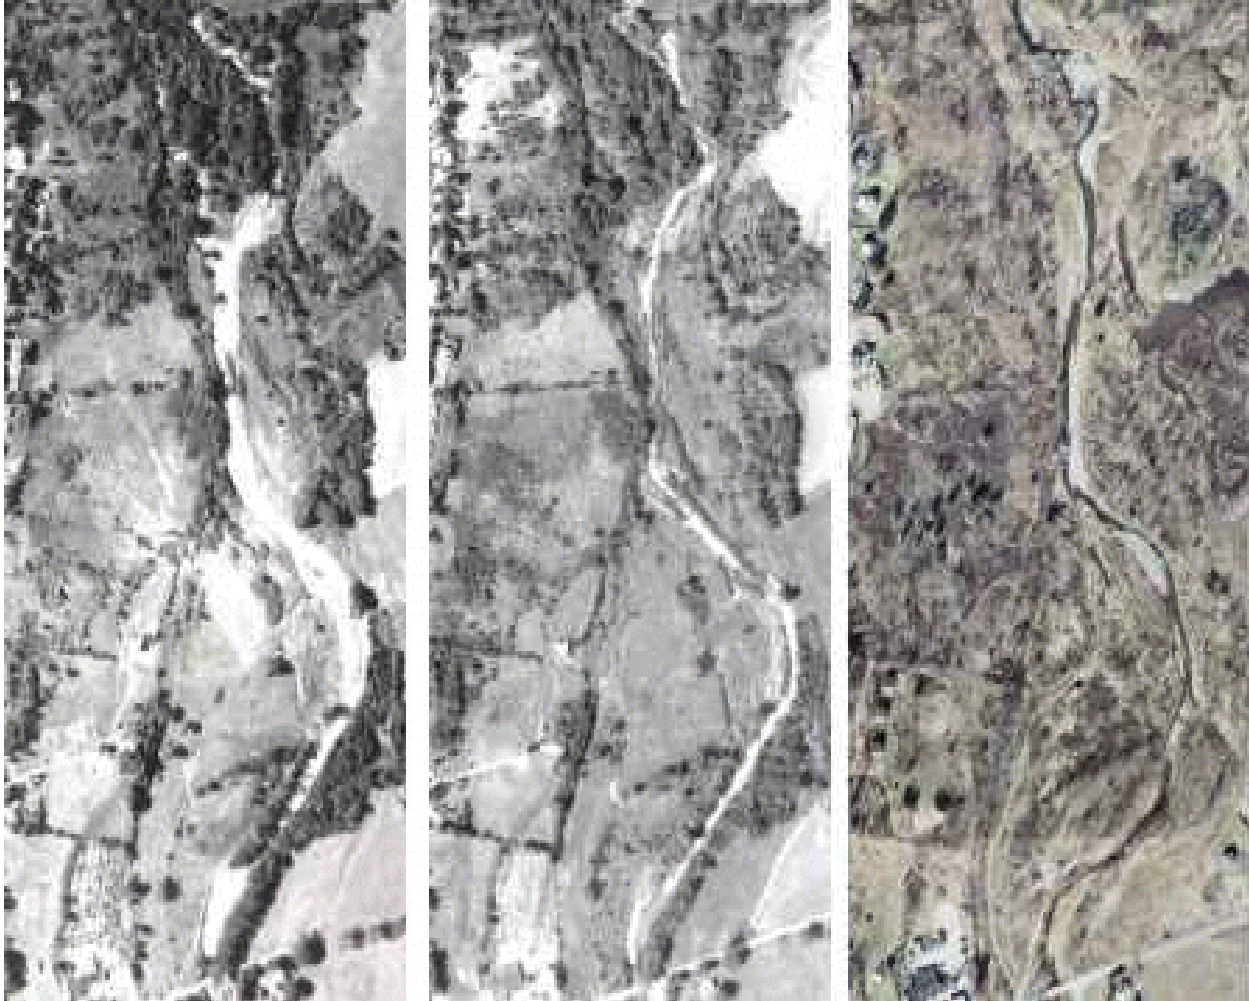
A review of aerial photographs from 1959, 1967 and 2000 (**Figure VI-31**) indicates that the reach has been experiencing relatively slow, but continual lateral adjustments in planform. There are several abandoned channels located within the reach presumably caused by channel migration and the rapid formation of chute cutoff during large flow events. The aerials show that the reach is characterized by significant sediment storage, starting at the point below the confluence with the Silver Lake tributary. A June 1980 aerial photograph shows evidence of active gravel mining through the floodplain in the upper extent of the reach.

**Figure VI-31:** Aerial view of upper end of reach 3a from 1959 (l), 1967 (c) and 2000 (r). Bridge at CR 65 in Hensonville is seen at bottom-center of each photo

and the grasses do not provide adequate rooting depth to prevent bank failure (**Figure VI-28b photo F**). The reach also contains a significant population of Japanese knotweed. As shown in **Figure VI-31**, the reach has exhibited poor riparian conditions as far back as 1959.

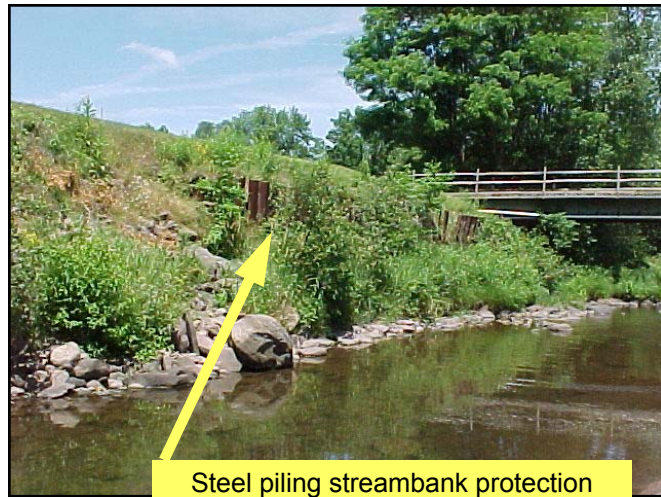
Steel piling streambank protection indicates past instabilities in this area

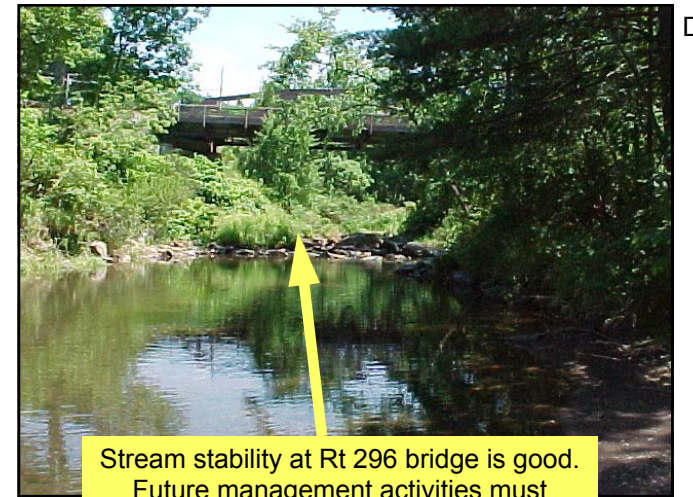
Stream stability at Rt 296 bridge is good. Future management activities must protect stream conditions

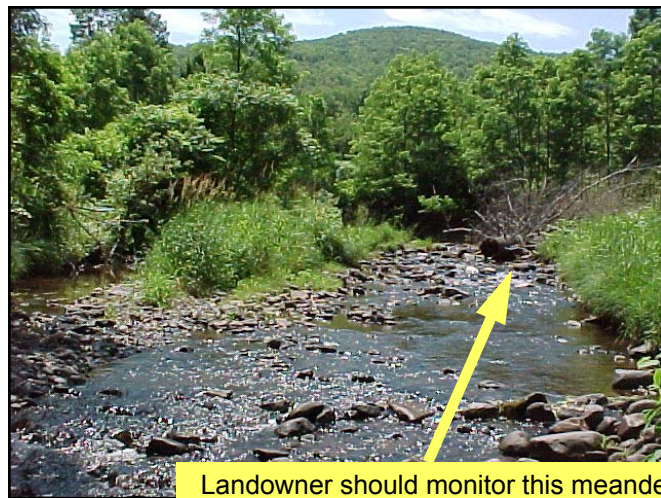
Landowner should monitor this meander for erosion. See GCSWCD for assistance prior to any management activities

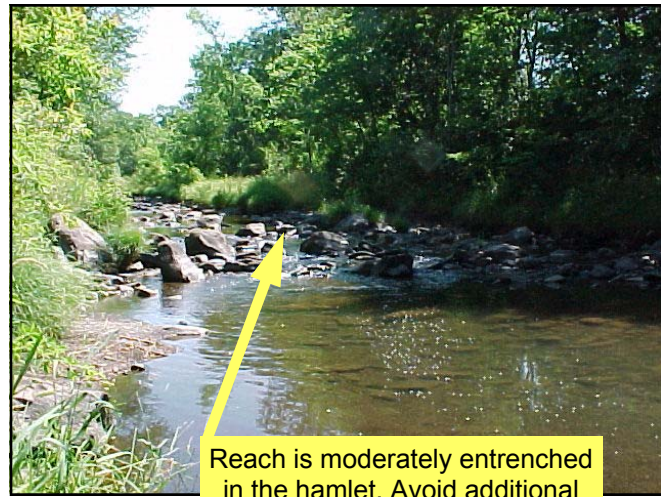
Reach is moderately entrenched in the hamlet. Avoid additional floodplain fills.

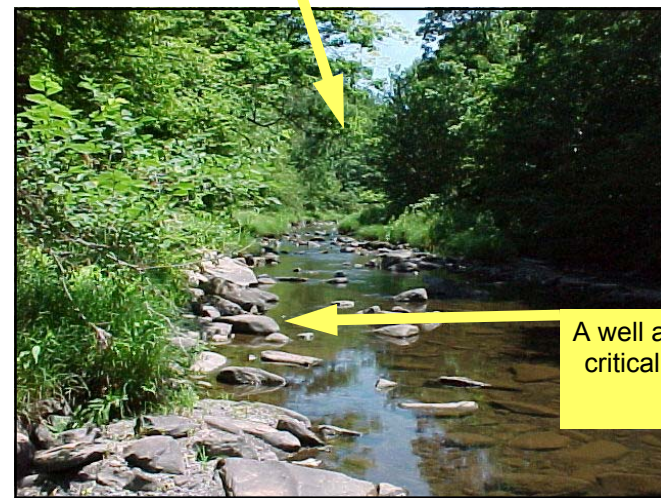
G

A well armored stream bottom is critical to stability. Disturbance must be avoided

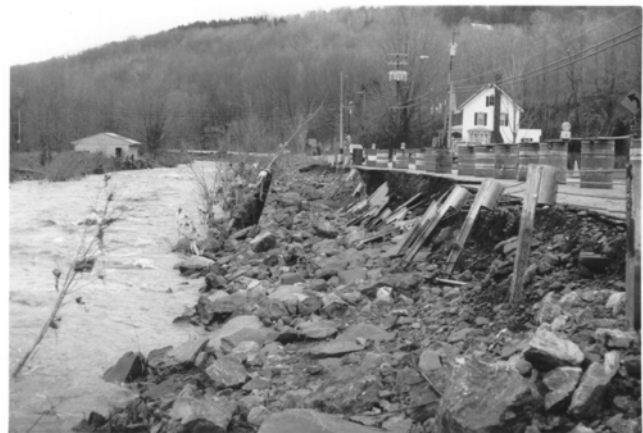
**Figure VI-33:** Severe streambank erosion along NYS 23 below GNH Lumber after 1961 flood.

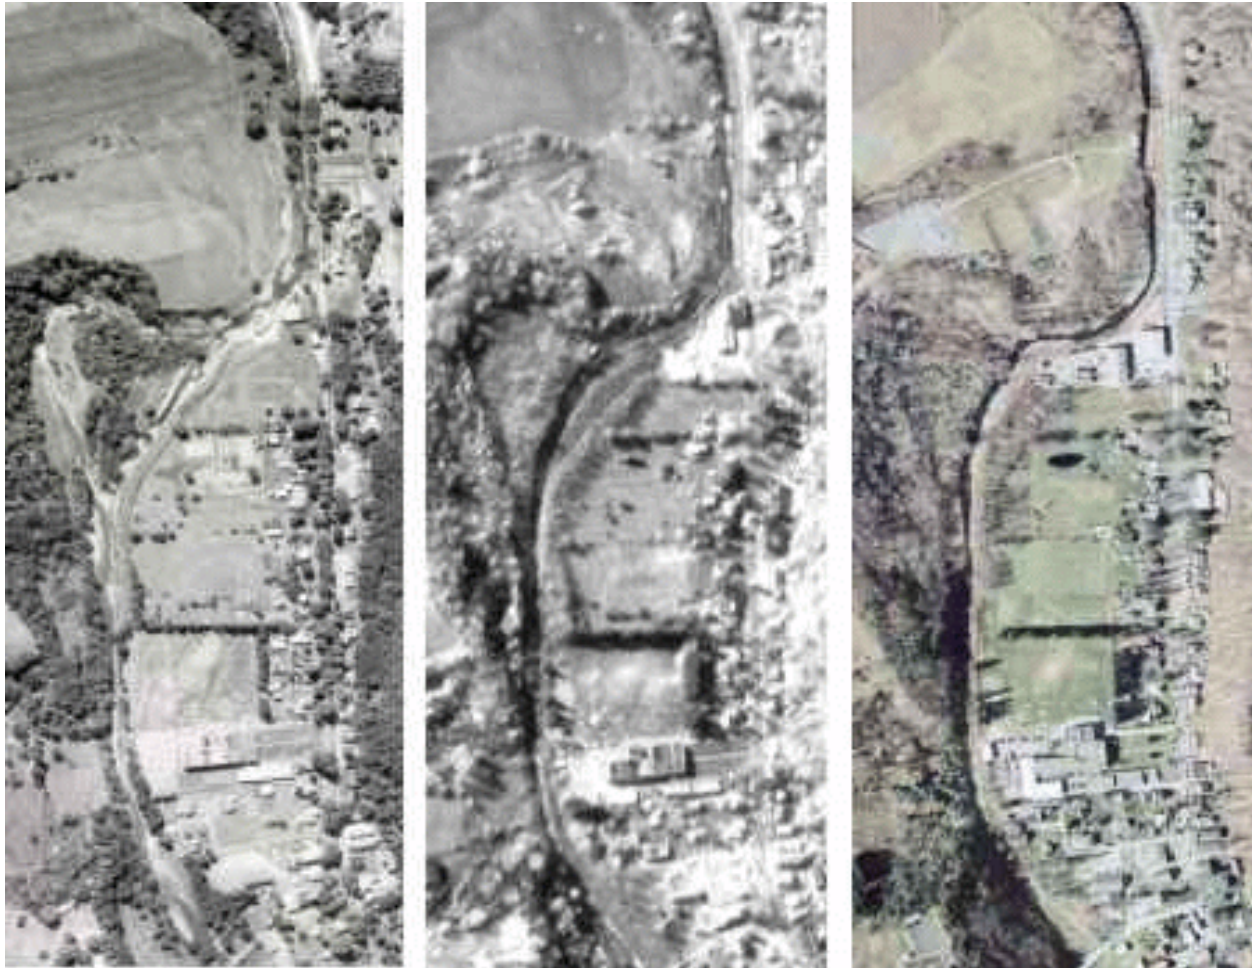
the upper section of the reach between South Street and GNH Lumber (**Figure VI-34**) was shown to have been more active. The aerial photographs indicated that the reach was once split into two channels behind GNH lumber, with only a single channel present in 2000.

**Figure VI-34:** Aerial view of western end of Windham hamlet, 1959 left, 1980 center, 2000 right. Note double channel to the left side of photos.

showing plans to dredge the single channel, which cut off a large meander right behind GNH Lumber. As the channel is located in this area, the GCSWCD assumed that this work had been done, though that could not be directly confirmed. The GCSWCD did not note any active headcuts in the reach, and the erosion of the streambanks does not appear to indicate any active adjustment in planform. It is possible that the channel has already responded to this channelization.

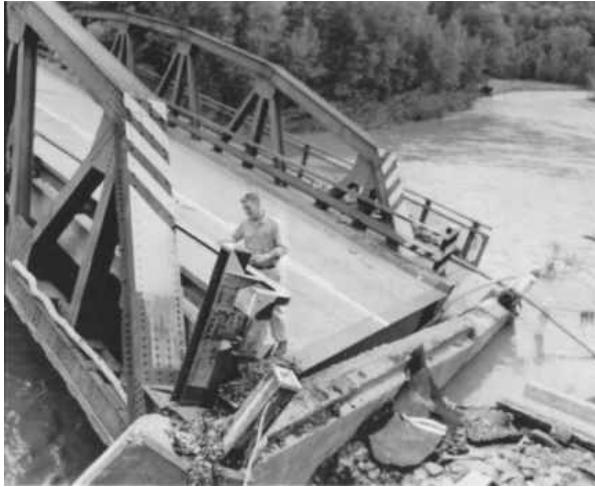
**Figure VI-36:** 1961 flood damage to Church Street bridge located in Reach 3c.

Other issues related to flooding in this reach includes the recurring flooding of NY Route 23 just west of GNH Lumber, and the threat of erosional damage to the bridges. Just west of GNH Lumber, the roadway has been washed out several times, and in the larger floods such as 1996 and 1999, the moderate entrenchment in the reach has resulted in the stream flooding the roadway. Earlier floods in the 1950's and 1960's resulted in significant infrastructure damage, with both bridges in Reach 3c experiencing total loss. As shown in **Figure VI-36**, the stream channel migrated around the bridge abutments causing them to fail. Since the time of these floods, the Batavia Kill Watershed District flood control structures

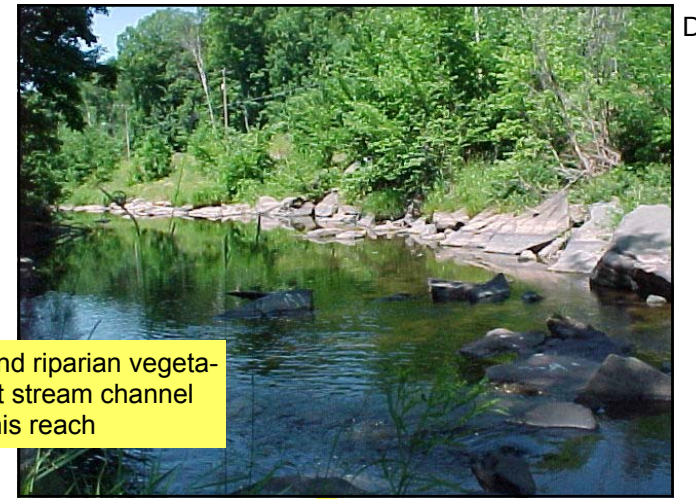
D

Well armored streambed and riparian vegetation are critical to prevent stream channel degradation in this reach

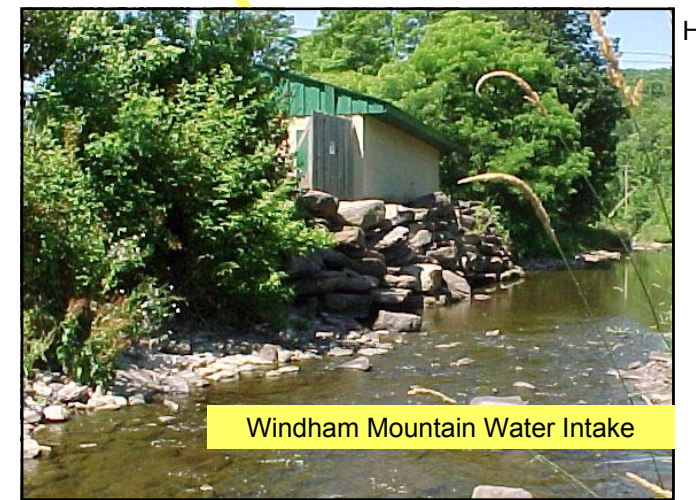
H

Channel exhibits good stability but is entrenched by a low terrace and NY route 23. Avoid new floodplain fills
