Reach 5b (Kane Bridge to Red Falls)

Stream Morphology/Stability

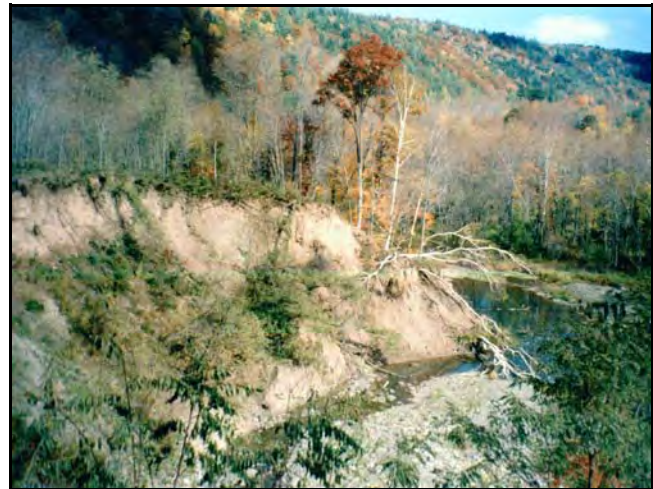
Figure VI-82: Mass wasting of high terraces along reach 5b present a significant water quality concern

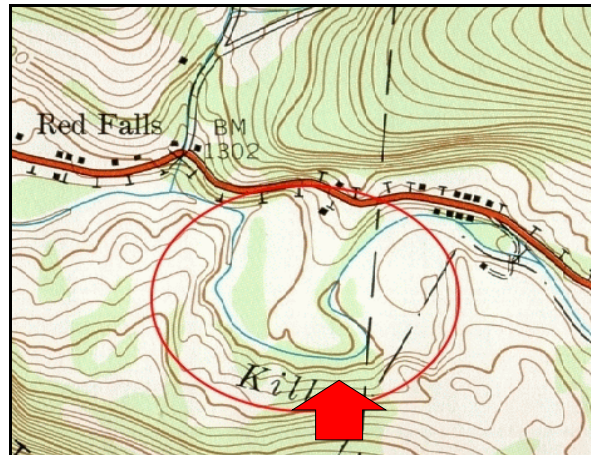
The primary factor influencing stream stability in reach 1b is the natural constriction of the valley. As seen in **Figure VI-83**, the remains of a large glacial moraine across the valley floor leaves very limited *beltwidth* for the stream channel. The moraine shows extensive signs of folding of the clay layers, indicating that the moraine was acted on by multiple glaciers. In several sections of the reach, the moraine impinges on the active channel completely detaching the channel from its floodplain.

Figure VI-83: Terminal moraine and natural valley topography strongly influence entrenchment in reach 5b.

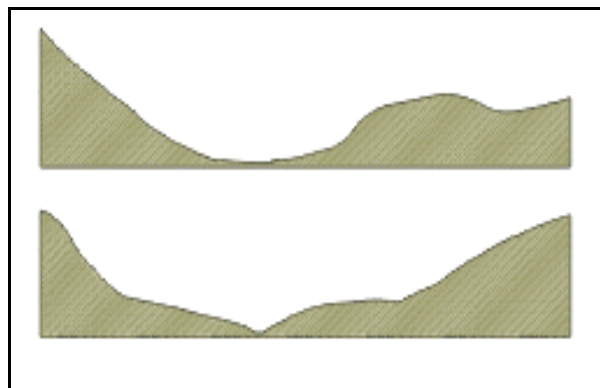
Figure VI-84 compares a valley cross section well above the Red Falls reach, to a typical valley cross section within the reach. Note the “U” shaped valley above, with a broader valley floor that allows for floodplain development. Conversely, the valley morphology at the Red Falls reach is characterized by a deep “V” shape in which the channel is confined.

Figure VI-84: Valley cross sections from 1000' above Red Falls (top) to a cross section in reach 5b

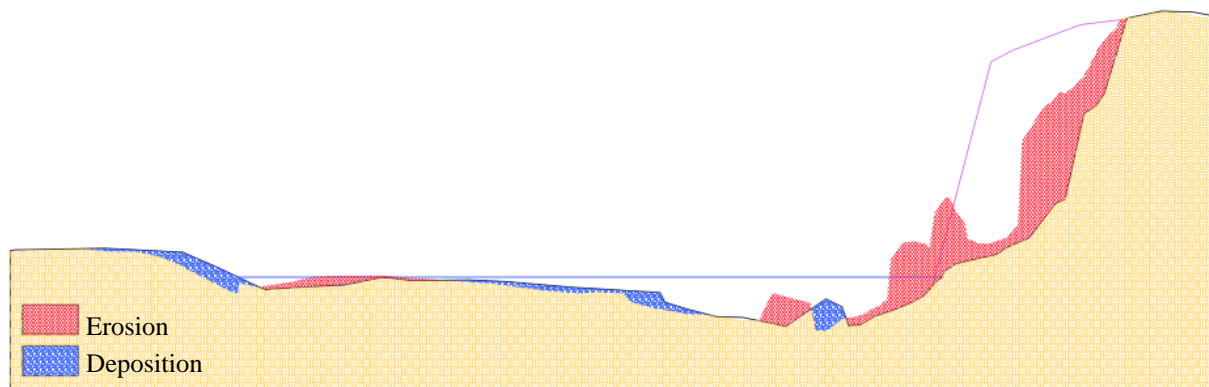
reach (**Figure VI-90**) the stream classifies as a C3 stream type, with a large flood plain along the west streambank. The right side of the stream channel runs along the upstream race of the glacial moraine which is approximately 40 feet in height and is comprised primarily of glacial clays and silt. At the lower end of the moraine, the channel has exhibited a tremendous amount of mass wasting during the monitoring period (**Figure VI-90a photo G, Figure VI-90b photo D,F,J**). Monitoring cross sections located at the bottom of this area show the erosion measured between 1997 and 2000 (**Figure VI-85**). It was estimated that the slope failure experienced nearly 50,180 cubic feet of erosion during an eight month period.

Figure VI-85: Overlay of cross section #2 at Red Falls site 1997 to 2000. Single thin line represents bank profile from 1997 data collection.

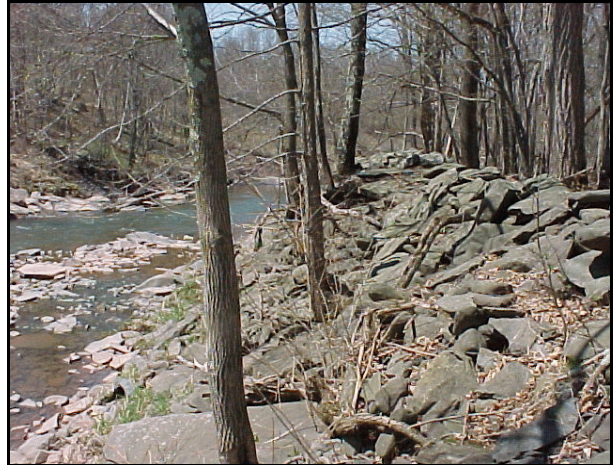
A significant section of the entrenched section of the reach contains a large stone wall running approximately 600 feet on the right streambank. The wall may have been a feature of the old mills or it may have been to protect the mills from flooding. In either case, it now cuts off the Batavia Kill's access to its adjoining floodplain (**Figure VI-86**). Inspections of reach 5b after the September 1999 flood event revealed no signs that streamflow had accessed the majority of the floodplain during and after the flood event. By preventing the

stream flow from entering the flood plain during floods, the main channel experiences increased velocity and shear stress which is contributing to the channel's downcutting. Further degradation of the channel only worsens the entrenchment condition, accelerating the process over time.

Figure VI-86: Large stone wall along right streambank increases channel entrenchment.

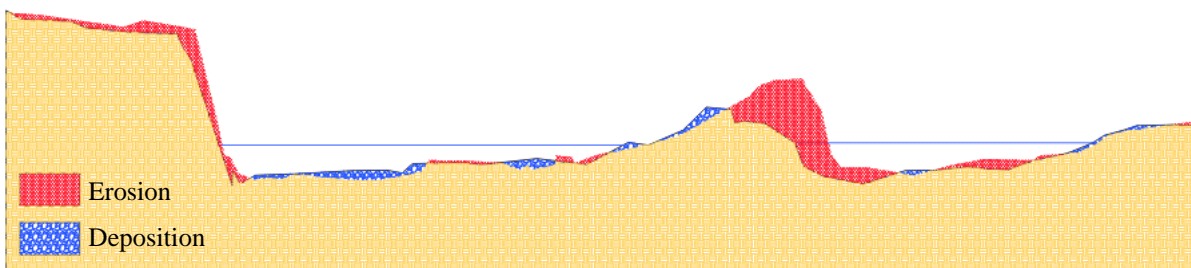
Proceeding down the reach, the Batavia Kill divides into two separate channels, with a fairly large central island. The left channel appears from the 1959 and 1980 aerials to have been the primary channel with the area where the right channel is located showing long term instability. In 1997, the GCSWCD noted that the right channel appeared to be a recently developed cut-off chute. The right channel has a steeper slope, and is characterized by a cobble and boulder streambed structure. A monitoring cross section located on the upper end of the divided channel has indicated that erosion is increasing the size of the right channel, with the left channel experiencing minor aggradation (**Figure VI-87**).

Figure VI-87: Monitoring cross section (#8) at upper end of divided stream channel. Note severe erosion of central island by the right hand channel. (1998-2000).

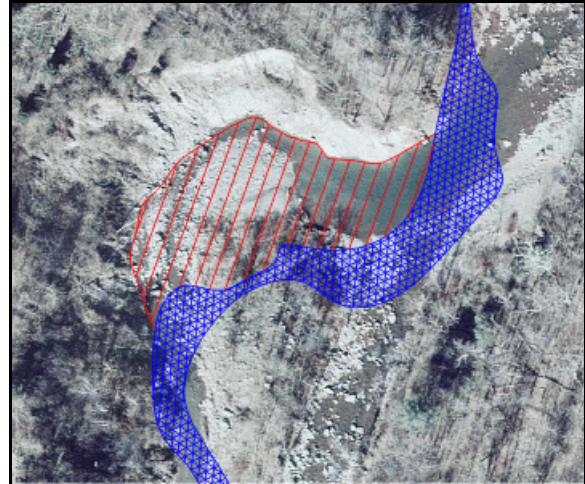
Noted on the 1959 aerial photograph was severe bank erosion located on the left bank just above the bottom of the reach. This erosion has continued to migrate nearly 150 feet toward the north west in the past 41 years, with 23,650 ft² of erosional loss. The magnitude of the erosion from this single stretch of stream channel is well represented by monitoring cross section #10 located at the slope failure area. As seen in **Figure VI-89**, between 1997 and 2000, tremendous areas of streambank materials were lost to erosion.

Figure VI-88: Stream channel migration between 1959 (blue) and 2000 (photo). Red is eroded area.

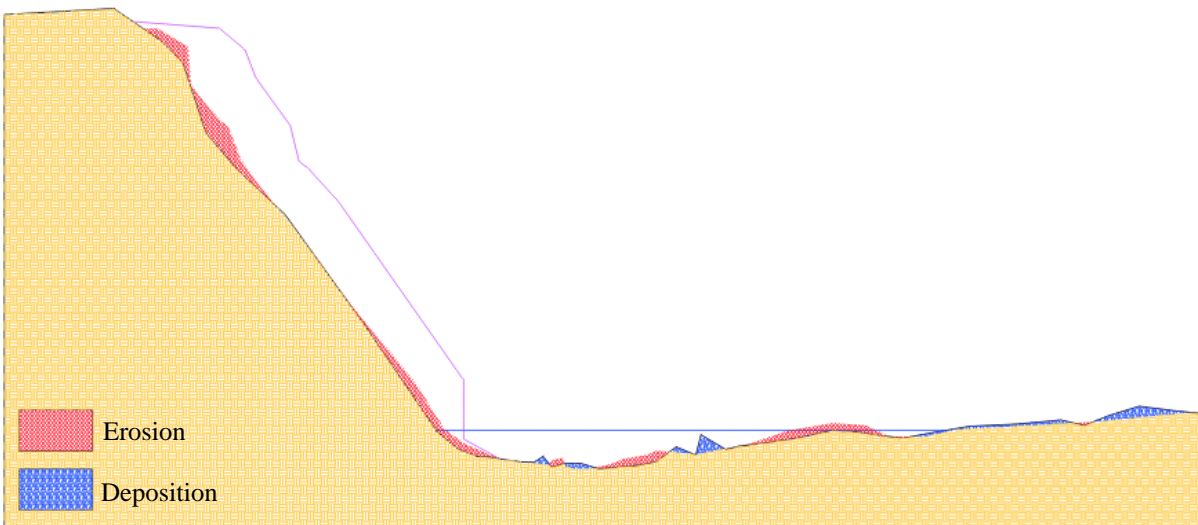
Figure VI-89: Soil erosional losses at Red Falls cross section #10 between 1997 and 2000. The thin line represents the 1997 bank and bed profile. Red is erosion, blue is deposition. View is looking downstream.

By calibrating historical aerial photographs to a topographic survey of the reach, the GCSWCD was able to develop a fairly accurate estimate of soil loss from the eroding banks near the bottom of the reach. Sediment loss was estimated by comparing the area between water surface boundaries and top of banks, and then multiplying by the average eroded bank height. This resulted in an estimate of nearly 1,182,500 ft³ of material loss. To put that in perspective, imagine 2,190 large dump truck loads of material eroded from a single, isolated reach.

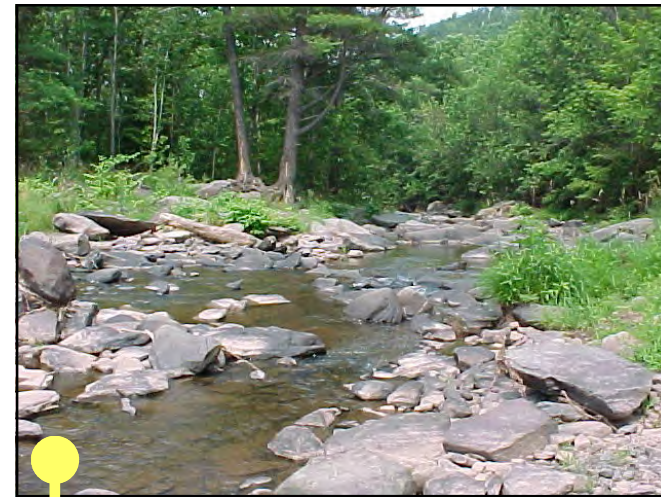
D

Severe erosion had previously been located upstream of the current failure, in the first meander bend below the Kane bridge. In the late 1980's, NYSDOT completed a major stabilization project on this bend, installing over 500 feet of heavy rock rip-rap on the right bank (**Figure VI-90a photo A,E**). It is presumed that the stream responded to the rip-rap by transferring erosional forces downstream to the current location.

Over 500 feet of rip-rap has been placed by NYSDOT to fix flood damage in early 1990's

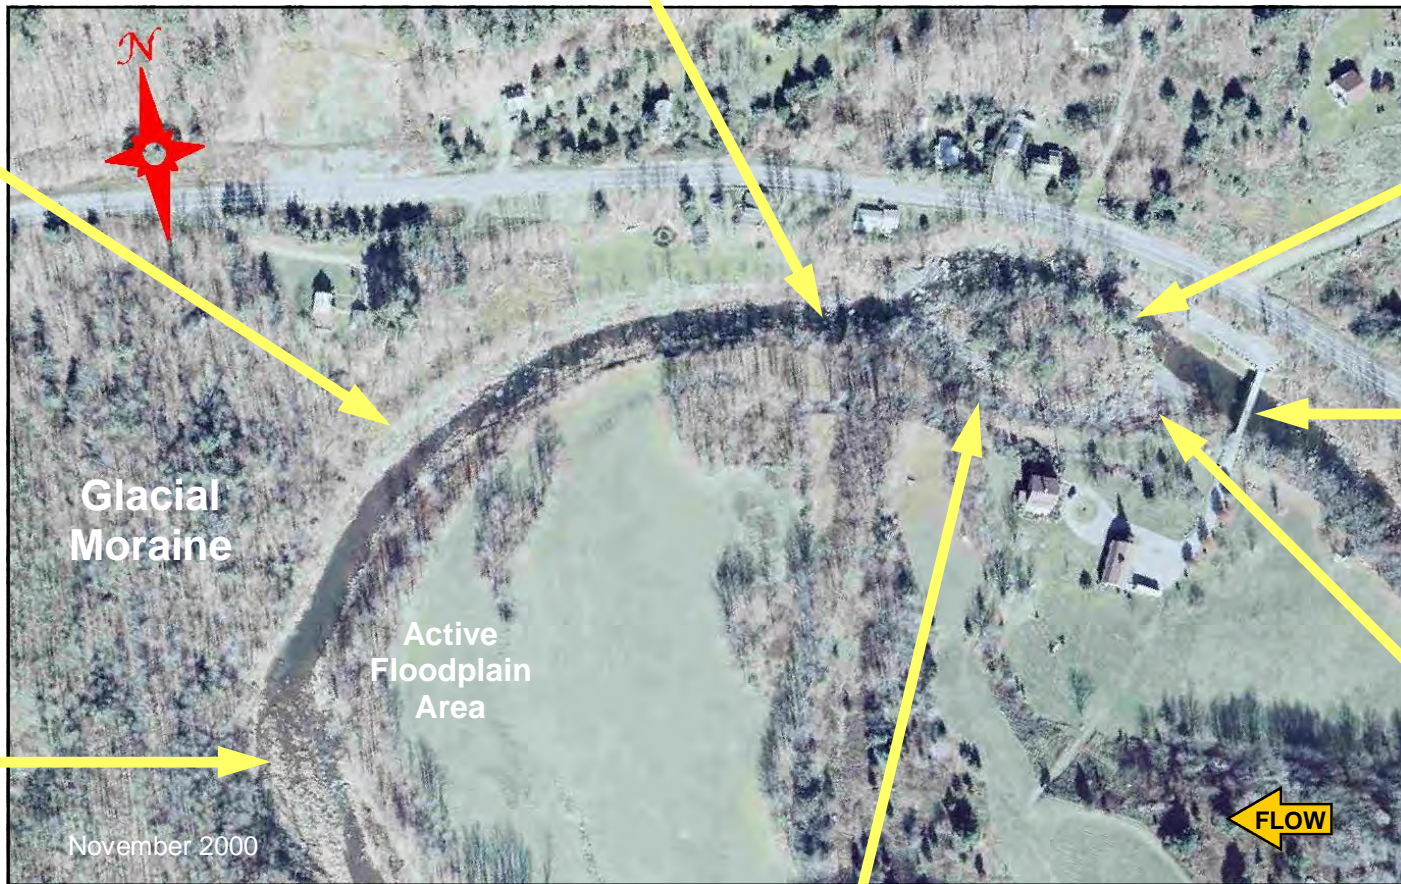
Figure VI-84a: Reach 5b-Upper

Upper portion of Reach 5b is fairly stable. Well armored streambed and dense riparian vegetation are key factors

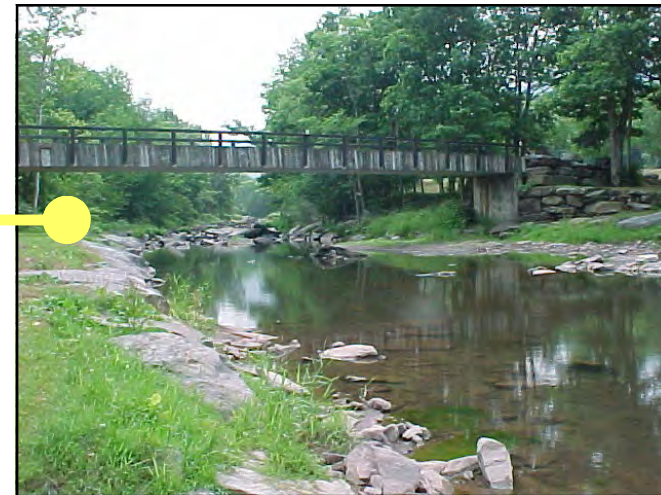
F

Red Falls erosion of high terrace starts in this are

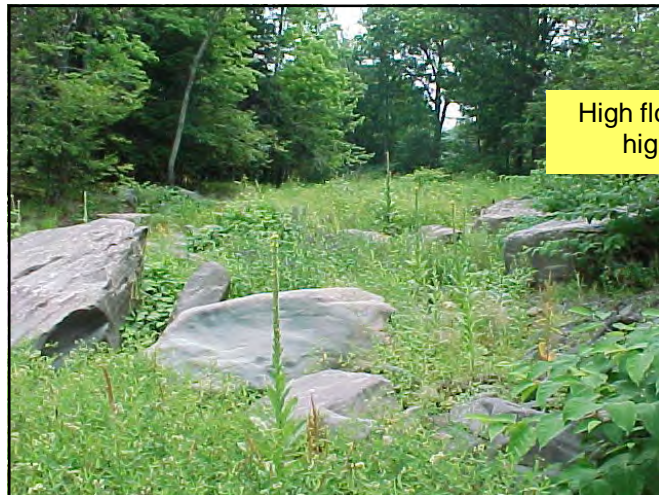
H

High flow channel is highly stable

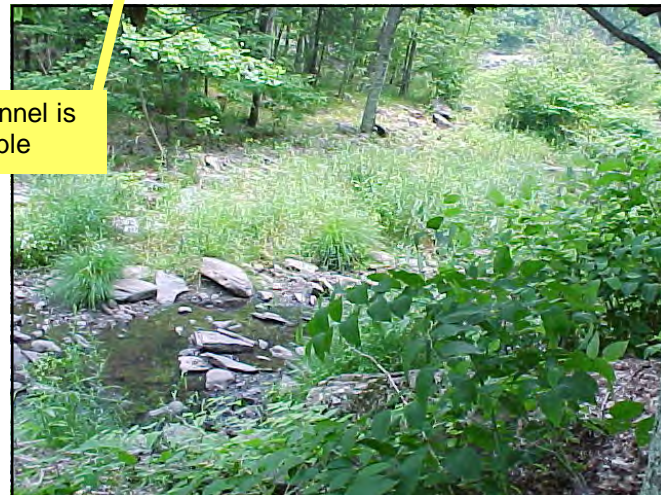
I

Channel splits just below Kane bridge, left channel is high flow area

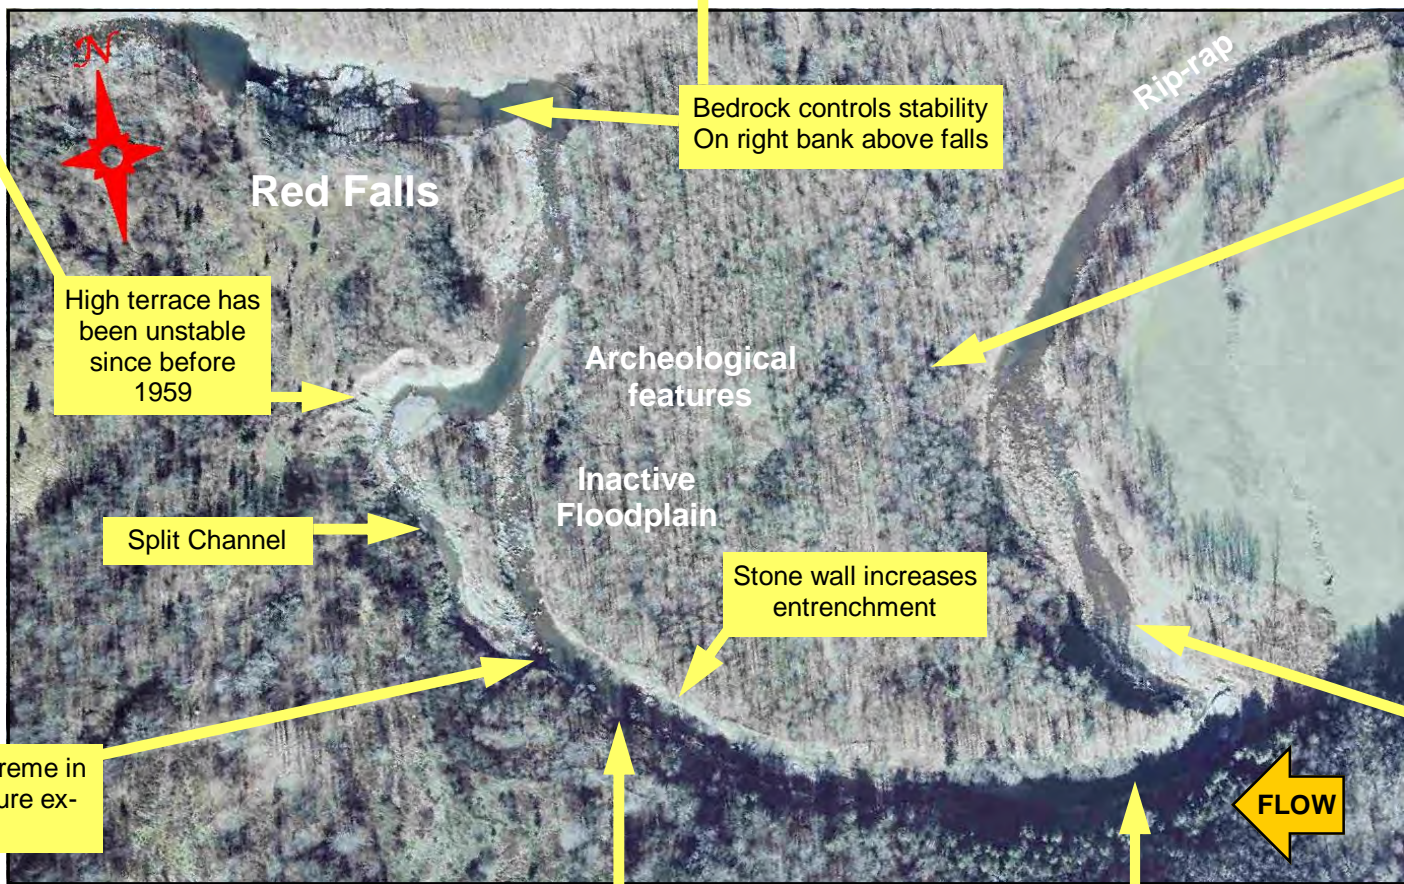
Figure 84b: Reach 5b-lower "Red Falls"

High terrace has been unstable since before 1959

Bedrock controls stability On right bank above falls

Rip-rap may contribute to instability. While rip-rap stabilizes that location, erosion energy is often deflected downstream

Streambank failure becomes extreme in the lower end of Reach 5b. Failure extends over 300' upslope

Major erosion is occurring along the moraine. Soils are dominated by clay and silts

Geo-technical slope failures start to show up in this area

Batavia Kill passes through narrow, bedrock notch
