Schoharie Creek Management Unit 15

Town of Lexington – Station 34336 to Station 31388

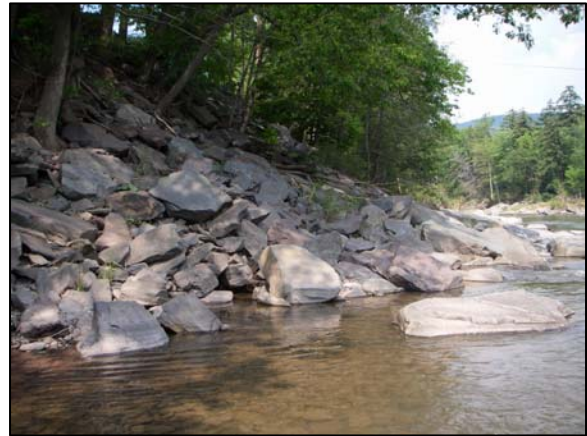
Rip-rap at Station 34360

At the upstream end of the management unit, rip-rap had been installed along 132 ft of the left stream embankment (Station 34360). While rip-rap and other hard controls may provide temporary relief from erosion, they are expensive to install, degrade habitat, and require ongoing maintenance or may transfer erosion problems to upstream or downstream areas. Alternate stabilization techniques should be explored for

streambanks whenever possible. Interplanting of this rip-rap, by inserting native tree and shrub plantings into the soil between the rocks, would increase bank protection and its long-term effectiveness. These plantings could also improve the aquatic habitat by providing shade, resulting in cooler water temperatures.

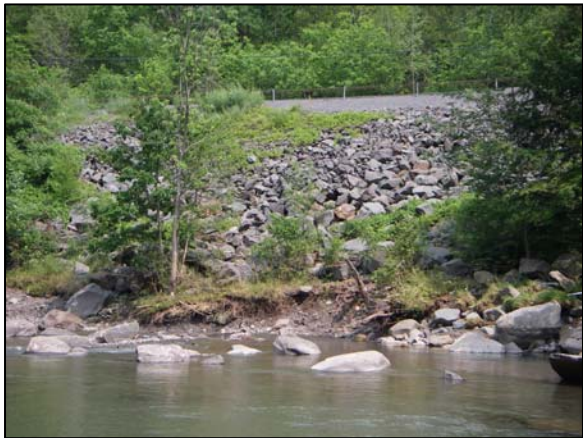
Rip-rap at Station 34050

On the opposite bank, the County Route 23A road embankment had scoured along 100 ft of the right streambank exposing the underlying *lacustrine* clay (Inset D, Station 34050). Fine sediment inputs into a stream increase *turbidity* and can act as a transport mechanism for other pollutants and pathogens. Sixteen small 1” drainage pipes outlet stormwater at the toe of the bank exacerbating this scour (Inset C). To provide

protection against further toe erosion, sedges and willows could be planted along the toe of the streambank. The rip-rap, which had been installed on the upper embankment, should be interplanted with native tree and shrubs to increase its longevity (Station 34000).

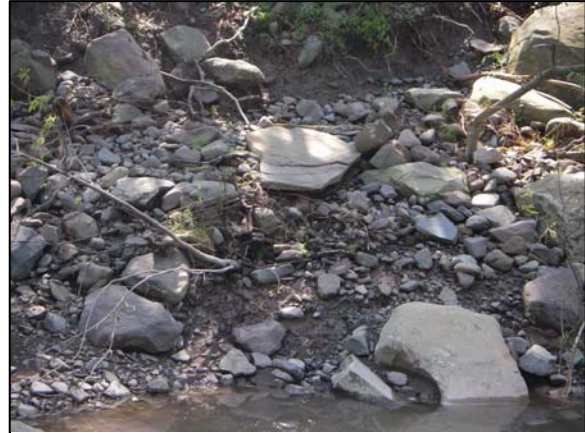
Clay exposure at Station 33800

Immediately downstream, the bank toe continued to scour exposing another 114 ft of clay and silt along both the streambank and bed (Station 33800). To increase bank stability and improve aquatic habitat, native shrubs and sedges should be planted along the streambank and toe. At the top of the streambank there was a NYSDEC public fishing access with a parking area. These access points allow the public to wade and walk along the streambed and banks for the purpose of fishing. Structured access should be provided from this parking area to avoid fishermen inadvertently increasing the erosion problem while accessing the stream.

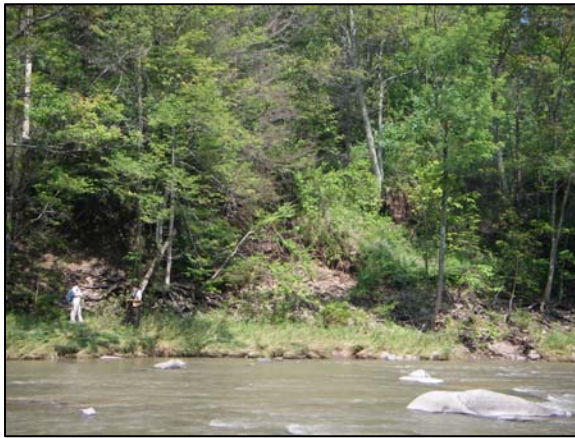
Bank erosion at Station 32900

Downstream, 126 ft of the hillslope on the left streambank was eroding resulting in the loss of mature vegetation from the face of the streambank (Station 32900). Stormwater from the outlet at the top of this bank appeared to be causing most of the erosion at this site (Inset B, Station 32800). Outlet protection, such as a rock lined channel, should be installed to dissipate flow and prevent erosion. To minimize erosion, stormwater outfalls

should be designed to outlet near the base of the streambank, set back from the active stream channel, and enter the stream at a low angle. The streambanks from here to the downstream end of the management unit appeared stable.
