Schoharie Creek Management Unit 1

Town of Hunter - Prediger Rd. (Station 159225) to Dale Lane (Station 151439)

This management unit begins at Prediger Road, continuing approximately 7,786 ft. downstream to Dale Lane in the Town of Hunter.

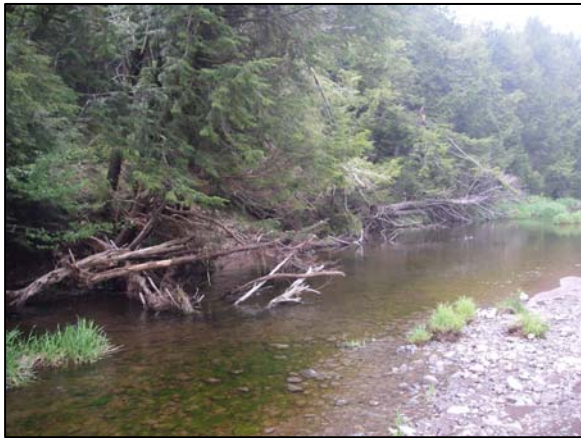
Bank erosion at Station 155250

This increase in runoff and sediment load may have contributed to the streambank erosion directly downstream of the tributary confluence (Station 155250). An area of approximately 1,276 ft² of the left streambank was experiencing erosion. As a result, many mature trees fell into the stream and lined the streambank toe providing some protection against future erosion.

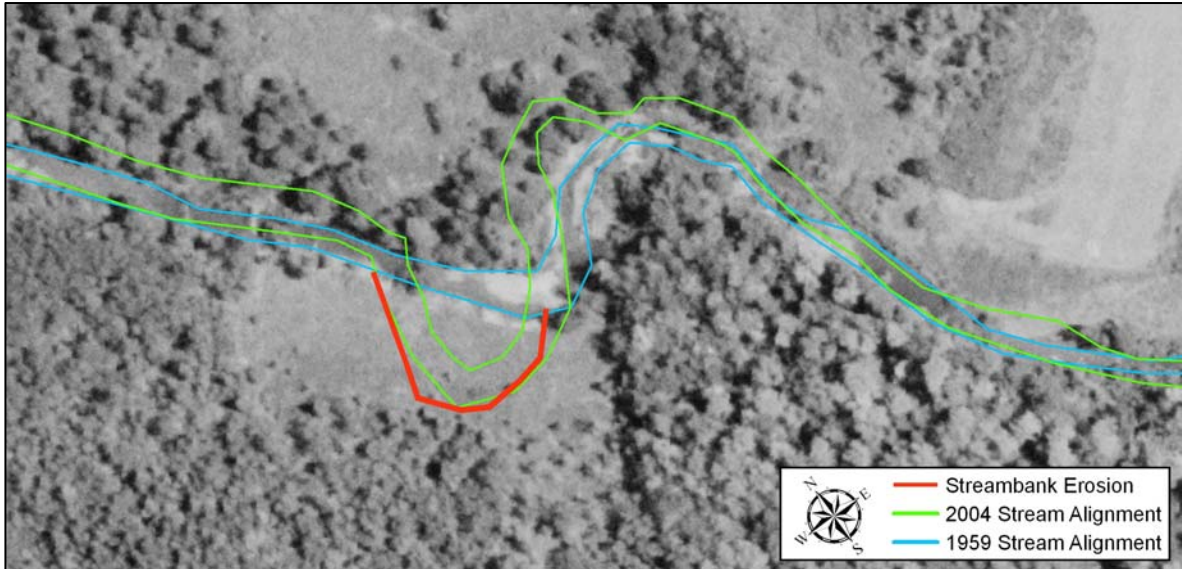
Downstream, the channel began to meander sharply. As shown in the aerial photo, this meander bend has significantly migrated since 1959, causing a 2,245 ft² area of erosion on the left bank in 2006 (Station 154070 Inset B). As the stream curved, it cut and eroded

Bank erosion at Station 154070 - Historic stream channel alignments overlaid with 1959 aerial photograph

into the outside of the meander bend and deposited sediment on the inside of the curve. This is due to the fact that the stream flow moves more rapidly on the outside of the curve and more slowly on the inside of the curve. As the erosion and deposition continued, the curve became larger and more circular. This is a natural process and typically happens slowly over time.

The land adjacent to this erosion appeared to have been cleared sometime prior to 1959 increasing its vulnerability to erosion. The eroding streambank had three clay exposures totaling 130ft. in length. Downstream of this meander the streambanks appeared stable.

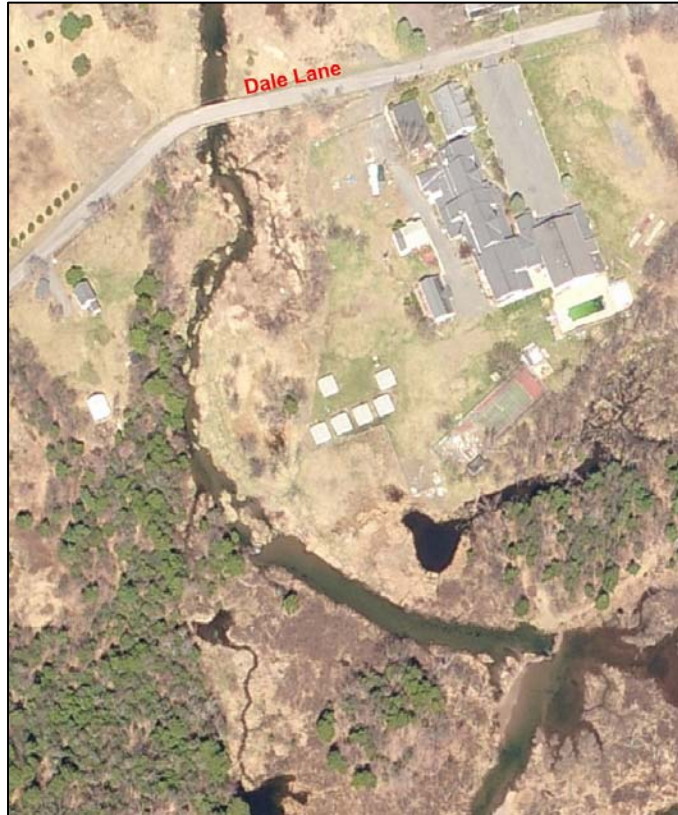
At the downstream end of this management unit the land use on the right streambank changed from forested to residential, with herbaceous vegetation in the riparian zone. Mown lawn or pasture does not provide as much resistance to streambank erosion as the deep and dense root structure found in streamside forest. The complex root systems of trees may also act to filter nutrients and pollutants from the septic effluent, if any, from the adjacent residences. Areas where the riparian zone has been maintained in pasture or lawn present opportunities to improve the

Riparian planting site (Station 152300 – 151750)

streamsides buffer with tree plantings in order to promote a more mature vegetative community along the streambank and in the floodplain. Recommendations for this site include planting native trees and shrubs along the edge of the stream bank and the upland area (Station 152300 – 151750). Buffer width should be increased by the greatest amount agreeable to the landowners, but increasing the buffer width by at least 100 feet will increase the buffer functionality. The dwellings situated in the floodplain should also be relocated, to protect both the private property and water quality.

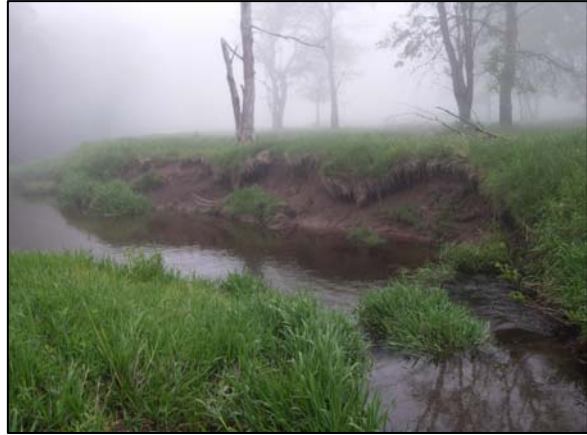
There were two minor erosion occurrences in this area. The first was located on the right streambank and was approximately 182 ft² in area (Station 152000). The second, with

Bank erosion at Station 152000

an area of 135 ft², was located on the right streambank at the very end of the management unit (Station 151590, Inset A). To prevent future erosion, vegetation plantings are recommended for both of these streambanks, including vegetative protection of the toe. Reshaping these streambanks by grading may be necessary prior to planting. This work should be preceded by a more detailed site assessment.

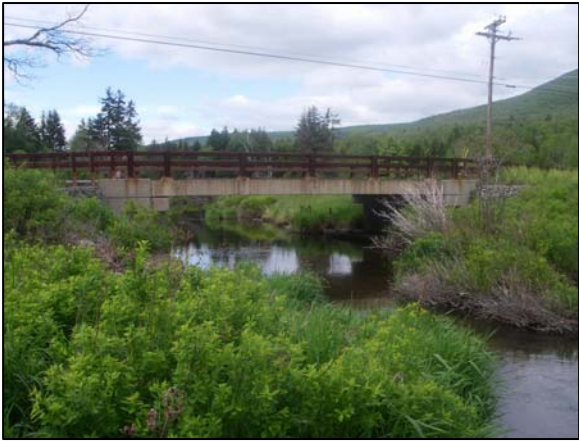
Bridge at Dale Lane

Lane Bridge (BIN 3200970). This bridge may constrict the floodplain at very high flows, but appeared to pass most flows effectively. Flood damage to bridges is typically caused by inadequate hydraulic capacity of the bridge, misaligned piers and/or abutments, or accumulation of debris. As bridges are replaced over time, these issues should be evaluated and adjusted if necessary to lessen the

Gabion baskets were placed at the abutments to provide scour protection. Rock-filled gabions are not generally a recommended management practice by the GCSWCD. They have a tendency to be unsightly, and when installed incorrectly they frequently blow out of the bank and scatter rocks and cages downstream. Their correct use requires professional installation and maintenance.

probability of flood damage by providing a more effective conveyance channel that promotes water and sediment flow through the bridge opening.

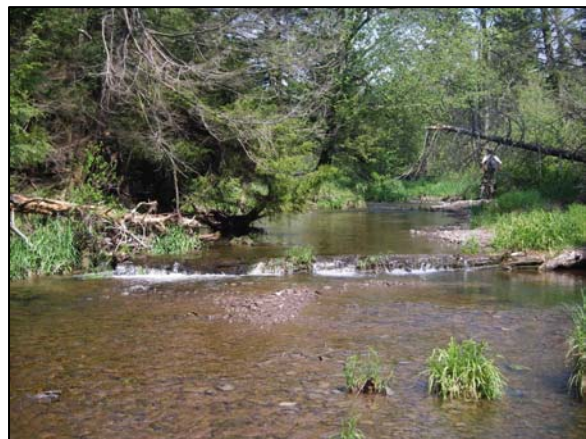
There were seven fish habitat structures installed in this management unit. Habitat structures were historically installed throughout the Schoharie Creek by the New York State Department of Environmental Conservation (NYSDEC), often in an effort to create scour pools. Scour pools offer deeper holding habitat, and the spillways raise the amount of dissolved oxygen in the water. The structures, most often in the form of a flat log weir perpendicular to the channel, also provided temporary grade

Habitat structure

control. In general, due to the horizontal, channel spanning design, they cause water to back up on the upstream side of the structure which can increase sediment deposition. Because most of these structures do not include an area for concentrated flow that provides for sediment transport, sediment deposition often occurs downstream from an initial scour area under the structure. This can cause widening of the channel, which further decreases sediment transport. In some settings, this can promote lateral channel migration, increase stream channel width-to-depth ratios and result in bank erosion up or downstream. In wild streams, these functions – both positive and negative – are performed to a large extent by large woody debris. It is recommended that an aquatic habitat study be conducted on the Schoharie Creek with particular attention paid to springs, tributaries and other potential
