Schoharie Creek Management Unit 3

Town of Hunter – Bunny Lane (Station 148641) to Station 138610

This management unit begins at Bunny Lane, continuing approximately 10,031 ft. to Station 138610 in the Town of Hunter.

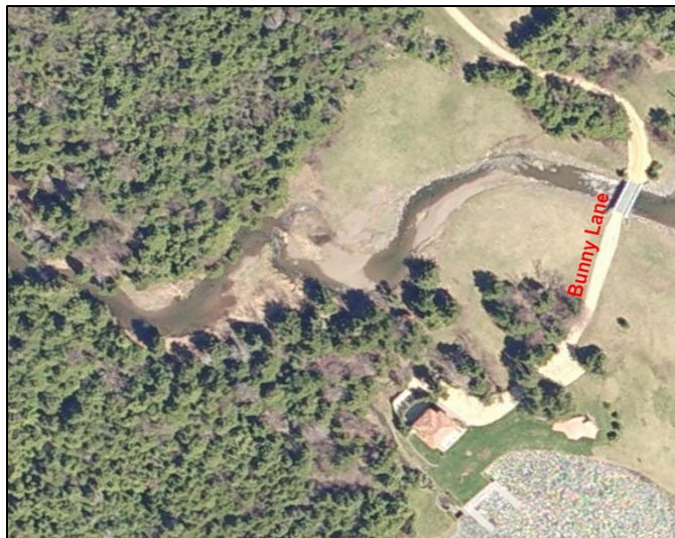
The riparian buffer beyond the rip-rap was comprised of mown grass to the edge of the bank (Station 148641- 148300). The risk to bank stability can be minimized by maintaining mature trees along the critical 100 foot buffer zone. Buffer width should be increased by the greatest amount agreeable to the landowners, but increasing the forested buffer width by at least

Riparian planting site downstream from Bunny Lane
(Station 148641- 148300)

100 feet will increase buffer functionality, such as filtering nutrients and pollutants, if any, from the adjacent lawn.

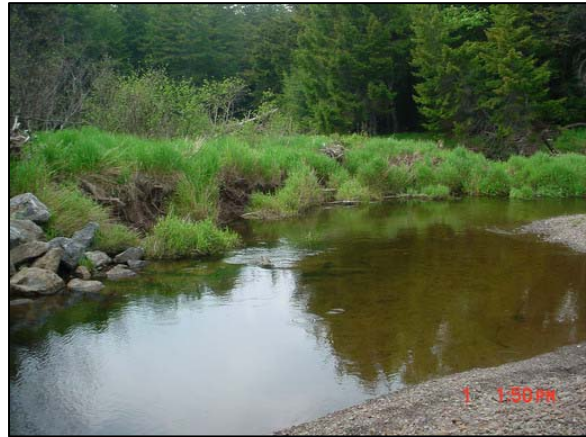
As the rip-rap on the left streambank ended, erosion began (Station 148200).

This erosion was 48 ft in length, exposing an area of 194 ft², including a 30ft² area of *lacustrine* clay. Fine sediment inputs into a stream can be a serious water quality concern because they increase *turbidity*, degrade fish habitat, and can act as a transport mechanism for other pollutants and *pathogens*. To prevent future erosion,

Bank erosion and clay exposure at Station 148200

riparian plantings including native willow and sedge species along the streambank toe are recommended. Reshaping these streambanks by grading may be necessary prior to planting. This work should be preceded by a more detailed site assessment.

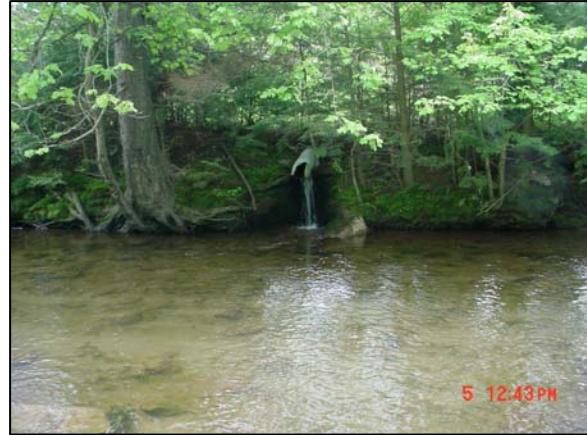
Just downstream, on the right streambank was a piped outfall which flowed intermittently and conveyed excess water from a pond in the adjacent field (Station 146830). This outfall was presumably installed flush with the streambank which has since been eroded by the pipe's discharge. Rock outfall protection is usually recommended in these instances to prevent bank erosion.

Piped outfall at Station 146830

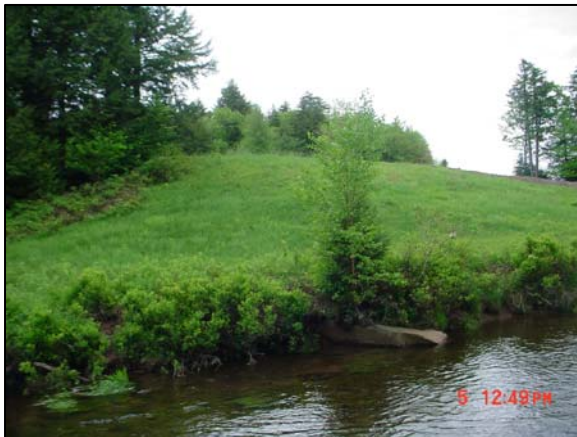
The adjacent riparian buffer has been mowed to the top of the streambank (Station 146750). Areas of *herbaceous* vegetation, such as this, present opportunities to improve the streamside buffer with tree plantings, in order to promote a more mature vegetative community along the streambank and in the floodplain. The deep and complex root systems of trees may also act to filter nutrients and pollutants found in stormwater runoff.

Riparian planting site at Station 146750

Another solution is to simply stop mowing this area and allow for natural regrowth.

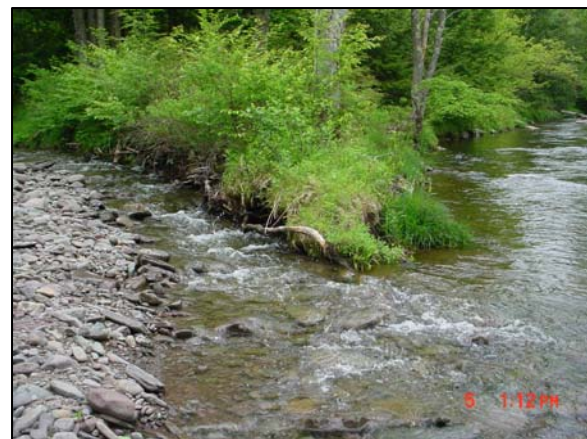
An unnamed tributary entered the stream at Station 146100. Originating on steep mountainous slopes, this stream drained parts of Roundtop Mountain before crossing under Platte Clove Road where the topography flattened before it entered the Schoharie Creek. As a result of this topography change, the tributary lost its ability to transport sediment gathered from the mountain slopes, and began to deposit

Tributary at Station 146100 - looking upstream

sediment at its mouth and into the more gently sloped Schoharie Creek. This is a common feature of confluence areas, which often contain extensive sediment bars, function as important sediment storage areas and are typically among the most dynamic and changeable areas in the stream system. This tributary is classified by the NYSDEC as C(t).

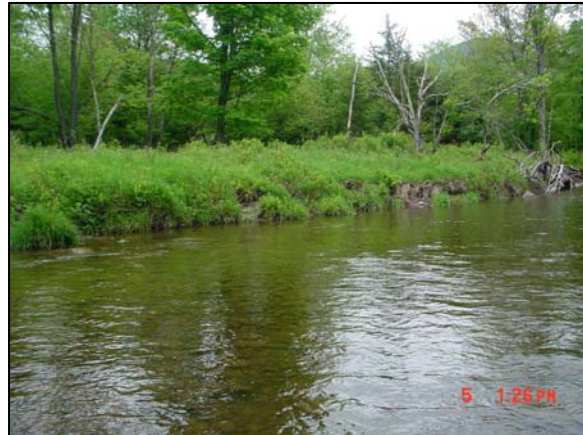
At Station 145900, the right streambank buffer was dominated by small herbaceous plants. This riparian area would benefit from native tree plantings.

Riparian planting site at Station 145900

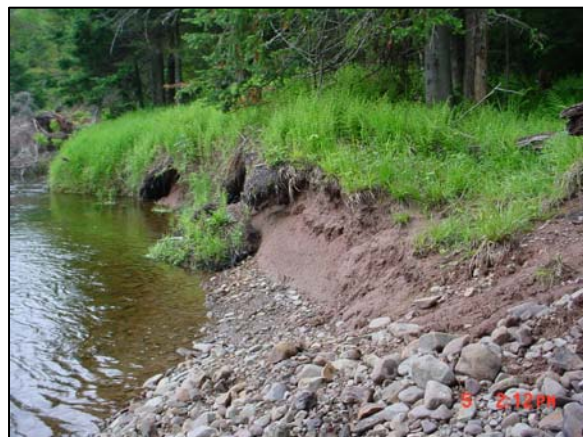
At the next meander bend there was another 120 ft² clay exposure on the right stream bank (Station 144700). This bank scour may have been exacerbated by upstream and downstream woody debris. While woody debris is valued for its many habitat features, it can also present problems when it diverts stream flows. Removal of some woody debris is recommended at this site to reduce potential clay inputs into the stream.

Clay exposure at Station 144700

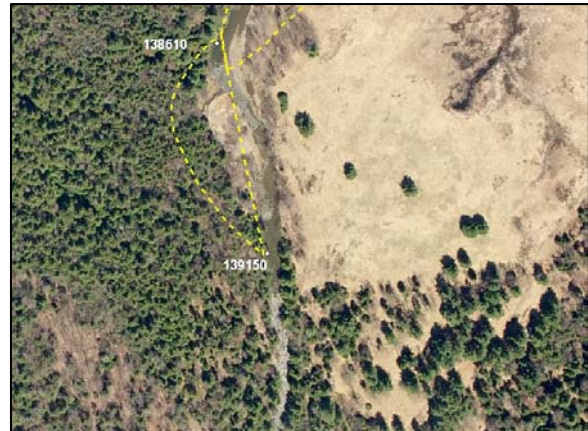
At the end of the management unit there was a large 1.3 acre wetland, classified as Palustrine, Scrub-Shrub, Broad-Leaved Deciduous, Temporarily Flooded (PSS1A) on the left bank (Station 139150). Across the stream, bank stability was suffering from scour, and the riparian buffer was inadequate (Station 138900, Inset A). To improve the buffer native trees should be planted in the upland area, and willows and sedges planted along the toe to improve bank stability and combat continued scouring.

*Wetland (Station 139150-138610) and planting site
Approximate wetland boundary delineated by NWI*
