## Management Segment 1

### Source to C.D. Lane Park

Map VI-2  
Greene County Soil & Water Conservation District  
Batavia Kill Stream Corridor Management Plan

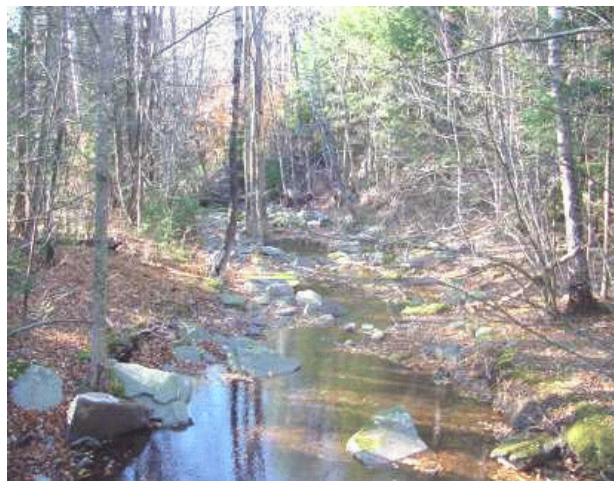
**Figure VI-1:** Headwater segments in 1a are characterized by a healthy riparian forest and a course streambed of boulders and cobble.

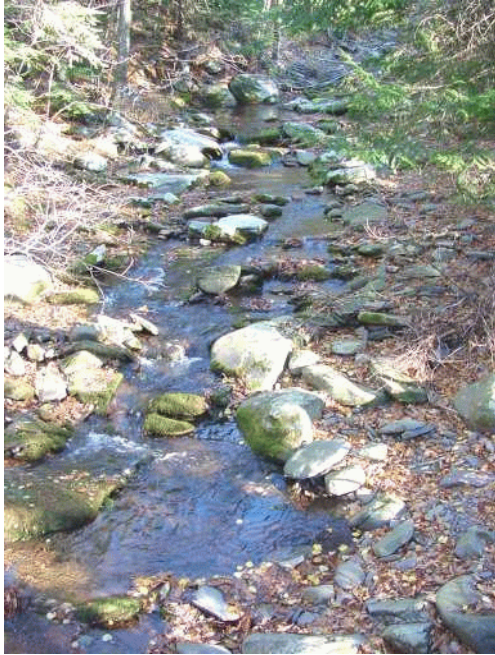
**Figure VI-2:** Heavy moss growth and imbrication of boulders and cobbles are characteristic of a stable stream profile

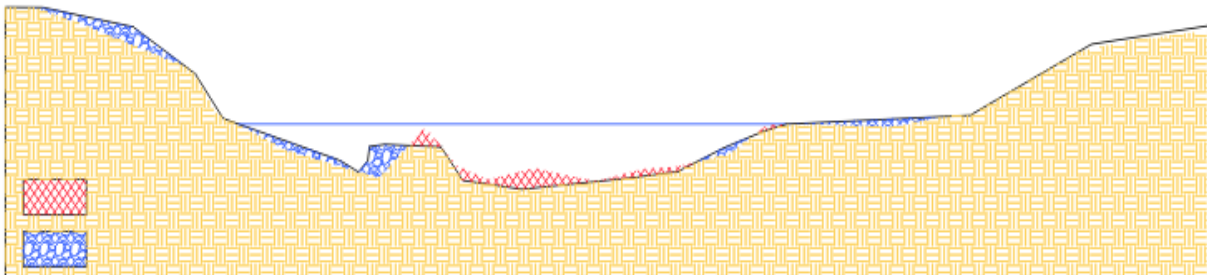
The stream channel approaching cross section #2 transitions from an entrenched A stream type into a moderately entrenched channel with the introduction of a narrow, defined *floodplain*. Stream type changes to B3, with channel material remaining fairly constant from cross section #1 . *Cobble* is the predominant particle size, although bedrock and medium boulders are also frequent seen throughout entire reach. Cross section #2 has exhibited a consistent and stable channel *morphology* throughout the monitoring period, with no appreciable lateral erosion observed. Measurements of *width/depth ratio*, *entrenchment ratio* and cross sectional area have remained essentially unchanged (**Figure VI-3**).

**Figure VI-3:** Overlay of 1999 and 2000 monitoring surveys for Headwaters #2 cross section, depicting minimal erosion or aggradation

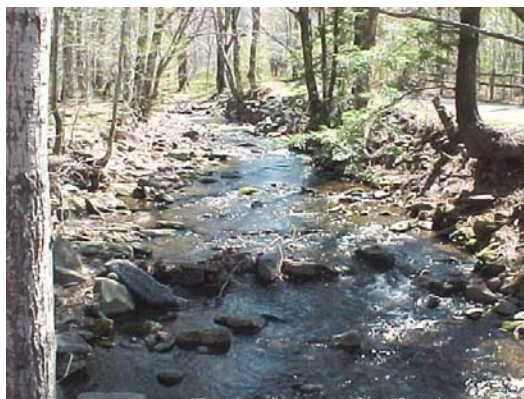
**Figure VI-4:** Section of segment 1b as it runs along access road to NYSDEC trail head.

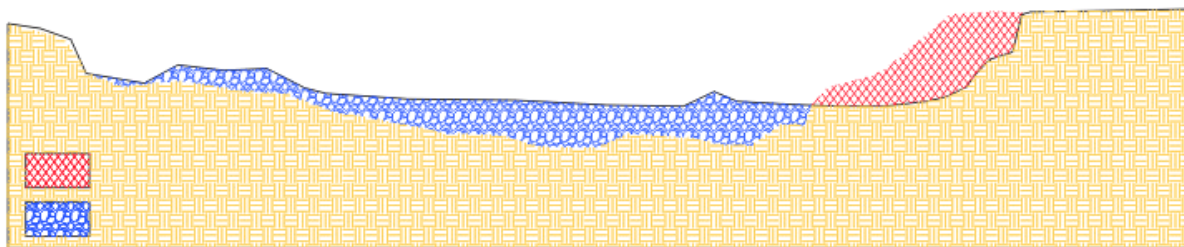
At the bottom portion of reach 1b, monitoring between 1999 and 2001 has indicated localized channel aggradation leading to flooding problems along CR 56 and the county bridge at the bottom of the reach. A single monitoring cross section (headwaters #5) was classified as an C4 stream type, and throughout the monitoring period the cross sectional area of the *bankfull* channel has remained constant, while the width/depth ratio has significantly increased due to over-widening and aggradation of the channel (**Figure VI-7**). In one year of monitoring, the channel has aggraded almost two feet and has eroded laterally approximately six feet along the highway (**Figure VI-8**). The aggradation significantly reduced channel capacity resulting in frequent flooding of CR56, while the lateral migration of the channel was threatening CR56. In 2002, the GCSWCD used FEMA funds to implement temporary measures in this area. The channel was excavated to provide more capacity, and large rock was buried in the right streambank along CR 56.

**Figure VI-7:** Headwaters cross section #5 overlay from 1999-2000 depicting channel aggradation and lateral migration. Red = erosion, Blue = deposition

The aggradation in the lower reach is most likely attributed to several factors. First, the GCSWCD had inventoried a large beaver dam located which was causing a decrease in sediment transport capacity and promoting local aggradation of the channel. A second factor contributing to the aggradation is an increase in overall sediment supply from the areas of degradation and lateral erosion above. The most significant change was noted

after the September 1999 flood event in which the stream discharge in this area exceeded 790 cfs, and completely buried the beaver dam with gravel. The result was significant localized flooding and nearly 6 feet of lateral erosion.

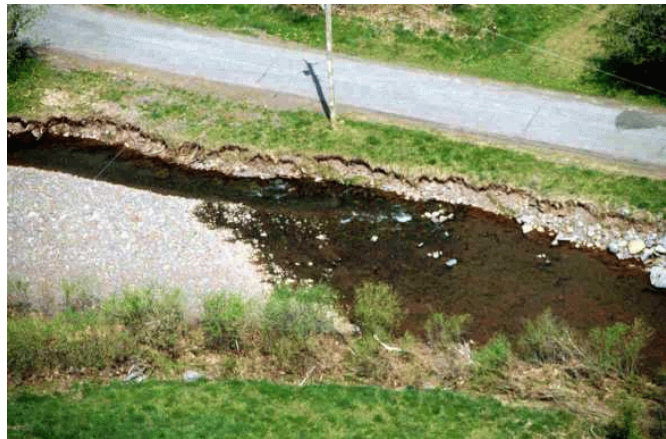
While the upper portion of reach 1b has only minor, localized instability problems, the lower extent of the reach is felt to be heading towards extreme instability. The GCSWCD has observed aggradation, degradation and lateral meander migrations in this section of the reach, and there is a very low probability that the stream channel will achieve an acceptable state of stability on its own. There is currently a seasonal structure threatened, and several homes are likely to be impacted in the future.

**Figure VI-8:** Aerial view of lateral migration along CRT in lower section of management segment 1b.

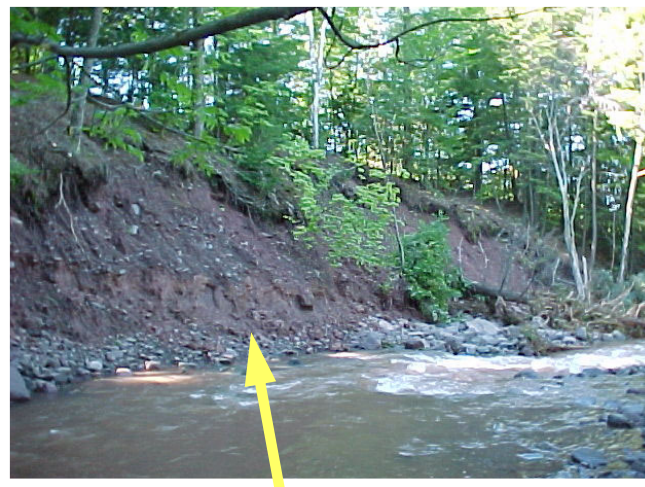
A

While the upper portion of the reach is characterized as being relatively stable, the lower portion of reach 1b was noted as having significant areas of channel erosion (**Figure VI-5b, photos A,B,D,E,F**). The erosion inventoried in 1997 was almost exclusively located to this sub-reach. Instabilities were noted in several areas, with channel aggradation and degradation observed, as well as lateral channel erosion. In August of 1999, three monitoring sections were installed in this section to determine stream type, and to determine the current state of instability.

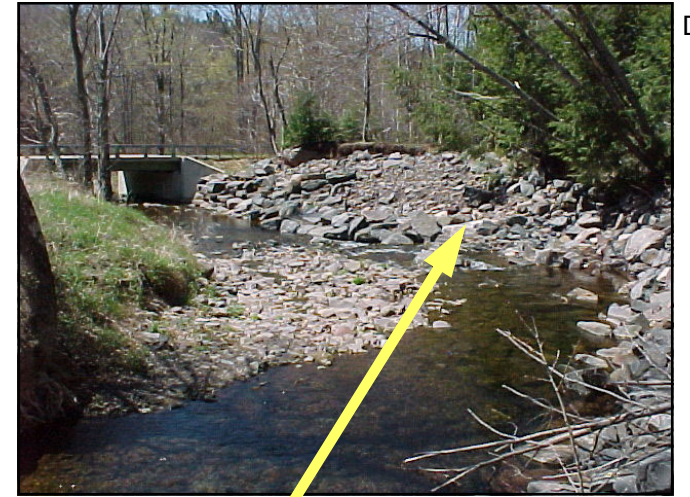
D

The first monitored cross section in the reach (Headwaters #3) is located just upstream of the county bridge (**Figure VI-5b**). This bridge was substantially damaged in the April 1987 flood event, and replaced in 1989. In 1990, the GCSWCD sponsored a stabilization project which included stacked rock rip-rap on the right bank above the bridge, and sloped rip-rap on the left bank below the bridge. The project also included extensive channelization, extending approximately 100 to 150 feet upstream and downstream of the bridge. Flood events in 1996 and 1999 resulted in repetitive damage to the stacked rock rip-rap above the bridge (**Figure VI-5b, photo D**). Subsequently, the GCSWCD has

observed active erosion just above the bridge. The lateral can likely be attributed to the rip-rap bank protection, floodplain fill and channelization of the stream.

While the bridge opening appears to be adequately sized for its location in the watershed, further evaluation of the stream/road alignment, as well as channel entrenchment, could identify an effective strategy to addressing the instability. *Mitigation* of the instability problem at the bridge would have a direct benefit by reducing the frequency and cost of repairs, as well as protecting the structure from future floods. Immediately below the bridge (150'), the stream channel has responded favorably to past disturbances (**Figure VI-5b, photo H**). A well vegetated *bankfull* channel has formed within the over widened channel, and a young, but healthy, riparian buffer is becoming established. The response of this short section to past channelization is an excellent example of a streams ability to re-establish a stable form.

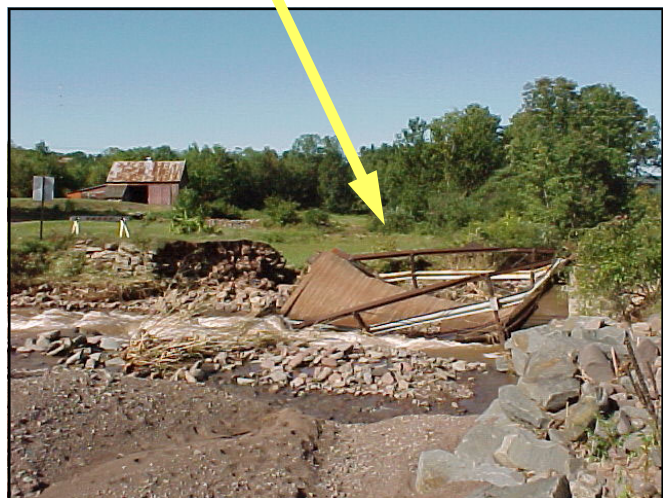
F

In September 1999, the town bridge at the L. Milton MacGlashan farm failed during the Tropical Storm Floyd flood event (**Figure VI-5b, photo F**). The cause of the failure was documented as scour of the left bridge abutment, most likely the result of inadequate capacity to pass the storm flow, as well as degradation of the streambed and lateral erosion. The placement bridge was relocated approximately 150 feet down stream, to a location where the stream planform was straight. The new bridge was built at 60 feet in length, in an area where the GCSWCD has determined the bankfull width to be approximately 35 feet. The combination of the new alignment, and the lengthening of the bridge, are both highly favorable to reestablishing a stable stream morphology in this reach.

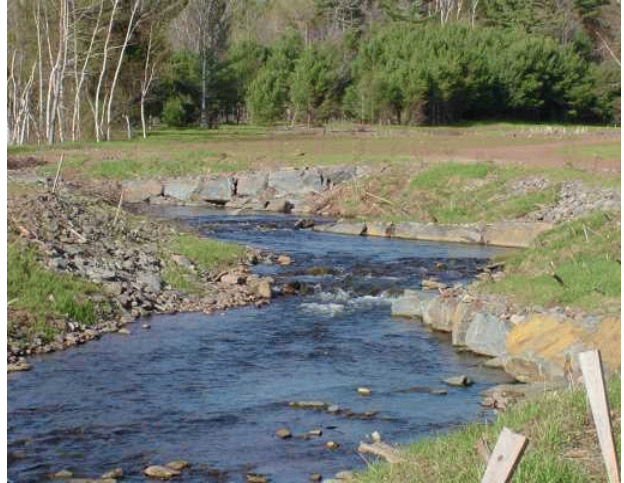
**Figure VI-9:** View of restoration work undertaken in segment 1c during 2001.

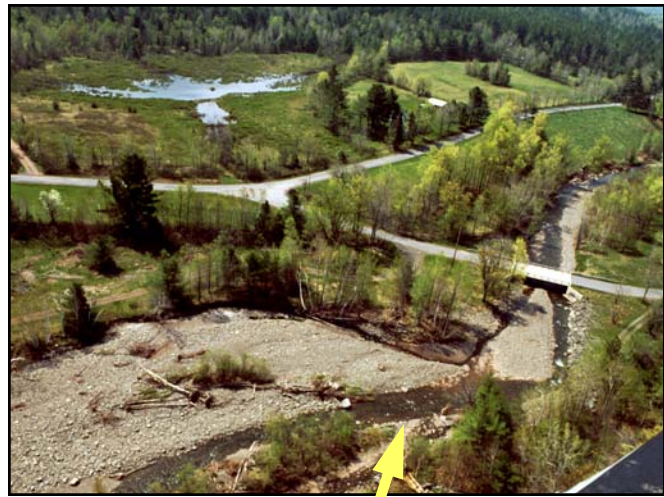
A

The condition of the riparian area in the segment was highly variable. At the head of the segment, much of the riparian area was characterized by open fields, with narrow strips of wooded riparian vegetation (**Figure VI-10, photo A,D,H**). In the lower extent of the reach, the stream was bordered by denser, woody vegetation, however extreme boundary shear stress from channel aggradation and over-widening has resulted in the trees being undercut and lost. While the high terraces in the segment support vegetation at the top of the terrace, and once were stabilized by forest cover, the unstable faces of the terrace are too steep to support bank stabilizing vegetation. The portion of the streambank which is exposed to the erosional forces of the stream is predominantly unprotected by vegetation.

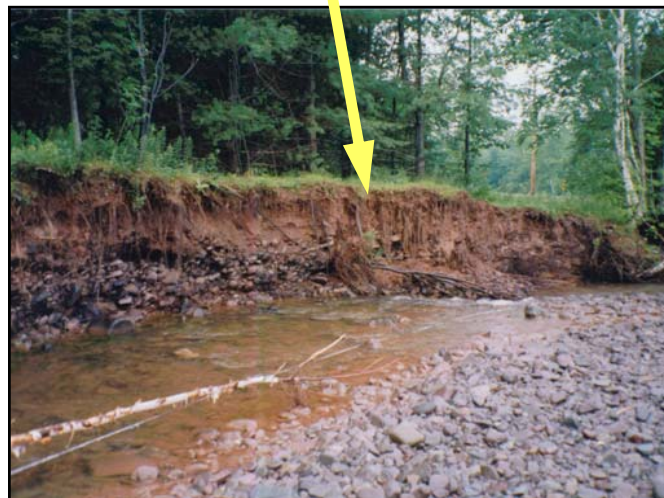
E

The lower half of reach 1c was primarily characterized as an aggradation area, with excessive sediment deposition, multiple channels and poor riparian conditions. Typical of aggradation areas, channel planform was highly variable, with even small storm events significantly changing the stream pattern. Between 1995 and 2000, some sections of the stream laterally migrated over 100 feet. Additionally, aggradation was transferring erosional forces against the outer banks, with active erosion on both the left and right banks was noted during the assessment process (**Figure VI-15**) (**Figure VI-10, photo E**).

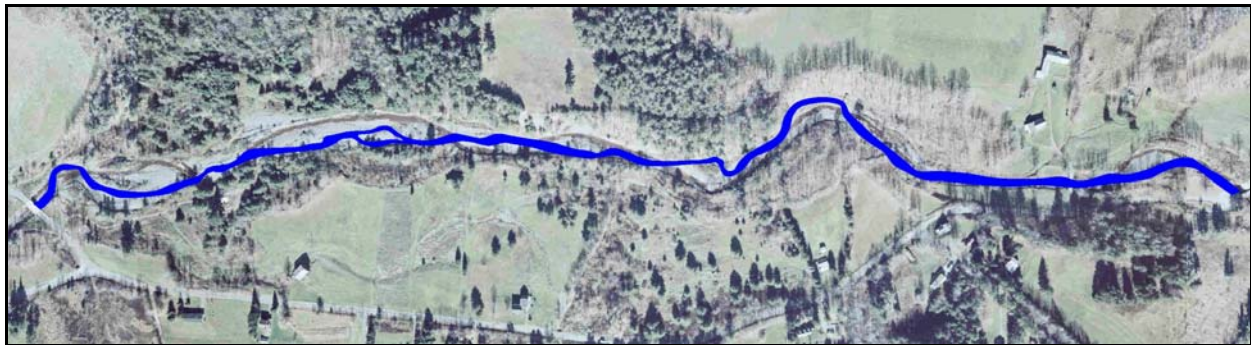
**Figure VI-11:** Aerial view of channel planform changes between 1995 (blue) and 2000 (photo).

Moving down the reach, a beaver dam 300 feet below the town bridge was observed to be impacting sediment transport through the reach (**Figure VI-11, photo G**), with the channel filled with gravel and other sediments. The stream channel was responding to the channel aggradation with lateral erosion as the stream attempted to cut a channel around the beaver dam. Monitoring cross sections showed the development of a divided channel below the dam (**Figure VI-12**), with the main (left) channel incising over one foot, and the right channel almost half a foot, during the monitoring period. Further below the beaver dam, the channel was experiencing lateral erosion and over widening, as well as having degraded nearly 2 ½ feet.

Moving down the reach, the alignment of the channel had migrated to a position against a high terrace on the right streambank (**Figure VI-11, photo B,C**). The terrace averages approximately 55 feet in height, and runs approximately 2200 along the center of reach 1c. Prior to restoration, approximately 1,075 feet of stream channel was directly against the high terrace, with large slope failures present. Most wasting of the high terrace was facilitated by erosion at the toe of the bank (**Figure VI-13**). The low terrace, running along the opposite bank also showed equal signs of instability (**Figure VI-11, photo E**).

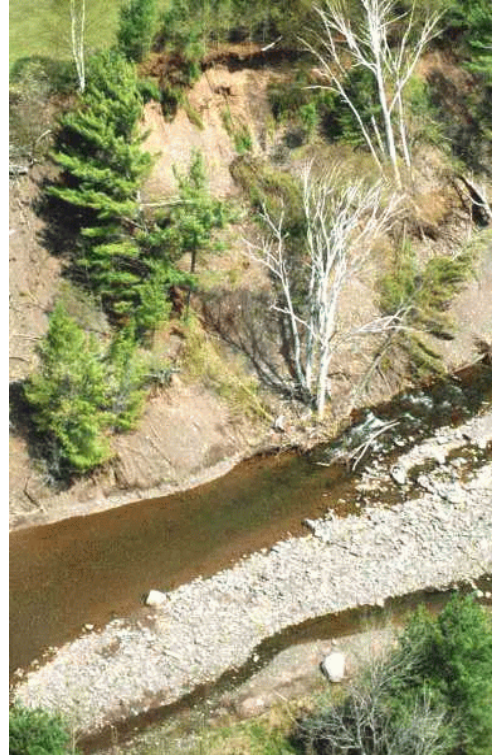
**Figure VI-13:** Eroded high terrace at middle of management segment.

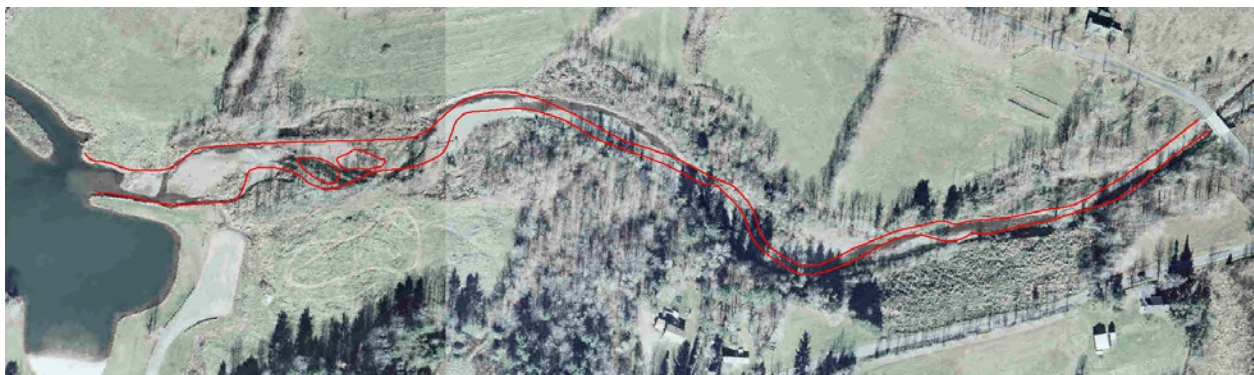
Analysis performed on the 1995 and 2000 aerials (**Figure VI-17**) revealed only minimal planform change through the majority of the reach, with the exception of two isolated areas. The first area is located along one meander, half way down the reach which has migrated north nearly 50 feet in the 5 year period. The second area is at the bottom of the reach where the stream confluences with the flood retention pool. Historic aerial photograph interpretation of stream channel shifts through this reach is limited by the available photographs after construction of the flood control structure.

**Figure VI-17:** Comparison of 1995 (red) and 2000 (photo) stream Planform in management segment 1d.

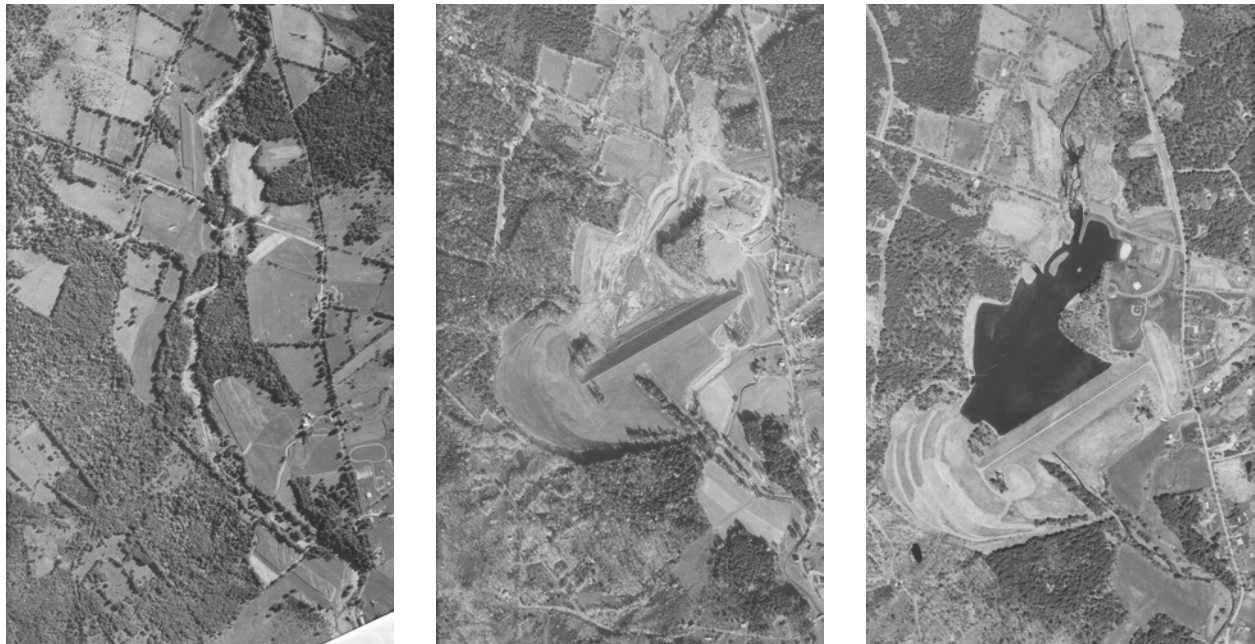
The riparian buffer in reach 1d is variable. The majority of the reach is in relatively good condition, but several sections require attention. Comparison of aerial photographs from 1959 to 2000 (**Figure VI-18**) indicate that there has been relatively minimal change in the riparian zone over the past 41 years. Prior to the construction of the flood control dam, the reach had several active farms along its length, with pen fields bordered by thin woody buffers. At this time, the right bank has a good buffer condition with the exception of a short section at the bottom of the reach. The left bank has a good buffer at the top and bottom of the reach, but the middle of the reach exhibits poor conditions. Active erosion in this area has removed critical deep rooted vegetation. It is interesting to note the changes in **Figure**

**Figure VI-18:** Aerial progression from 1959, 1980 and 1995 indicates reach 1d has exhibited poor riparian conditions for over 40 years. Note that the C.D.Lane lake is empty in the center photo.
