# Ashland Connector Stream Restoration Project

## *Project Implementation Report*

*Town of Ashland, Greene County, New York*

*December 2006*

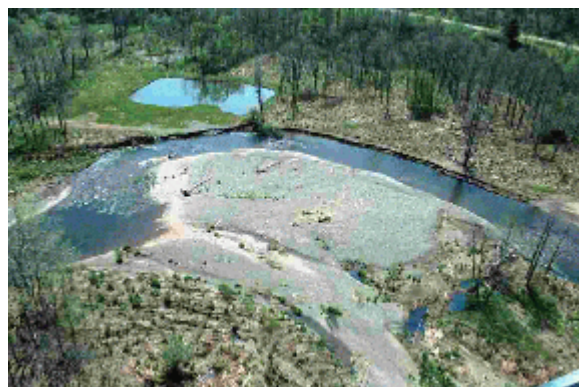
**Active channel migration has historically threatened this floodplain pond. Knotweed is a significant limiting factor to the likelihood of the reach regaining natural stability.**

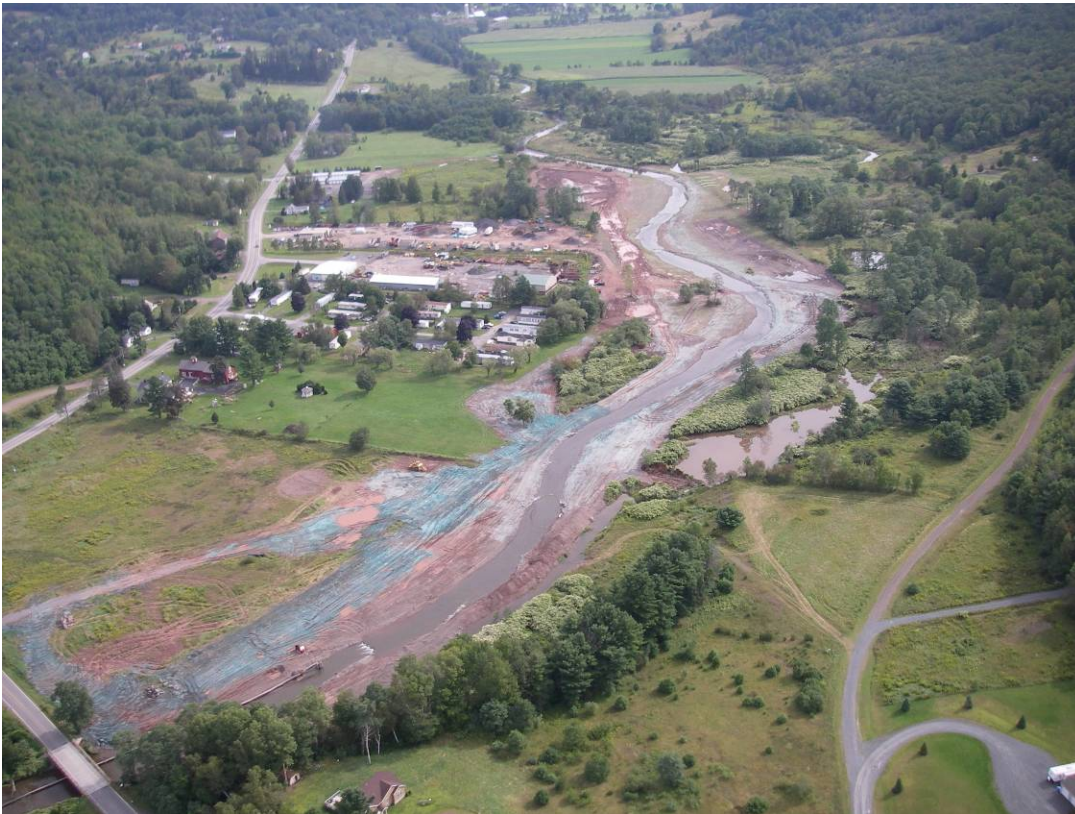
**View from helicopter on September 9, 2006. Ashland project in foreground with Brandwyne project in background.**

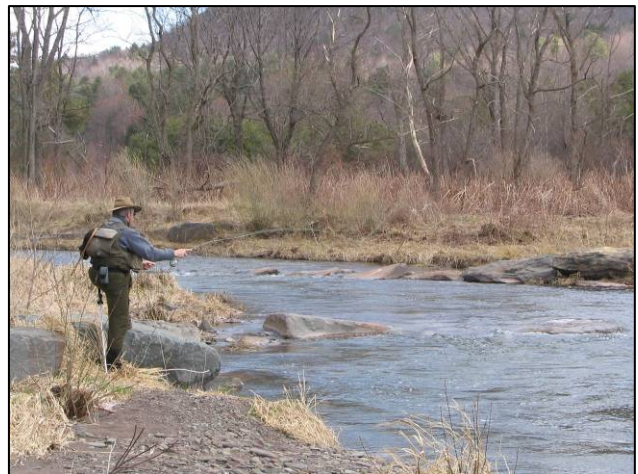
**An angler at the Brandywine project enjoying fishing the pools created by cross vanes.**
