V-C. Stream Corridor Inventory and Assessment

Map V-3
Greene County Soil & Water Conservation District
Batavia Kill Stream Management Plan

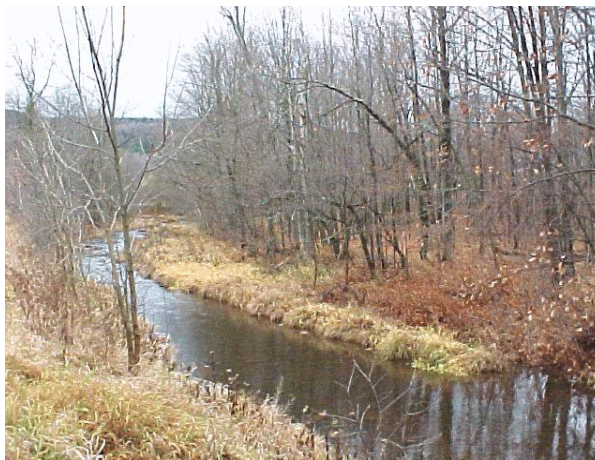
Figure V- 25: B stream type in Hensonville.

As discussed in **Section III**, the Rosgen's Level I classification delineates stream types based on entrenchment, pattern, slope, and shape. The Level I Rosgen classification was used to determine the primary stream types located in the Batavia Kill watershed, and was completed by GCSWCD staff in 1997 using remote sources of information including 1995 aerial photography, and USGS topographic quadrangle maps. The stream types delineated during the Level I classification included A, B, C, F, & E stream types.

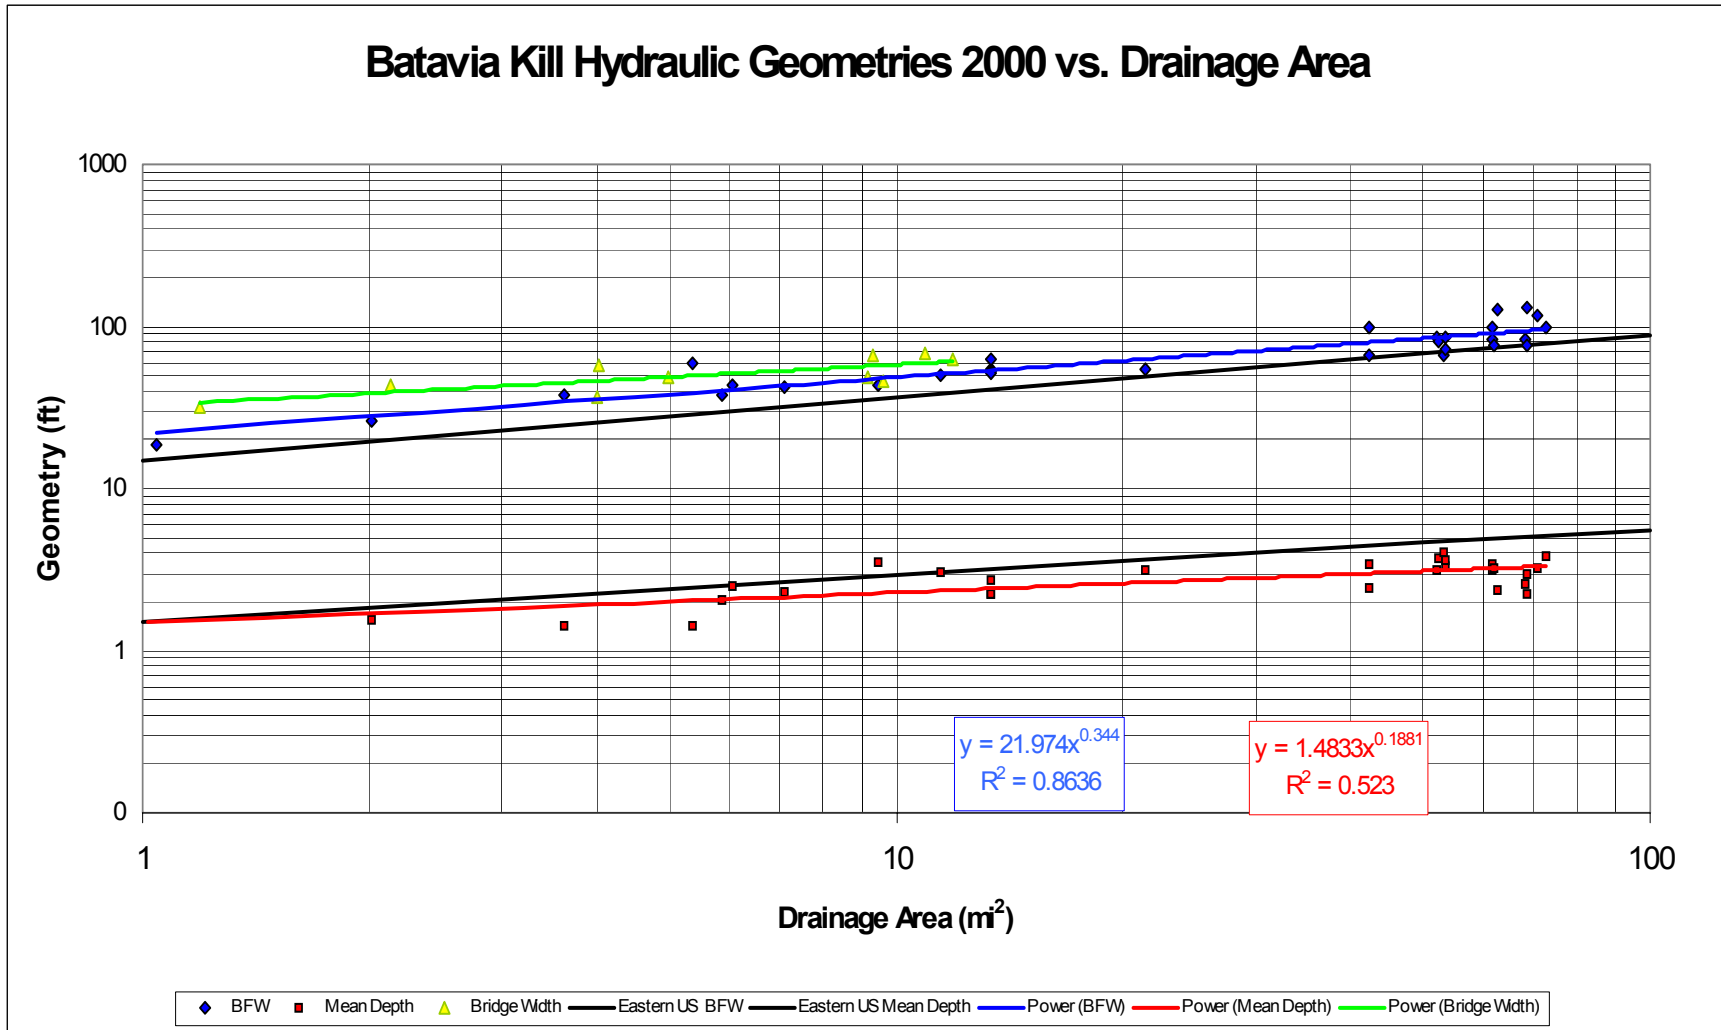
Figure V-27: Local hydraulic geometry relationships for the Batavia Kill base on bankfull indicators.

On the Batavia Kill, the relationship between watershed area and hydraulic geometry is complicated by the presence of the flood control structures. As discussed previously, impoundments are designed to modify stream flow, and one would expect to see different relationships between drainage area and channel features above the flood structures influence, and stream morphology features below the structures. To assist the GCSWCD with validation of hydraulic geometry for restoration designs, data collected based on field observations of bankfull were used to develop local curves for the watershed (**Figure V-27**). While the use of visual indicators to develop hydraulic geometry curves is not a recommended procedure, in the absence of adequate gage data on the Batavia Kill and in recognition of the flood structure influences, the GCSWCD used the best available data. To the extent possible, the GCSWCD used other methods such as regional regression curves for discharge to determine/verify observations made on the Batavia Kill.

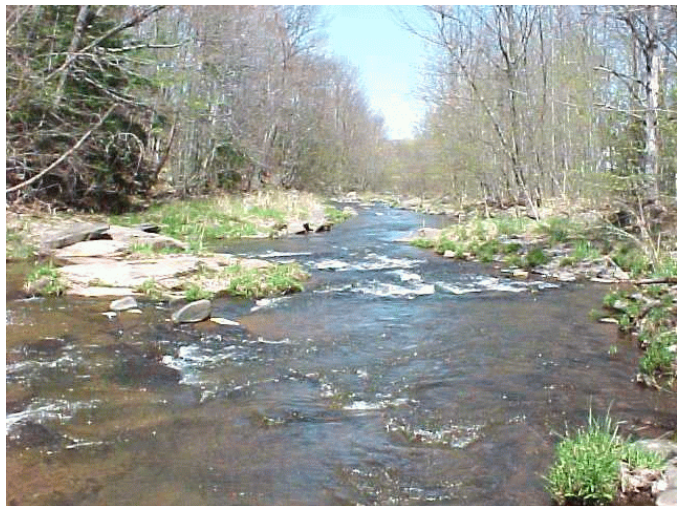
Figure V-30: Hensonville Reference Reach.

Since 1997, GCSWCD has surveyed two reaches within the stream corridor that were determined to be stable enough to be considered reference reaches. While both reaches are highly stable, they are limited in their application to restoration designs due to the influence of the C.D.Lane flood control structure on the streams flow and sediment regime. The two reaches (Hensonville and Church Street) are also vertically controlled by the presence of bedrock which also limits their use in other sections of the stream corridor where bedrock is not present in the stream corridor. The reaches have been valuable in understanding the functioning condition in relation to the flood control structures.

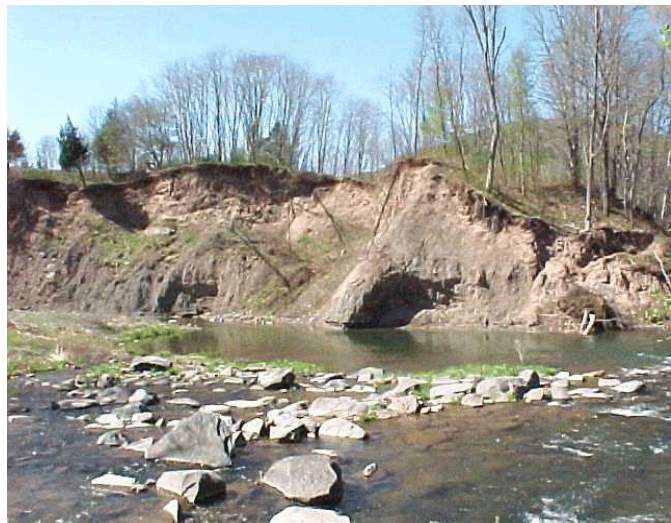
Figure V-31: Unstable banks such as these at Red Falls are characterized by soils which are a challenge to restore.

The magnitude of lacustrine clay exposures at Red Falls (**Figure V-31**) results in significant water quality impacts. The clay exposures are well represented by the stratigraphic column presented in **Figure V-33**, which is a cross section being monitored by the GCSWCD. As seen in **Figure V-33**, lacustrine deposits are exposed along significant portions of the eroded bank, while in the remainder of the channel area the clays are covered by a thin layer of gravel and cobble. This streambed cover is clearly inadequate in depth, and it is suspected that the underlying clays are exposed to erosional forces when the stream flows are elevated and the bed load is mobile.

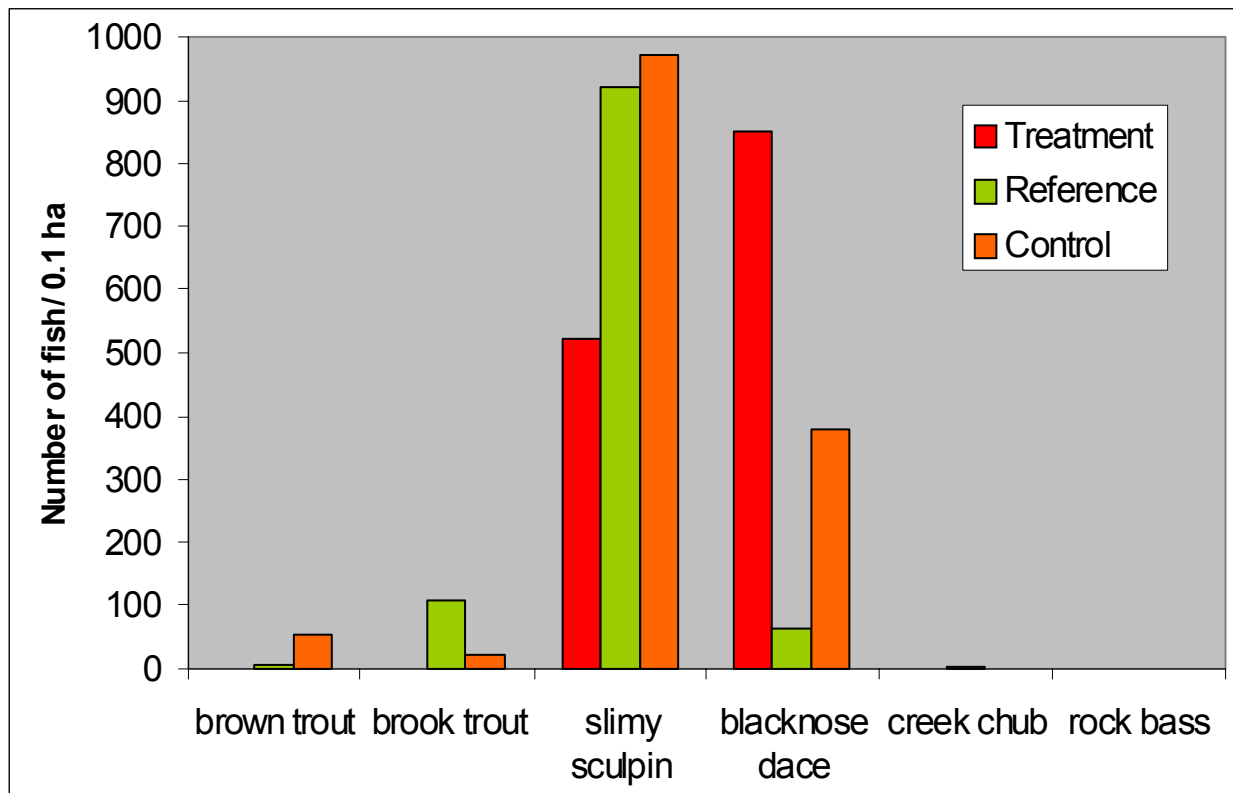
Figure V-34: Density of fish species on project, reference and control reaches in Big Hollow. Provisional data, USGS 2001.

Density of fish populations observed at the three reaches (**Figure V-34**) show the underlying cause for differences in community indices. The fish community at the treatment reach (red) consisted almost entirely of slimy sculpin and black nose dace (one rock bass was also collected). The community at the reference reach (green) was composed of a very large number of sculpin, but fewer dace and a small number brook and brown trout (a few creek chubs were also collected).

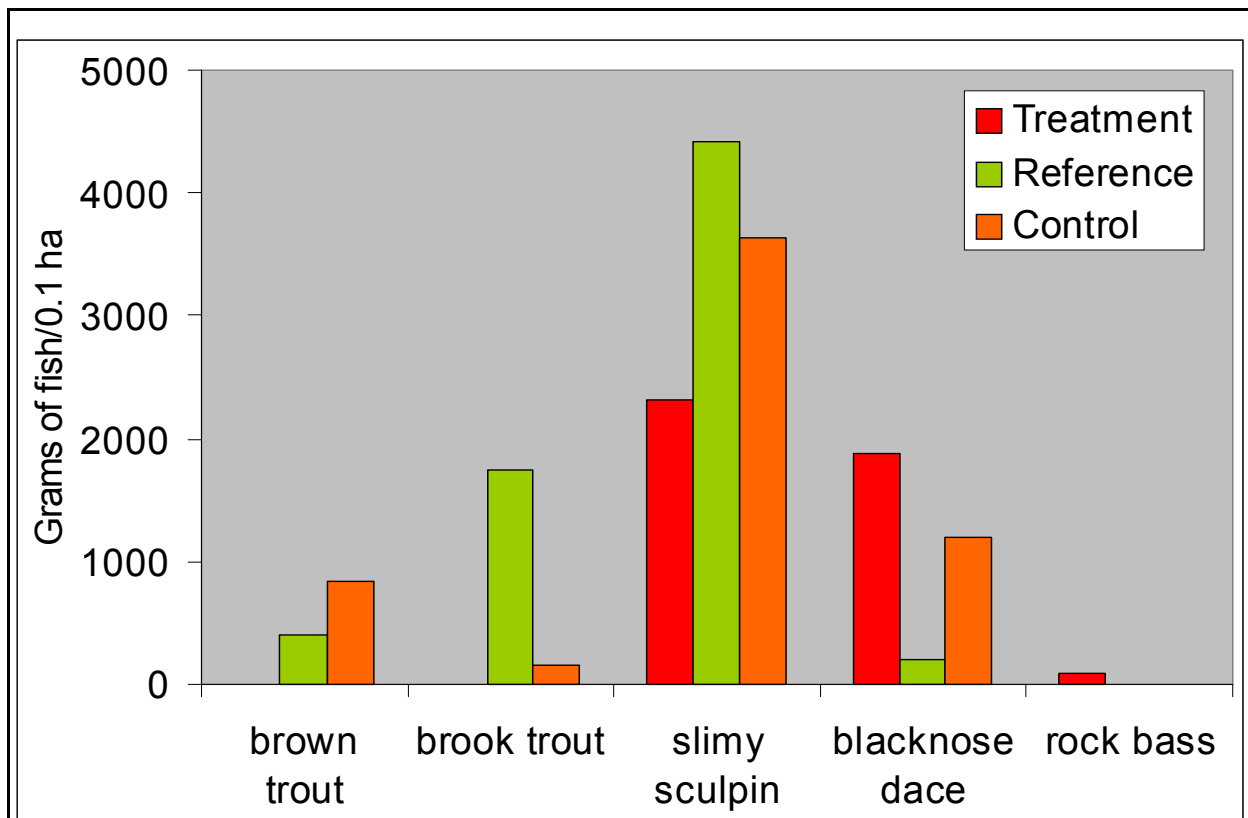
Figure V-35: Biomass of fish populations from treatment, control, and reference reaches in the Upper Batavia Kill Basin, Provisional data, USGS 2000.

Estimates of species biomass at the three reaches (**Figure V-35**) tell a slightly different story. Biomass of slimy sculpin and black nose dace still dominate (98%) at the treatment reach (red), however, brook and brown trout constitute 32 to 35 percent of the community biomass at the reference (green) and control (orange) reaches. Sculpin biomass does not change greatly across study reaches.

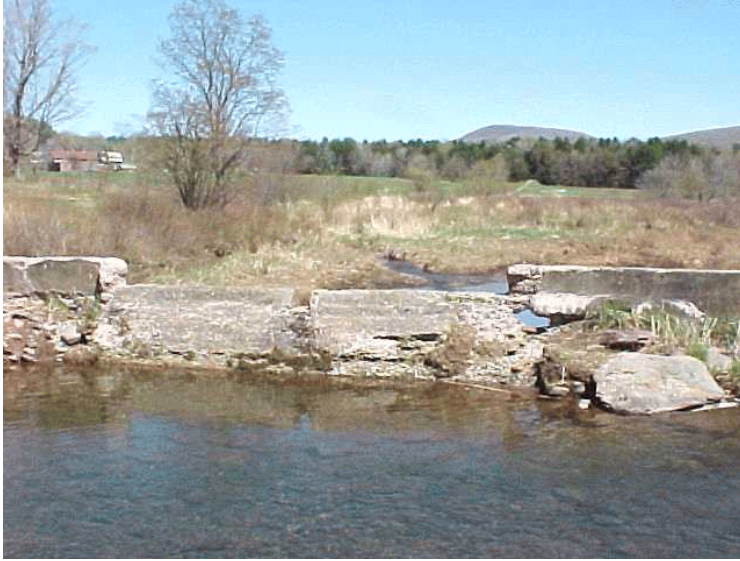
Figure V-39: Concrete dam presents a fisheries migration barrier on small tributary on the Batavia Kill.

migration barriers. These barriers create in some cases permanent barriers and the loss of tributary areas which are essential nursery and rearing areas for the young fish. With the 3 flood control structures controlling close to 30% of the watershed area, miles of the stream system have been cut off and are no longer available to fish.
