# IV-D: Geology & Topography

Map IV-1 Greene County Soil & Water Conservation District Batavia Kill Stream Corridor Management Plan

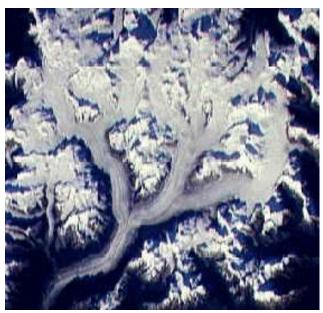
**Figure IV-11:** Satellite View of Alpine Glacier. Ice lobes as shown would be similar to the glaciers which were active in the Catskills.

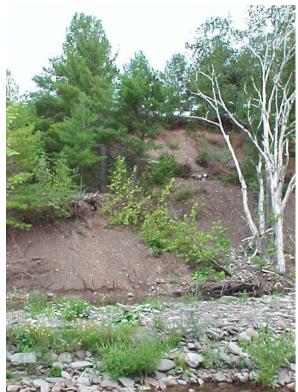
**Figure IV-12:** Typical eroding high terrace formed by glacial out wash, Big Hollow

On the valley floor, deep layers of fine clay and silt were deposited as they settled out of the glacial lake, while along the edge of the lake large deltas were formed from glacial out-wash as the surrounding streams carried meltwater and sediment from the retreating ice sheet. Today, these same glacial lake clay deposits present a challenge to maintaining water quality as the Batavia Kill stream erodes into these

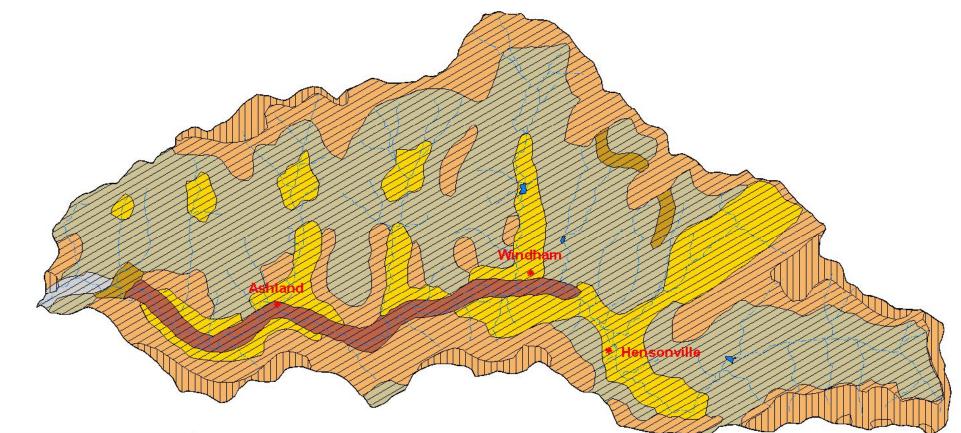
#### Batavia Kill Watershed Surficial and Bedrock Geology

Typically, grey sandstones and conglomerates are found in the base of these depositional cycles. These are followed by red sandstone, red siltstone and finally red shale or mudstone (**Map IV-1**) (Lucier 1966, Fletcher 1967). These depositional patterns were created by ancient rivers as they cut across the great Catskills Delta. This effect is observable at outcrops where the resistant sandstones form cliffs and the finer, more erodible materials form gentler slopes.

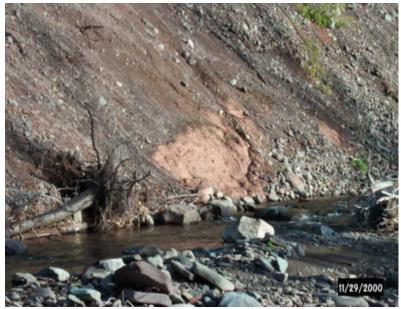
Figure IV-14: Lighter colored soil seen in this bank in Big Hollow is an exposed clay lens.

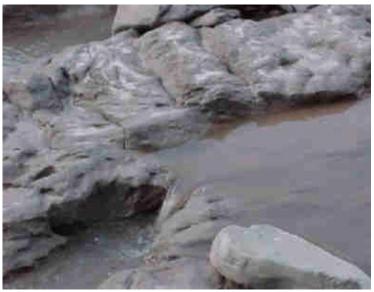
**Figure IV-15:** Clays exposed within the stream channel contribute to stream turbidity and the reduction of water quality.

While in general, the soils in the Batavia Kill watershed present multiple challenges to the management of the stream system, one of the primary concerns is the impact on the water quality of soils with lacustrine origin. These soils are comprised of clays and extremely fine silt particles, which are very easily eroded. When these materials entrained are (suspended) in the water column, it requires a long period of time combind with still water. Fine materials suspended in the water can have pollutants attached, can mask the effects of treatment, and if severe, they can require special treatment to clarify the water prior to chlorination.

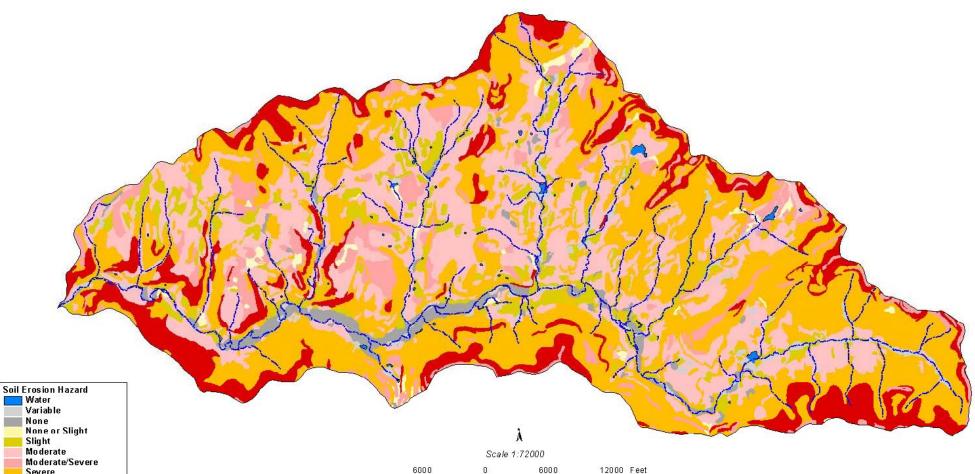
Batavia Kill Watershed Soil Erosion Hazard

As shown on **Map IV-4**, the watershed is characterized by a predominance of soils which exhibit moderate to very severe erosion hazards. Based on soil erosion hazard classifications, the watershed is comprised of approximately 54% of soils classified as severe to very severe, with 88% of soils characterized as having a moderate erosion hazard or worse. As would be expected, the erosion hazard is directly related to soil slope with steeper slopes being more erosion prone.

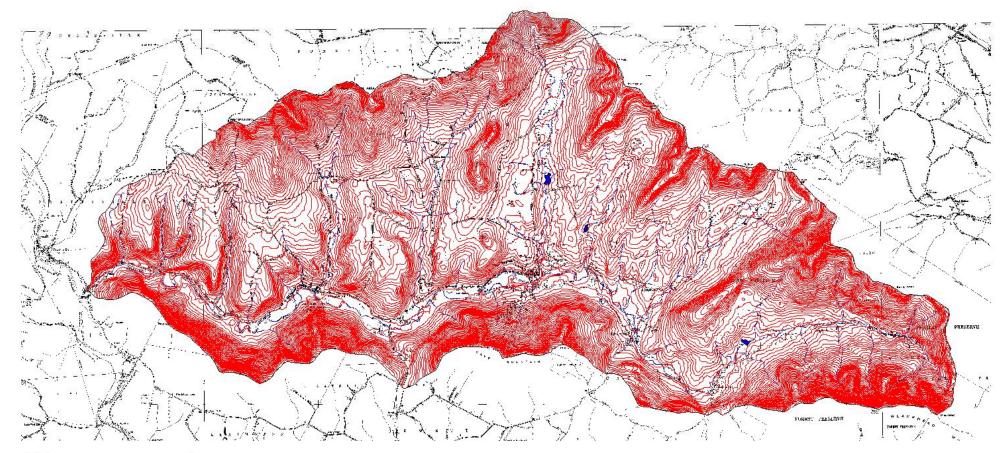
Map IV-5 Greene County Soil & Water Conservation District Batavia Kill Stream Corridor Management Plan

## Batavia Kill Watershed Topographic Map

In the Batavia Kill watershed, topography plays a significant role in the stream hydrological regime. In the upper headwaters, the steep slopes of Windham High Peak, Burnt Knob, Acra Point, and the Blackhead Range form an elongated basin which narrows as the mountains close in on the valley near Hensonville Map IV-5. In this section of the watershed, slopes in excess of 11% make up approximately 3/4 of the basin, with the balance in gentle slopes at the base of the mountains and a narrow floodplain on the valley floor.
