Schoharie Creek Management Unit 5

Town of Hunter - Station 124311 to Klein Ave. (Station 108605)

This management unit begins at Station 124311, continuing approximately 15,705 ft. downstream to Klein Ave. in the Town of Hunter.

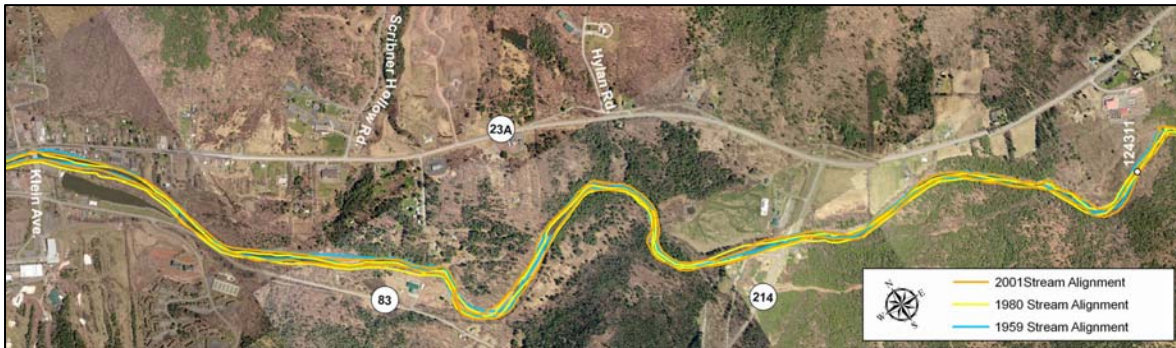
Historic stream channel alignments overlaid with 2006 aerial photograph

As seen from the historical stream channel alignments, the channel alignment has not changed significantly since 1959.

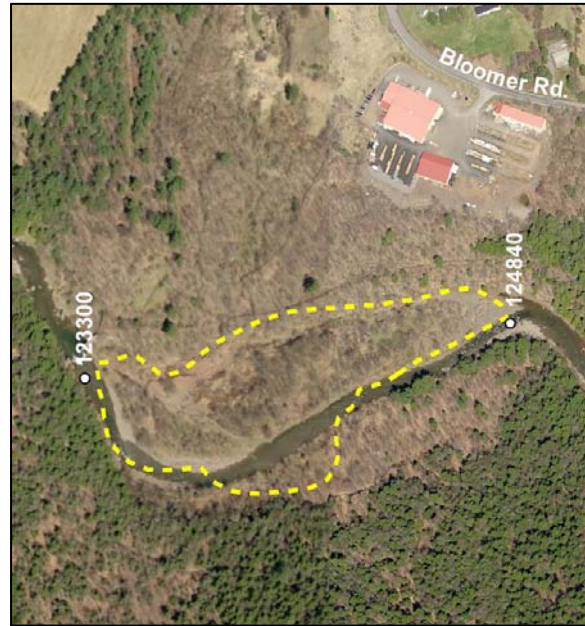
As the start of the management unit there was a large 8 acre palustrine wetland (Station 124840-123300). Wetlands are important features in the landscape that provide numerous beneficial functions including protecting and improving water quality, providing fish and wildlife habitats, storing floodwaters, and maintaining surface water flow during dry periods. This wetland was classified as palustrine, forested broad-leaved deciduous, temporarily flooded (PFO1A) (see Section 2.6 for detailed wetland type descriptions).

Wetland boundary approximately delineated by NWI (Stations 124840-123300)

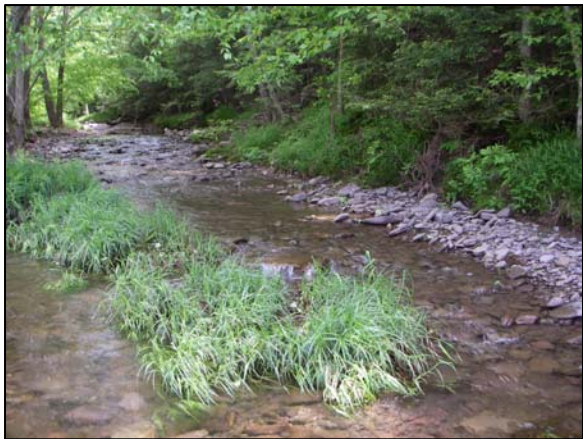
Tributary at Station 120500 - looking upstream

On the right streambank an unnamed tributary entered the Schoharie Creek (Station 120650). This tributary drains the lower slopes of Onteora Mountain before crossing under Route 23A, flowing through pastures before entering the Schoharie Creek. The New York State Department of Environmental Conservation classifies streams and rivers based on their “best use” (NYSDEC, 1994). The headwaters of this

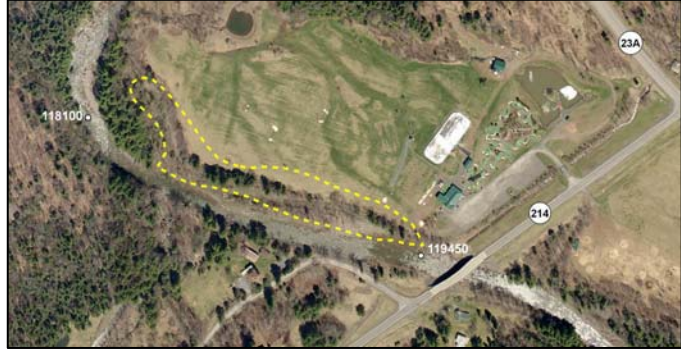
Along the right streambank, there was a 3.5 acre palustrine wetland with scrub-shrub vegetation (Station 119450-118100) (PSS1C). Rip-rap had been installed on the left streambank (Station 119300). This rip-rap was in good functioning and structural condition, but interplanting with native shrub and sedge species would help strengthen the revetment, while enhancing aquatic habitat.

Wetland boundary approximately delineated by NWI (Stations 119450-118100)

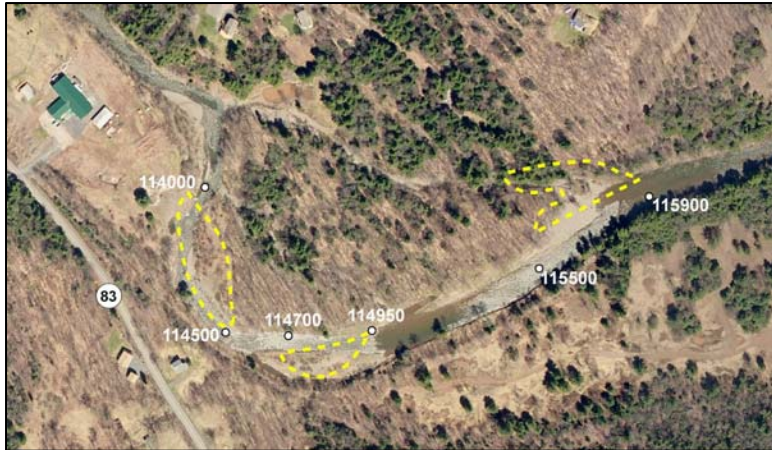
*Wetland boundary approximately delineated by NWI
(Stations beginning at 115900 & 114950 & 114500)*

flood chute (Station 115900-115500) (R2USC). On the left streambank at station 115800 the streambank was experiencing minor toe scour along 303ft, resulting in an erosion area of approximately 884 ft². This erosion site was a good candidate for remediation using vegetative toe and bank protection, but may self recover with time. At the next meander bend there were two wetlands. A small 0.4 acre wetland classified as riverine lower perennial (Station 114950-114700) (R2USC) and a 0.9 acre palustrine wetland dominated by scrub-shrub vegetation (Station 114500-114000) (PSS1A).

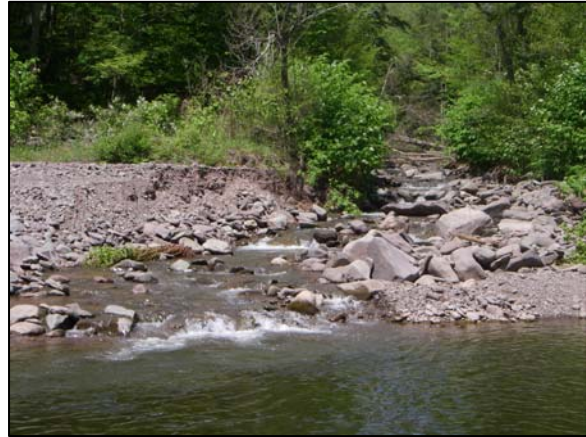
Downstream, Red Kill entered the Schoharie on the right streambank (Station 112400). This tributary drains the slopes of the East Jewett Range and Onteora Mountain before it reaches the flatter topography of the valley floor where it flowed into the Schoharie Creek. As a result of this change in stream slope, the tributary lost its ability to transport sediment gathered from the mountain slopes, and began to deposit sediment at its mouth and into the more gently sloped Schoharie Creek.

Red Kill Creek tributary at Station 112400 looking upstream

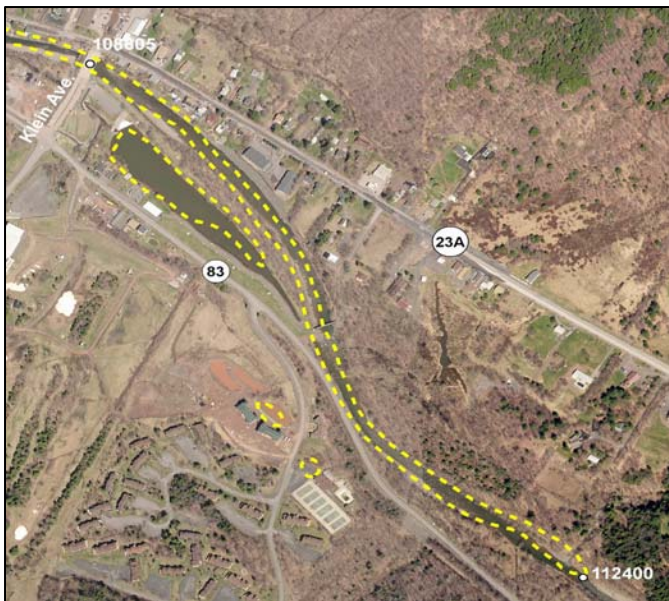
Wetland boundary approximately delineated by NWI (Station 112400-108605)

channel, classified as riverine lower perennial, stretched from here to the end of this management unit (Station 112400-108605) (R2UBH).

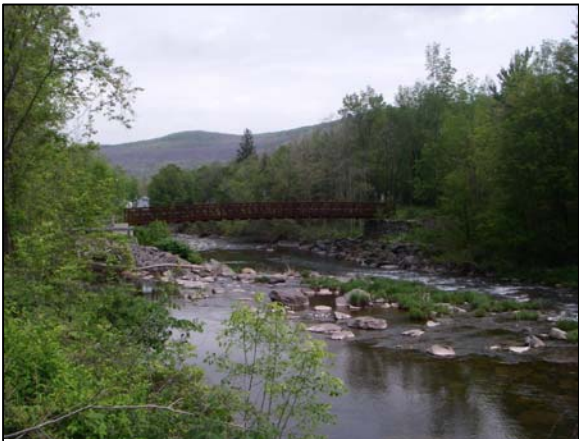
Foot bridge at Station 110470

originally constructed by Michael B. Dolan, a resident of Hunter, for his ice business. Dolan's Lake recreation area now offers public swimming, fishing and picnic facilities. The foot bridge (Station 110470) may constrict the floodplain at very high flows as evidenced by some upstream deposition, but appeared to pass most flows effectively.

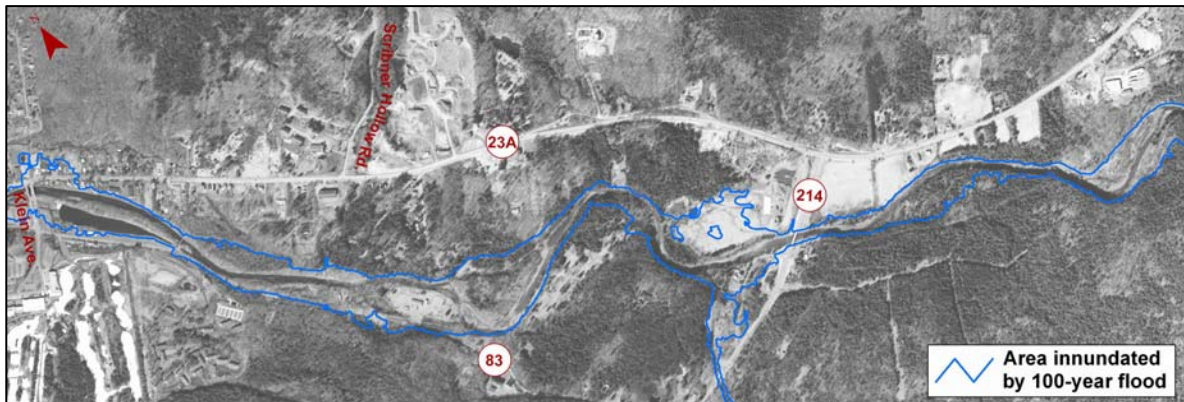
100-year floodplain boundary map

According to the 2006 floodplain maps (above), twenty-four existing structures in this unit appeared to be situated within the estimated 100-year floodplain. The 100-year floodplain is that area predicted to be inundated by floods of a magnitude that is expected to occur once in any 100-year period, on the basis of a statistical analysis of local flood record.
