Schoharie Creek Management Unit 6

Town of Hunter – Klein Ave. (Station 108605) to Bridge St. (Station 104521)

This management unit begins at Klein Ave., continuing approximately 4,085 ft to Bridge St. in the Town of Hunter.

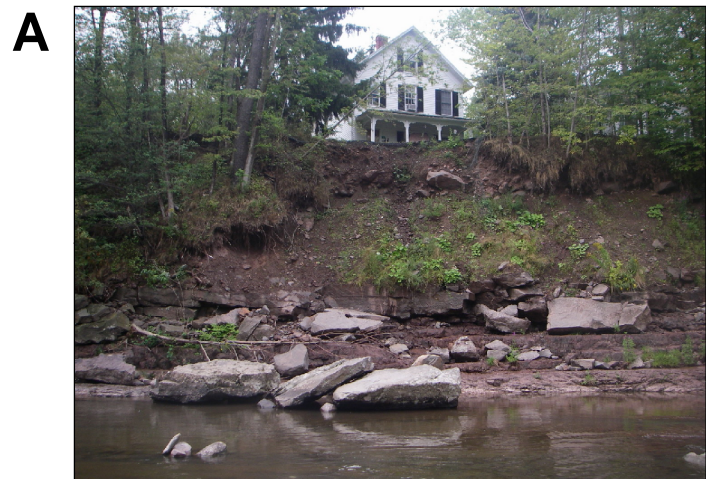
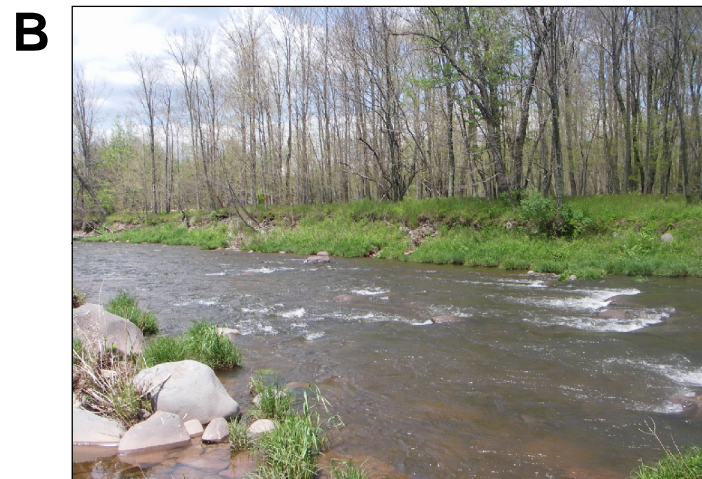
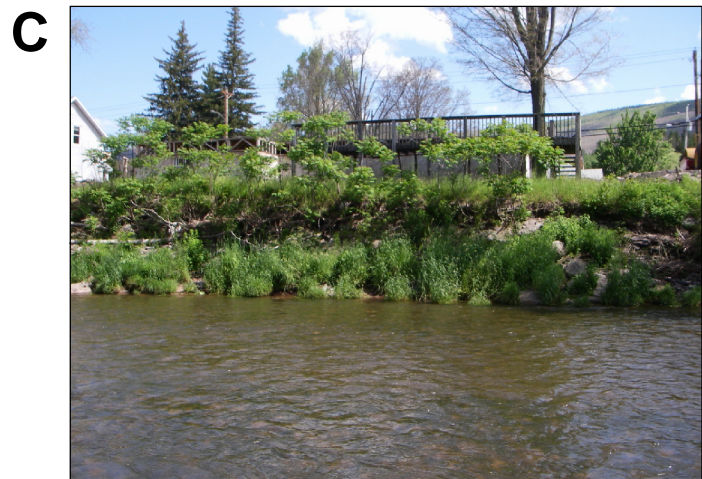
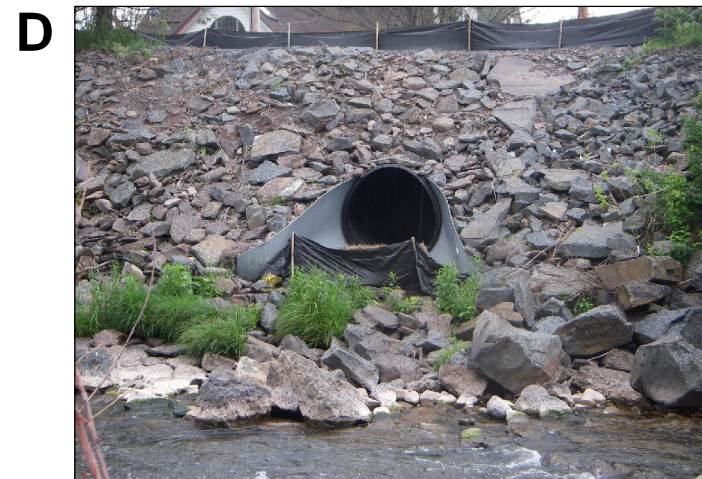
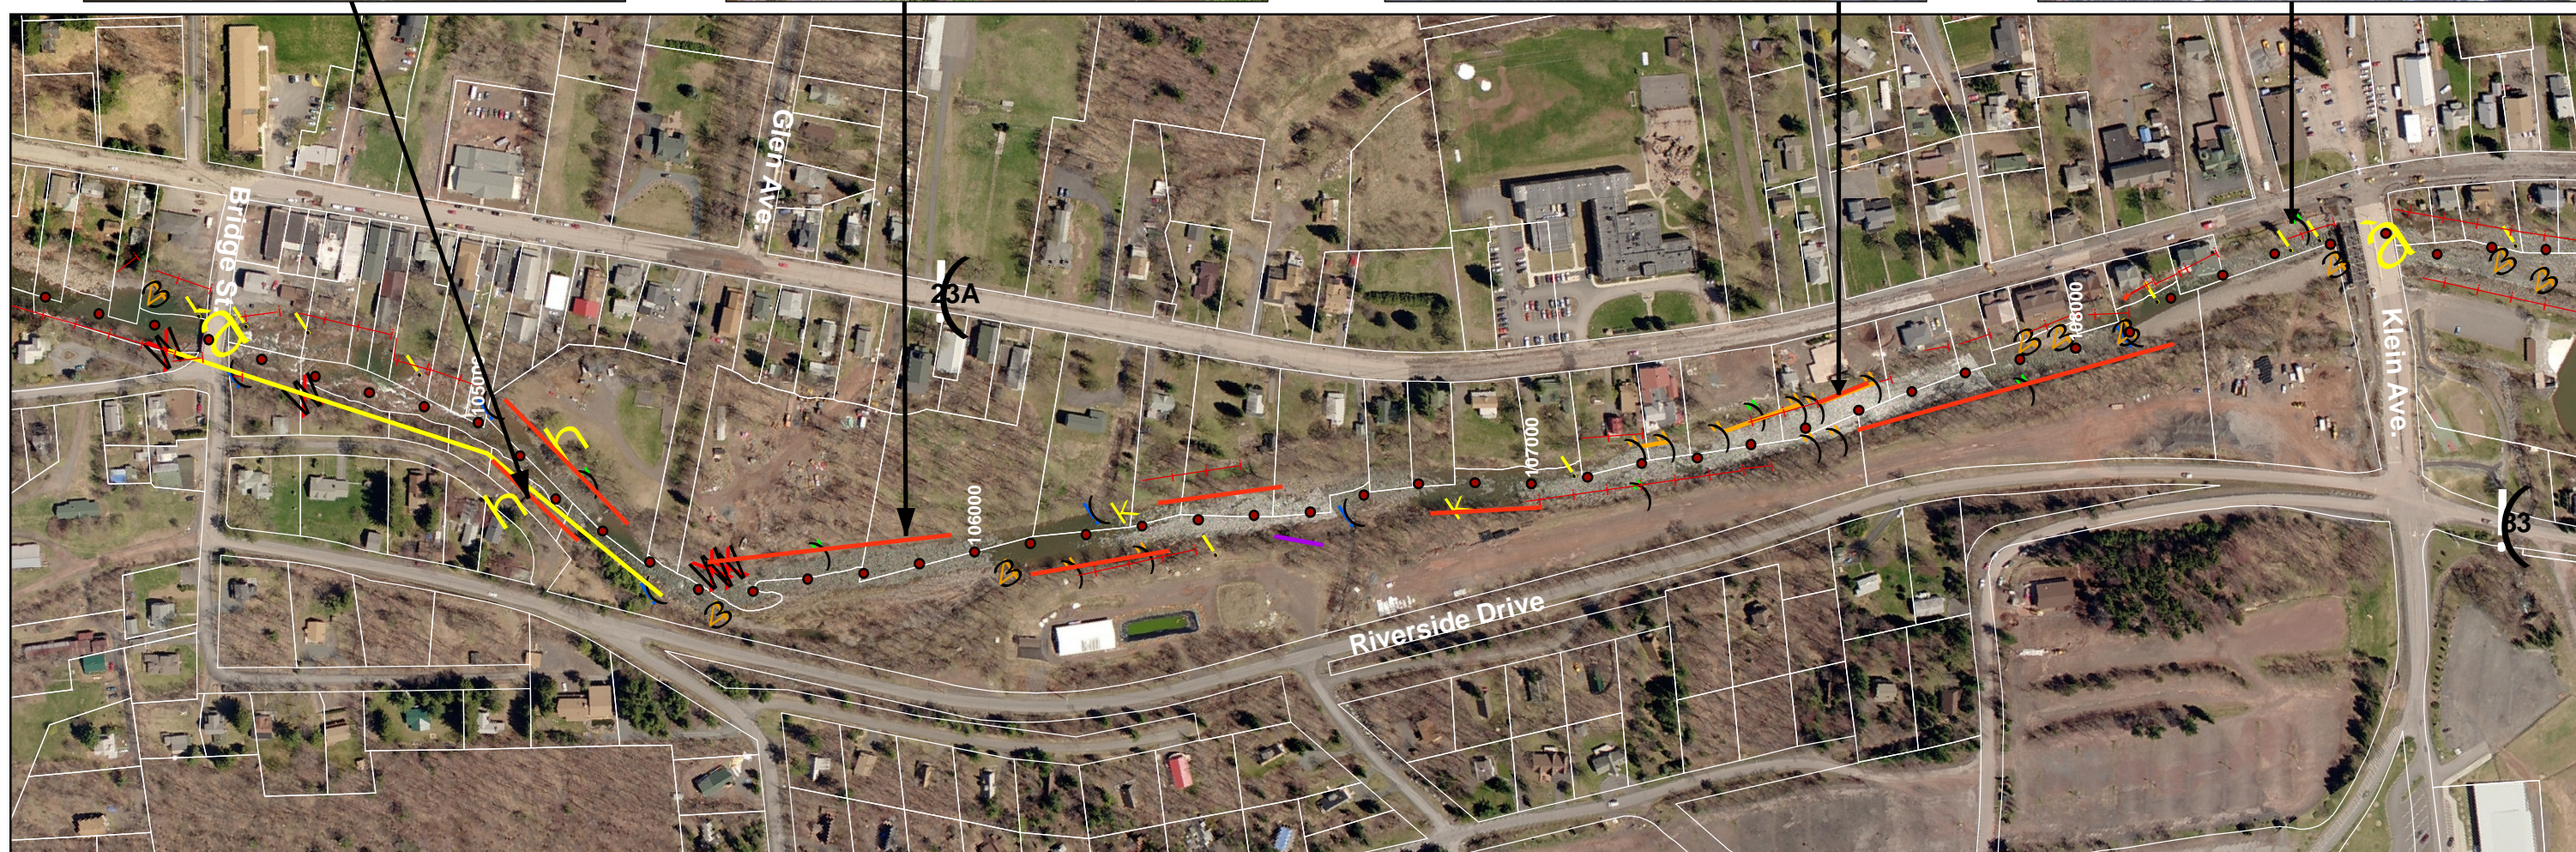
Figure 4.6.1 Management Unit 6 - 2006 aerial photography with stream feature inventory

The 2006 stream feature inventory revealed that 28.3% (2,316 ft) of the streambanks exhibited signs of active erosion along the 8,170 ft of total channel length in the unit (Figure 4.6.1). The total surface area of active erosion totaled approximately 23,034 ft². *Revetment*

has been installed on 25.2% (2,060 ft) of the streambanks. One berm was so long it covered 1% (82 ft) of the streambanks in the management unit.

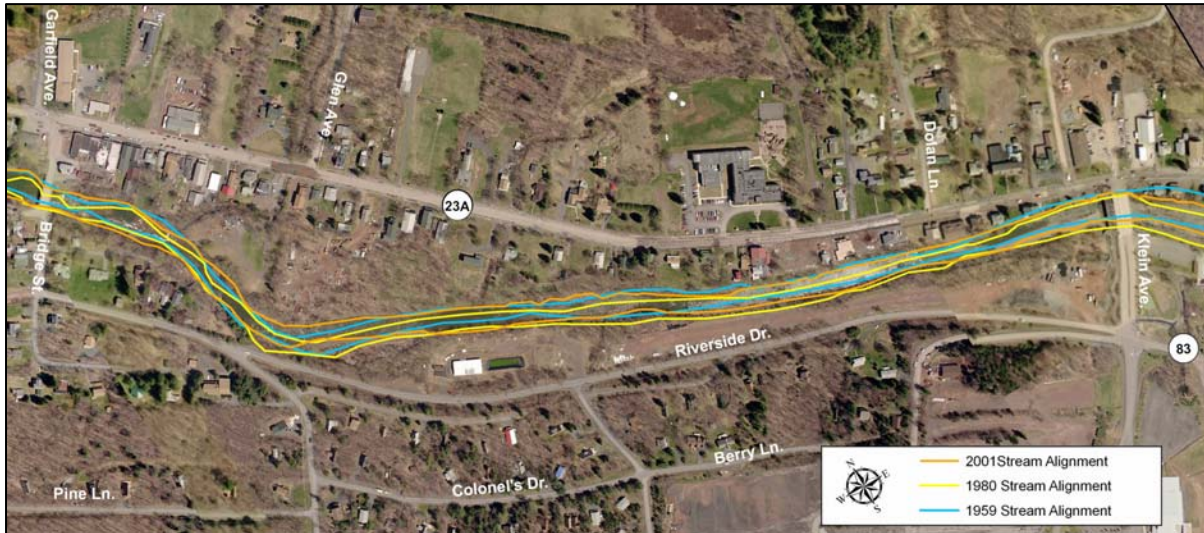
As seen from the historical stream alignments (below), the *planform* of the channel has remained fairly stable since 1959.

Historic stream channel alignments overlaid with 2006 aerial photograph

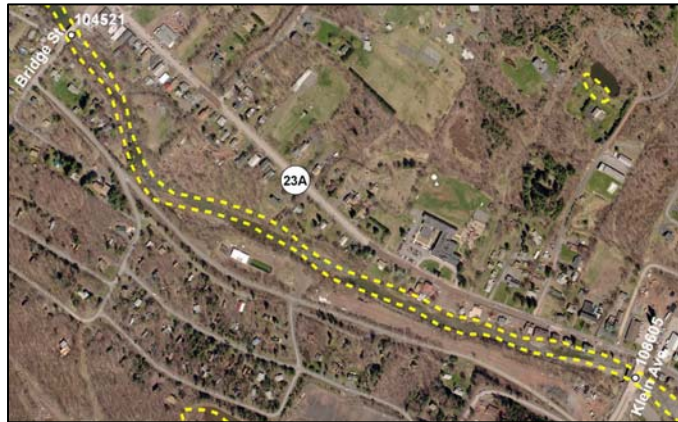
The entire stream channel within this management unit was designated as a wetland. This wetland was approximately 7 acres in size and classified as riverine lower perennial, signifying it is contained in the natural channel and characterized by a low gradient and slow water velocity (R2UBH, Station 108605-104521) (see Section 2.6 for detailed wetland type descriptions).

Wetland boundary approximately delineated by NWI (Station 108605-104521)

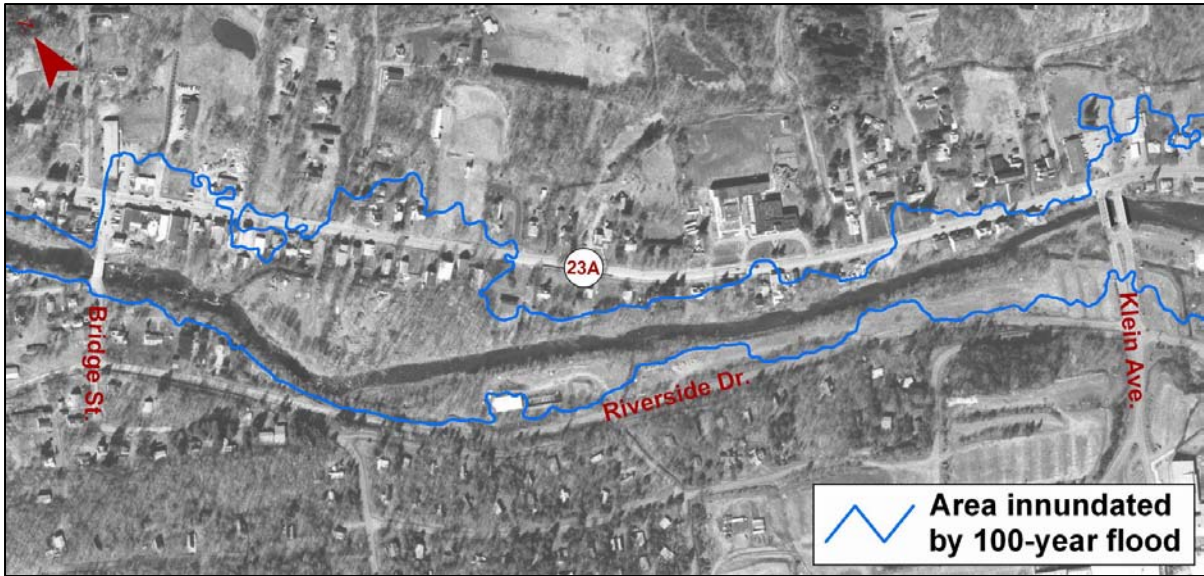
According to the current floodplain maps (below), thirty-six existing structures in this unit appeared to be situated within the estimated 100-year floodplain. The 100-year floodplain is that area predicted to be inundated by floods of a magnitude that is expected to occur once in any 100-year period, on the basis of a statistical analysis of local flood records. Most communities regulate the type of development that can occur in areas subject to these flood risks.

100-year floodplain boundary map
