Schoharie Creek Management Unit 7

Towns of Hunter and Jewett – Bridge St.(Station 104521) to Station 91473

Figure 4.7.1 Management Unit 7 - 2006 aerial photography with stream feature inventory

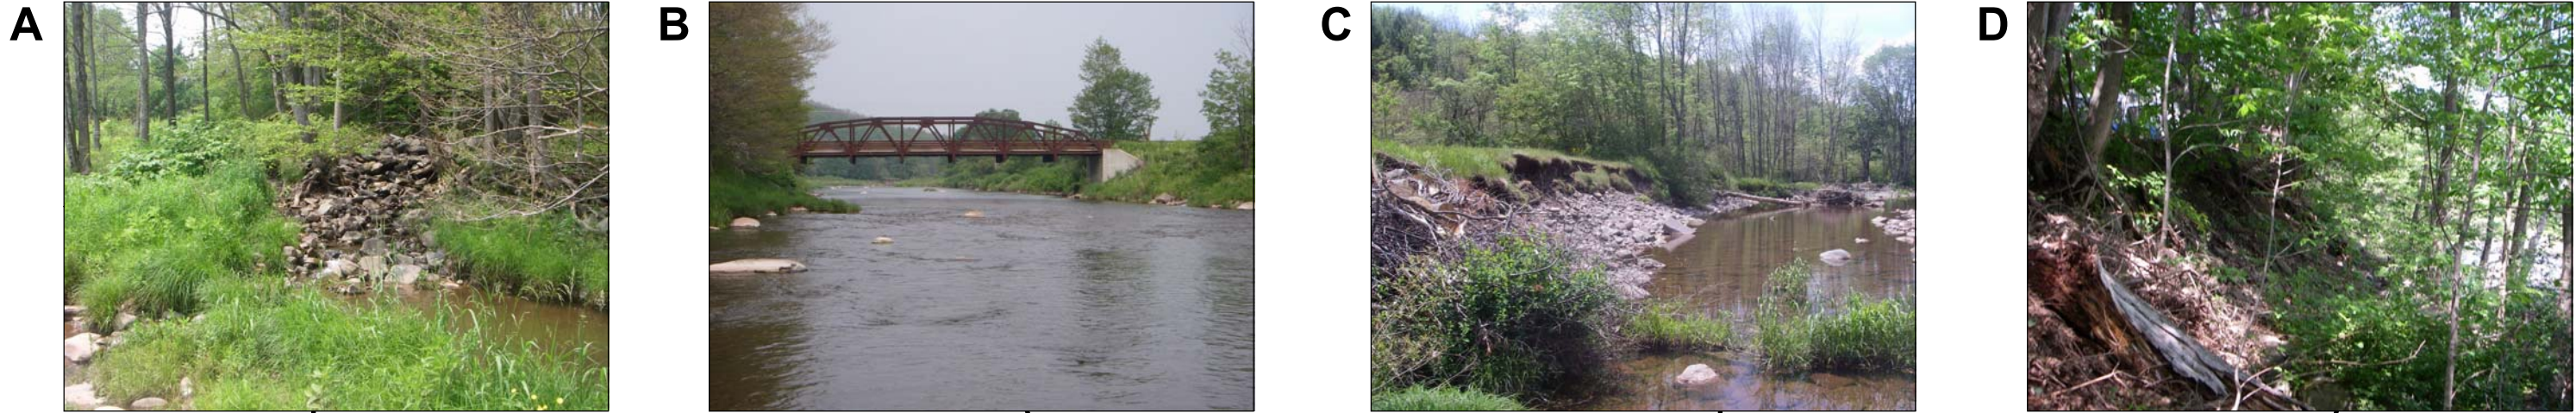
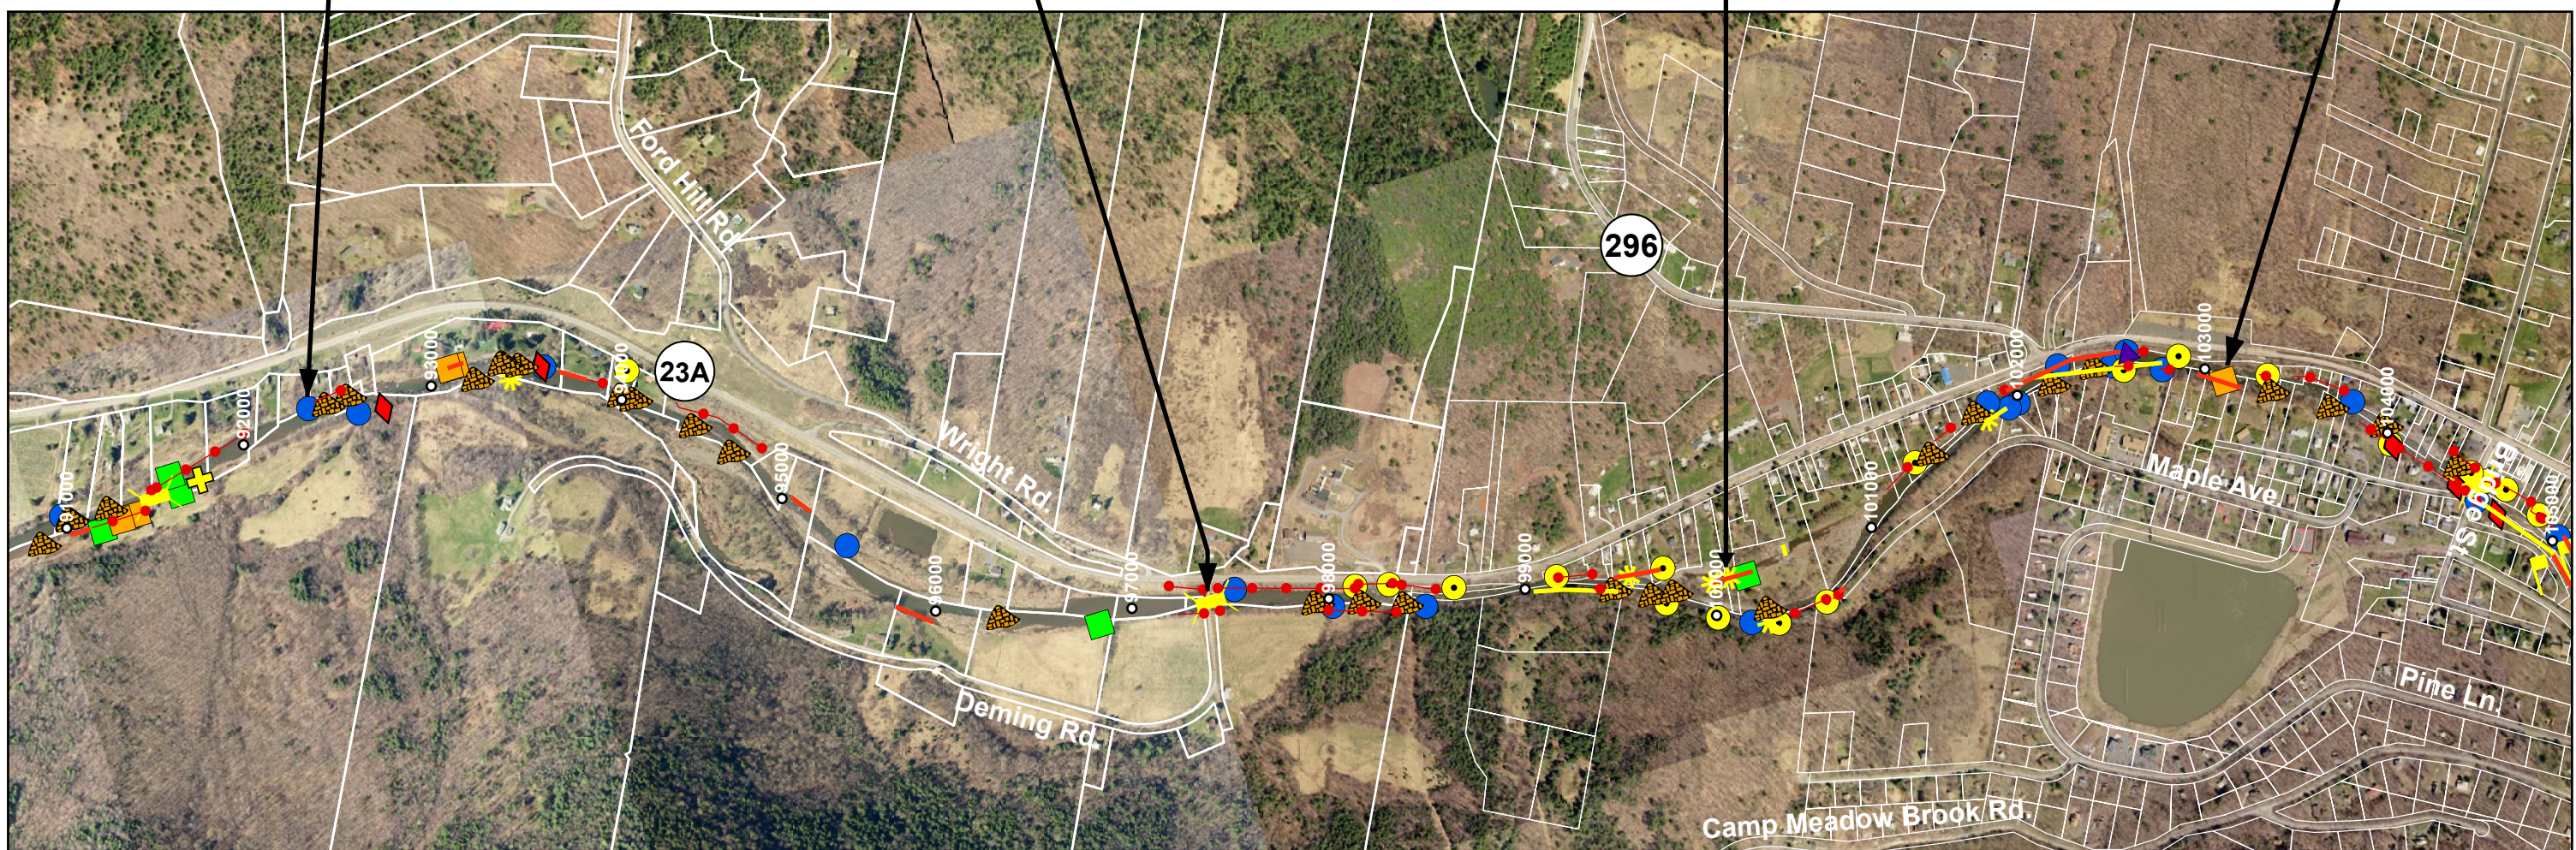
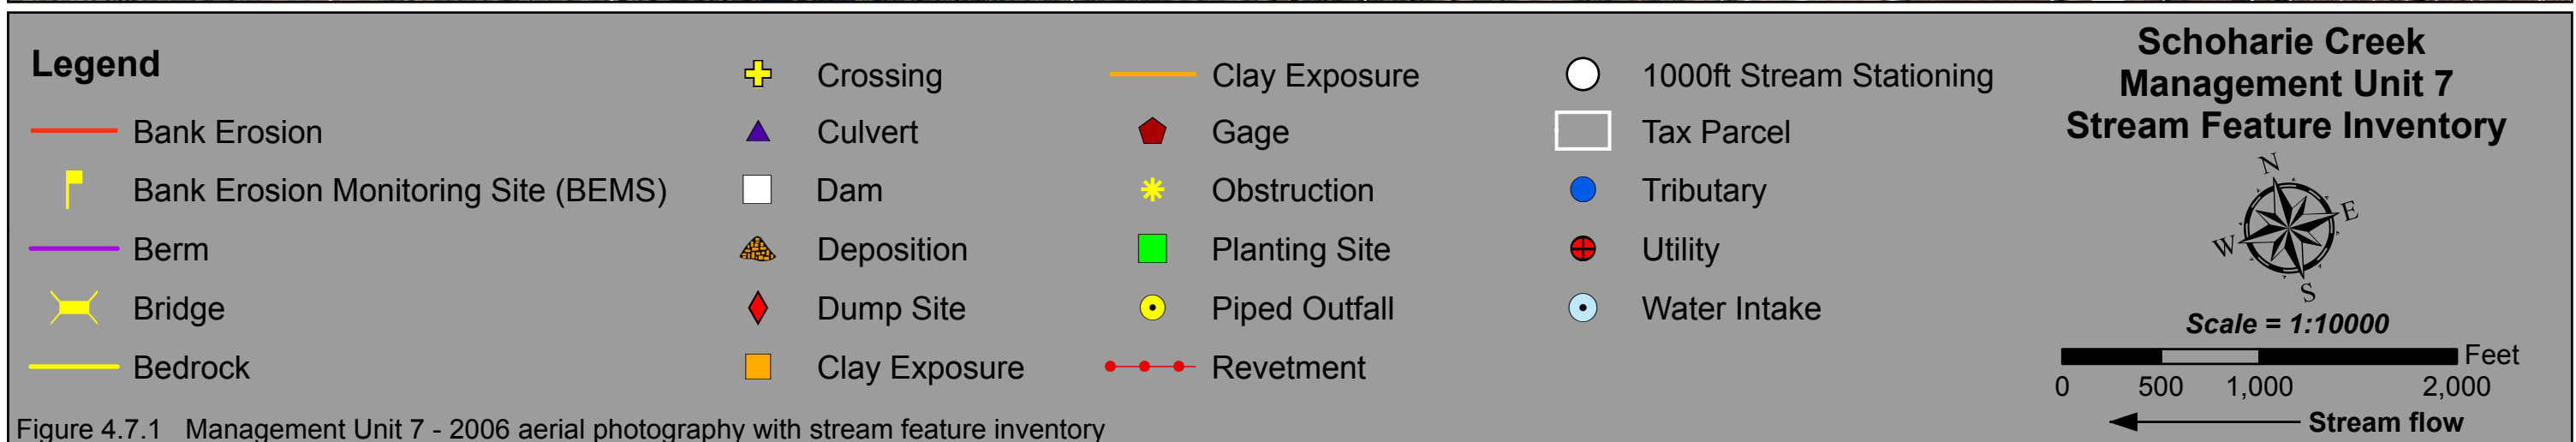
The 2006 stream feature inventory revealed that 7.5% (1,958 ft) of the streambanks exhibited signs of active erosion along the 26,096 ft of total channel length in the unit (Figure 4.7.1). The total surface area of active erosion totaled approximately 29,691 ft². *Revetment* has been installed on 20.1% (5,247 ft) of the streambanks. No *berms* were identified in this management unit at the time of the stream feature inventory.

Summary of Recommendations Management Unit 7	
Intervention Level	Passive, Assisted Self-Recovery
Stream Morphology	No recommendations at this time
Riparian Vegetation	Plantings for assisted self-recovery of eroding banks at Stations 101130 & 99700, and enhancement of riparian buffer at Station 97370.
Infrastructure	No recommendations at this time
Aquatic Habitat	Watershed Aquatic Habitat Study
Flood Related Threats	Installation of flood plain drainage, and/or regrading of the right streambank floodplain area to floodplain elevation, and installation of riparian plantings to address flooding issues at private bridge (Station 91473).
Water Quality	Removal of dump sites at Stations 104440 & 104050.
Further Assessment	Community-Wide Stormwater Infrastructure Assessment & Planning

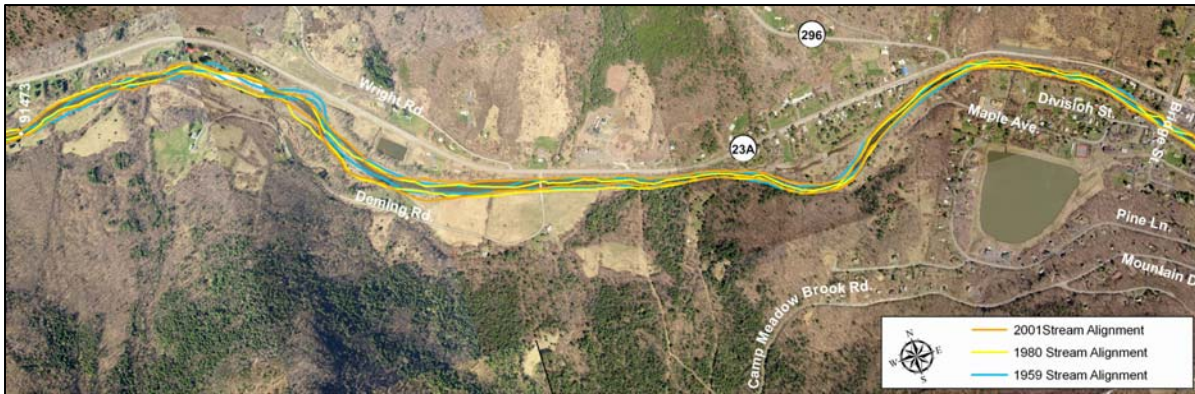
As seen from the historical stream alignments (below), the *planform* of the channel has remained fairly stable since 1959.

Historic stream channel alignments overlaid with 2006 aerial photograph

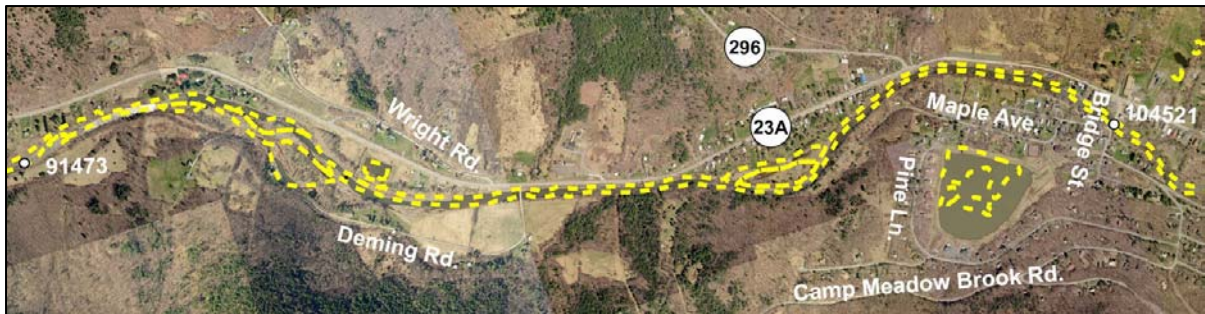
The entire stream channel within this management unit was designated as a wetland. This wetland was approximately 26 acres in size and classified as riverine lower perennial, signifying it is contained in the natural channel and characterized by a low gradient and slow

water velocity (R2UBH, Station 104521-104521) (see Section 2.6 for detailed wetland type descriptions). Wetlands are important features in the landscape that provide numerous beneficial functions including protecting and improving water quality, providing fish and wildlife habitats, storing floodwaters, and maintaining surface water flow during dry periods.

Wetland boundary approximately delineated by NWI (Station 104521-91473)

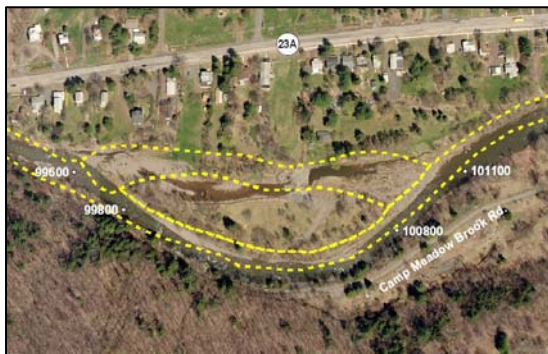
Wetland (Station 101100-99600 & 100800-99800)
Approximate wetland boundary delineated by NWI

At the next meander bend, stream confinement was reduced allowing some floodplain access. There were two wetlands mapped in this area. Along the right streambank there was a 2.5 acre palustrine wetland with emergent vegetation (PEM1E, Station 101100-99600) and a 3 acre upland wetland on the center bar (U, Station 100800-99800).

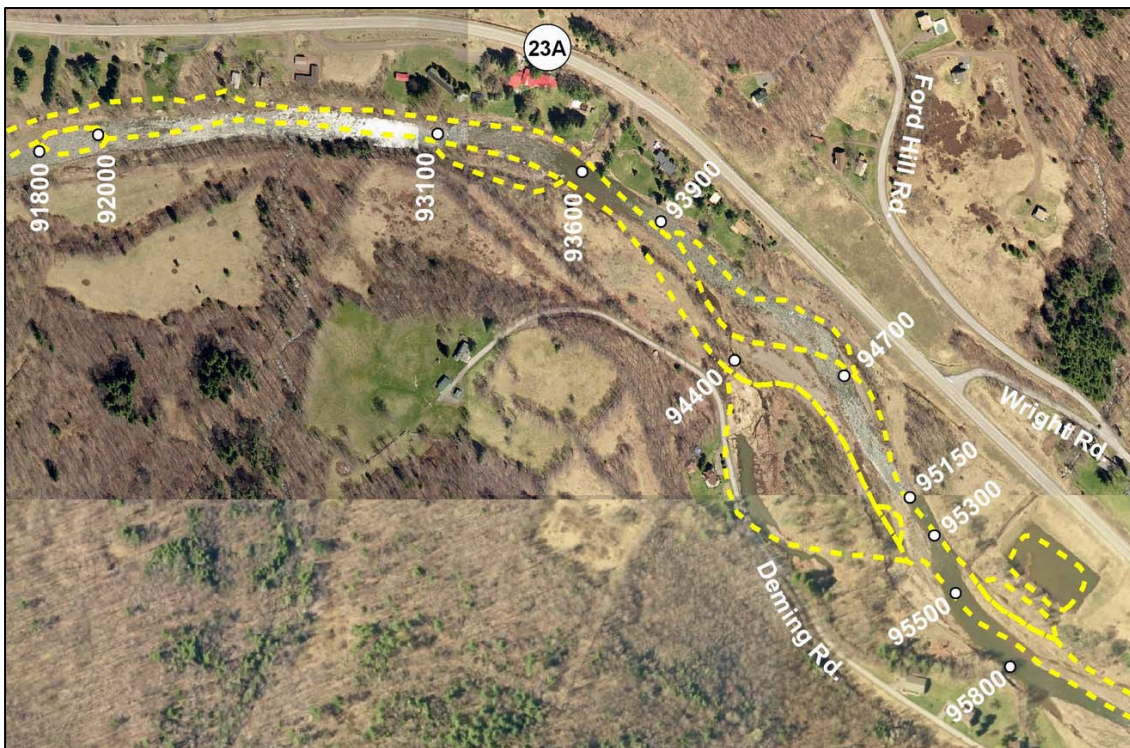
There were six wetlands located along the stream corridor from here to the end of the management unit. Four of these were classified as riverine lower perennial wetlands, located at Station 95800-95500 (R2USC, 0.4ac), Station 95300-95150 (R2USC, 0.09ac), Station 94700-93900 (R2USC, 1.7ac), Station 92000-91800 (R2USA 0.3ac). Two palustrine forested wetlands were located along the left streambank at Station 95300-94400 (PFO1A, 4.8ac) and Station 93600-93100 (PFO1A, 0.7ac).

Wetland boundaries approximately delineated by NWI from Station 95800 to 91800

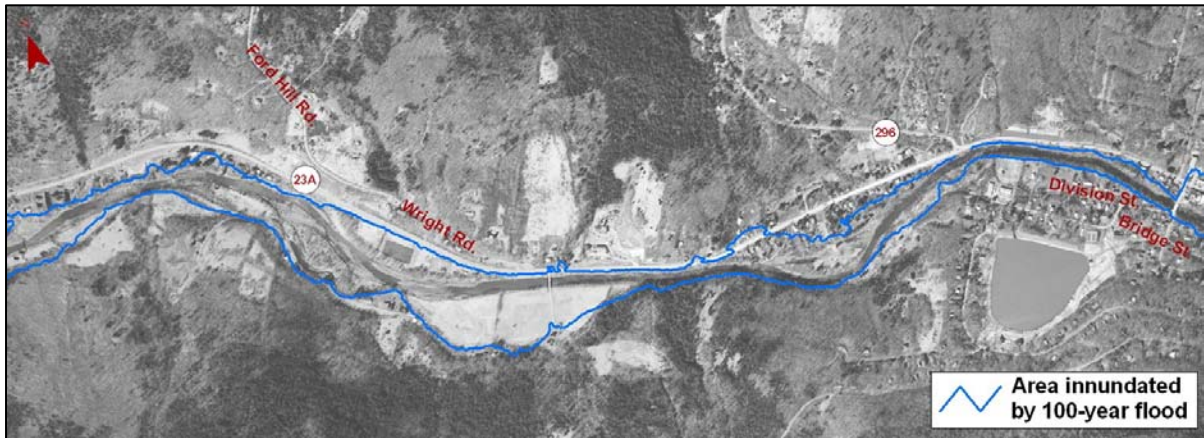
100-year floodplain boundary map

According to the current floodplain map (above), twenty-five existing structures in this unit appeared to be situated within the estimated 100-year floodplain. The 100-year floodplain is that area predicted to be inundated by floods of a magnitude that is expected to occur once in any 100-year period, on the basis of a statistical analysis of local flood record. Most communities regulate the type of development that can occur in areas subject to these flood risks.
