Schoharie Creek Management Unit 8

Town of Jewett – Station 91473 to Carr Road Bridge (Station 83957)

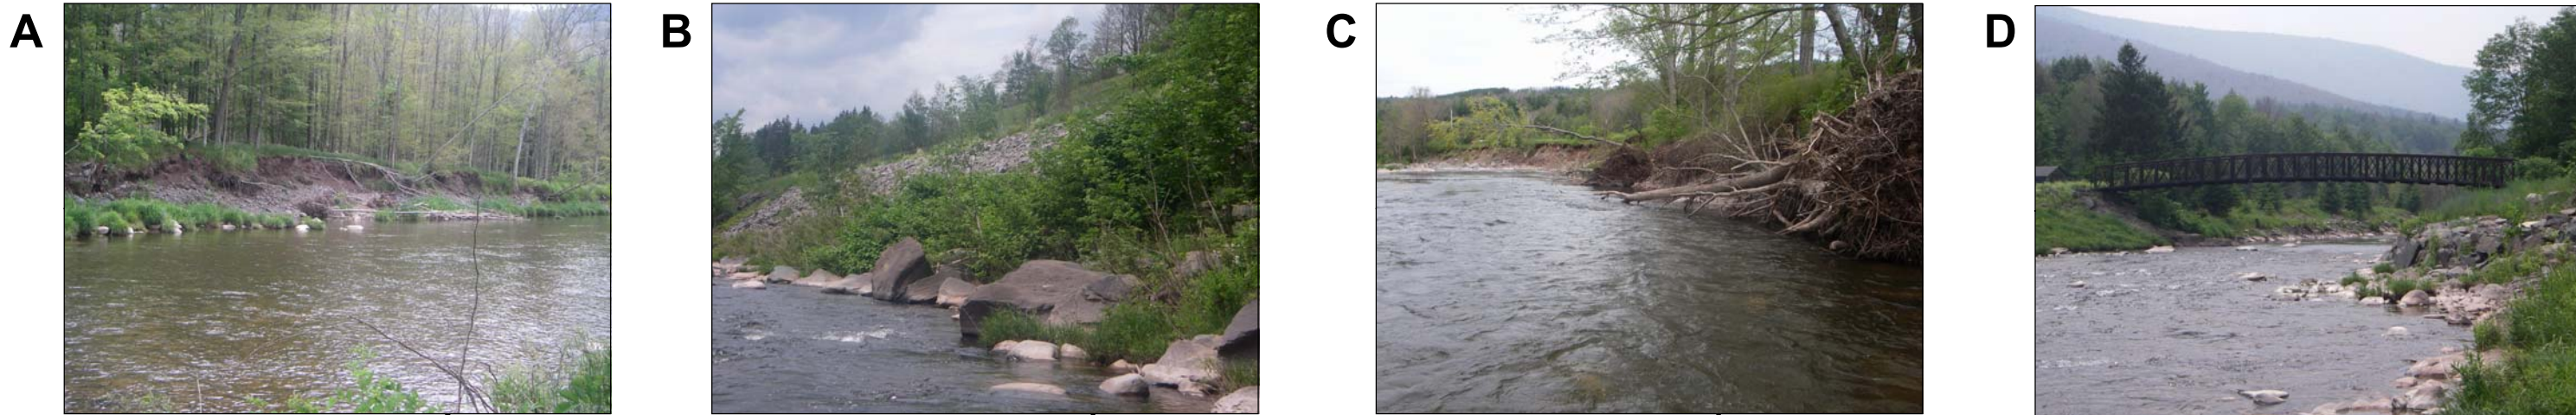
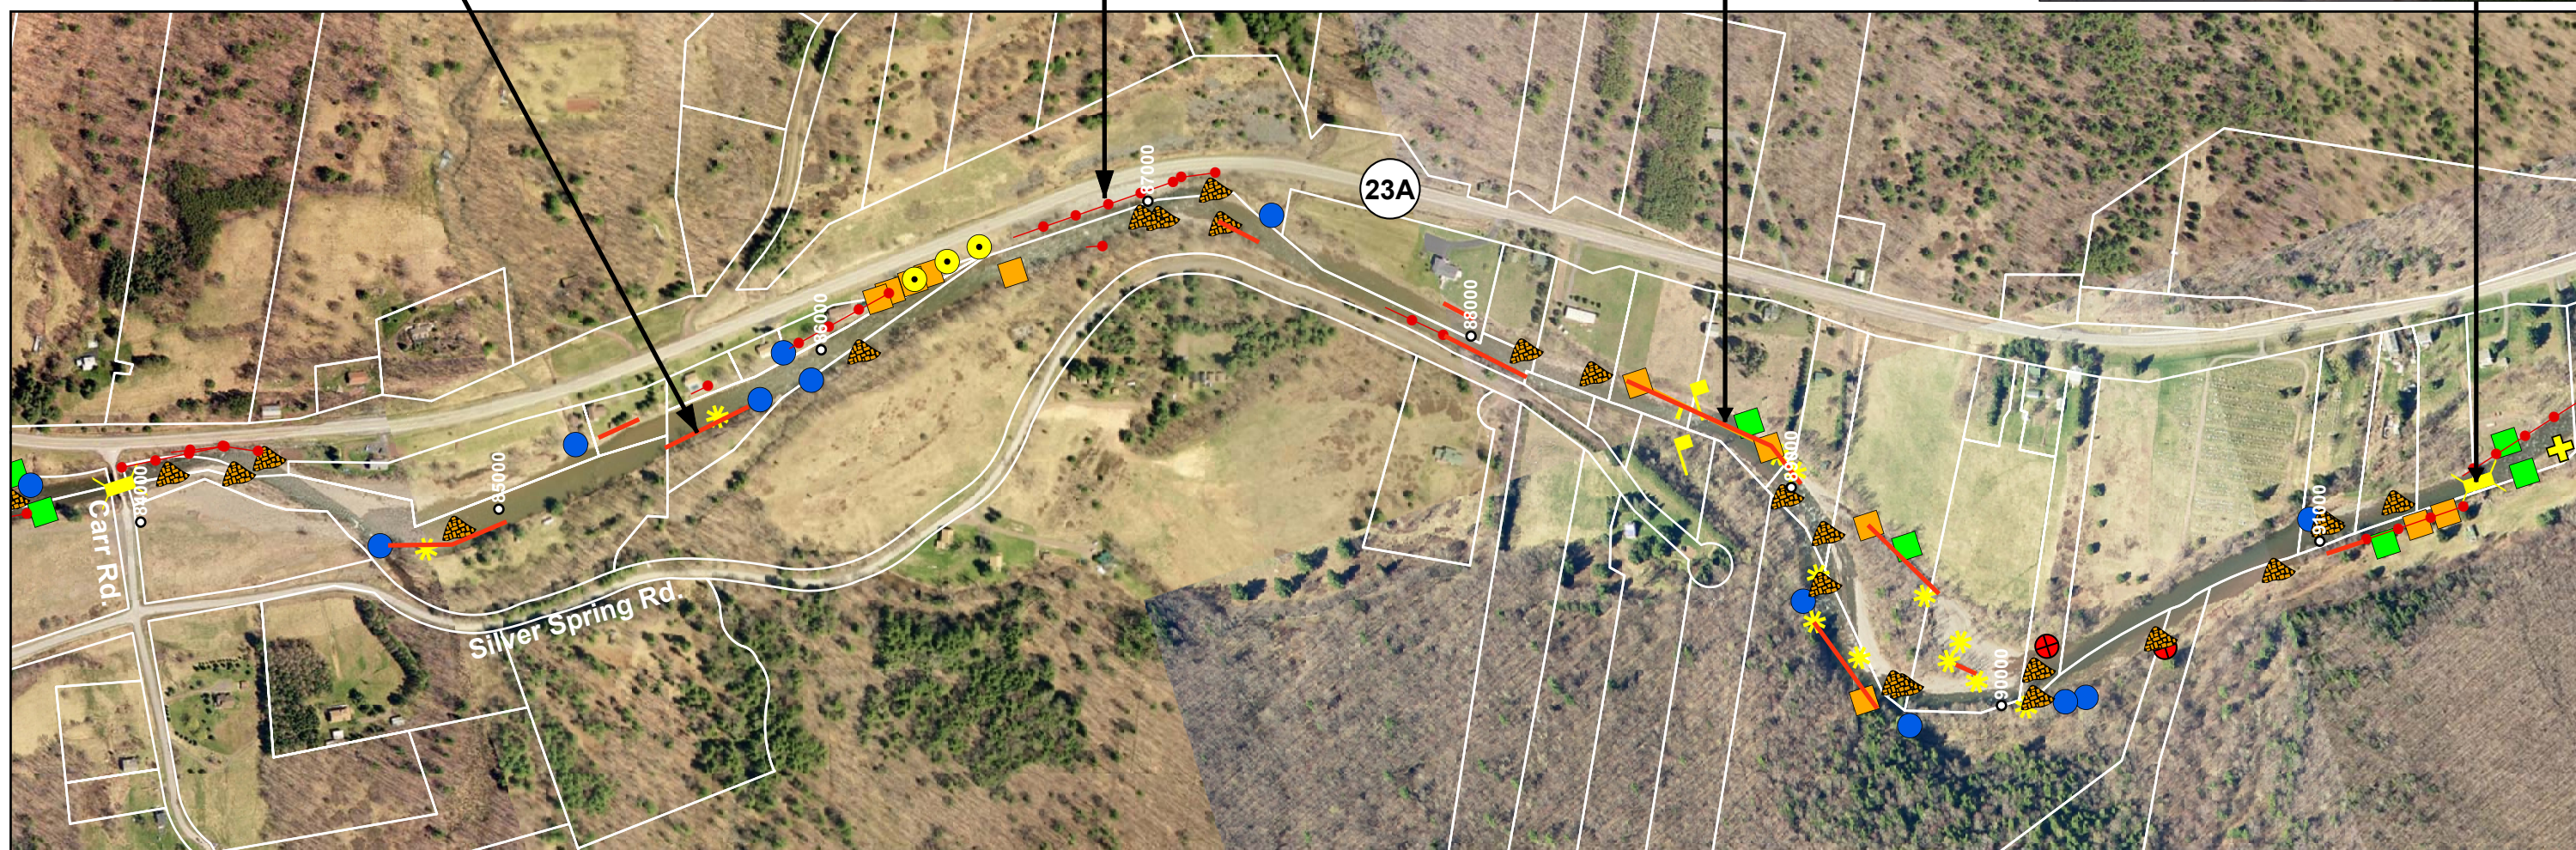
Figure 4.8.1 Management Unit 8 - 2006 aerial photography with stream feature inventory

The 2006 stream feature inventory revealed that 16.8% (2,524 ft) of the streambanks exhibited signs of active erosion along the 15,031 ft of total channel length in the unit (Figure 4.8.1). The total surface area of active erosion totaled approximately 28,031 ft². *Revetment* had been installed on 13.7% (2,060 ft) of the streambanks. No *berms* were identified in this management unit at the time of the stream feature inventory.

Summary of Recommendations Management Unit 8	
Intervention Level	Passive, Assisted Self-Recovery, Full Restoration
Stream Morphology	No recommendations at this time
Riparian Vegetation	Plantings for assisted self-recovery of eroding banks at Stations 91100, 88000, 88200 & 85750, enhancement of riparian buffer at Stations 90100, 88900 & 84700, and interplanting of rip-rap at Stations 91400, 87930 & 87200
Infrastructure	Remediate repetitive road wash out of Carr Road and improve emergency access during floods.
Aquatic Habitat	Watershed Aquatic Habitat Study
Flood Related Threats	Hydraulic analysis of Carr Road bridge and upstream floodplain to determine capacity to convey flood flows. Installation of floodplain drains at Carr Road bridge.
Water Quality	Relocation of septic system outside of floodplain for home at Station 84700
Further Assessment	Resurvey of bank erosion monitoring site at Station 88700 to assess erosion rate.

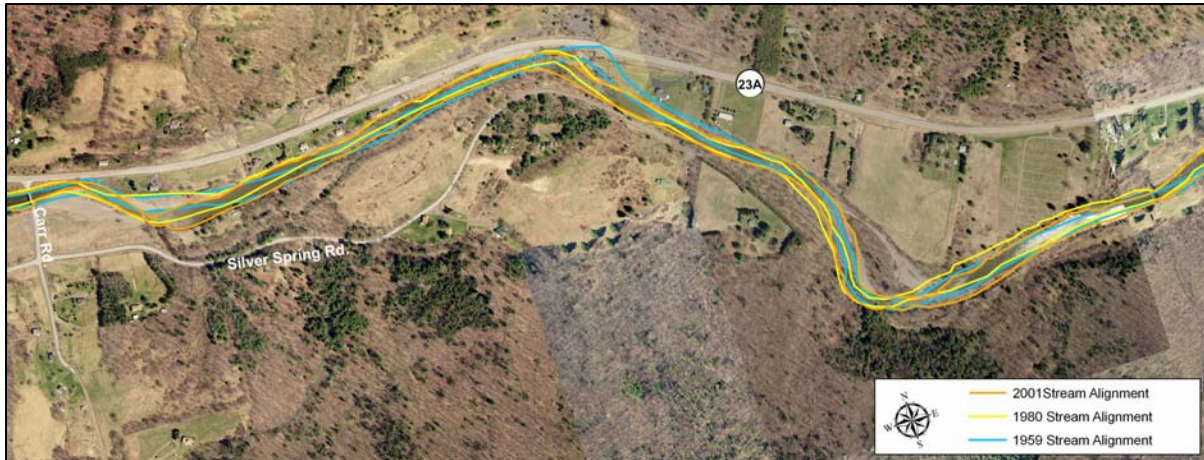
As seen from the historical stream alignments (below), the *planform* of the channel has remained fairly stable since 1959.

Historic stream channel alignments overlaid with 2006 aerial photograph

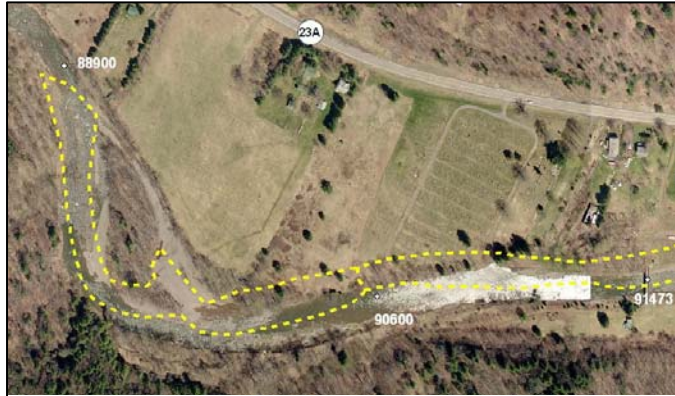
Most of the stream channel within this management unit was designated as a wetland. At the upstream end was a 2 acre wetland classified as riverine lower perennial, signifying it was contained in the natural channel and characterized by a low gradient and slow water velocity (R2UBH, Station 91473-90600);

*Wetlands (Station 91473-90600 & 90600-88900)
Approximate wetland boundary delineated by NWI*

this wetland was followed by another 3.8 acre riverine lower perennial wetland (R2USA, Station 90600-88900) (see Section 2.6 for detailed wetland type descriptions). Wetlands are important features in the landscape that provide numerous beneficial functions including protecting and improving water quality, providing fish and wildlife habitats, storing floodwaters, and maintaining surface water flow during dry periods.

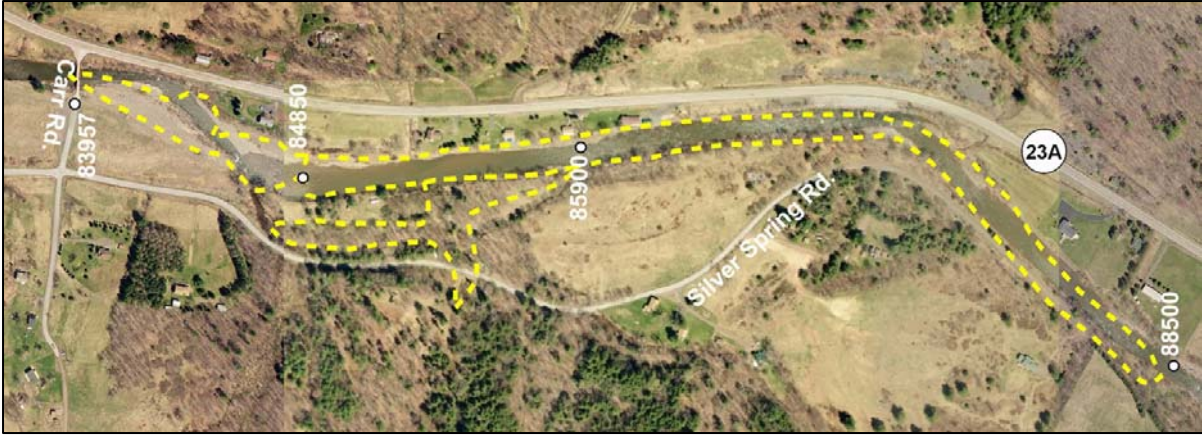
The downstream half of this management unit contained three federally designated wetlands (see photo below). The first was an 8.6 acre wetland classified as riverine lower perennial, signifying it is contained in the natural channel and characterized by a low gradient and slow water velocity (R2UBH, Station 88500-84850); and this was followed by another 2.5 acre riverine lower perennial wetland (R2USA, Station 84850-83957). Along the left streambank there was a 3 acre palustrine wetland with forested vegetation (PFO1C, Station 85900-84850).

Wetlands (Station 88500-84850 & 85900-84850 & 84850-83957)

Approximate wetland boundary delineated by NWI
