Schoharie Creek Management Unit 9

Town of Jewett – Carr Road Bridge (Station 83957) to County Route 17 (Station 70652)

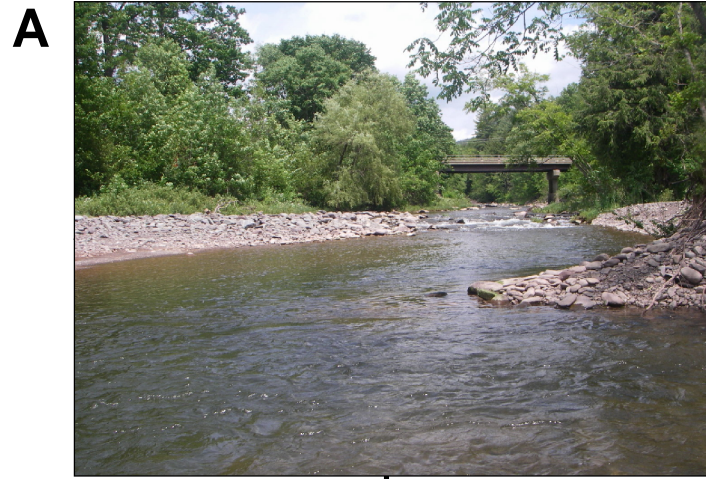
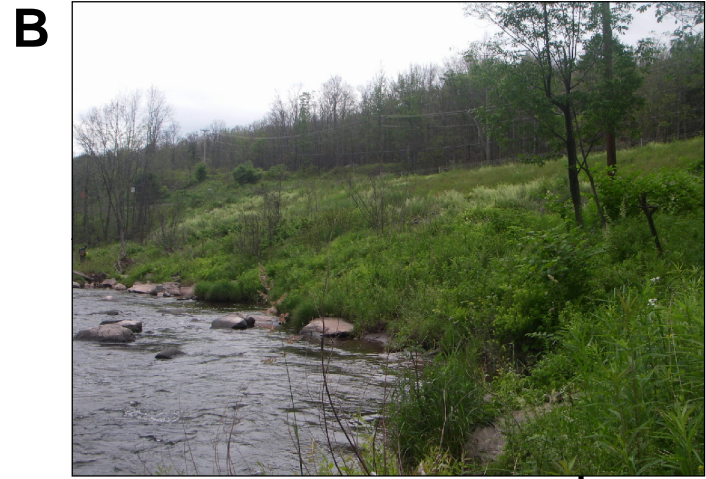
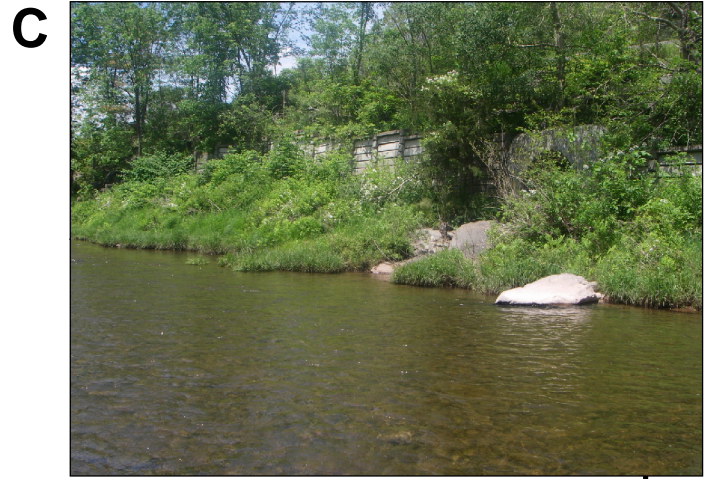
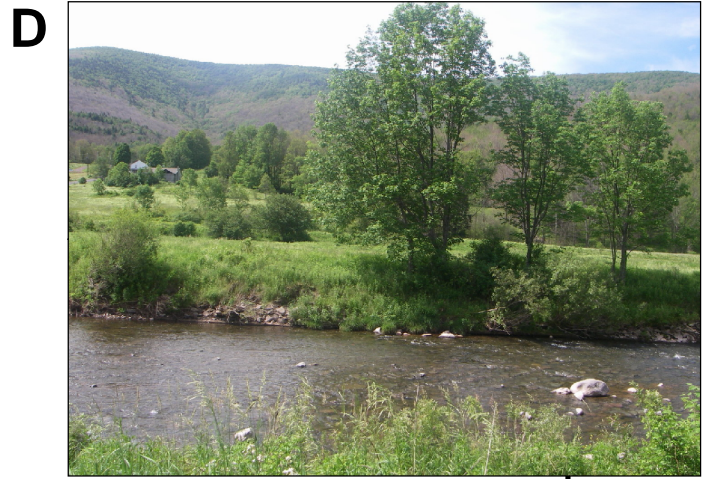
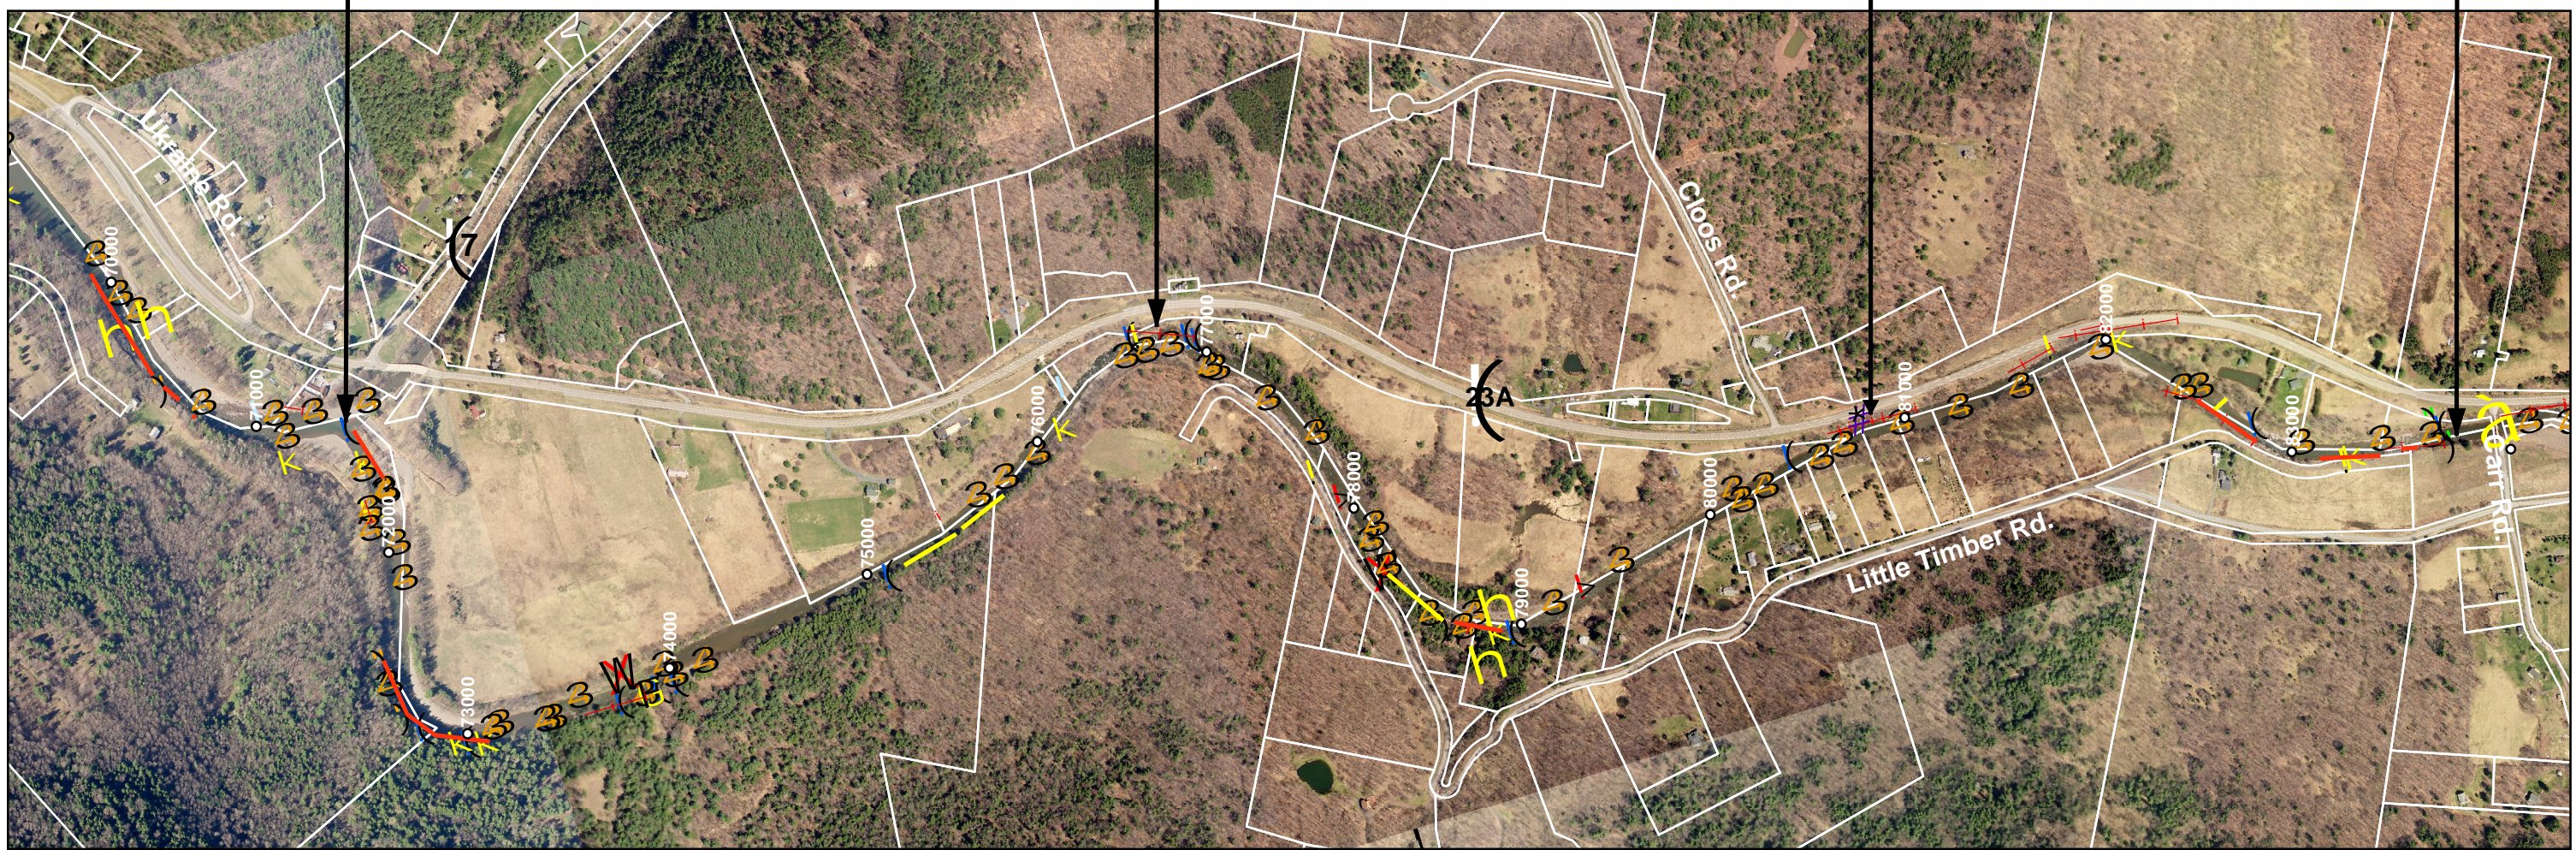
Figure 4.9.1 Management Unit 9 - 2006 aerial photography with stream feature inventory

The 2006 stream feature inventory revealed that 7% (1,861 ft) of the streambanks exhibited signs of active erosion along the 26,610 ft of total channel length in the unit (Fig. 4.9.1). The total surface area of active erosion totaled approximately 70,973 ft². *Revetment* had been installed on 10% (2,691 ft) of the streambanks. No *berms* were identified in this management unit at the time of the stream feature inventory.

The following description of stream channel conditions references insets in foldout, Figure 4.9.1. Stream stationing presented on this map is measured in feet and begins at the Schoharie Reservoir. “Left” and “right” streambank references are oriented looking downstream, photos are also oriented looking downstream unless otherwise noted. Italicized terms are defined in the glossary. This characterization is the result of an assessment conducted in 2006.

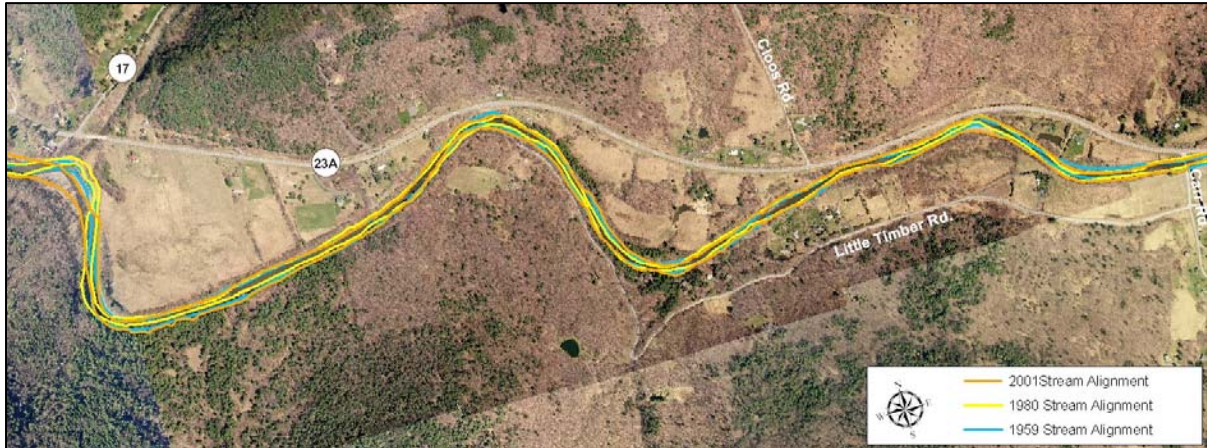
As seen from the historical stream alignments (below), the *planform* of the channel has remained fairly stable since 1959.

Historic stream channel alignments overlaid with 2006 aerial photograph

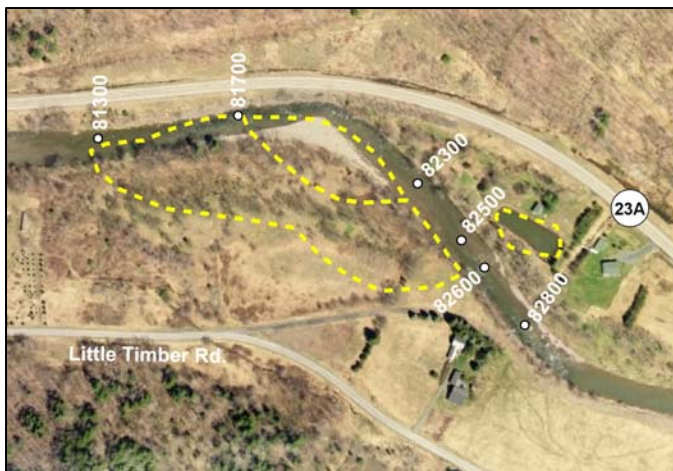
Wetlands (Station 82800-82500 & 82600-81300 & 82300-81700) Approximate wetland boundary delineated by NWI

There were three wetlands in this vicinity. On the right streambank was a 0.4 acre impounded palustrine wetland (PUBFh, Station 82800-82500). On the left streambank was a large 4.7 acres palustrine forested wetland (PFO1A, Station 82600-81300) along with a 1.4 acre riverine lower perennial wetland (R2USA, Station 82300-81700) (see Section 2.6 for detailed wetland type descriptions).

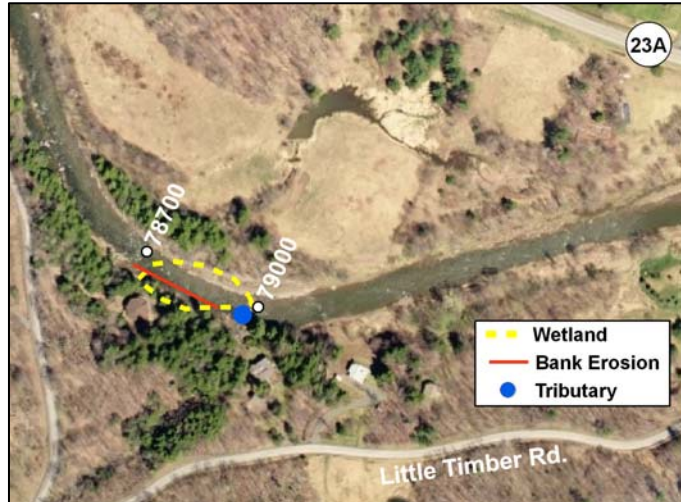
*Wetland (Station 79000-78700)
Approximate wetland boundary delineated by NWI*

As the stream *meandered* downstream a 0.5 acre riverine, upper perennial, seasonally flooded wetland was located within the stream channel (R2USC, Station 79000-78700). Near the upstream end of this wetland an unnamed tributary entered the Schoharie Creek from the left streambank (Station 78965). This tributary drained the steep slopes of Evergreen Mountain, before it reached the flatter topography of the valley floor where it entered the Schoharie Creek. As a result of this stream slope change, the tributary lost its ability to transport sediment gathered from the mountain slopes, and began to deposit sediment at its mouth and into the more gently sloped Schoharie Creek. This is a common feature of confluence areas, which often contain extensive sediment bars, function as important sediment storage areas, and are typically among the most dynamic and changeable areas in the stream system. This tributary was classified C by the NYSDEC (NYSDEC, 1994).

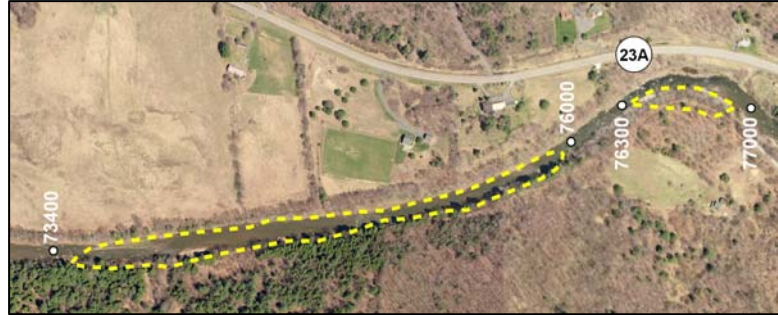
*Wetland (Station 7700-76300 & 76000-73400)
Approximate wetland boundary delineated by NWI*

There was a 0.9 acre riverine, upper perennial, seasonally flooded wetland located along the left streambank (R2USC, Station 77000-76300). A larger 5.4 acre riverine, upper perennial, permanently flood wetland was located within the stream channel downstream (R2UBH, Station 76000-73400).

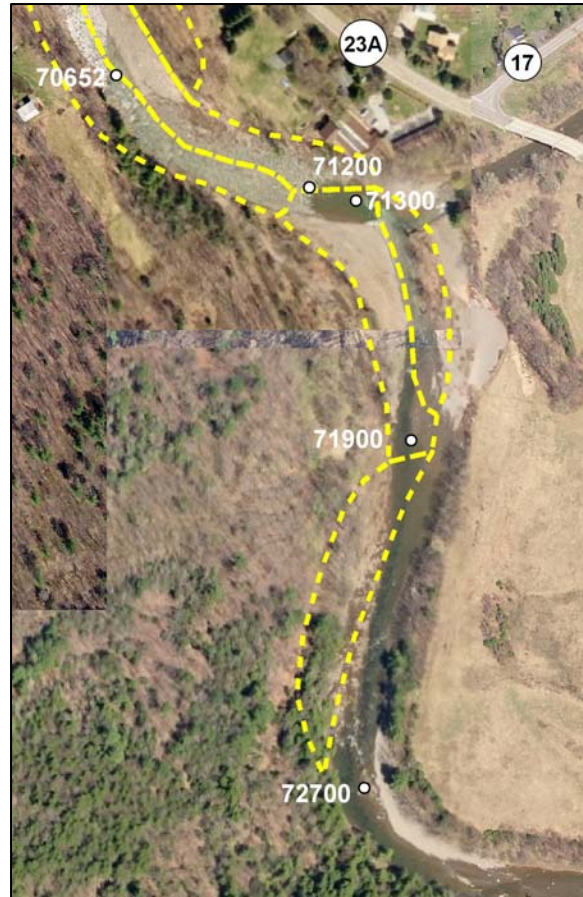
*Wetlands at downstream end of management unit
Approximate wetland boundary delineated by NWI*

The downstream end of this management unit was dominated by wetlands including four riverine, upper perennial wetlands, totaling 5 acres (R2USC, Station 72700-71900) (R2USC, Station 71900-71300) (R2USC, R2UBH, Station 71200-70652). A 1.7 acre palustrine, forested wetland was located along the left streambank (PFO1A, Station 71900-71200).

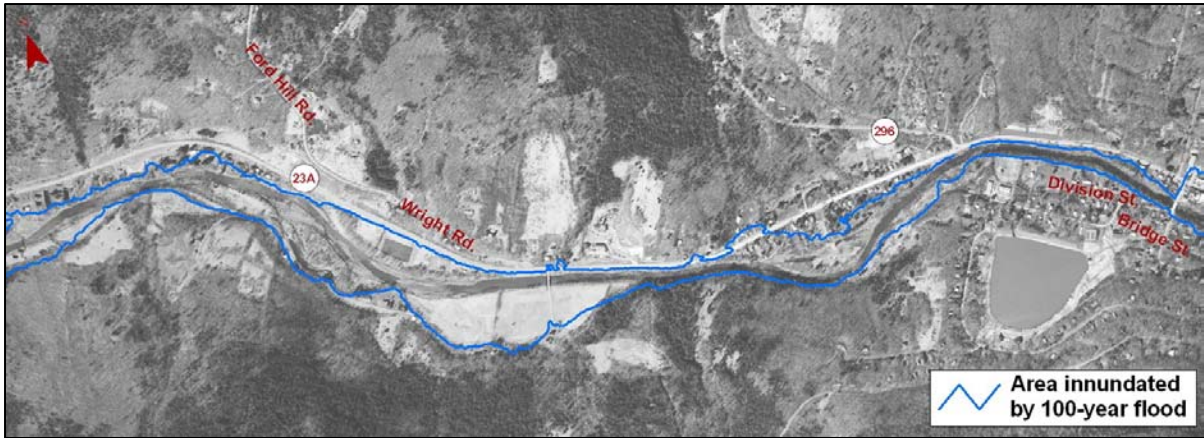
According to the current floodplain maps (below), fourteen existing structures in this unit appeared to be situated within the estimated 100-year floodplain. The 100-year floodplain is that area predicted to be inundated by floods of a magnitude that is expected to occur once in any 100-year period, on the basis of a statistical analysis of local flood record. Most communities regulate the type of development that can occur in areas subject to these flood risks.

100-year floodplain boundary map
