Schoharie Creek Management Unit 10

Towns of Jewett and Lexington – County Route 17 (Station 70652) to
Bush Road Bridge (Station 63446)

Figure 4.10.1 Management Unit 10 - 2006 aerial photography with stream feature inventory

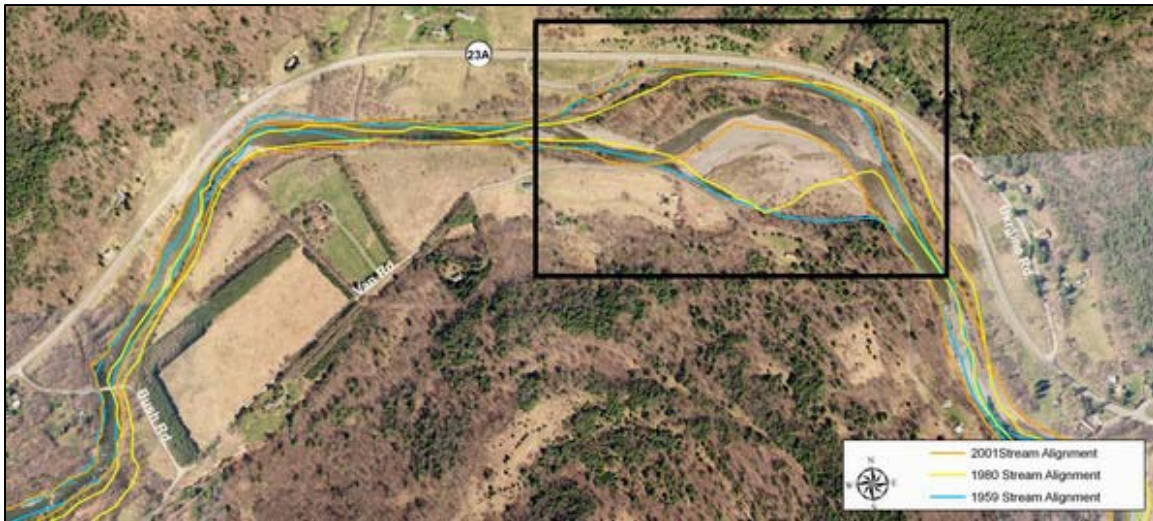
Historic stream channel alignments overlaid with 2006 aerial photograph

As seen from the historical stream alignments (below), the *planform* of the stream channel at the upstream half of the management unit has changed over the years (Station 69400-66700), but the downstream half has remained fairly stable since 1959.

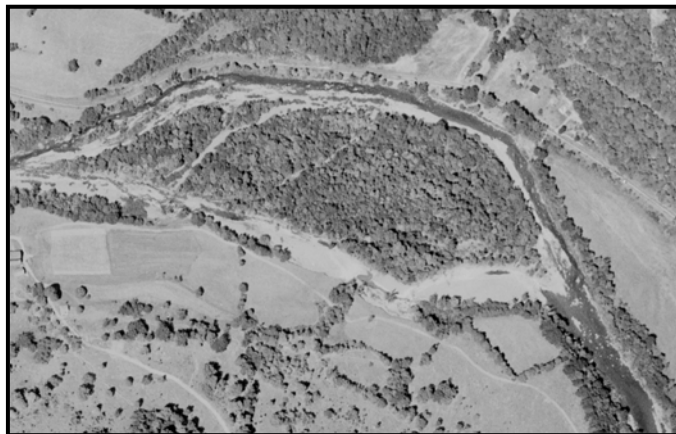
1959 aerial photograph (Station 69400-66700)

The 1959 aerial photograph (above) shows the upstream half of the management unit was historically affected by floods. The mainstem flowed against County Route 23A, however one large flood chute along the agricultural fields can be seen, as well as several smaller flood chutes across the forested area in between. Sometime between 1980 and 2001

another large flood chute was cut directly across the forested area most likely during a large flood event. The mainstem has remained split in two channels as shown on the 2006 aerial photograph. A general widening of the stream channel was also noted. As of 2006, according to available NYS DEC records dating back to 1996, no stream disturbance permits were issued in this management unit.

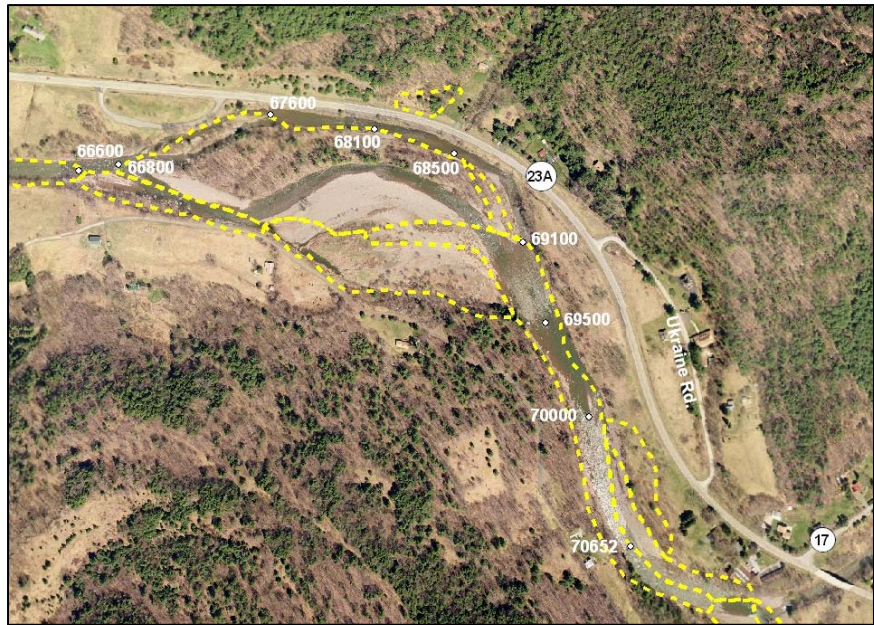
Wetlands in upstream half of management unit (Stations 70652-66600) approximate wetland boundary delineated by NWI

ac, Station 70652-68500) (R2USC, 0.9ac, Station 70652-70150) (R2USC, 5.9ac, Station 69500-67600), (R2USC, 0.5ac, Station 69100-68500) (R2USC, 1.9ac, 67600-666000). A 1.9 acre palustrine wetland with a mixture of shrub-scrub and emergent vegetation was located along the right streambank near the upstream end of the management unit (PSS1/EM1A, Station 70652-70000). A 15 acre palustrine wetland with forested vegetation was located on the island between the stream channel divergence (PFO1A, Station 69000-66880). Wetlands are important features in the landscape that provide numerous beneficial functions including protecting and improving water quality, providing fish and wildlife habitats, storing floodwaters, and maintaining surface water flow during dry periods (see Section 2.6 for detailed wetland type descriptions).

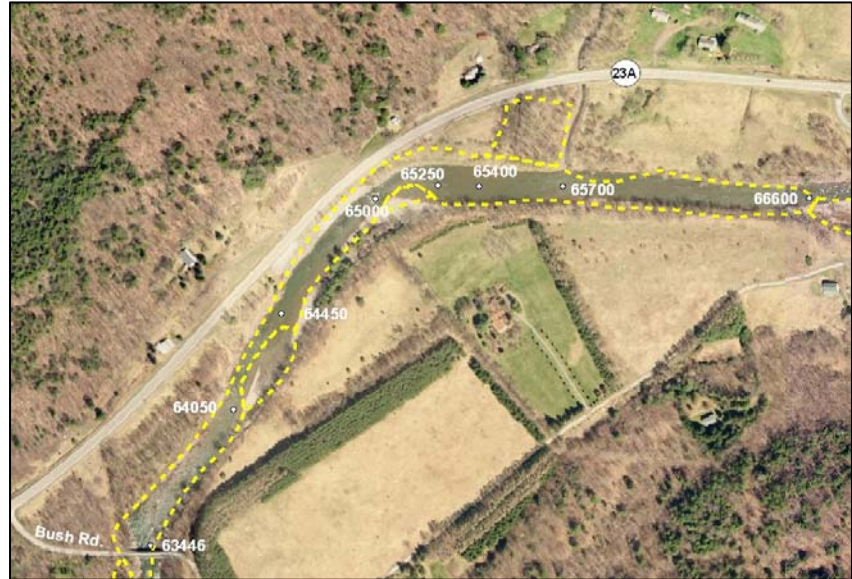
Wetlands in downstream half of management unit (Stations 66600-63446) approximate wetland boundary delineated by NWI

with forested vegetation was located on the right streambank (PFO1A, Station 65700-65400).

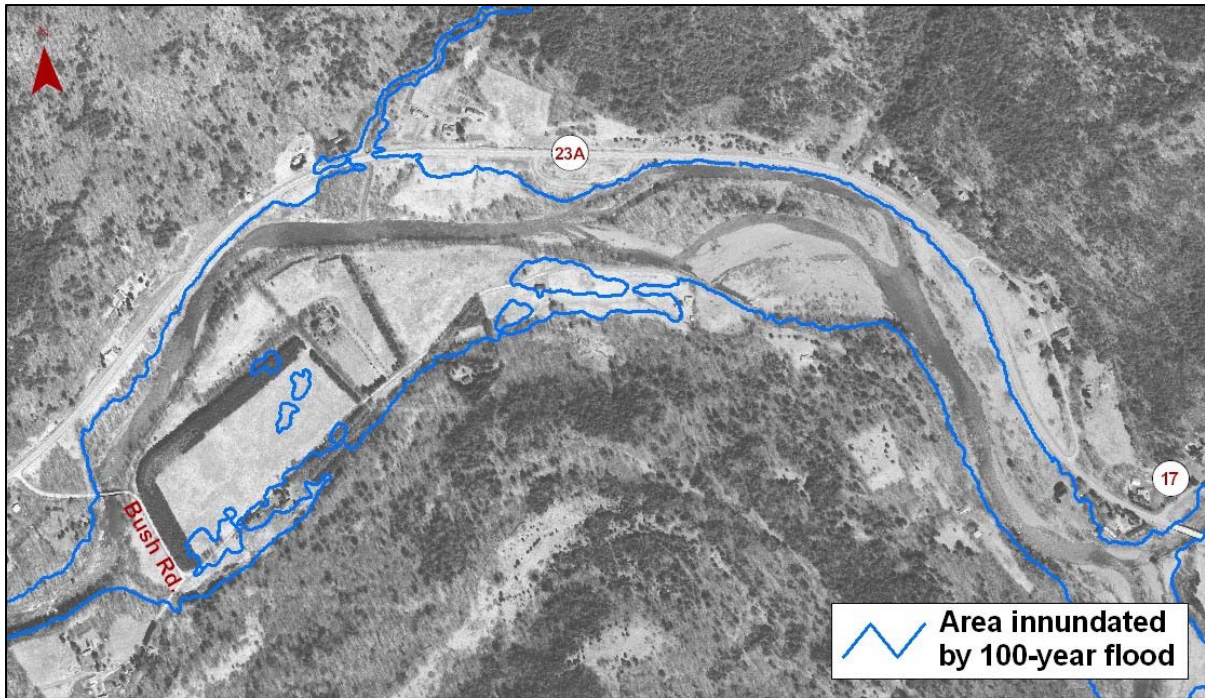
100-year floodplain boundary map

According to the current floodplain maps (below), one existing structure in this unit appeared to be situated within the estimated 100-year floodplain. The 100-year floodplain is that area predicted to be inundated by floods of a magnitude that is expected to occur once in any 100-year period, on the basis of a statistical analysis of local flood record. Most communities regulate the type of development that can occur in areas subject to these flood risks.
