Schoharie Creek Management Unit 11

Town of Lexington – Bush Road Bridge (Station 63446) to County Route 42 Bridge (Station 55350)

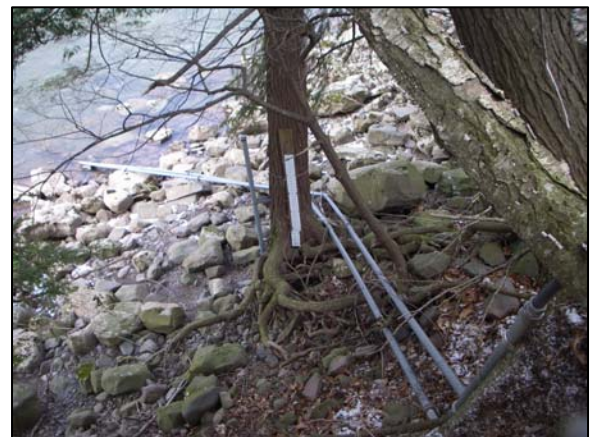
USGS stream gage #01349705 - Station 62740

A United State Geologic Survey (USGS) continuously recording stream gage was located on the left streambank approximately 700 ft downstream from the Bush Road bridge (Station 62740). This gage (#01349705) has a drainage area of 96.8mi² and has been collecting data from August 1999 to the present. All gage information including real time discharge and gage height

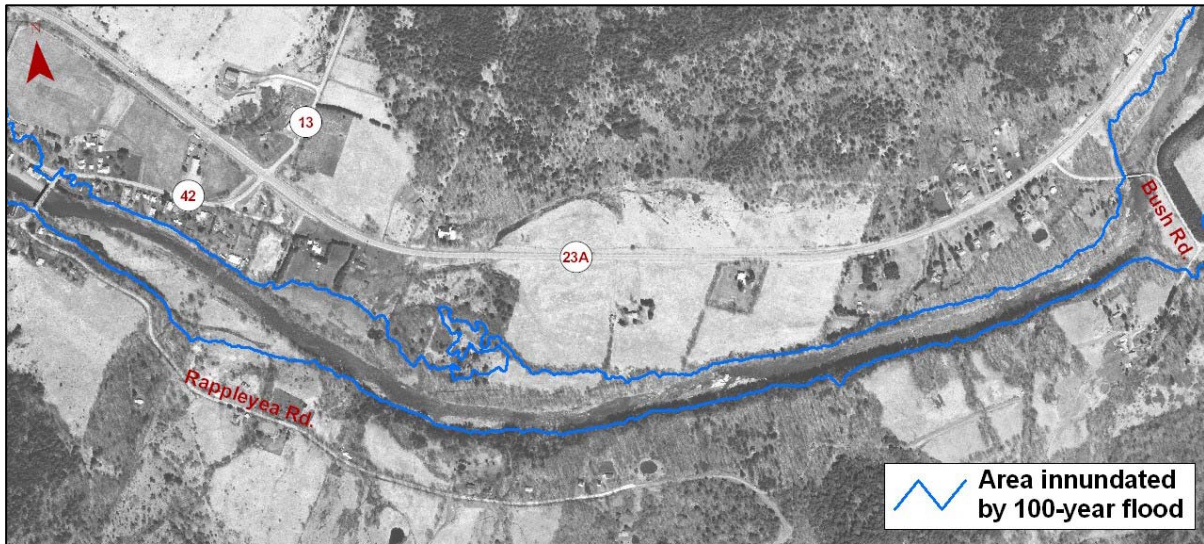
100-year floodplain boundary map

According to the current floodplain maps (above), six existing structures in this unit appeared to be situated within the estimated 100-year floodplain. The 100-year floodplain is that area predicted to be inundated by floods of a magnitude that is expected to occur once in any 100-year period, on the basis of a statistical analysis of local flood record. Most communities regulate the type of development that can occur in areas subject to these flood risks.
