Schoharie Creek Management Unit 12

Town of Lexington – County Route 42 Bridge (Station 55350) to Station 48154

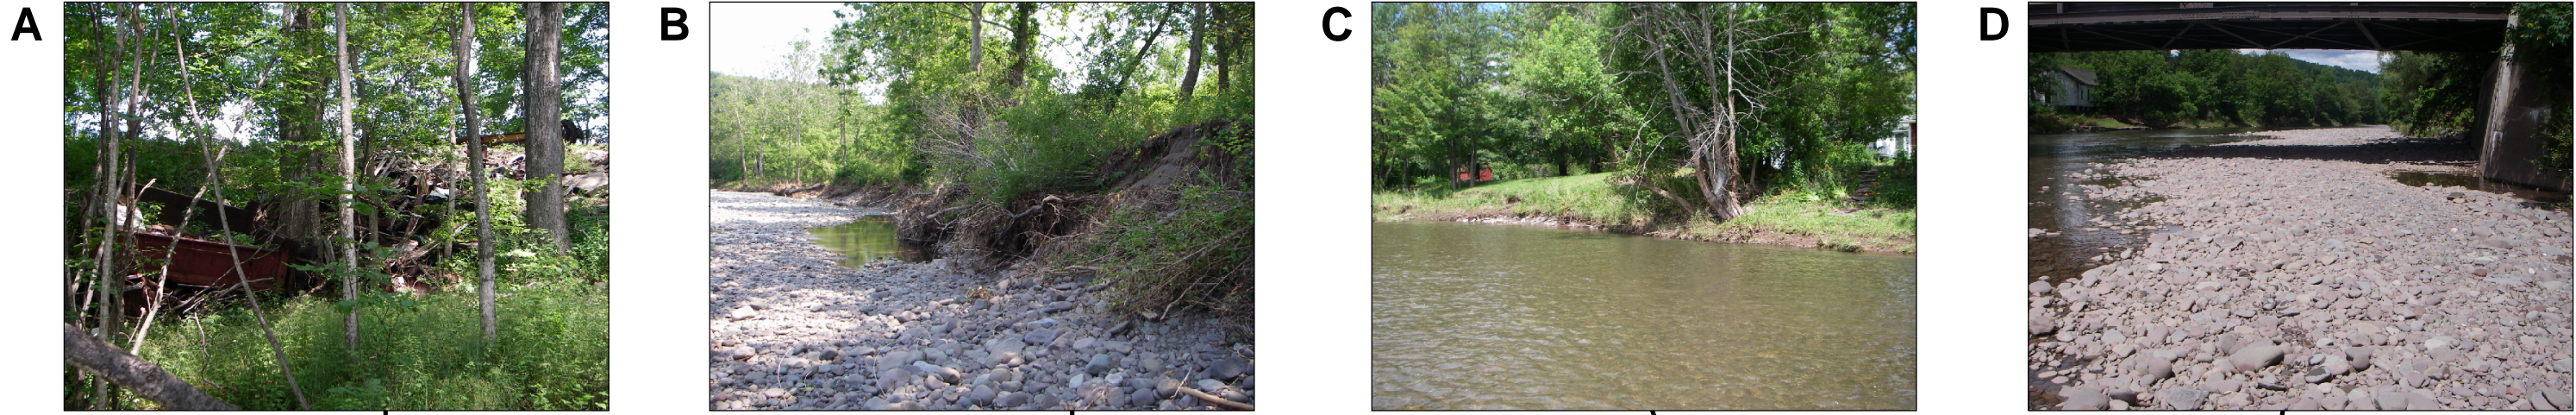
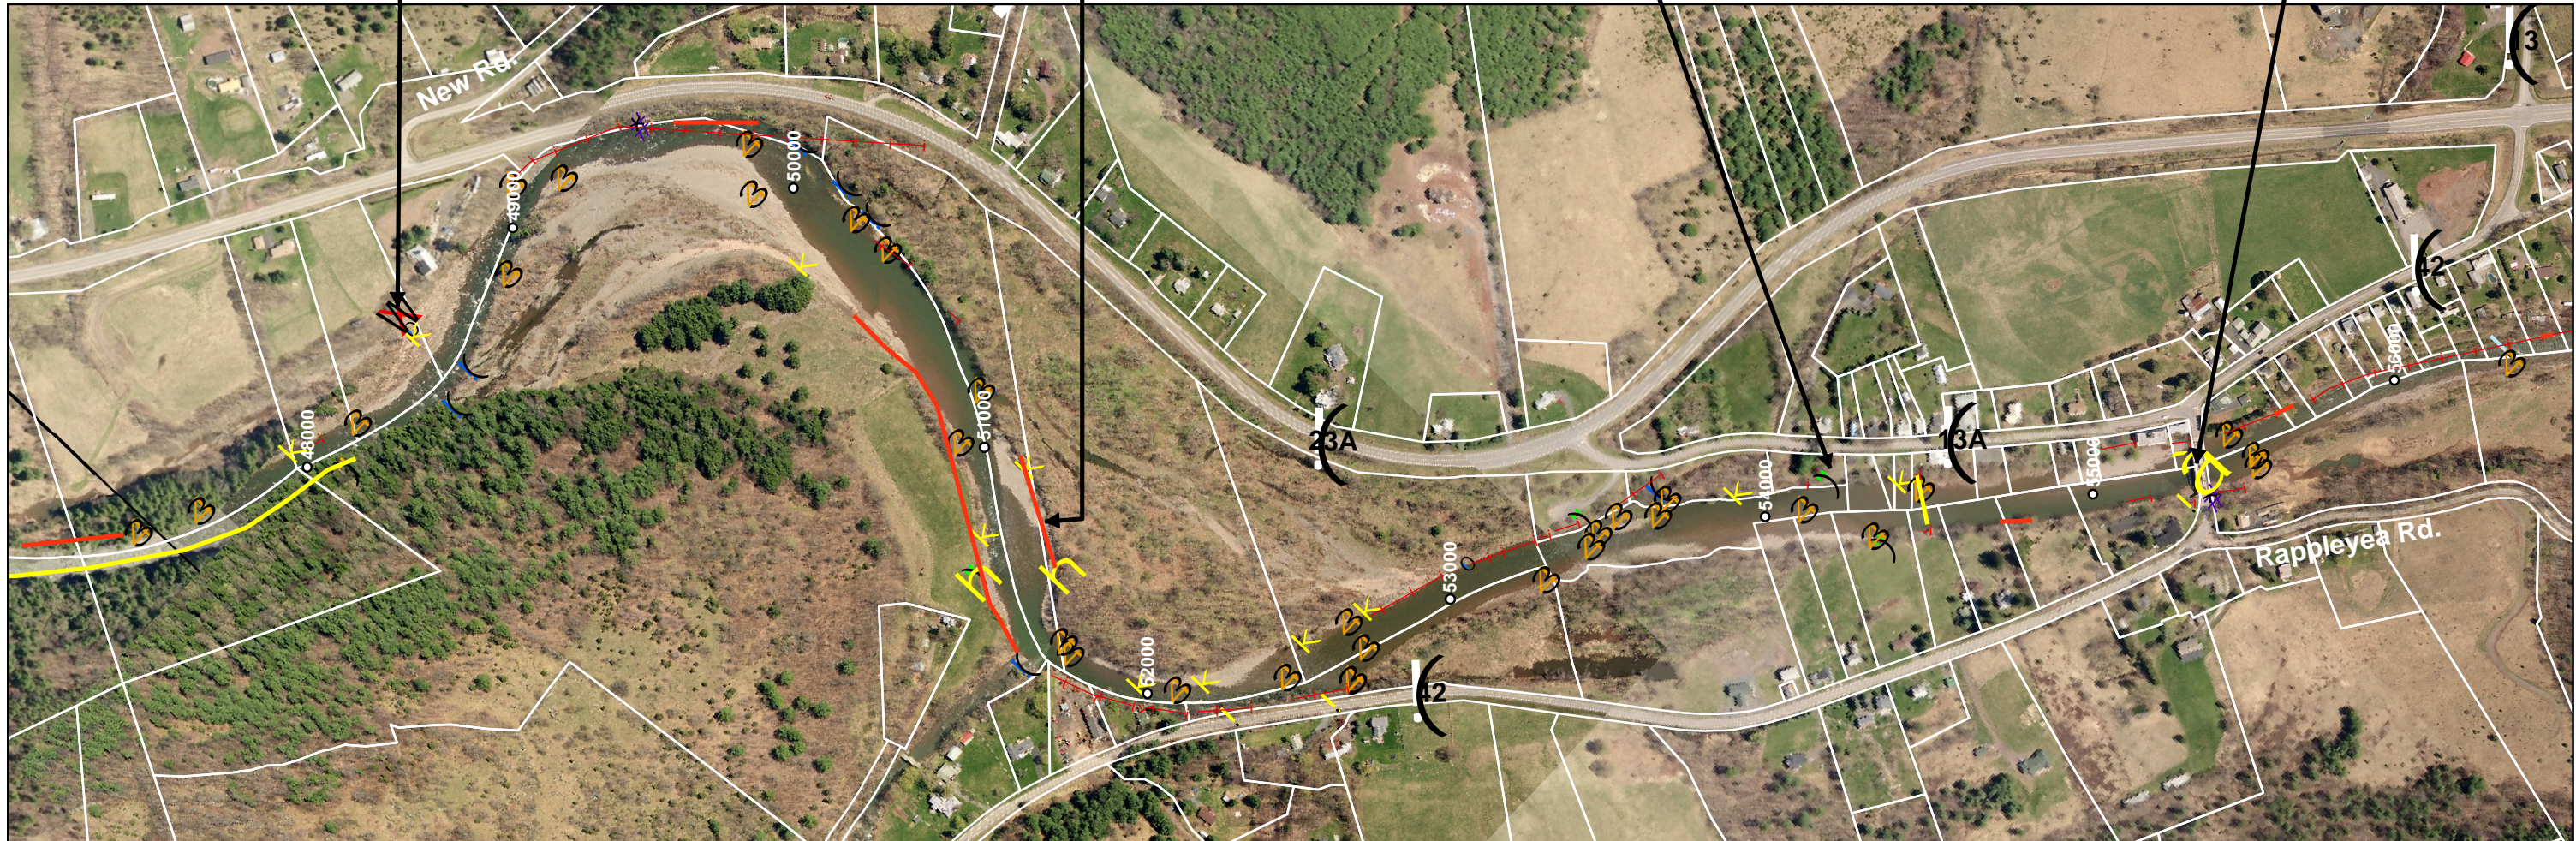
Figure 4.12.1 Management Unit 12 - 2006 aerial photography with stream feature inventory

The 2006 stream feature inventory revealed that 13.1% (1,884 ft) of the streambanks exhibited signs of active erosion along the 14,391 ft of total channel length in the unit (Figure 4.12.1). The total surface area of active erosion totaled approximately 9,794 ft². *Revetment* has been installed on 22.3% (3,205 ft) of the streambanks. No *berms* were identified in this management unit at the time of the stream feature inventory.

Summary of Recommendations Management Unit 12	
Intervention Level	Passive, Assisted Self-Recovery, Full Restoration
Stream Morphology	No recommendations at this time.
Riparian Vegetation	Plantings for assisted self-recovery of eroding banks at 51400 & 51600, enhancement of riparian buffer at Station 53500, 54350 & 54200, and interplanting of revetment at Stations 52600-51700.
Infrastructure	No recommendations at this time.
Aquatic Habitat	Watershed Aquatic Habitat Study.
Flood Related Threats	Replacement of County Rt. 13A culvert and installation of floodplain drainage to remediate flooding of roadway and residences.
Water Quality	Removal of dump site at Station 48500.
Further Assessment	Study effects of sill removal or creation of low flow channel in sill at Station 54480. Resurvey of bank erosion monitoring site at Station 51400 to assess erosion rate.

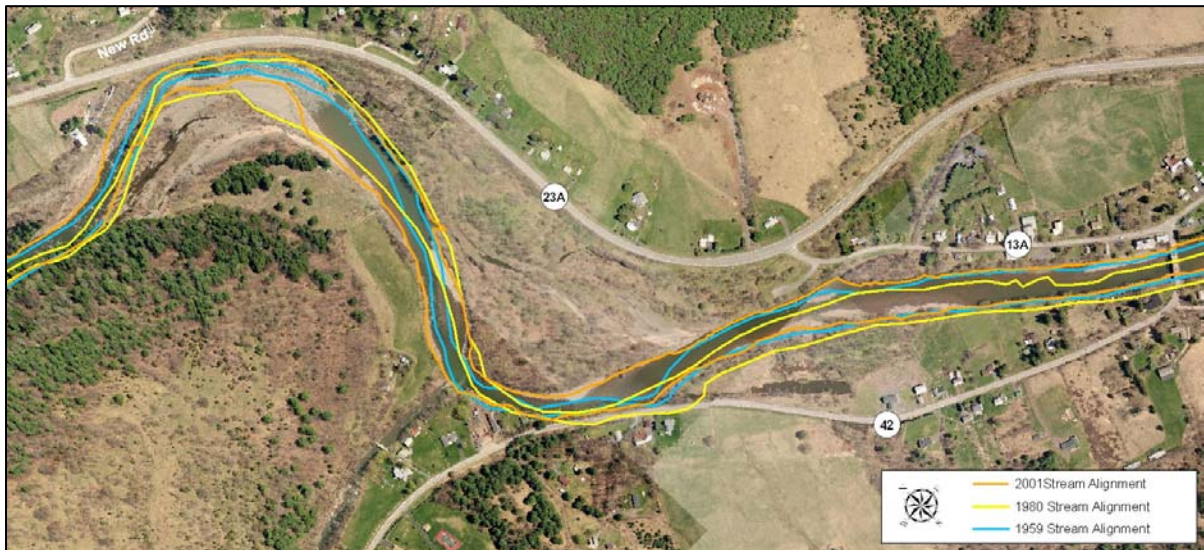
Historic stream channel alignments overlaid with 2006 aerial photograph

As seen from the historical stream alignments (below), the general *planform* of the channel has remained fairly stable since 1959. However, it was apparent the stream channel had widened significantly over the years. As of 2006, according to available NYS DEC records dating back to 1996, there had been no stream disturbance permit issued in this management unit.

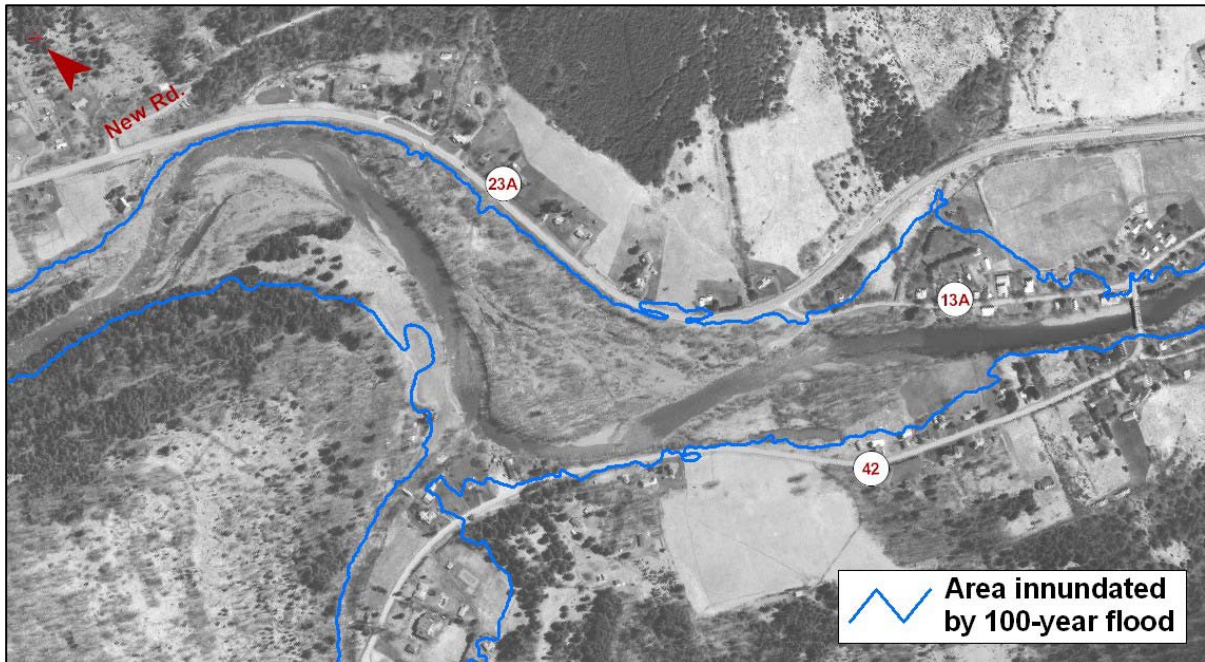
100-year floodplain boundary map

According to the current floodplain maps (below), twenty-three existing structures in this unit appeared to be situated within the estimated 100-year floodplain. The 100-year floodplain is that area predicted to be inundated by floods of a magnitude that is expected to
