Schoharie Creek Management Unit 13

Town of Lexington – Station 48154 to Mosquito Point Bridge (Station 41722)

Schoharie Creek Management Unit 13 Stream Feature Inventory

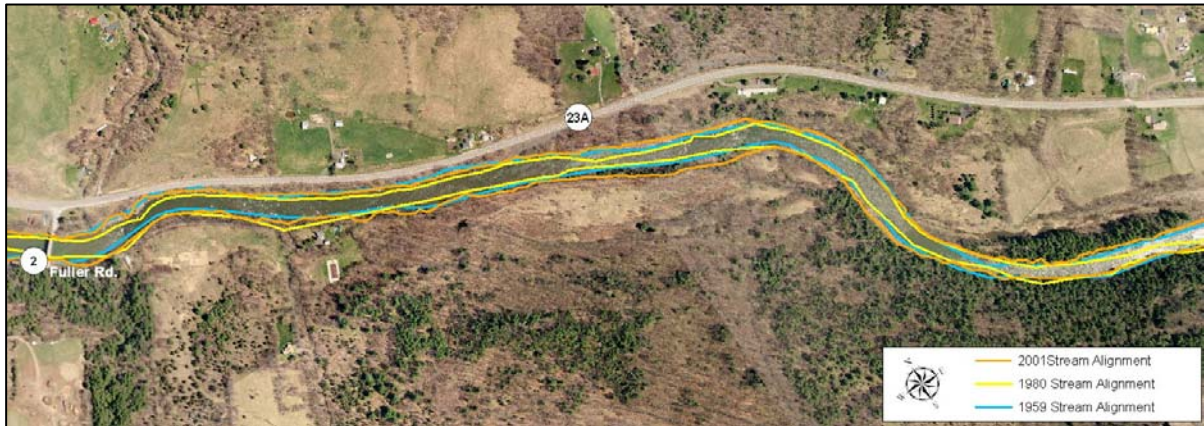
As seen from the historical stream alignments (below), the *planform* of the channel has remained fairly stable since 1959. As of 2006, according to available NYSDEC records dating back to 1996, there had been no stream disturbance permits issued in this management unit.

Historic stream channel alignments overlaid with 2006 aerial photograph

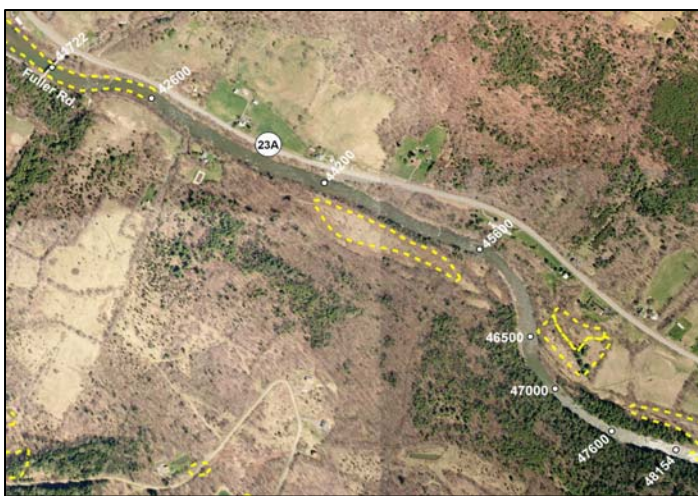
Wetlands (Stations 48154-41722)
approximate wetland boundary delineated by NWI

Five wetlands were located within this management unit. Continued from the previous unit, there was a palustrine wetland with shrub-scrub vegetation along the right streambank at the beginning of the unit (PSS1E, 1.1 ac, Station 48154-47600). Just downstream, two palustrine wetlands were located along the right streambank, one was dominated by shrub-scrub vegetation

while the other emergent vegetation (PSS1E, 2.6ac, PEM1E, 1.5ac, Station 47000-46500). A fourth palustrine shrub-scrub wetland was located along the left streambank (PSS1E, 4.5ac, Station 45600-44200). The wetland at the downstream end of the unit was classified as riverine lower perennial, signifying it was contained in the natural channel and characterized by a low gradient and slow water velocity (R2UBH, 2.2ac Station 42600-41722). Wetlands are important features in the landscape that provide numerous beneficial functions including protecting and improving water quality, providing fish and wildlife habitats, storing floodwaters, and maintaining surface water flow during dry periods (see Section 2.6 for detailed wetland type descriptions).

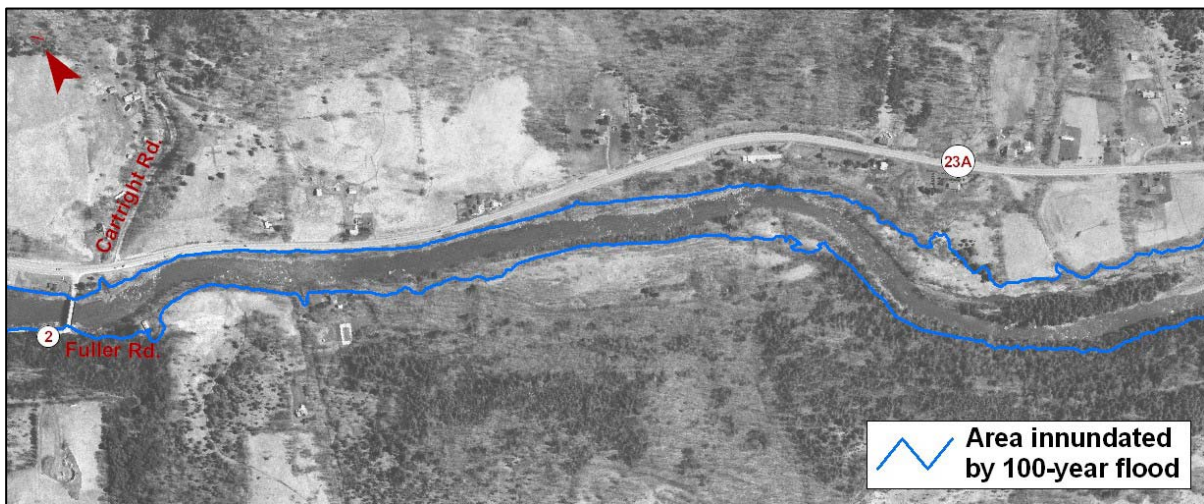
100-year floodplain boundary map

According to the current floodplain maps (above), no existing structures in this unit appeared to be situated within the estimated 100-year floodplain. The 100-year floodplain is that area predicted to be inundated by floods of a magnitude that is expected to occur once in any 100-year period, on the basis of a statistical analysis of local flood records. Most
