# Schoharie Creek Management Unit 14

Town of Lexington – Mosquito Point Bridge (Station 41722) to Station 34336

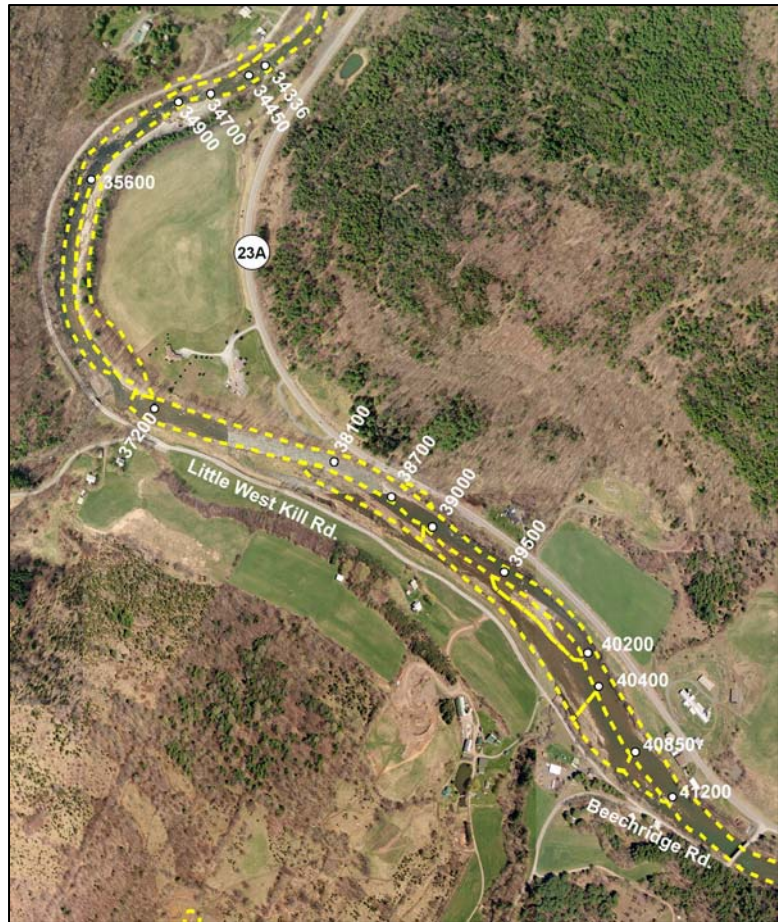
*Wetlands (Station 41722-34336)  
approximate wetland boundary delineated by NWI*

Ten wetlands were located within this management unit. Three wetlands, along the stream channel were classified as riverine lower perennial, signifying they were contained in the natural channel and characterized by a low gradient and slow water velocity (R2UBH, 18.5ac Station 41722-34336) (R2USC, 1.1ac Station 40200-39500) (R2USA, 0.2ac Station 39000-38700). The remaining wetlands were classified as palustrine; five had emergent vegetation (PEM1E, 0.5ac, Station 41200-40850) (PEM1C, 3.9ac, Station 40400-

39000) (PEM1E, 3.3ac, Station 37200-35600) (PEM1E, 0.3ac, Station 34900-34700) (PEM1E, 0.3ac, Station 34450-34336), one along the left streambank at the upstream end of the unit was dominated by shrub-scrub vegetation (PSS1C, 1.7ac, Station 40850-40400), and one along the left streambank in the middle of the unit was forested (PFO1A, 1.7ac, Station 39000-38100). Wetlands are important features in the landscape that provide numerous beneficial functions including protecting and improving water quality, providing fish and wildlife habitats, storing floodwaters, and maintaining surface water flow during dry periods (see Section 2.6 for detailed wetland type descriptions).

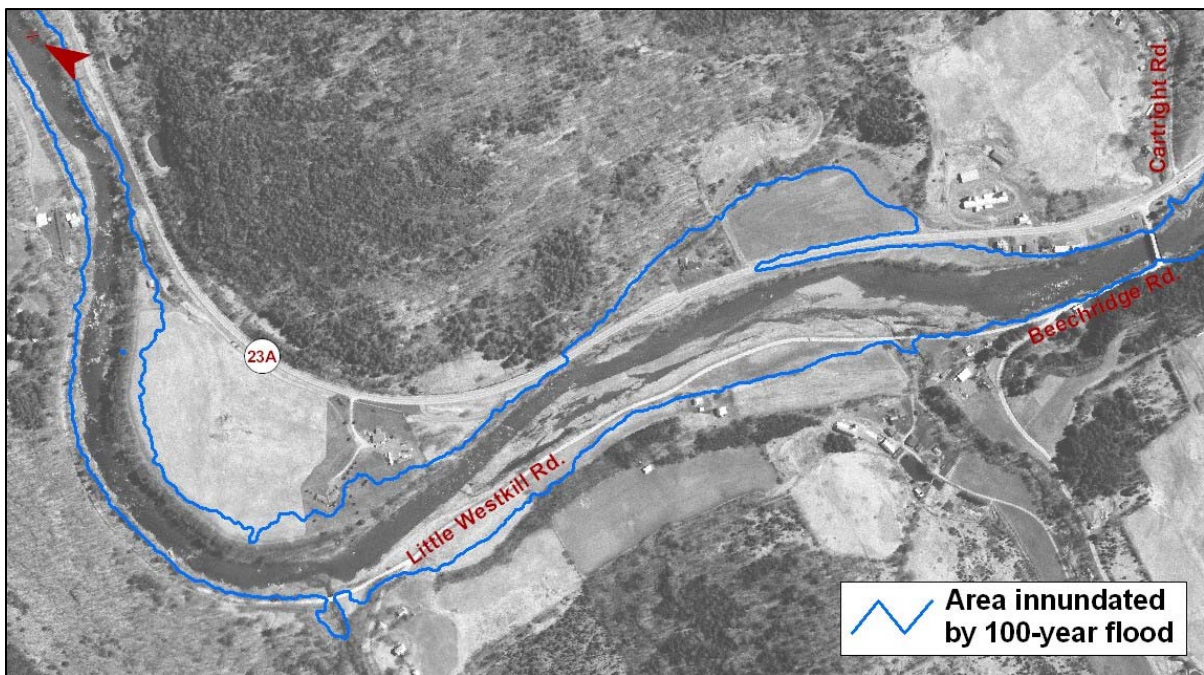
*100-year floodplain boundary map*

According to the current floodplain maps (below), three existing structures in this unit appeared to be situated within the estimated 100-year floodplain. The 100-year floodplain is

that area predicted to be inundated by floods of a magnitude that is expected to occur once in any 100-year period, on the basis of a statistical analysis of local flood record. Most communities regulate the type of development that can occur in areas subject to these flood risks.
