Schoharie Creek Management Unit 15

Town of Lexington – Station 34336 to Station 31388

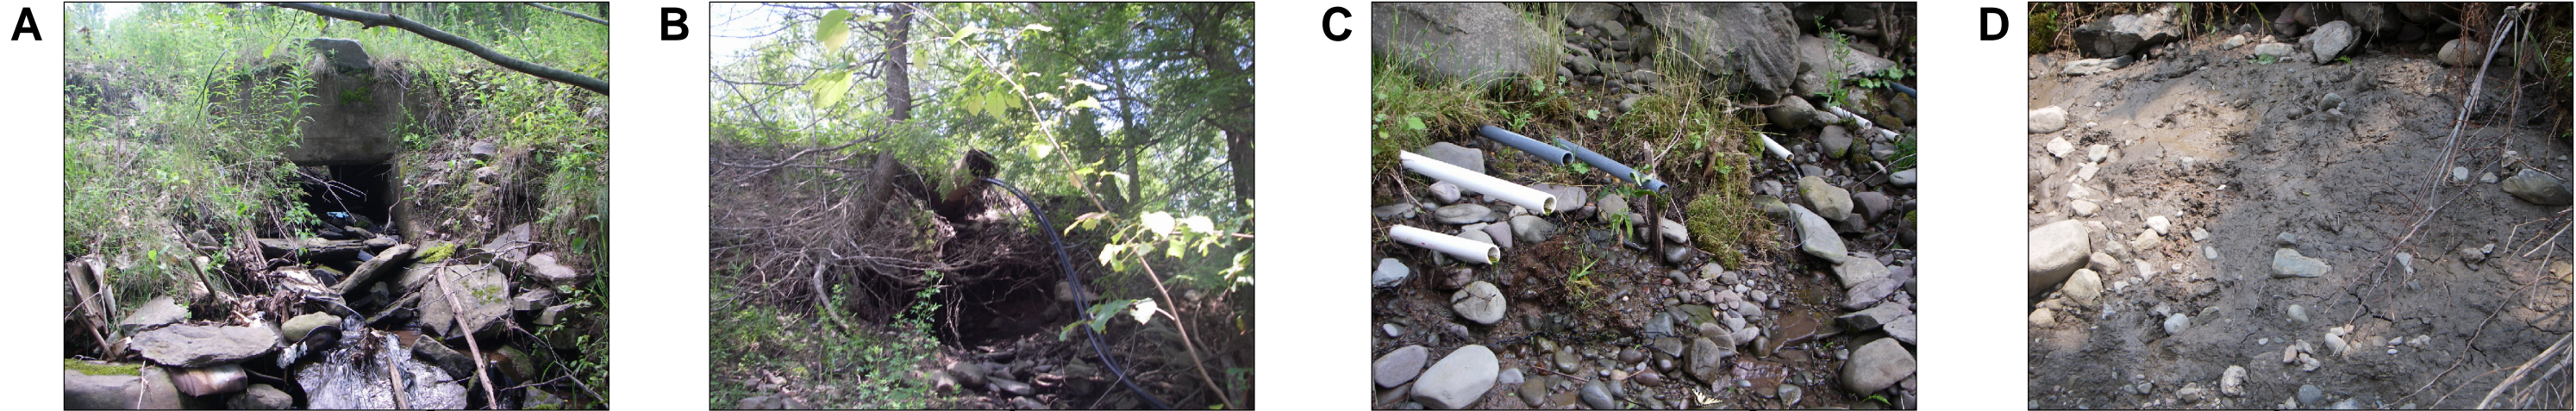
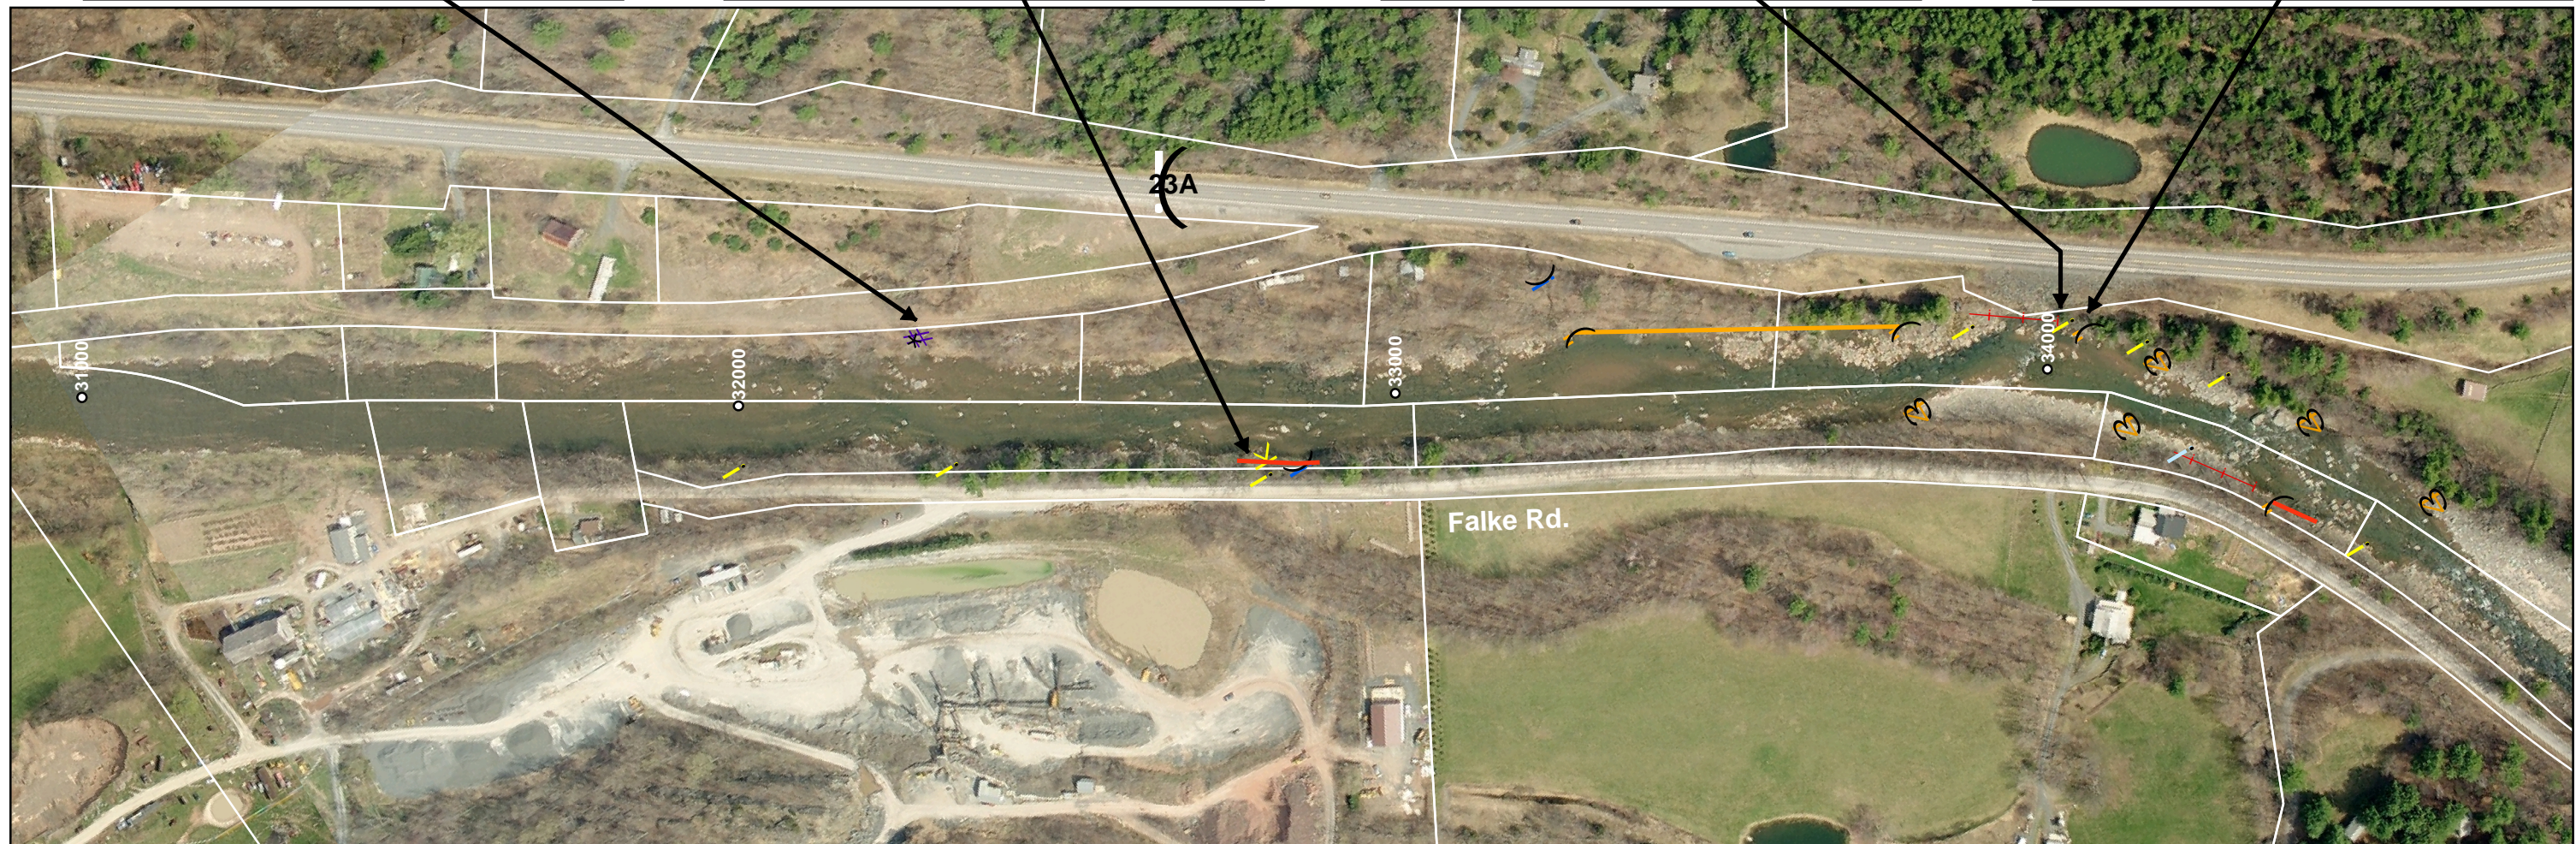
Figure 4.15.1 Management Unit 15 - 2006 aerial photography with stream feature inventory

The 2006 stream feature inventory revealed that 2.1% (126 ft) of the streambanks exhibited signs of active erosion along the 5,896 ft of total channel length in the unit (Figure 4.15.1). The total surface area of active erosion totaled approximately 3,283 ft². *Revetment* had been installed on 4.5% (265 ft) of the streambanks. No *berms* were identified in this management unit at the time of the stream feature inventory.

On the opposite bank, the County Route 23A road embankment had scoured along 100 ft of the right streambank exposing the underlying *lacustrine* clay (Inset D, Station 34050). Fine sediment inputs into a stream increase *turbidity* and can act as a transport mechanism for other pollutants and pathogens. Sixteen small 1” drainage pipes outlet stormwater at the toe of the bank exacerbating this scour (Inset C). To provide

Summary of Recommendations Management Unit 15	
Intervention Level	Assisted Self-Recovery
Stream Morphology	No recommendations at this time
Riparian Vegetation	Plantings for assisted self-recovery of eroding banks at Stations 34050 & 33800 and interplanting of rip-rap at Stations 34360 & 34000
Infrastructure	Installation of stormwater outfall protection at Station 32800
Aquatic Habitat	Watershed Aquatic Habitat Study
Flood Related Threats	No recommendations at this time
Water Quality	No recommendations at this time
Further Assessment	No recommendations at this time
