Schoharie Creek Management Unit 16

Town of Prattsville – Station 31388 to County Route 23 (Station 19376)

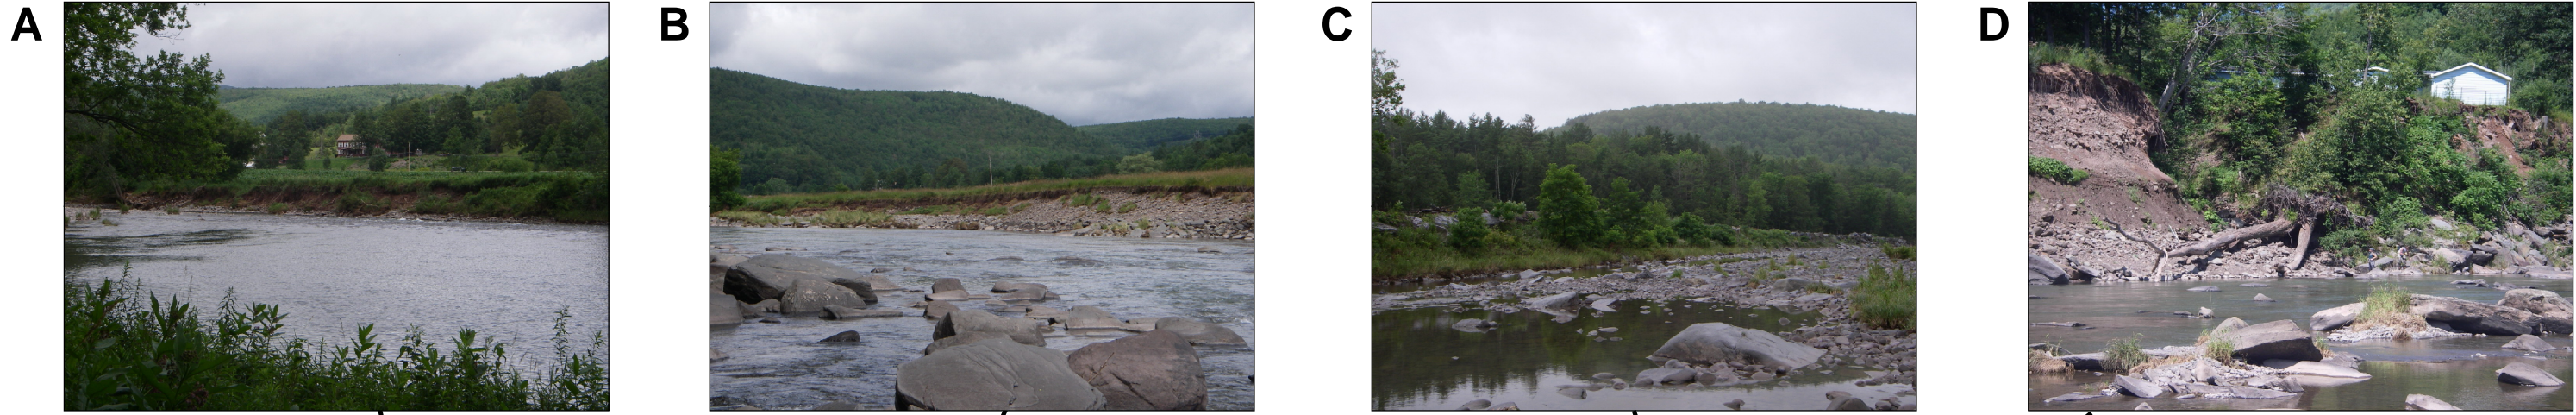
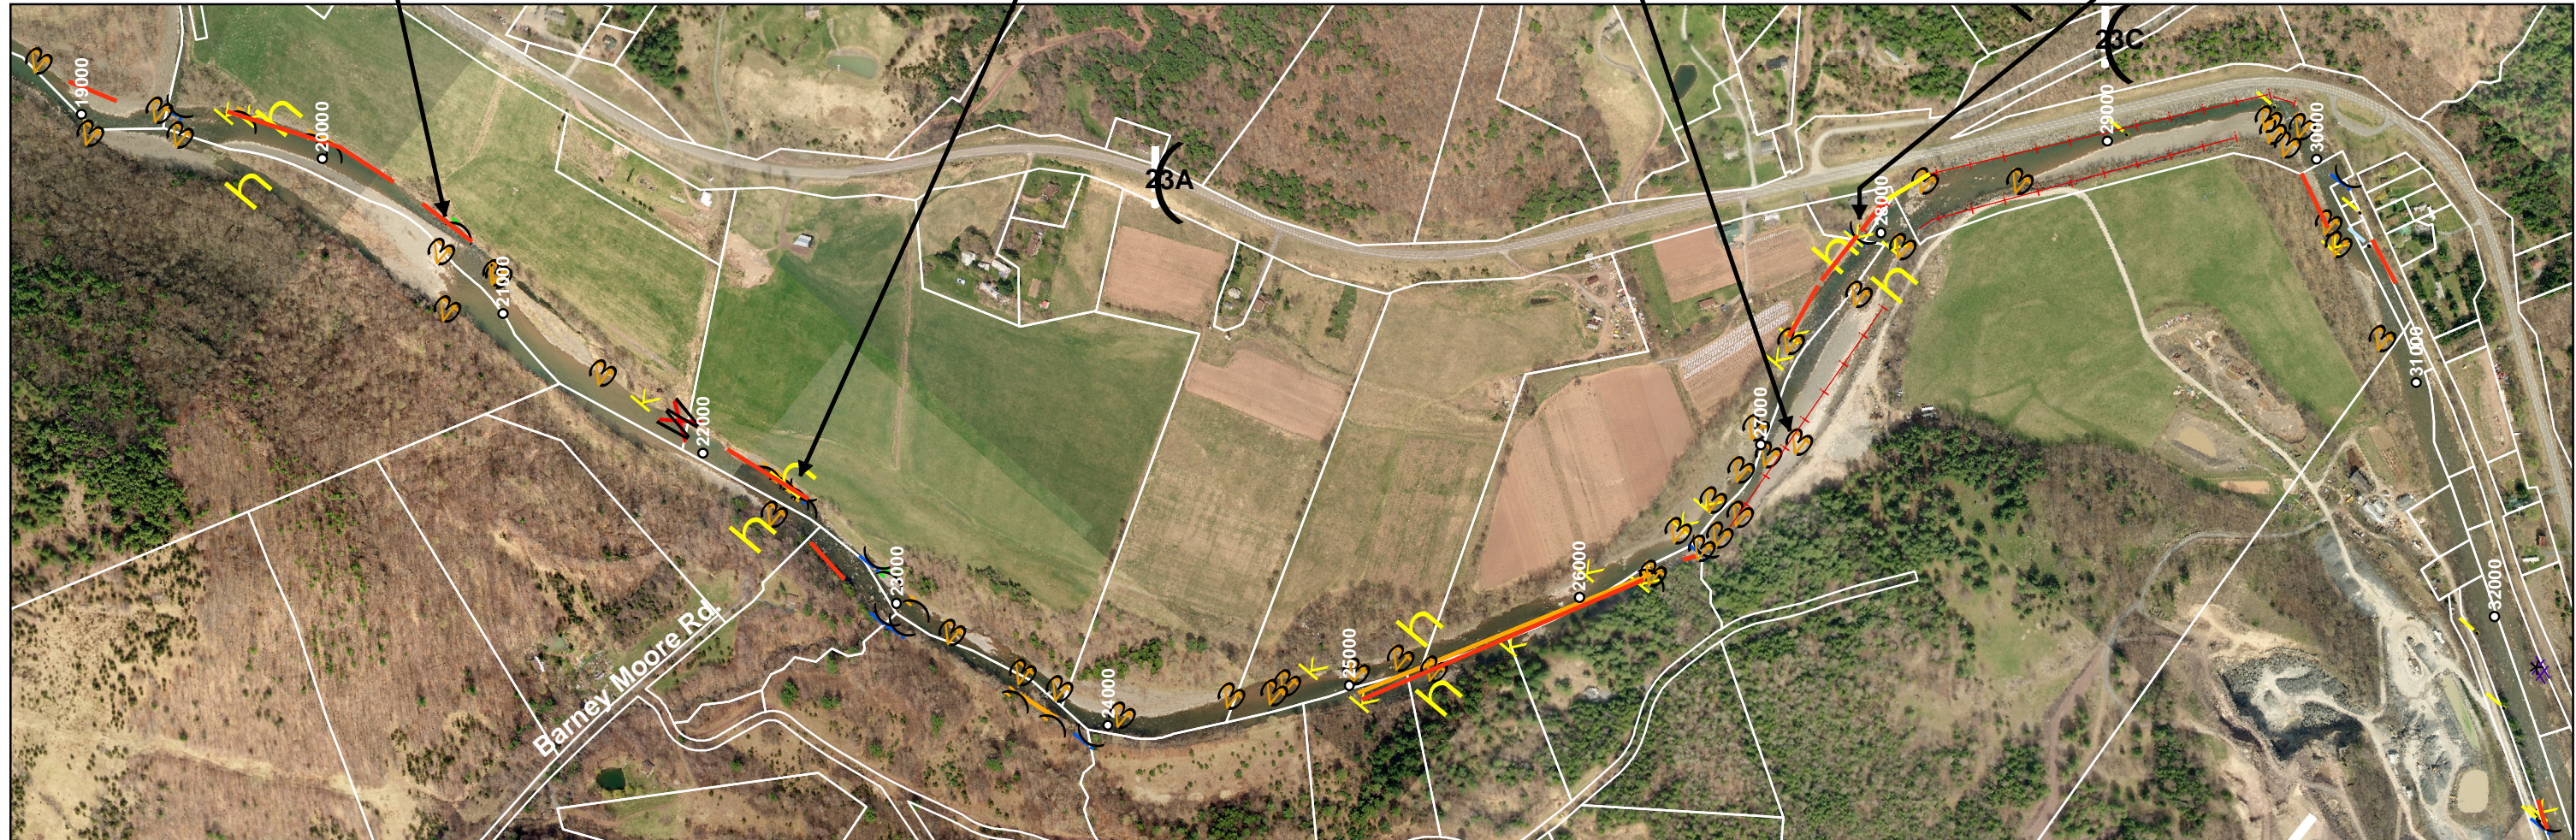
Figure 4.16.1 Management Unit 16 - 2006 aerial photography with stream feature inventory

The 2006 stream feature inventory revealed that 16.5% (3,962 ft) of the streambanks exhibited signs of active erosion along the 24,025 ft of total channel length in the unit (Figure 4.16.1). The total surface area of active erosion totaled approximately 76,453 ft². *Revetment* had been installed on 16.9% (4,064 ft) of the streambanks. No *berms* were identified in this management unit at the time of the stream feature inventory.

Summary of Recommendations Management Unit 16	
Intervention Level	Passive, Assisted Self-Recovery
Stream Morphology	No recommendations at this time
Riparian Vegetation	Plantings for assisted self-recovery of eroding banks at Stations 30600 & 20750, enhancement of riparian buffer at Station 22900, 20750, & 20300, and interplanting of rip-rap at Stations 29750, 29500 & 27700.
Infrastructure	No recommendations at this time
Aquatic Habitat	Watershed Aquatic Habitat Study
Flood Related Threats	No recommendations at this time
Water Quality	Removal of dump site at Station 21850.
Further Assessment	Resurvey of bank erosion monitoring site at Stations 27840, 25340, 22350 & 19770 to assess erosion rate.

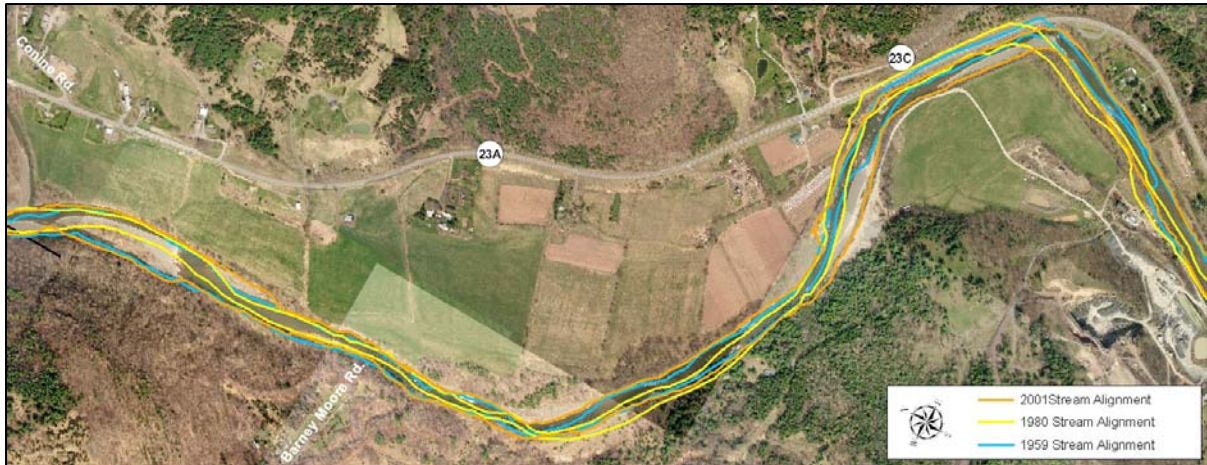
As seen from the historical stream alignments (below), the *planform* of the channel has remained fairly stable since 1959.

Historic stream channel alignments overlaid with 2006 aerial photograph

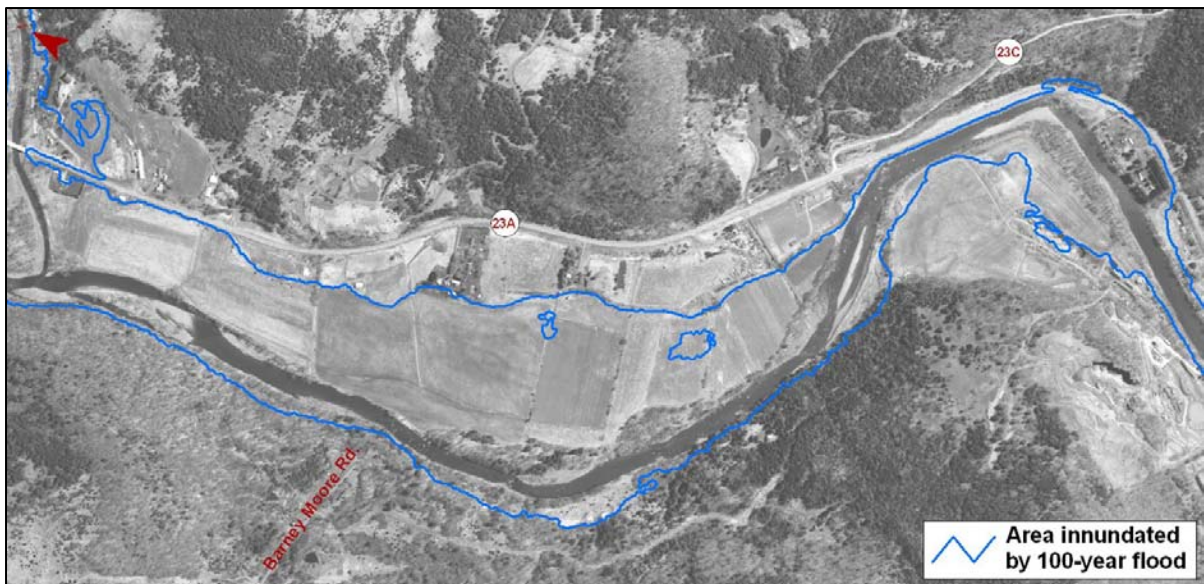
According to the current floodplain maps (below), fourteen existing structures in this management unit appeared to be situated within the estimated 100-year floodplain. The 100-

100-year floodplain boundary map
