Schoharie Creek Management Unit 17

Town of Prattsville – Station 19376 to NYS Route 23 Bridge (Station 10486)

This management unit began at the confluence with Batavia Kill (Station 19376), and continued approximately 8,890 ft to the NYS Route 23 Bridge (Station 10486) in the Town of Prattsville.

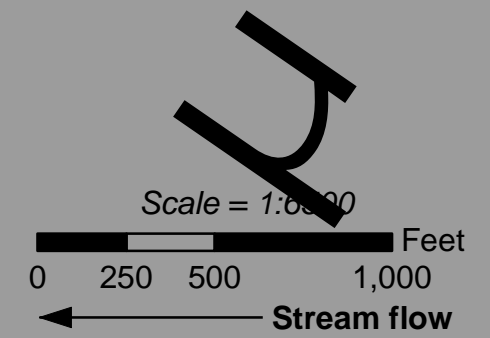
Figure 4.17.1 Management Unit 17 - 2006 aerial photography with stream feature inventory

The 2006 stream feature inventory revealed that 10.6% (1,888 ft) of the streambanks exhibited signs of active erosion along the 17,779 ft of total channel length in the unit (Figure 4.17.1). The total surface area of active erosion totaled approximately 15,754 ft². *Revetment* has been installed on 18.7% (3,328 ft) of the streambanks. No *berms* were identified in this management unit at the time of the stream feature inventory.

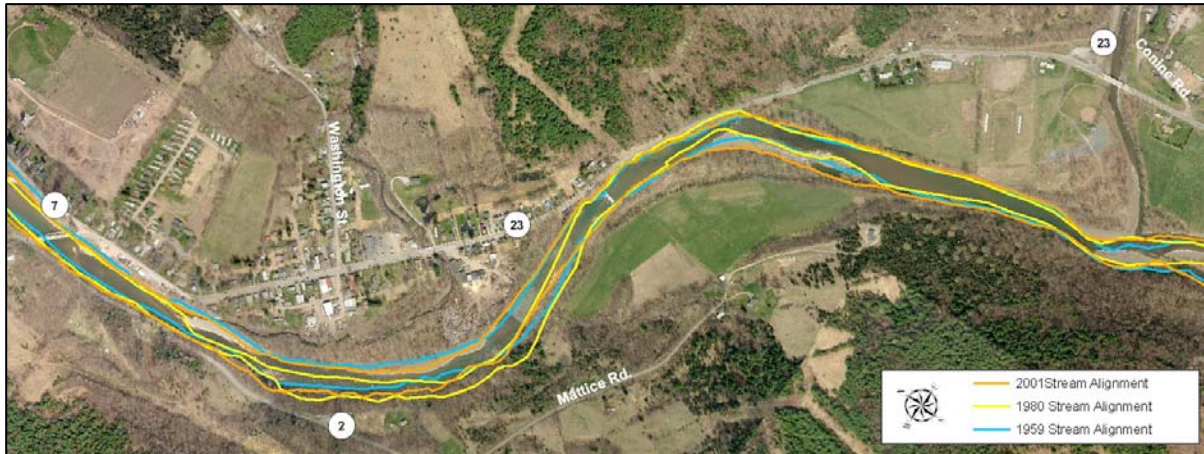
As seen from the historical stream alignments (below), the *planform* of the channel has remained fairly stable since 1959.

Historic stream channel alignments overlaid with 2006 aerial photograph

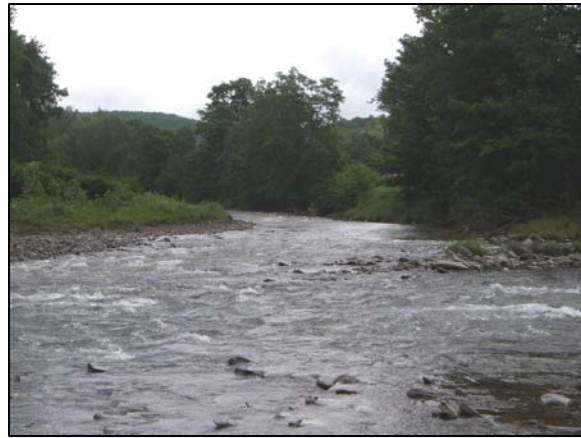
At the upstream end of this management unit the Batavia Kill entered the Schoharie Creek from the right streambank (Station 19300). The Batavia Kill originates in the Big Hollow area of the Town of Windham on the south slopes of Windham High Peak, Burnt Knob and Acra Point Mountains, and flows west 21 miles through the towns of Windham, Ashland and Prattsville to its confluence with the Schoharie Creek, near the hamlet of Prattsville. As the stream winds its way down the valley floor, it drops approximately 2,000 feet in elevation from its origin at around 3,600 feet, to the stream’s confluence with the

Schoharie Creek at approximately 1,600 feet. As a result of this topography change, the tributary lost its ability to transport sediment gathered from the Batavia Kill Watershed, and began to deposit sediment at its mouth and into the Schoharie Creek. This is a common feature of confluence areas, which often contain extensive sediment bars, function as important sediment storage areas and are typically among the most

Batavia Kill tributary - looking upstream

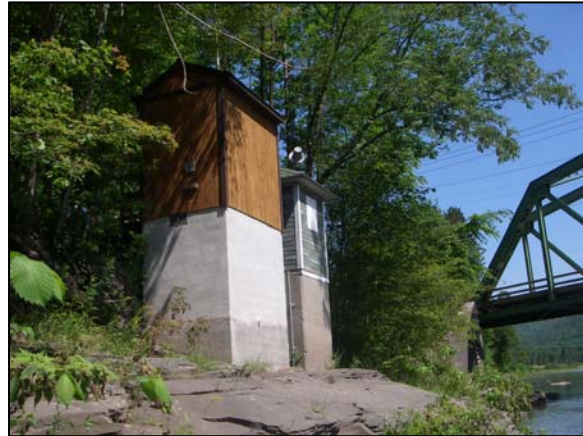
A United States Geologic Survey (USGS) continuously recording stream gage was located on the left streambank approximately 100 ft upstream from the NYS Route 23 bridge in Prattsville (Station 10600). This gage (#01350000) has a drainage area of 237 mi² and has been collecting data from November 1902 to the present. All gage information including real time discharge and gage height is available online at the USGS website:

USGS stream gage #01350000 at State Route 23 bridge in Prattsville - Station 10600

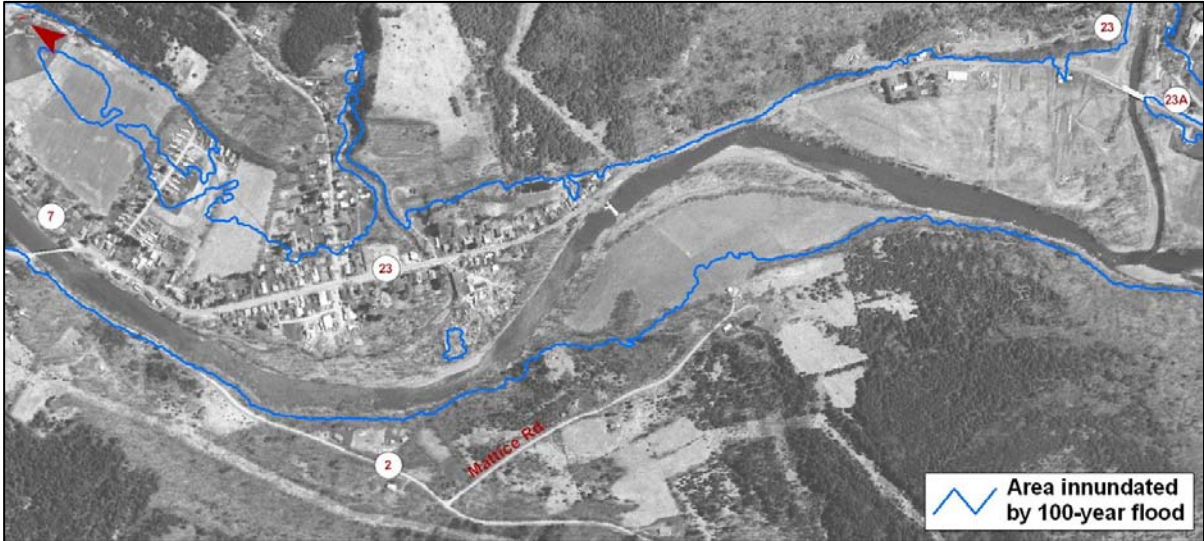
100-year floodplain boundary map

According to the current floodplain maps (above), one hundred sixty-five existing structures in this unit appeared to be situated within the estimated 100-year floodplain. The 100-year floodplain is that area predicted to be inundated by floods of a magnitude that are expected to occur once in any 100-year period, on the basis of a statistical analysis of local
