Schoharie Creek Management Unit 18

Town of Prattsville – County Route 23 Bridge (Station 10486) to Station 0

This management unit began at the County Route 23 Bridge (Station 10486), and continued approximately 10,486 ft to Station 0 in the Town of Prattsville.

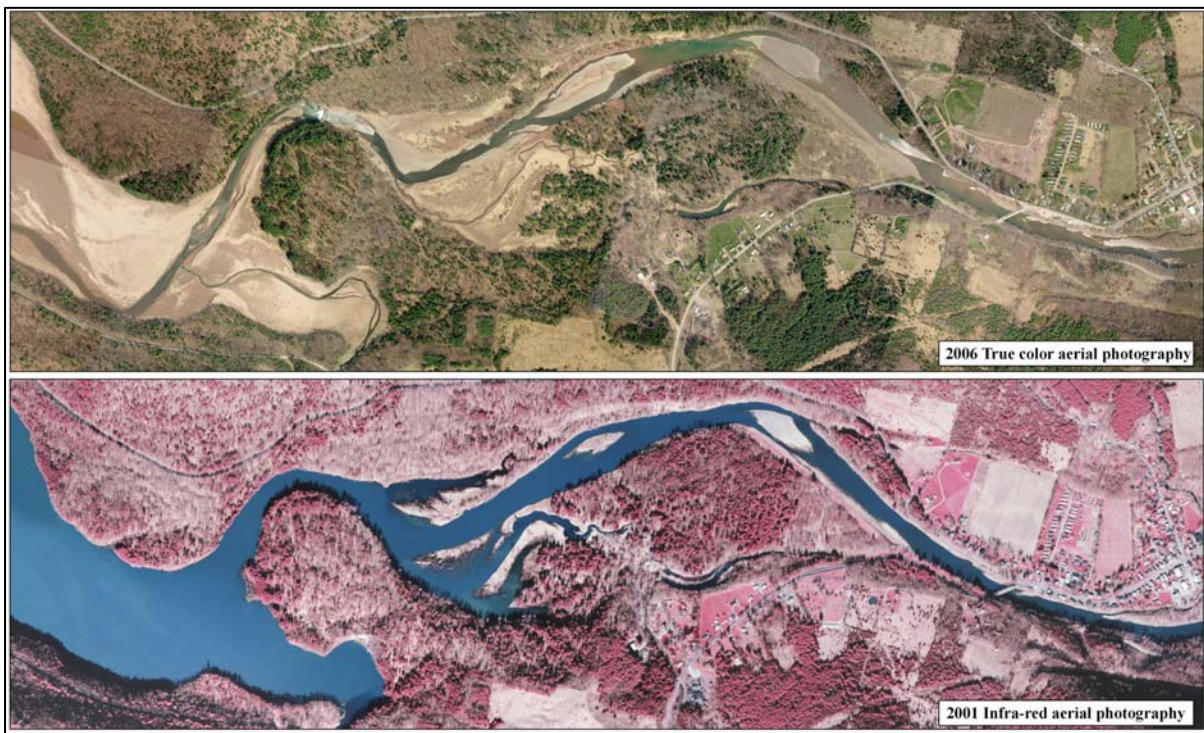
During the 2006 stream feature inventory water levels in management unit 18 were uncharacteristically low (photo below) due reduced water storage in the Schoharie Reservoir necessary while completing upgrades to the Gilboa dam located at the downstream end of the Schoharie reservoir. Following an engineering analysis in 2005, it was determined that the

2001 (bottom photo) & 2006 (top photo) Management Unit 18 aerial photographs
